Submitted by:
AECOM
Vernon Hills, IL
Project No. 60159452
September 28, 2010

Structural Engineering Evaluation of the Estabrook Park Dam

Milwaukee River, Milwaukee, WI

RE: Structural Engineering Evaluation of the Estabrook Park Dam Located on the Milwaukee River, Milwaukee, Wisconsin – AECOM Project No. 60159452

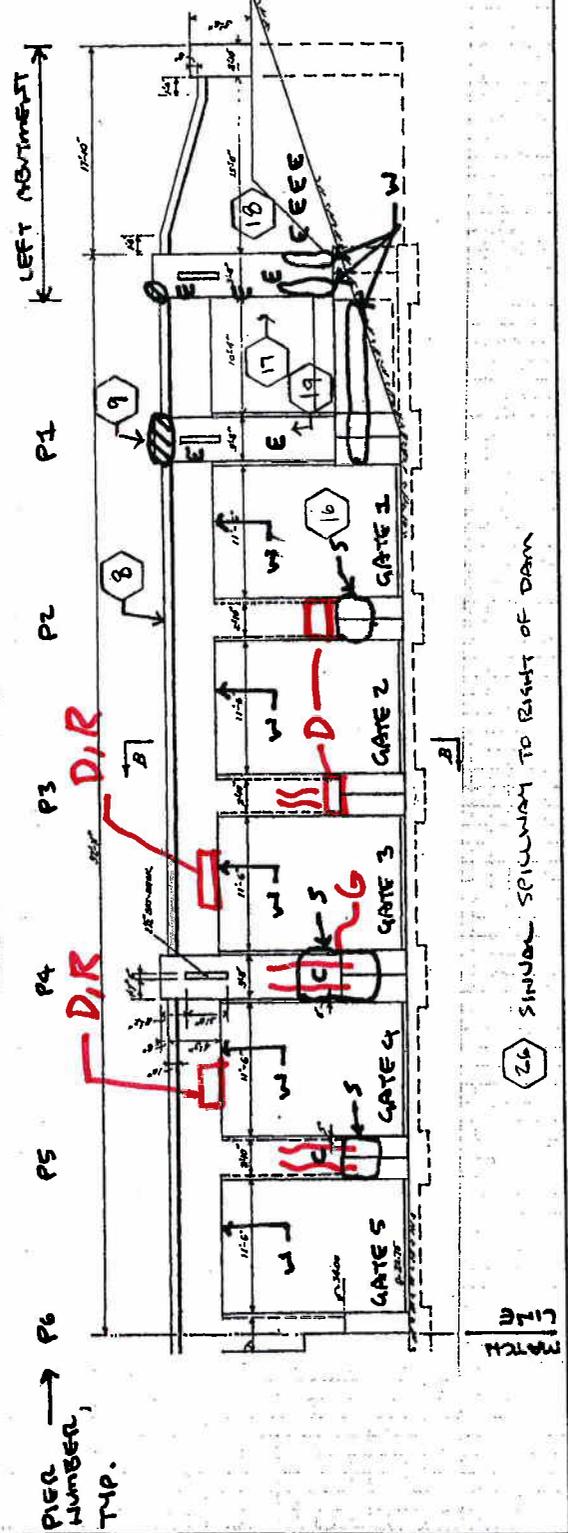
FIGURE 3

26 SIMILAR SPALLING TO RIGHT OF DAM

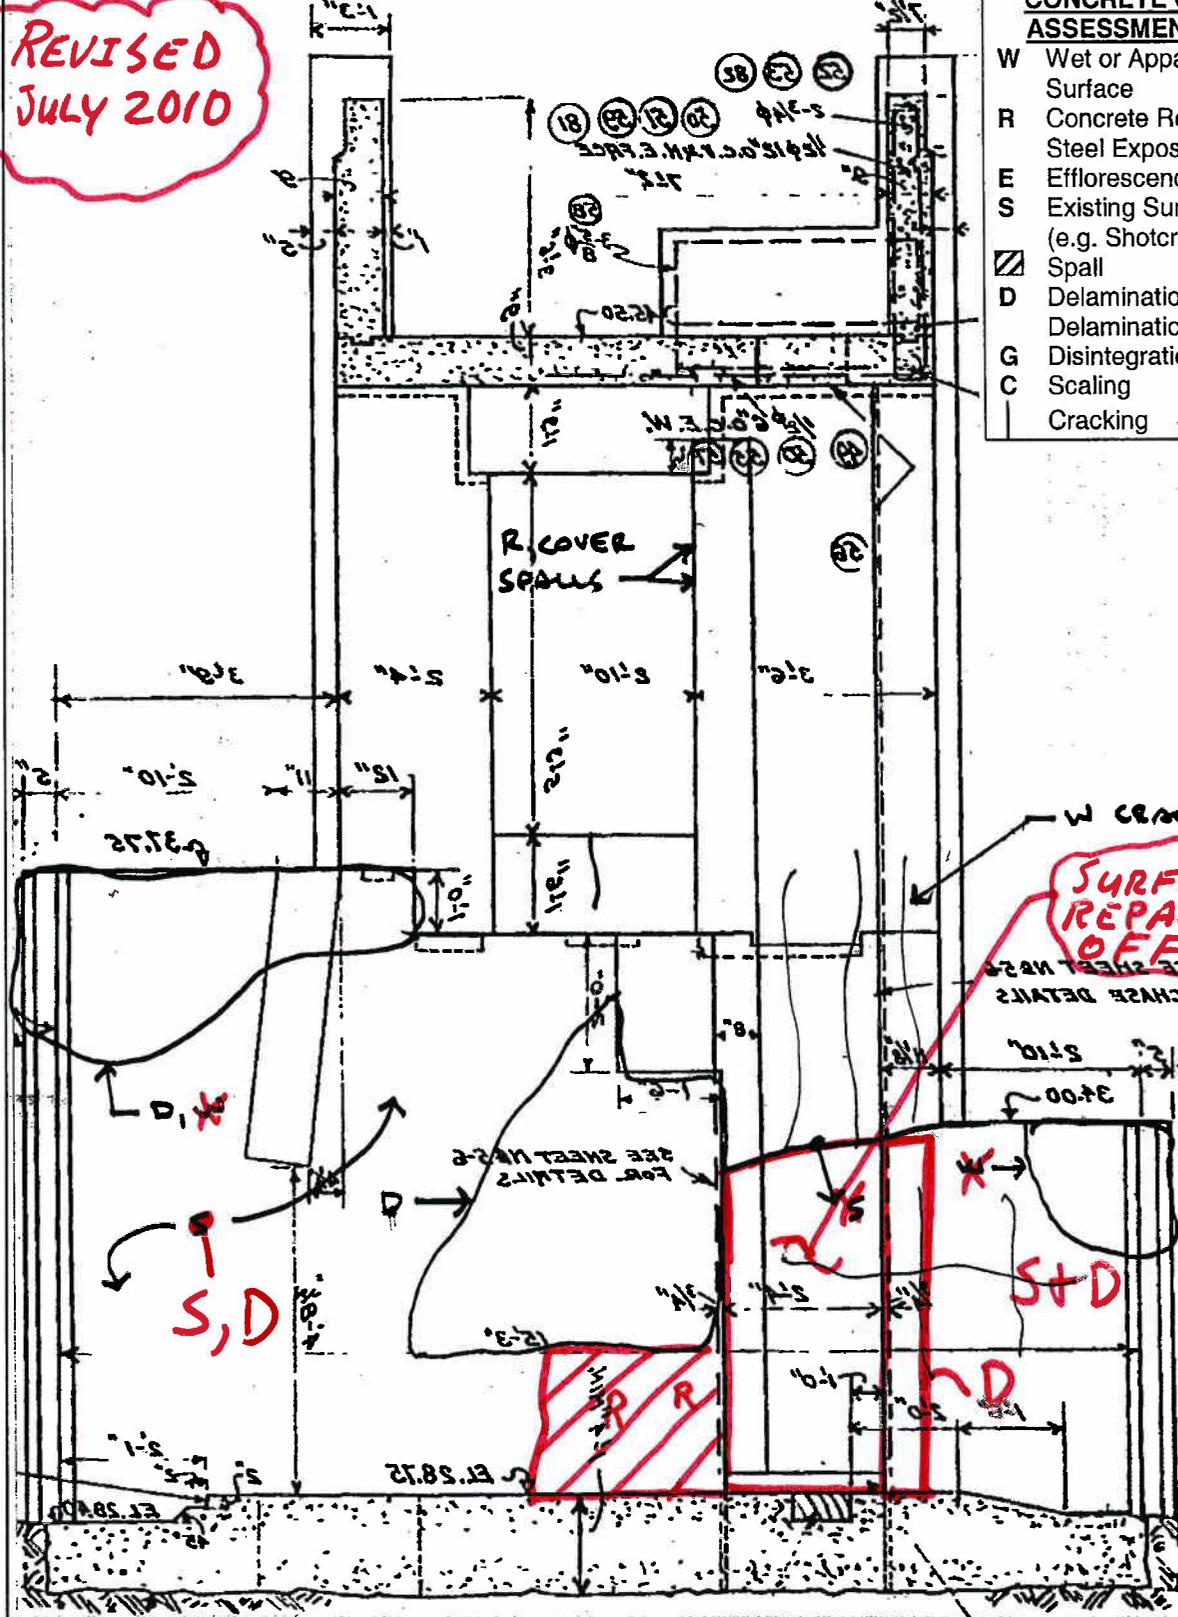
FIGURE 22

W CRACKS
SURFACE REPAIR SPALLED OFF

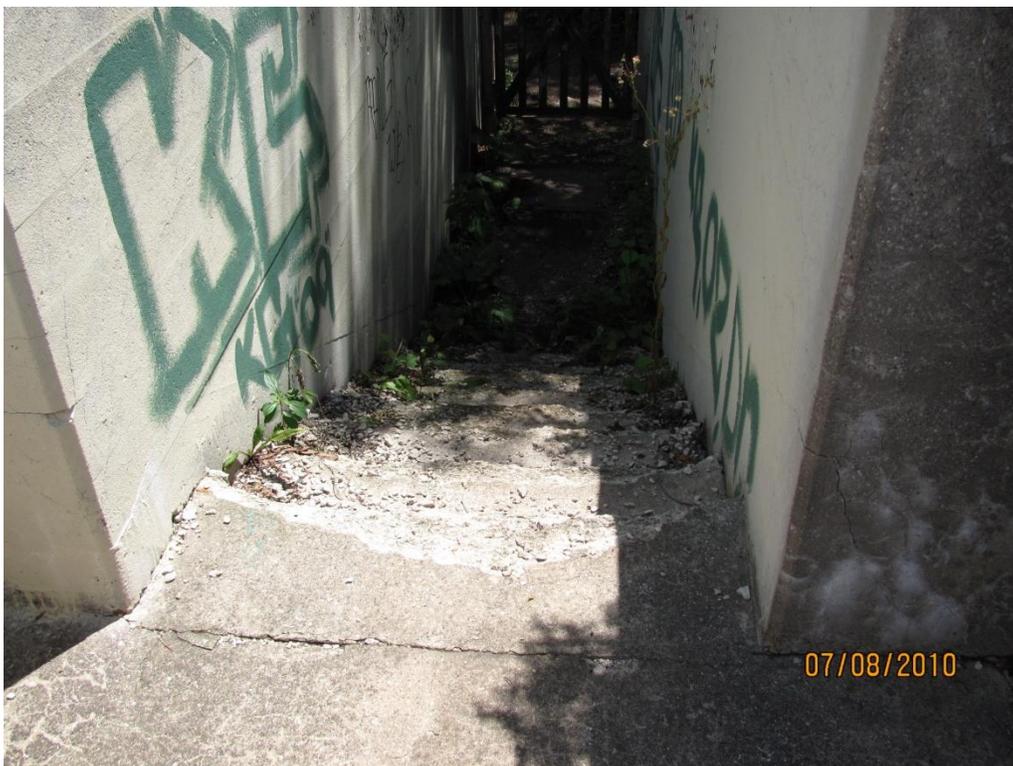
Photo 4: View of deterioration on the right abutment steps.

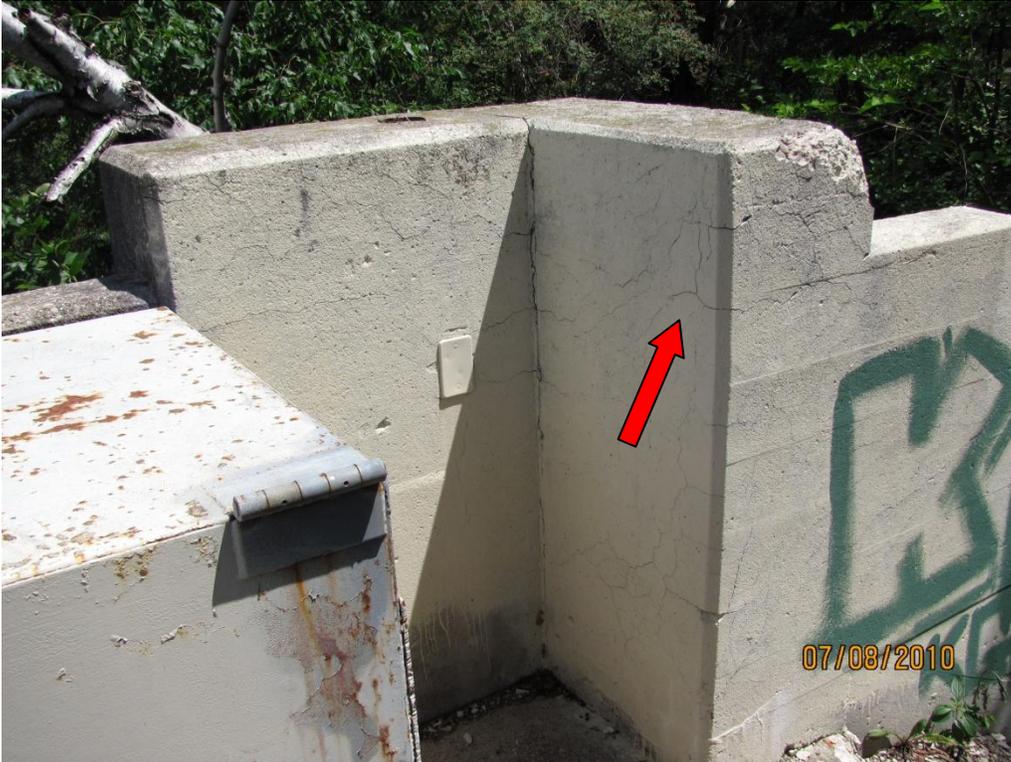
Photo 5: View of the downstream side wall at the right abutment. Note map cracking (arrow) and spalling of the wall.

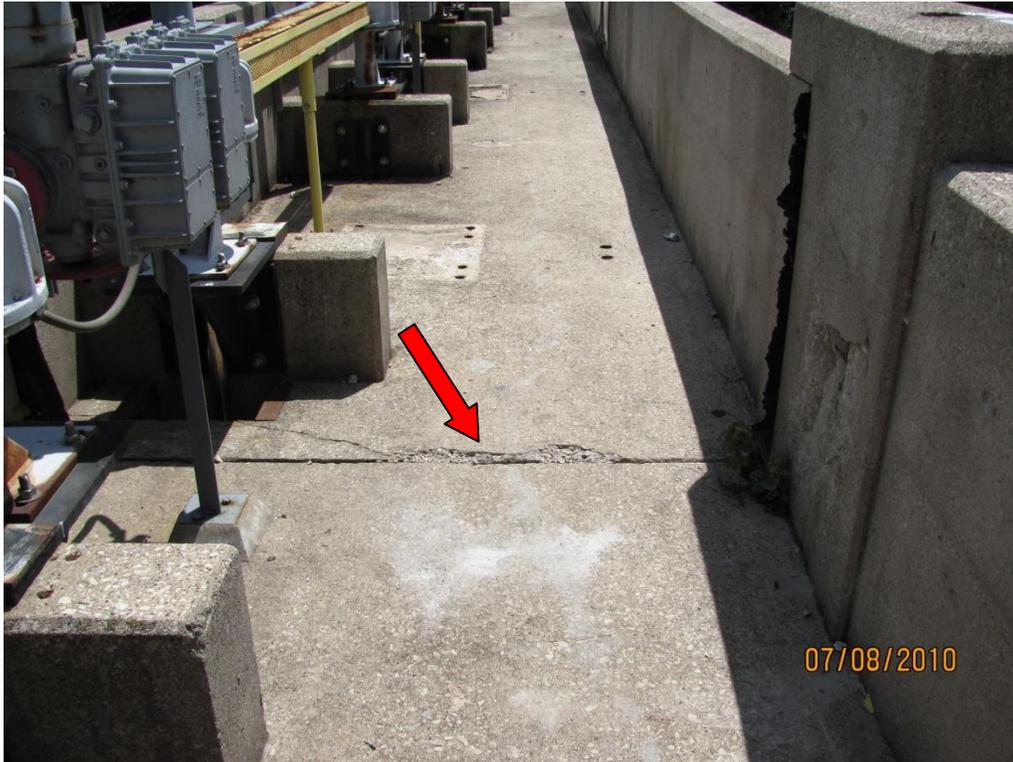
Photo 7: View of the expansion joint in the operating deck at Pier 1. Note joint material extending outward from joint at wall (right) and spalling at the joint (arrow).

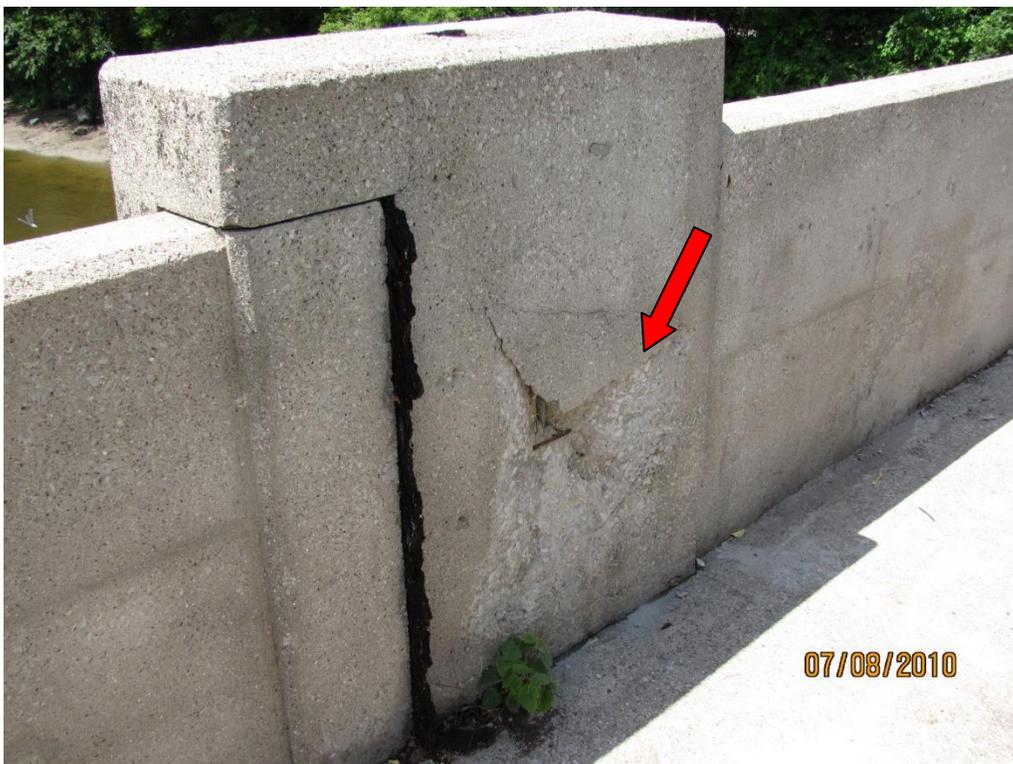
Photo 8: Typical spall of the operating bridge wall (arrow) and expansion joint filler material squeezed outward from the joint.

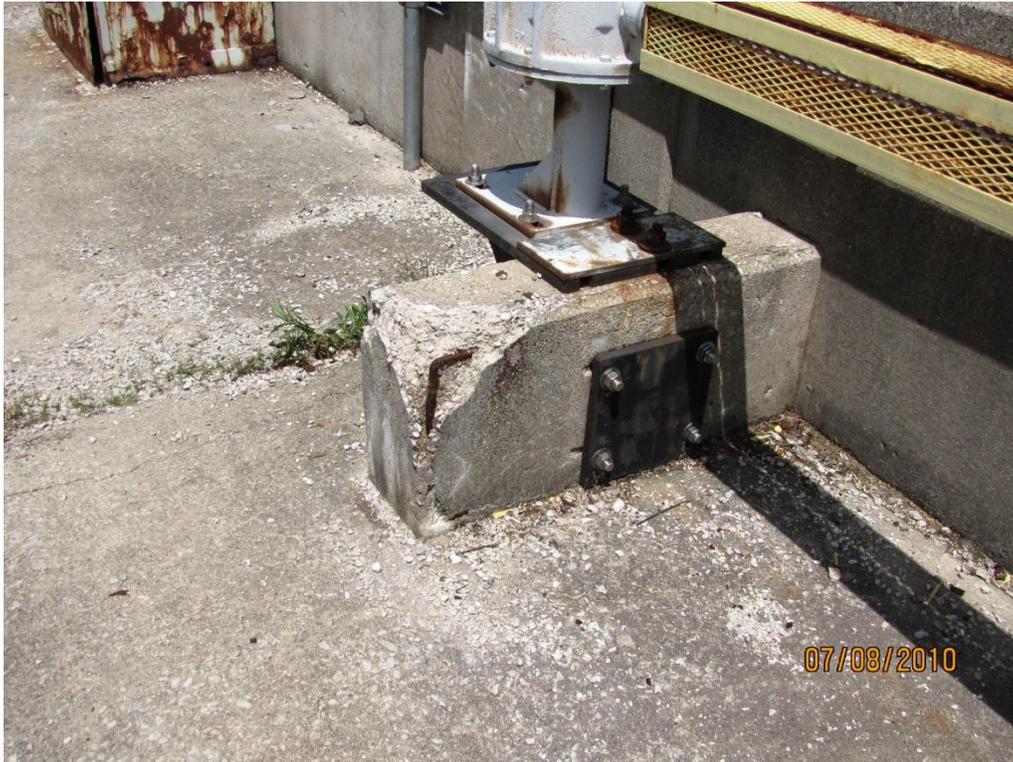
Photo 9: View of concrete deterioration on pedestal and disintegration of concrete of the operating deck and gate hoist block at Pier 1.

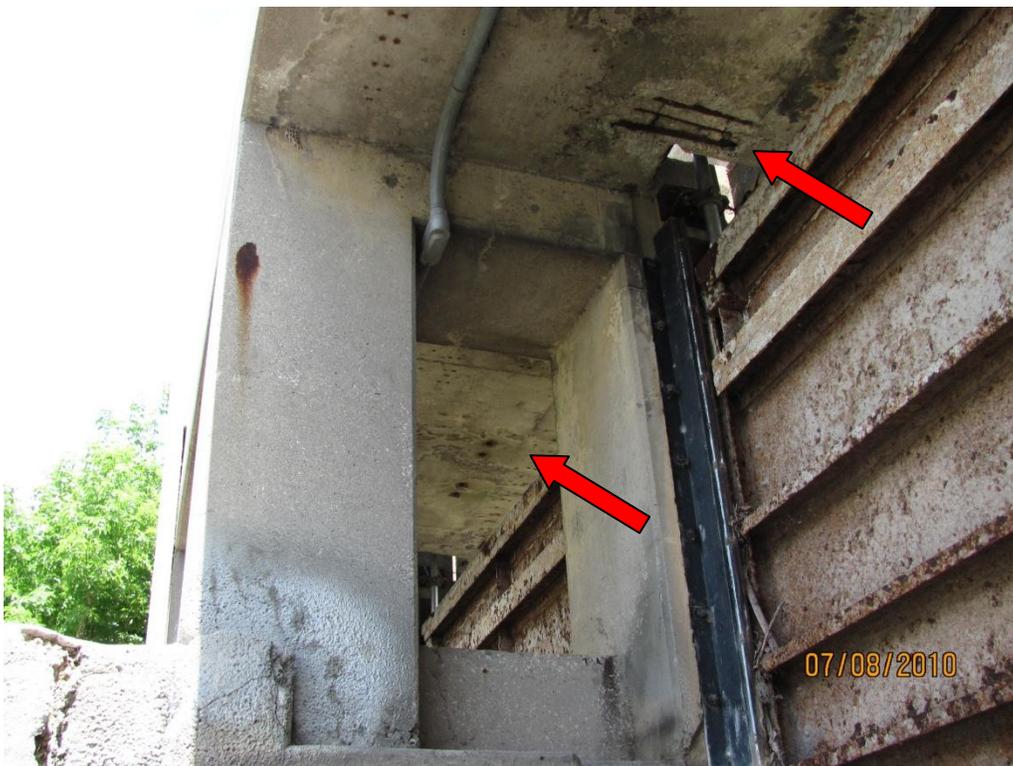
Photo 10: View of the underside of operating bridge deck (arrows) with water staining and isolated spalls with exposed reinforcing steel.

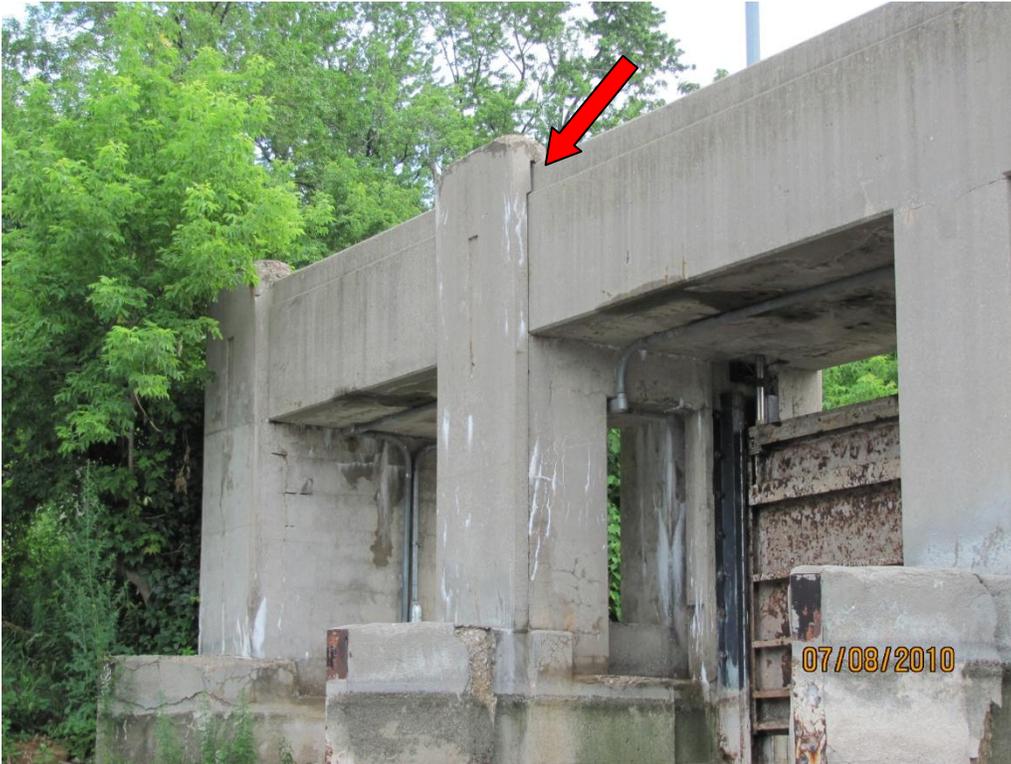
Photo 11: View of the separation of wall from Pier 1 facing (see photo 12) and white efflorescence at cracks of the operation bridge walls.

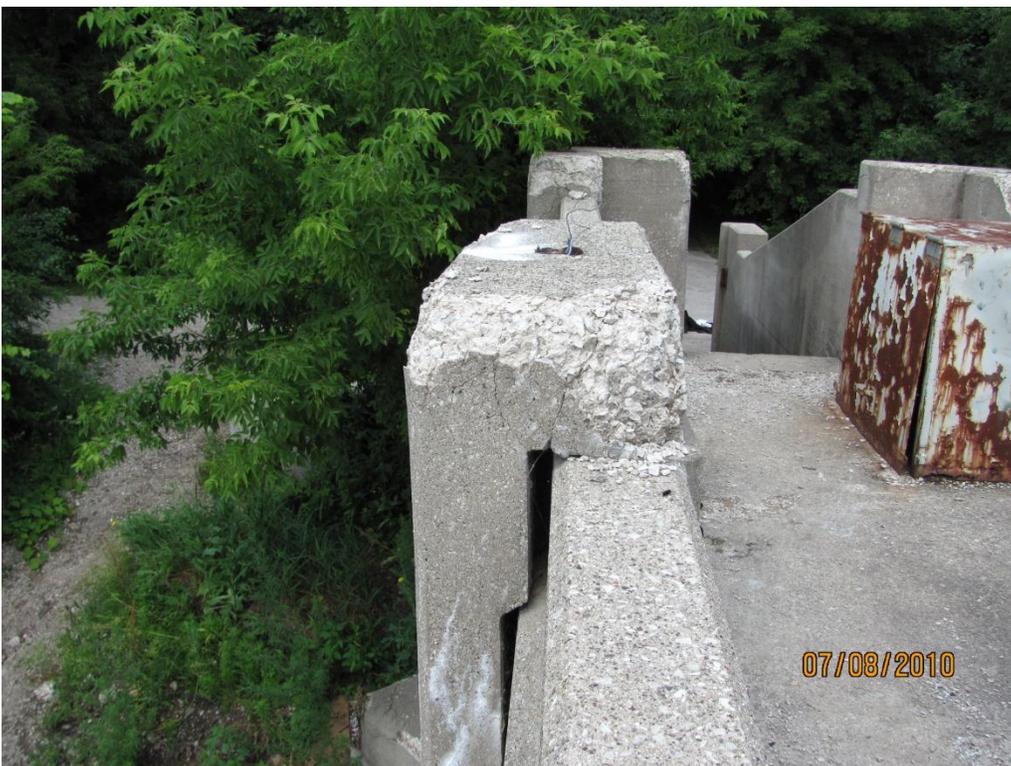
Photo 12: Concrete disintegration and Pier 1 separation at the operating bridge wall, upstream side (see photo 11).

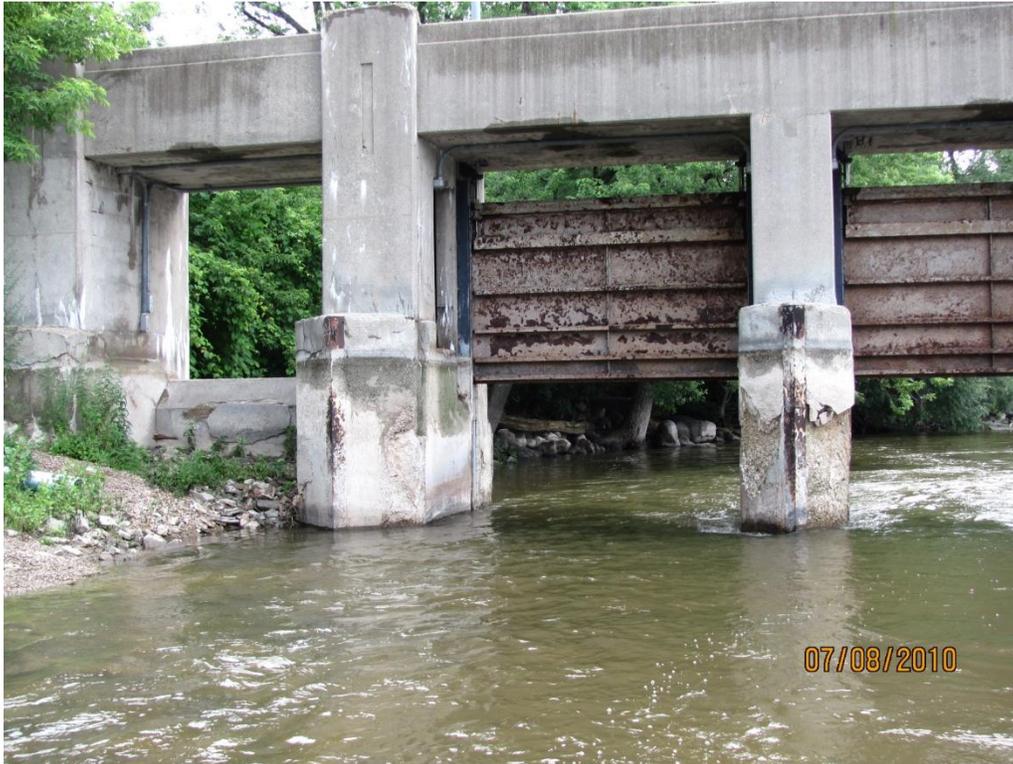
Photo 17: Upstream side of Piers P1 and P2 (left to right). Note previous surface repair is failing on Pier P2.

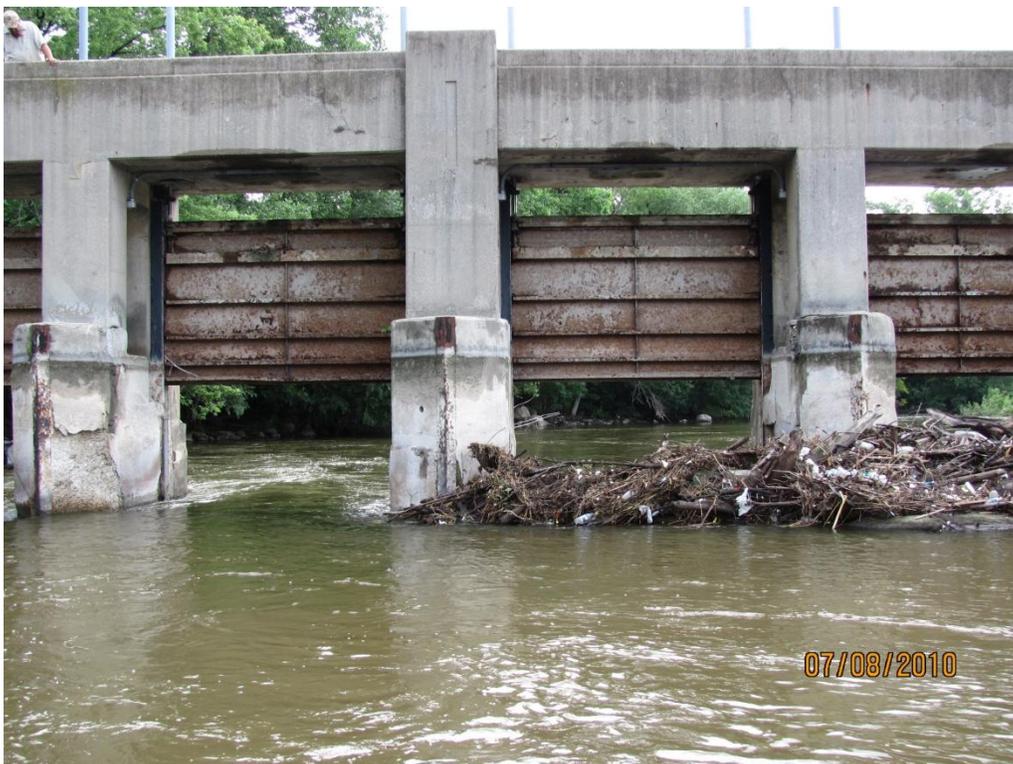
Photo 18: Upstream side of Piers P3 to P5 (left to right). Note previous surface repair is failing on Pier P3.

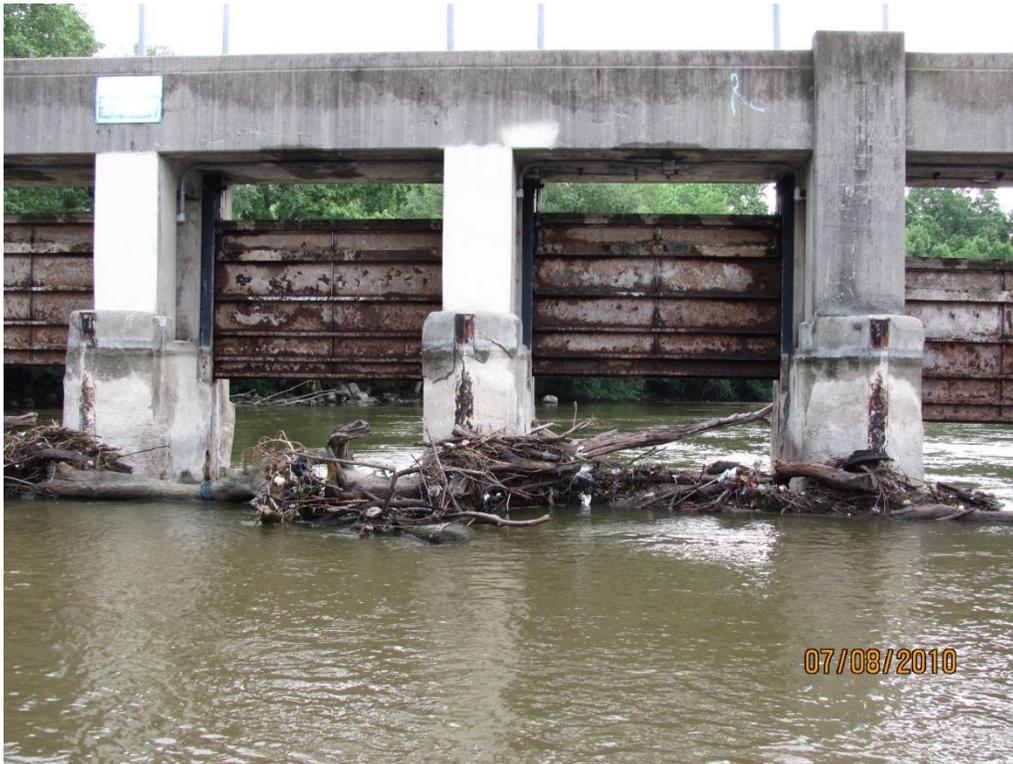
Photo 19: Upstream side of Piers P6 to P8 (left to right). Note previous surface repair is failing on Pier P7 and wet surface on all three piers.

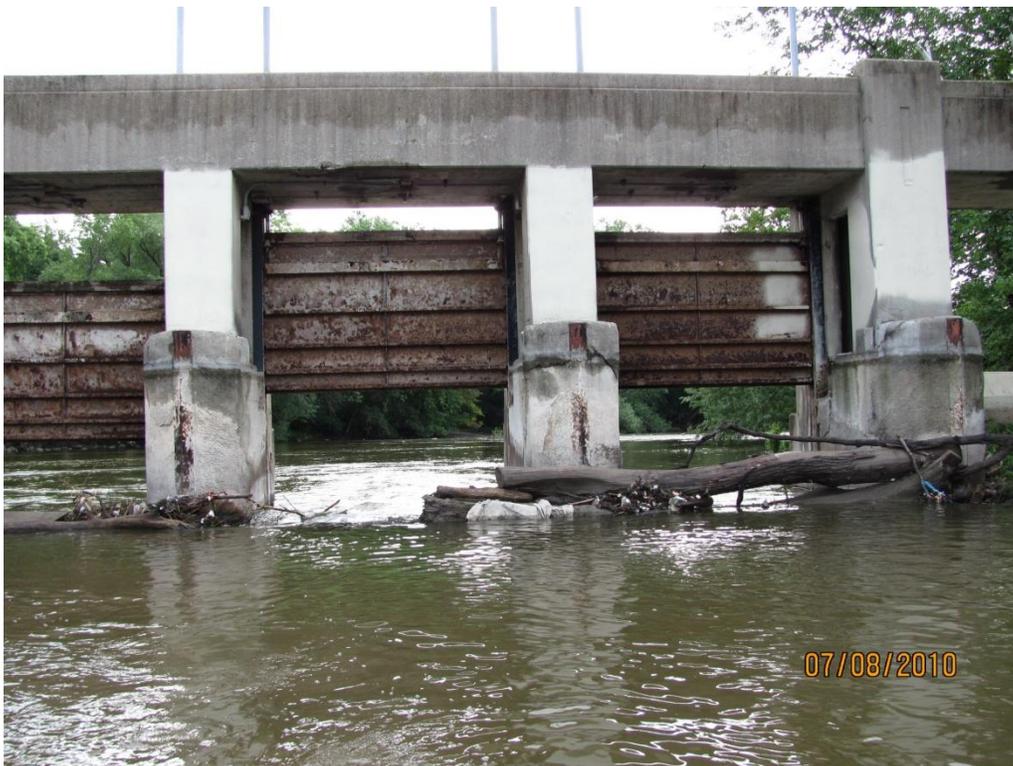
Photo 20: Upstream side of Piers P9 to P11 (left to right). Note previous surface repair is failing on Piers P9 and P10. Wet surface observed on all three piers.

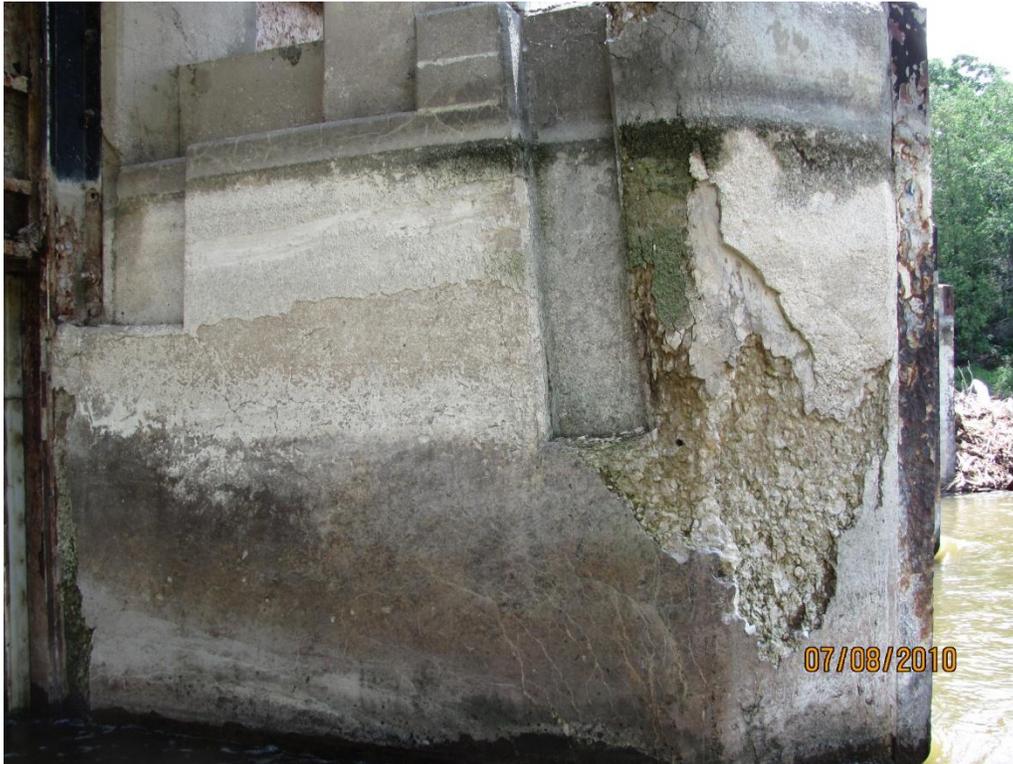
Photo 21: Typical view of failing surface repair at the upstream tip of pier (Pier P2).

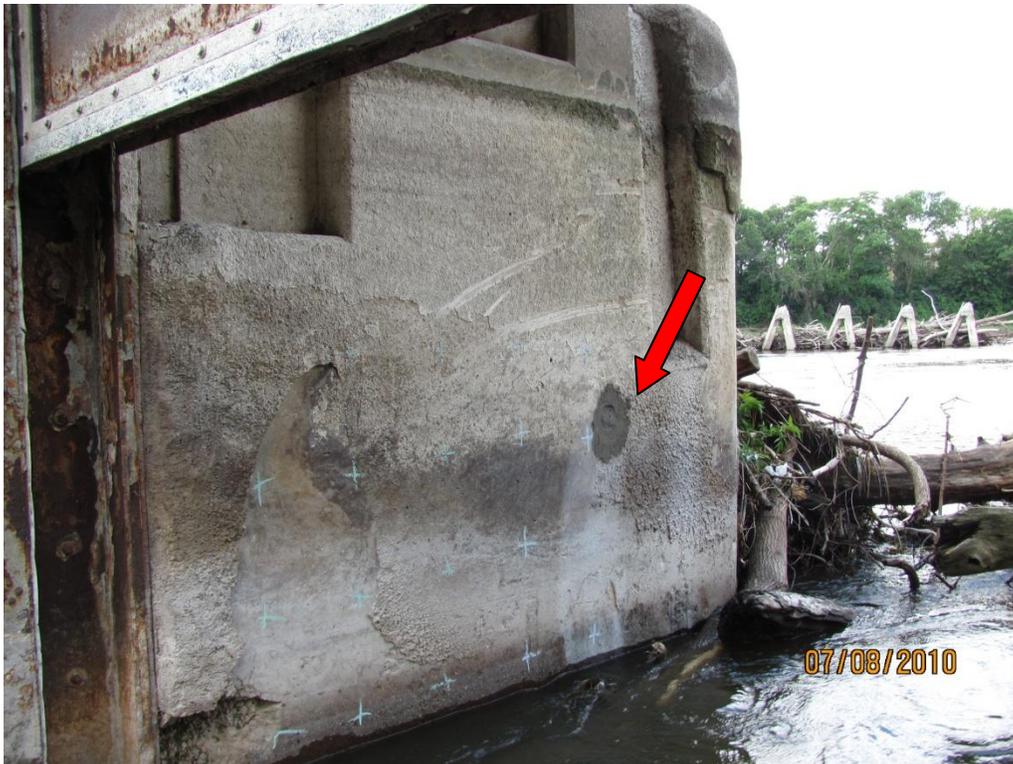
Photo 22: Typical view of the right side of Pier 7 with surface repair. Note blue chalk marks are UPV grid lay-out for testing and concrete core location (arrow).

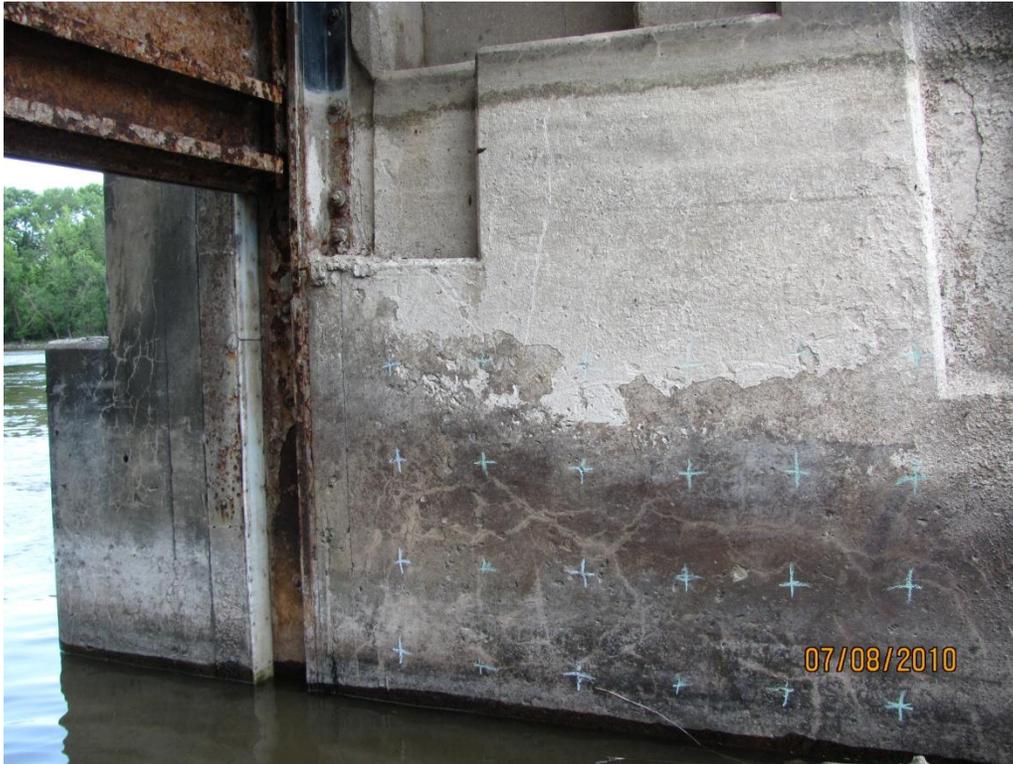
Photo 23: Typical view of the left side of piers, looking downstream, with minimal distress (Pier P6).

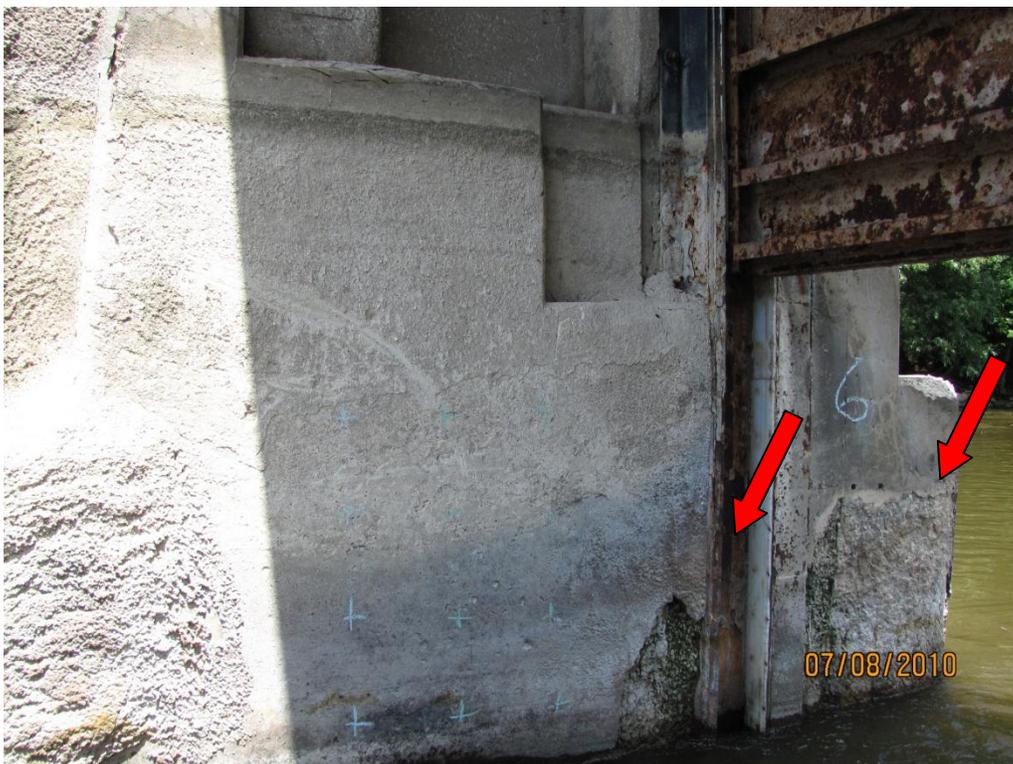
Photo 24: Typical view of the right side of piers, looking downstream, with disintegrating concrete and delaminated surface repairs (arrows) (Pier P6).

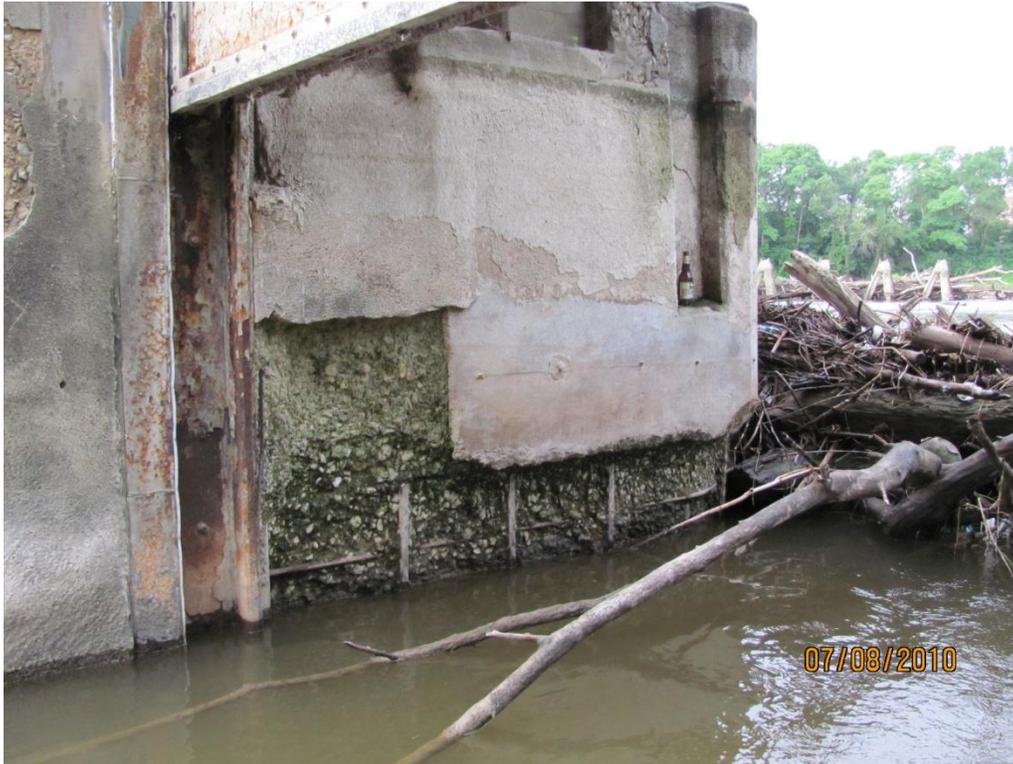
Photo 25: Severe erosion of pier with exposed reinforcing steel on Pier P5.

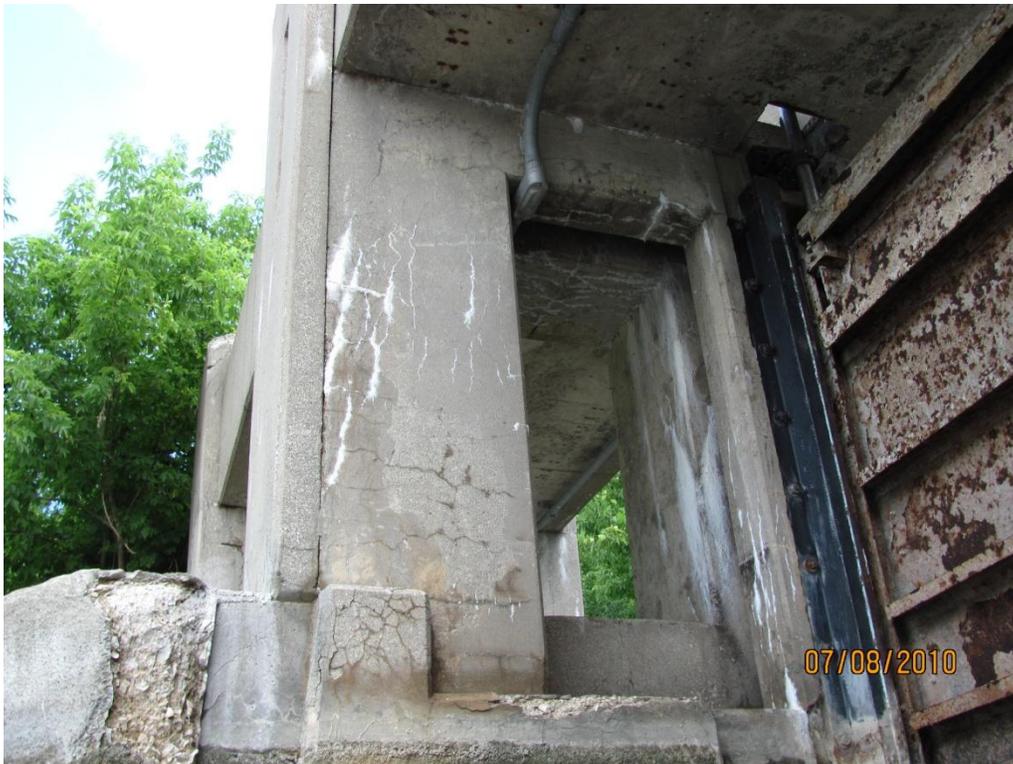
Photo 26: Typical view of cracking and efflorescence on the piers above Elevation 37.75'.

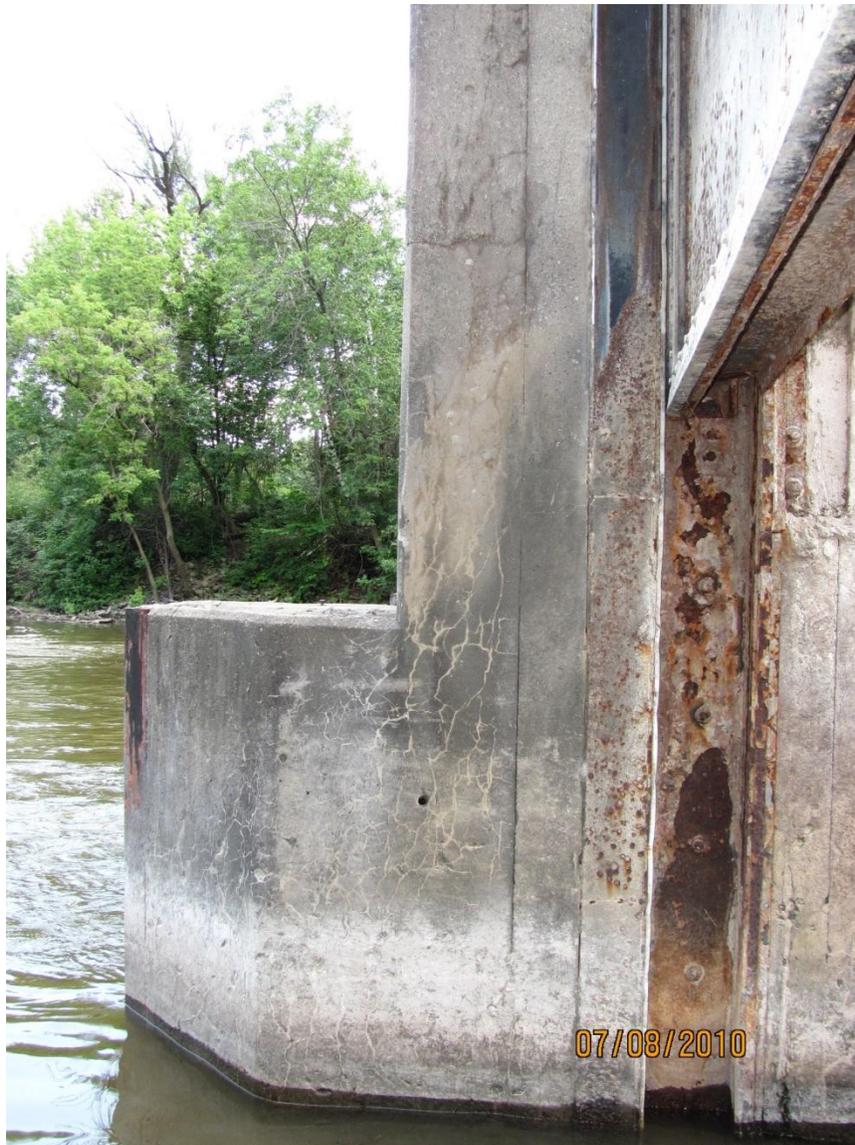
Photo 27: Map cracking at the downstream tip of Pier P6.

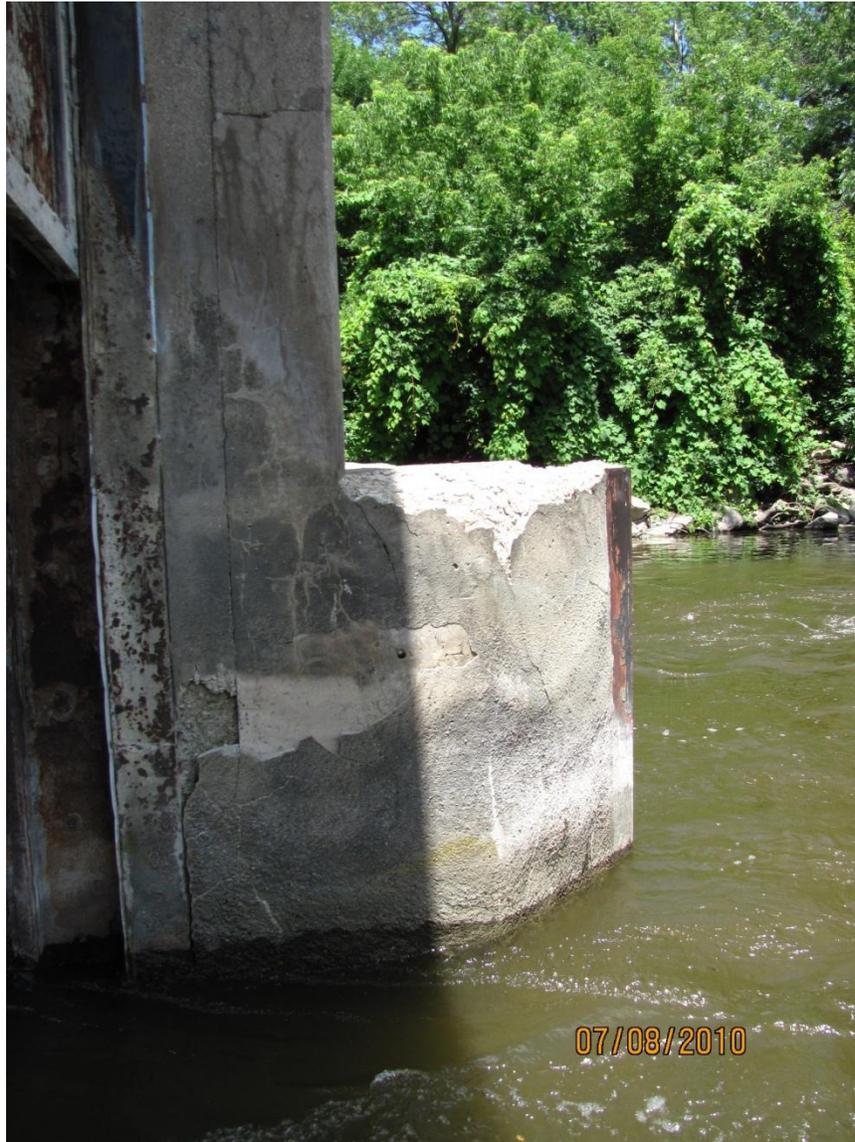
Photo 28: View of disintegrated concrete on top and delaminated concrete on side, downstream tip of Pier P3.

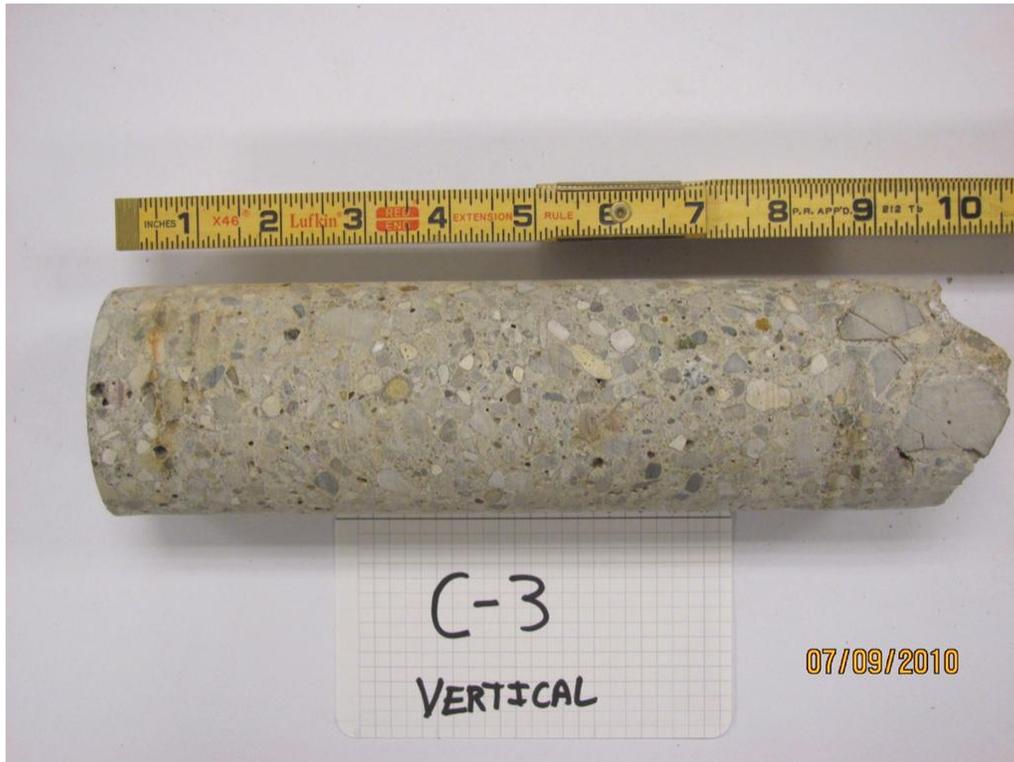
Photo 33: View of Core C-3. Note concrete above 9-inches is previous repair material.

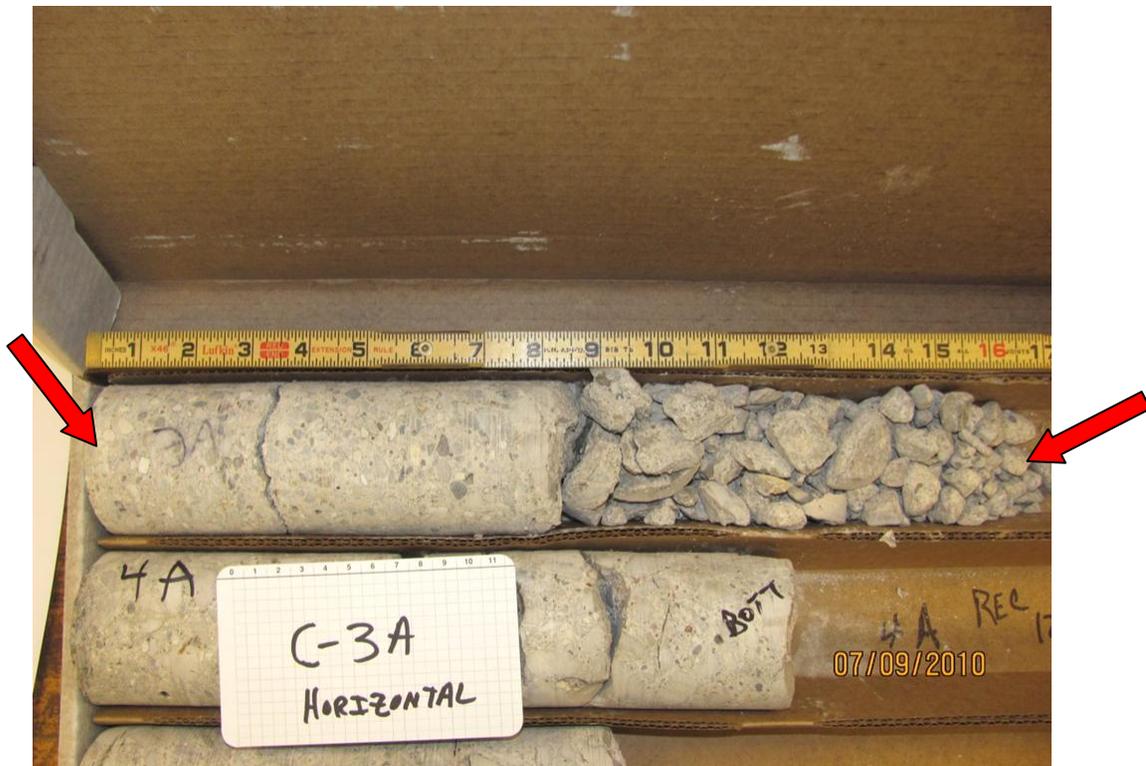
Photo 34: View of Core C-3A (between arrows). Note concrete for first 9-inches is previous repair material. The remainder is original deteriorated concrete.

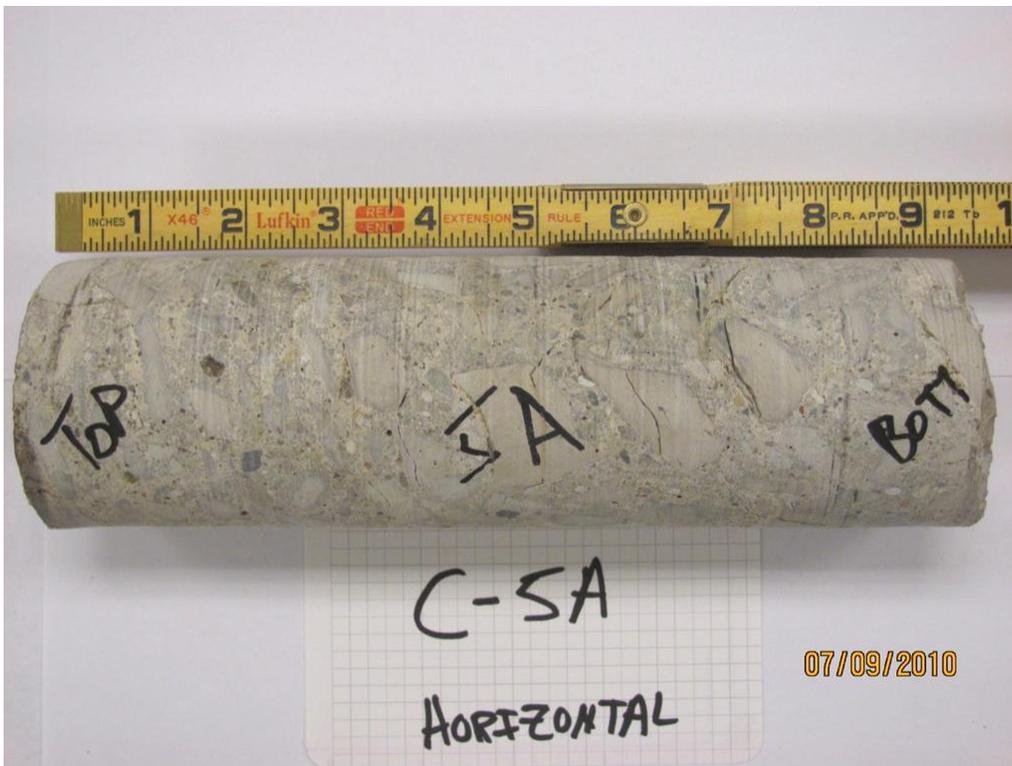
Photo 38: View of Core C-5A. Note cracking in the aggregate and cement paste.

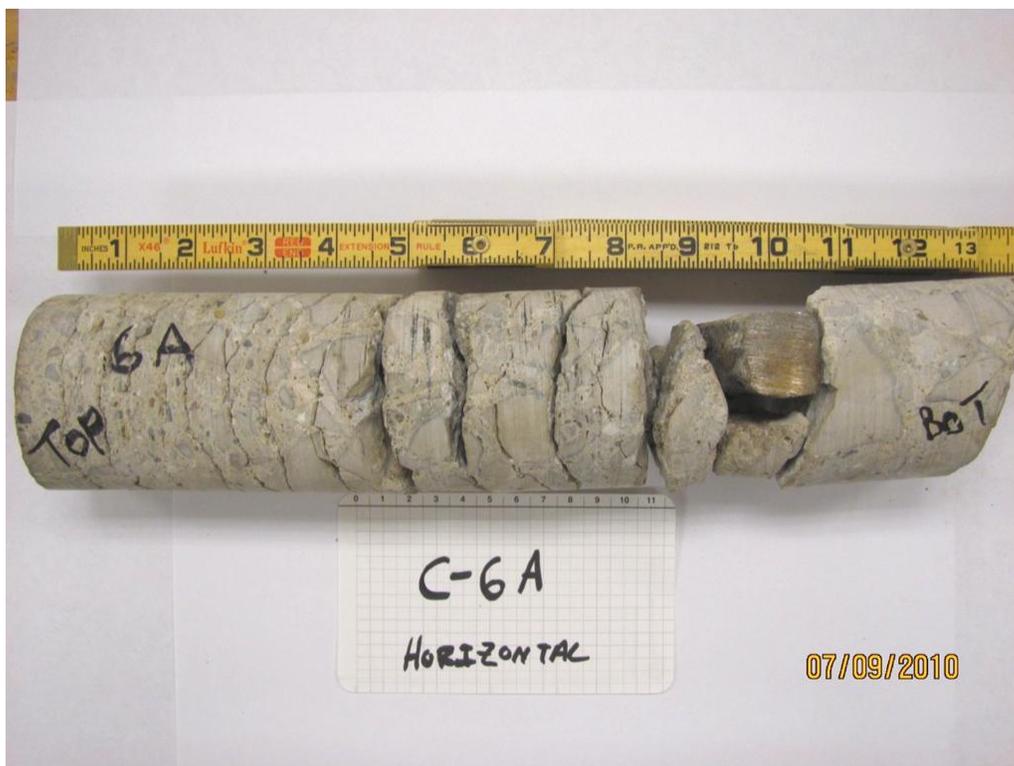
Photo 40: View of Core C-6A. Note cracking in the aggregate and cement paste.
