Submitted by:
AECOM
Vernon Hills, IL
Project No. 60159452
September 28, 2010

Structural Engineering Evaluation of the Estabrook Park Dam

Milwaukee River, Milwaukee, WI

RE: Structural Engineering Evaluation of the Estabrook Park Dam Located on the Milwaukee River, Milwaukee, Wisconsin – AECOM Project No. 60159452

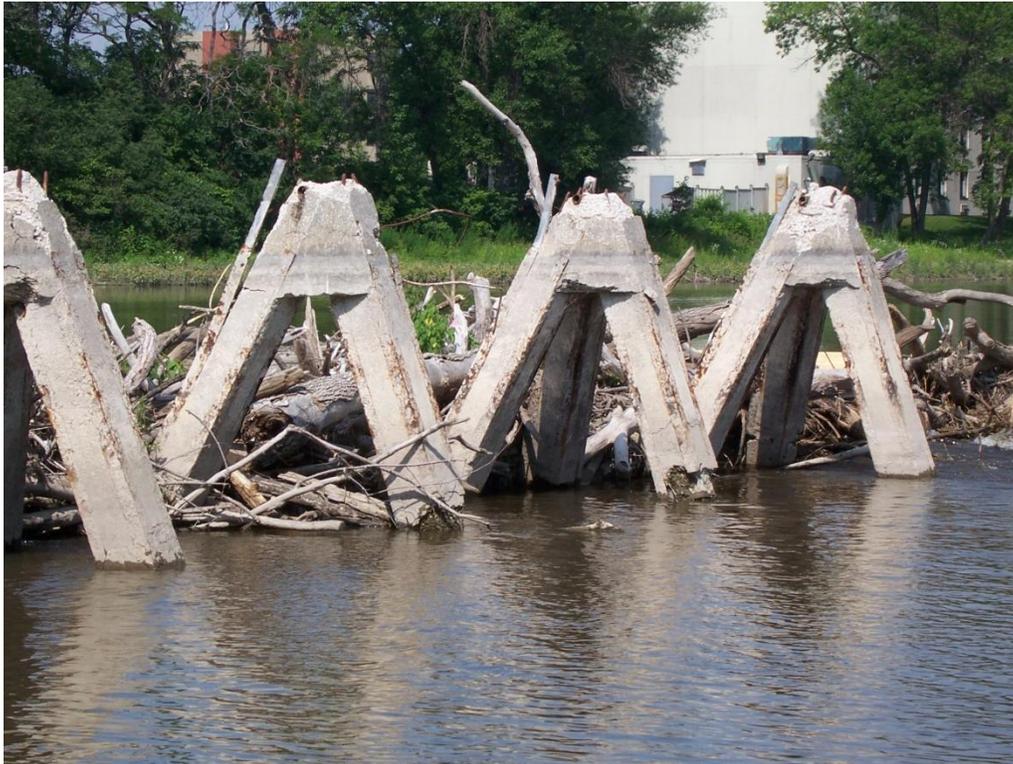
Photo 41: Typical condition of concrete ice breakers.

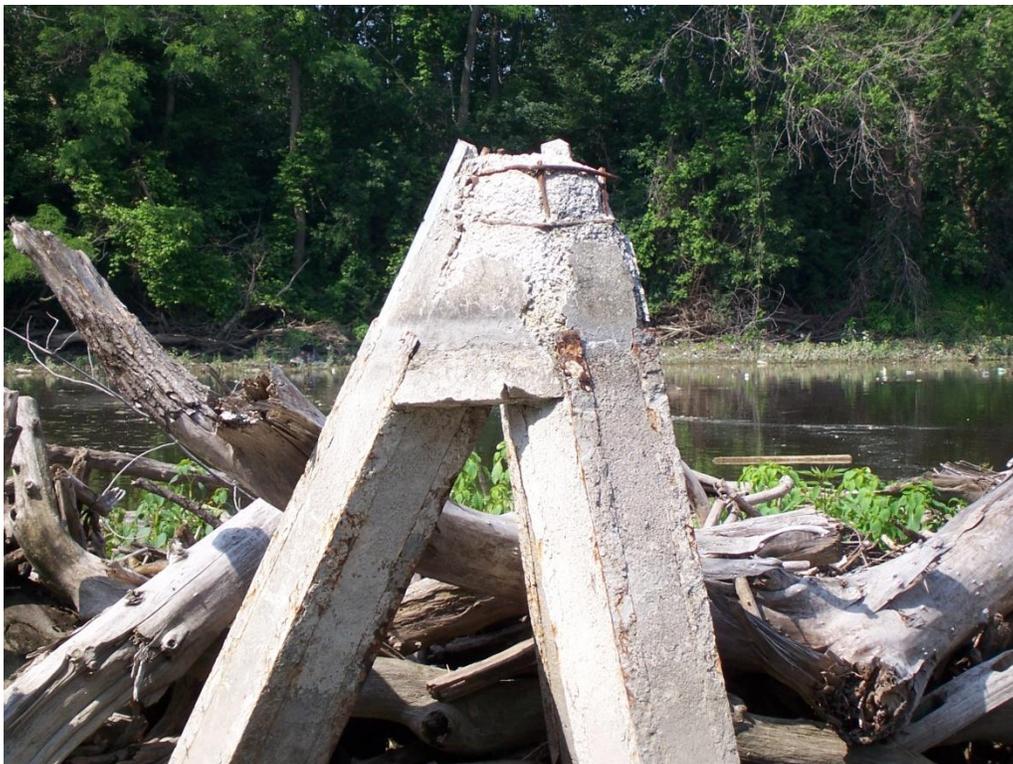
Photo 42: Deteriorated top of ice breaker, typical.

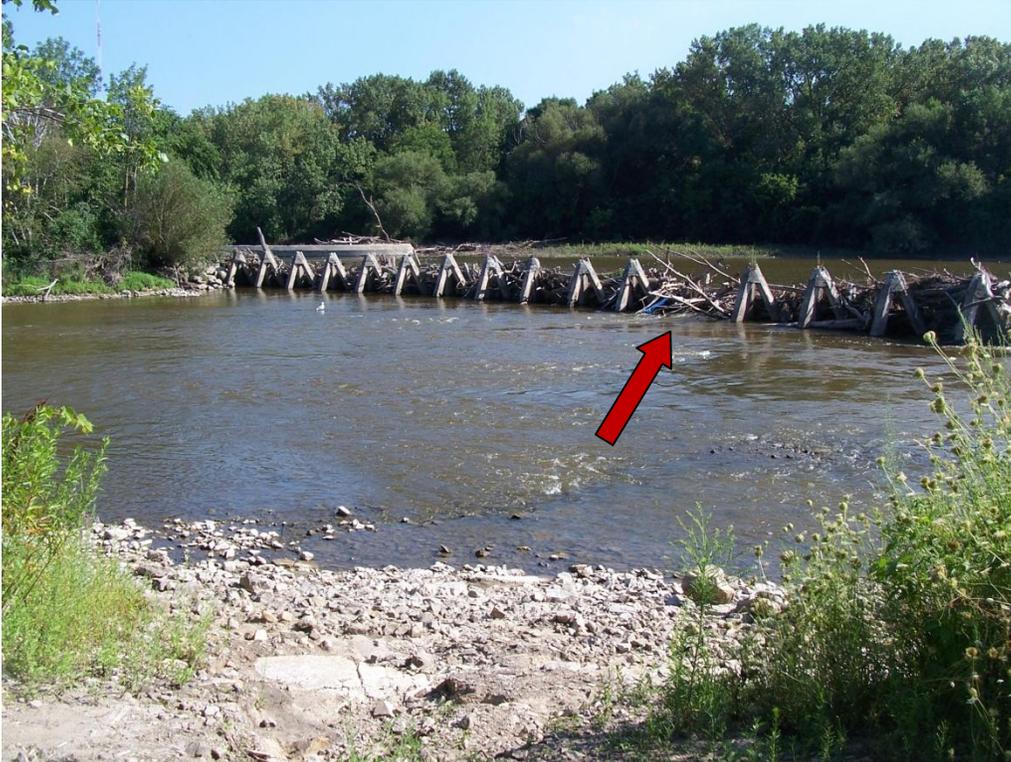
Photo 43: Ice breakers act as “trash racks”. Note missing ice breaker at arrow.

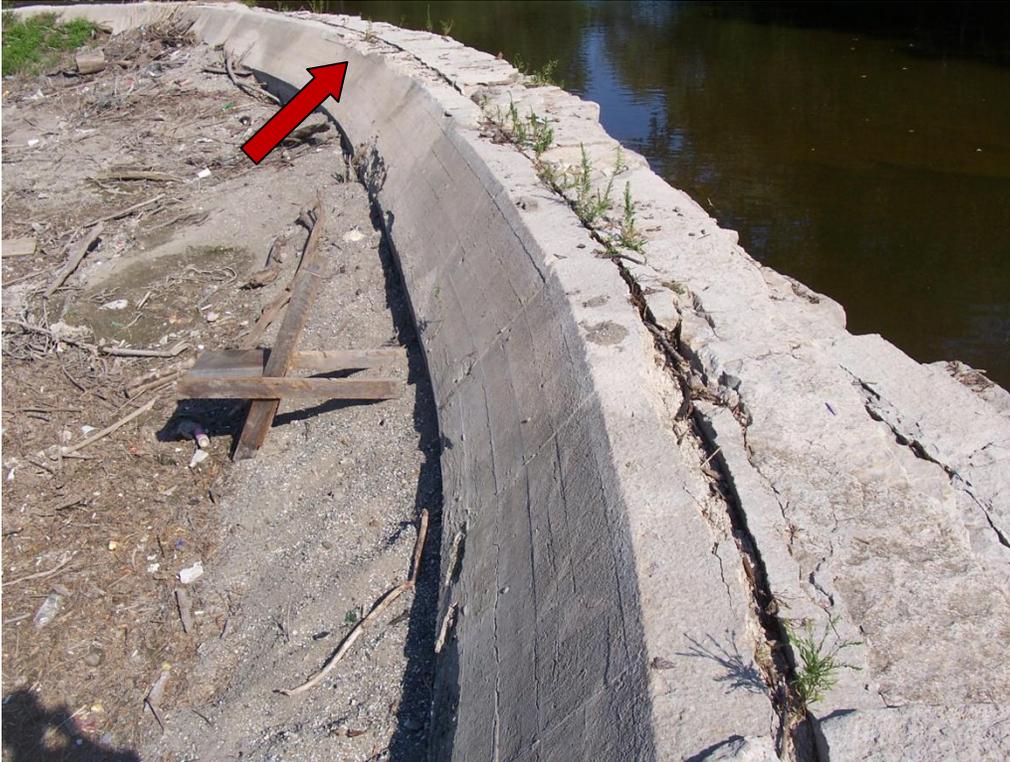
Photo 49: Typical spillway cap condition. Note weathering of long joint with masonry facing and spalling of concrete at arrow.

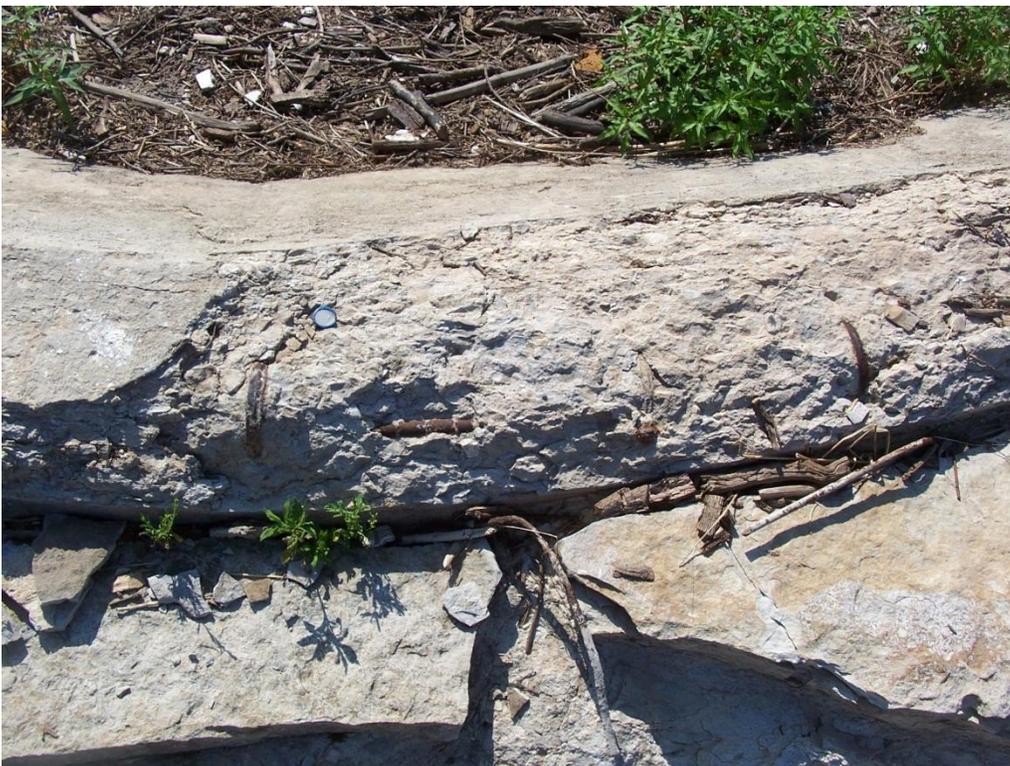
Photo 50: Spalled concrete at spillway cap with exposed reinforcing steel. Also note weathered mortar joint between concrete and masonry facing.
