**Safety Building  
Penthouse and  
Light Court  
Parapet  
Evaluation**

**Milwaukee County  
Department of Public Works**

Project No.: 2010-0345.00

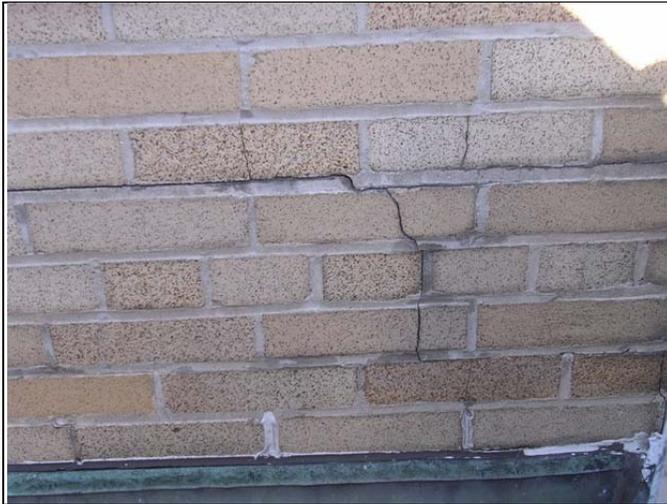
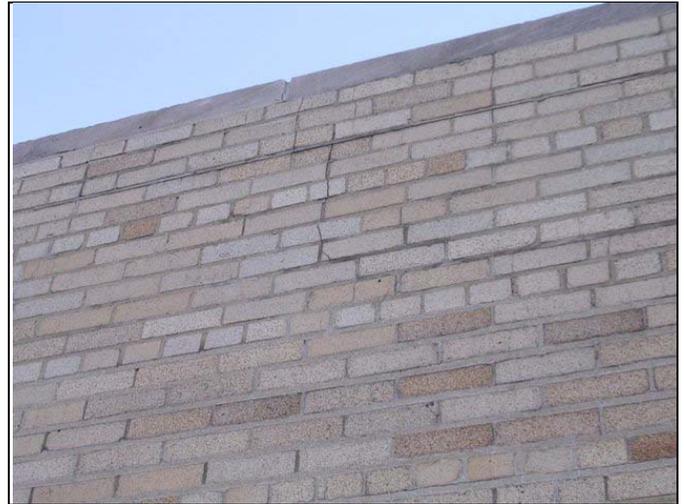
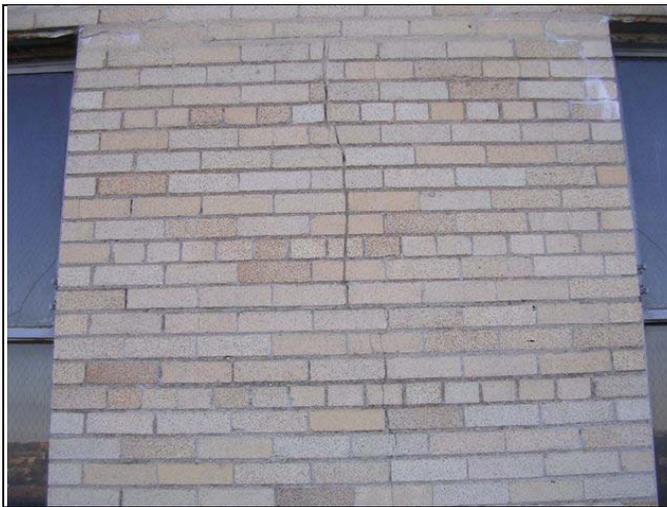
**Condition #1 Light Deterioration of Mortar Joints**

*Observations:* Light deterioration of mortar joints.

Condition 1 - North penthouse

*Evaluation:* Mortar joint deterioration due to moisture penetration and freeze thaw action.

*Repair Recommendation:* Tuck pointing mortar joints

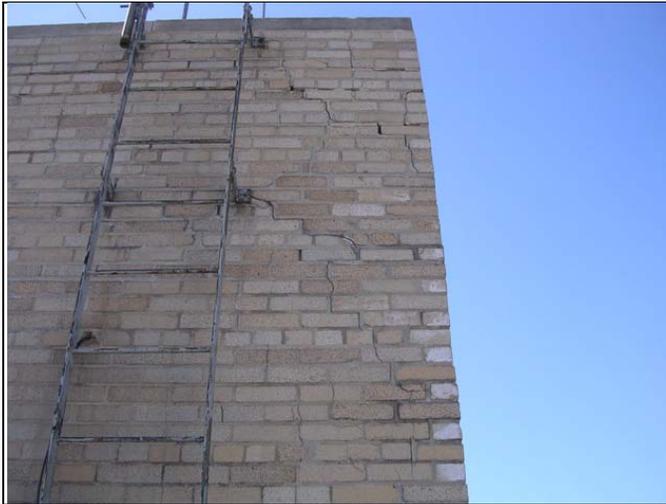
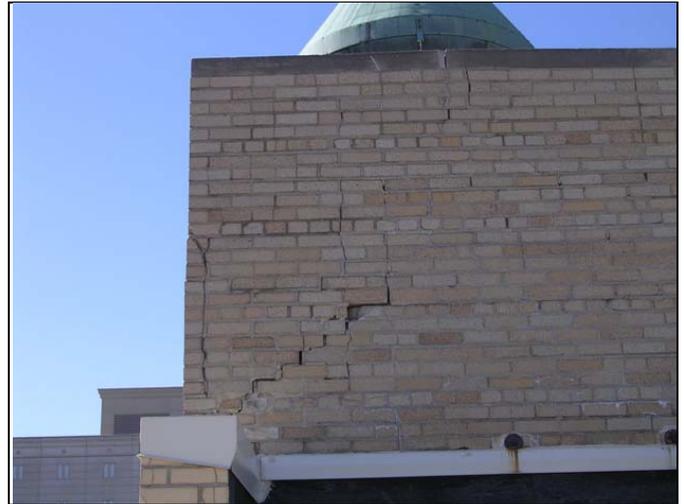
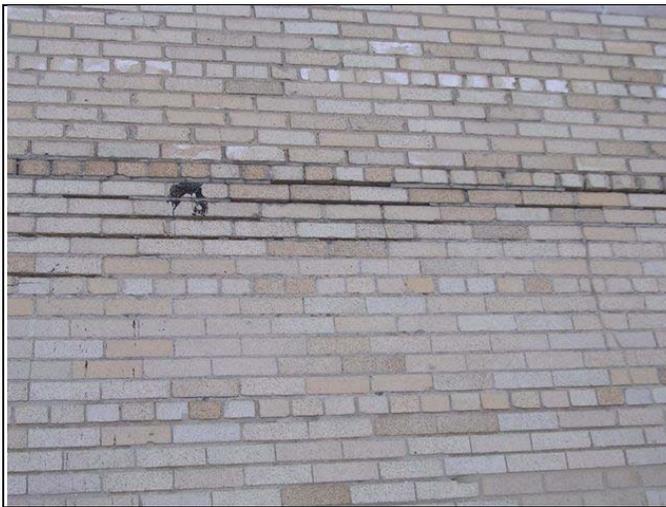
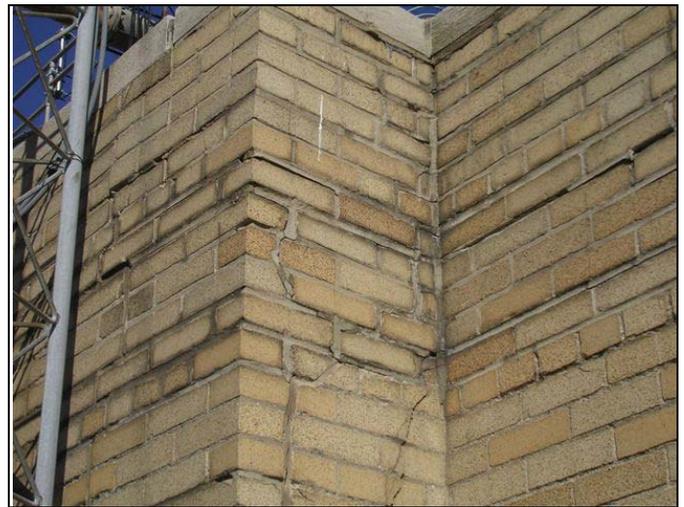
## **Condition #2 Heavy Deterioration of Mortar Joints**

*Observations:* Heavy deterioration of mortar joints.

Condition 2 - North penthouse

Condition 2 - East penthouse

*Evaluation:* Mortar joint deterioration due to moisture penetration and freeze thaw action.

*Repair Recommendation:* Tuck pointing mortar joints

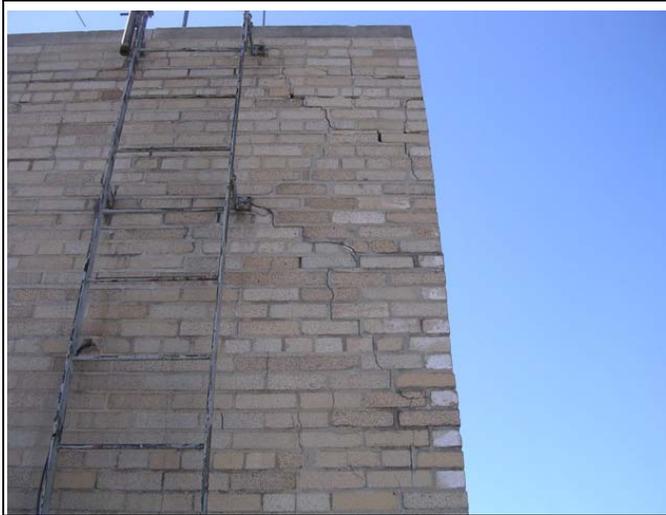
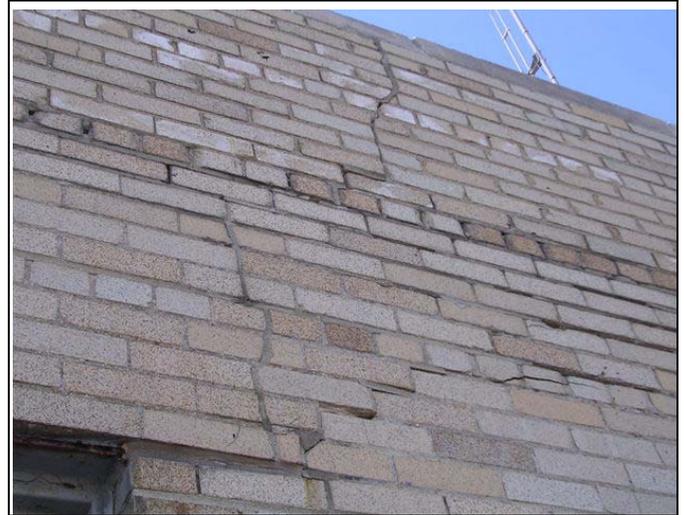
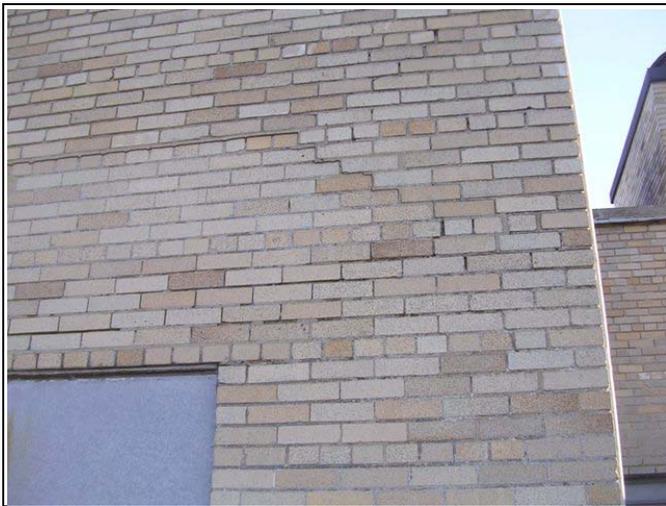
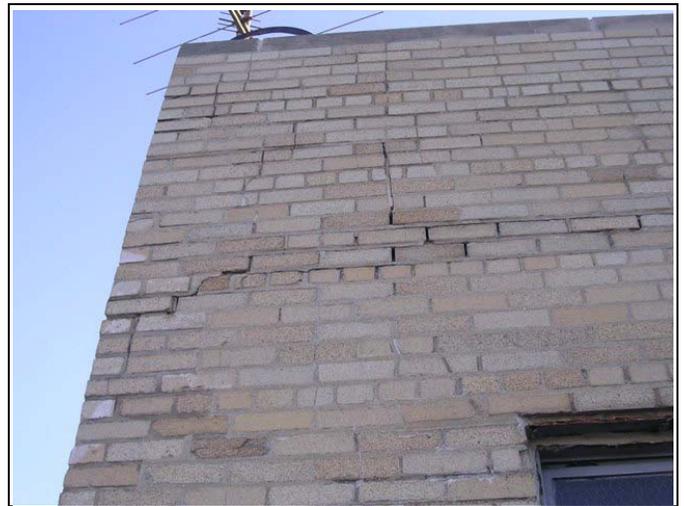
### **Condition #3 Potential Loose Outer Wythe**

*Observations:* Heavy deterioration of mortar joints, open cracks and slight movement of outer wythe.

Condition 3 - North penthouse

Condition 3 - East penthouse

Condition 3- North penthouse

*Evaluation:* Open joints and cracks with slight movement

*Repair Recommendation:* Add renovation anchors to reattach outer brick wythe to inner wall.

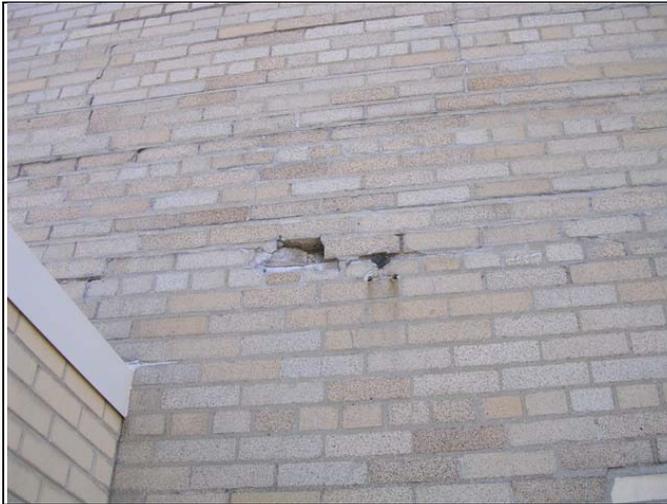
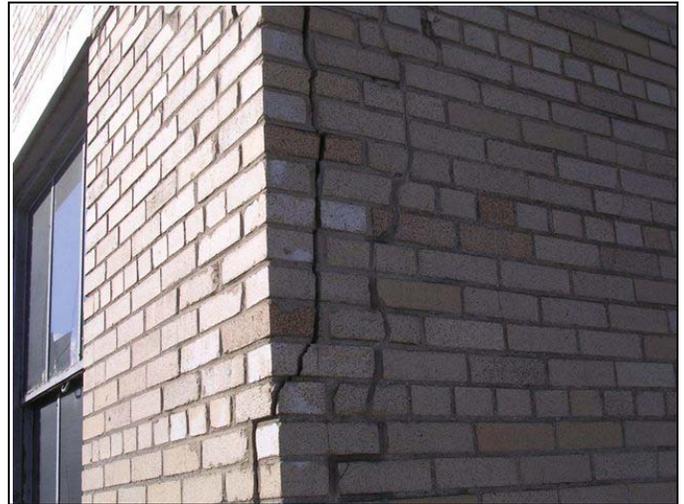
**Condition #4 Deteriorated or Cracked brick**

*Observations:* Face spalls or broken bricks at wall cracks.

Condition 4 - North penthouse

Condition 4 - South Penthouse

*Evaluation:* Wall cracks due to thermal movement of walls.

*Repair Recommendation:* Replace cracked or deteriorated bricks. Further enhance wall system by adding additional control joints.

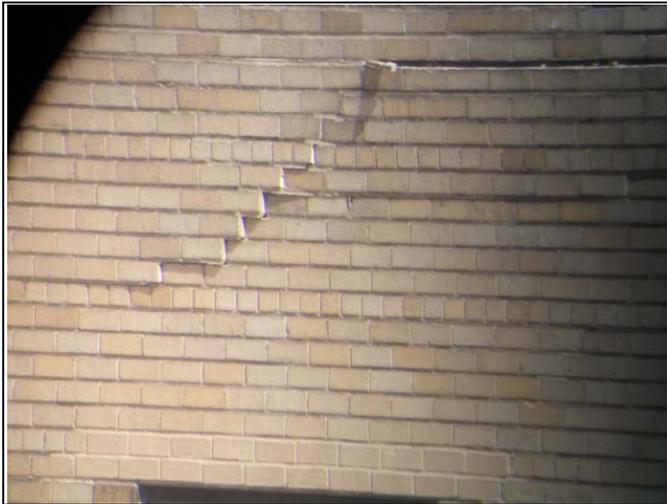
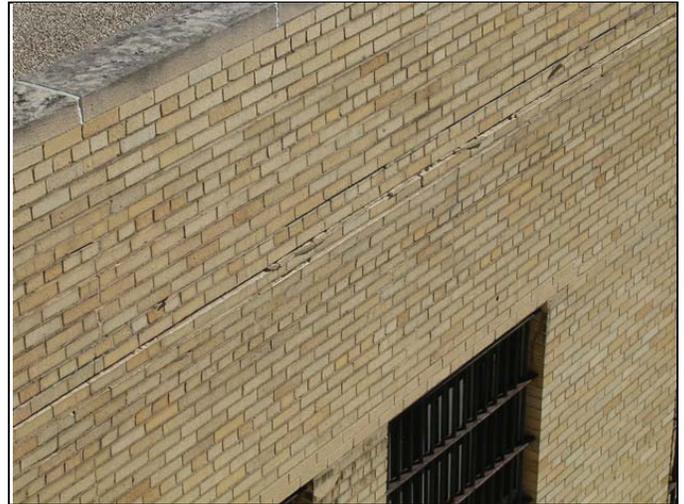
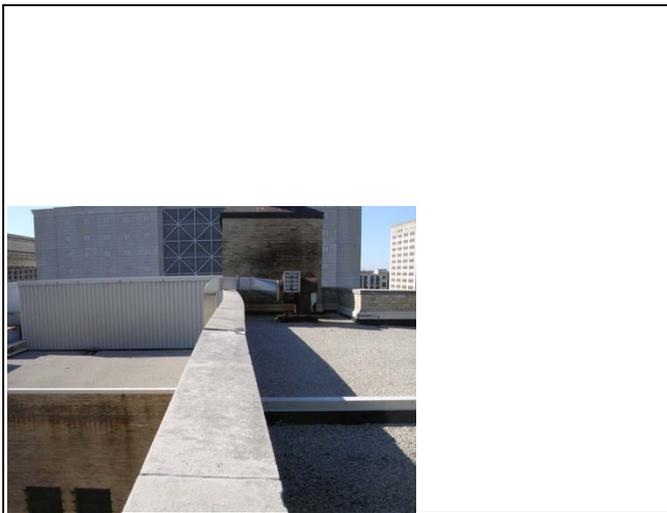
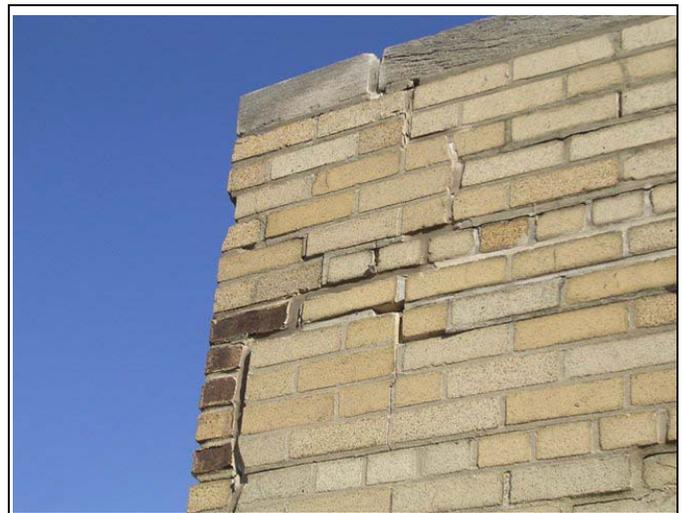
**Condition #5 Severe Deterioration and Shifted Outer Wythe**

*Observations:* Severe deterioration of mortar joints and shifted outer wythe.

Condition 5 - East inner court parapet

Condition 5 - North inner court parapet

Condition 5 - East penthouse

*Evaluation:* Lateral movement of outer wythe occurs when water penetration into the wall freezes, and expands. Brick ties to the inner wall wythes are generally loosened or broken. Damage to the inner wythe may be found.

The first priority for the recommended repairs is the east light court parapet wall. The displaced masonry may be loose or could become loose. Falling masonry could hit the skylight at the bottom of the light court. Also the loose flashing on the south elevation of the south penthouse should be removed. These potentially loose items should be repaired during first repair cycle.

*Recommendation:* Reconstruction of outer wythe. Evaluation of inner wythe once outer wythe is removed.

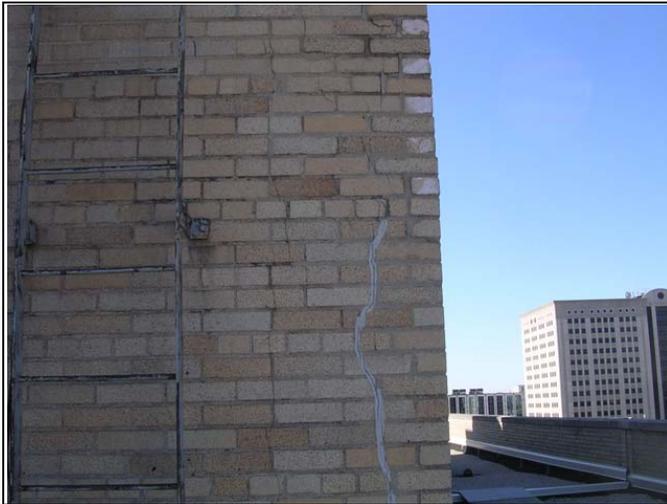
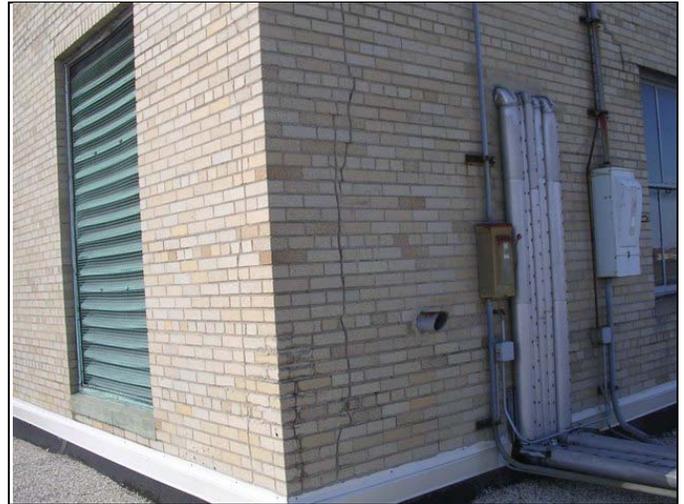
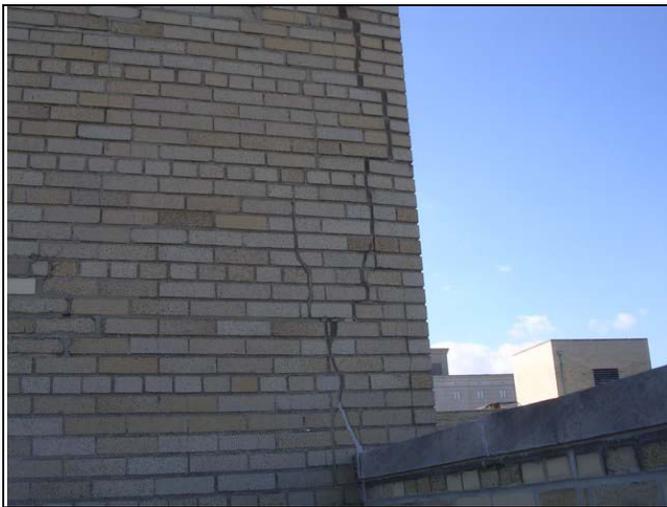
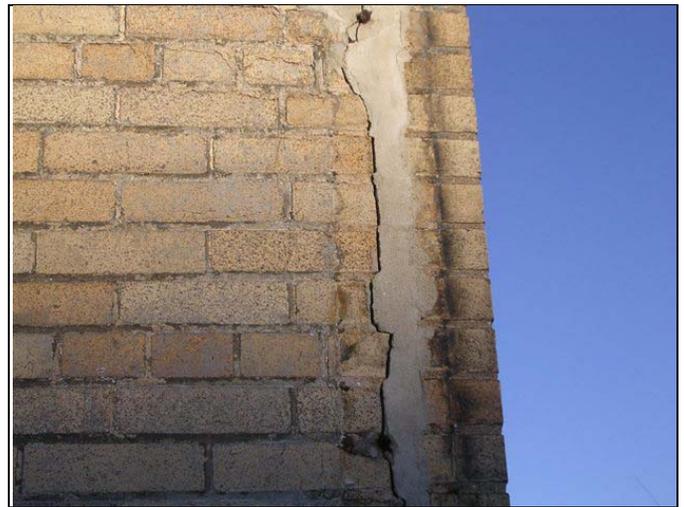
**Condition #6 New Control Joints**

*Observations: Vertical cracks at corners*

Condition 6 - North Penthouse

Condition 6 - East Penthouse

Condition 6 - South Penthouse

Lack of control joints prevents thermal movements. Vertical cracks generally indicate locations where the brick facing relieves thermal expansion.

Sawcut new vertical control joints. Provide backer rod and sealant.

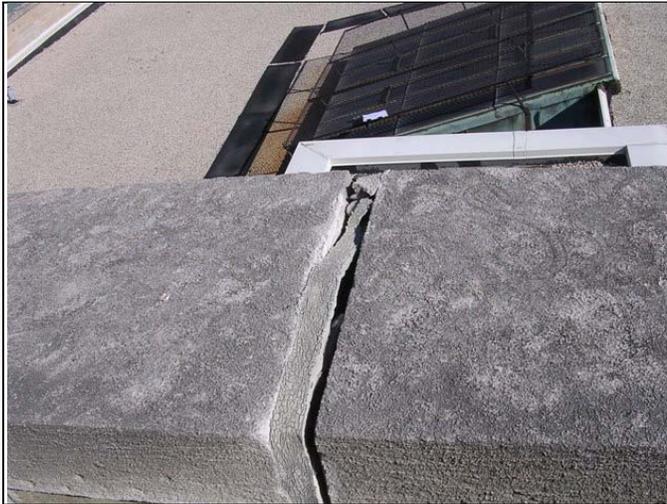
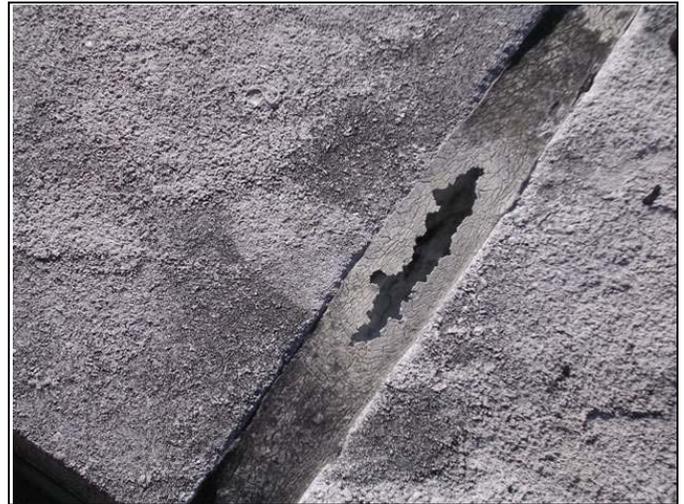
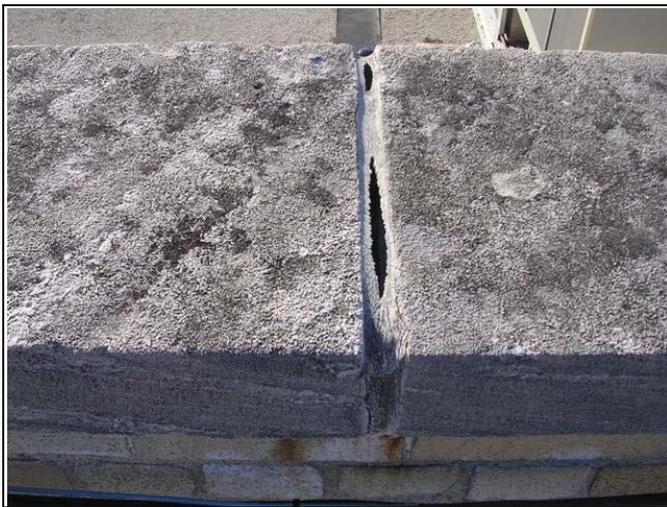
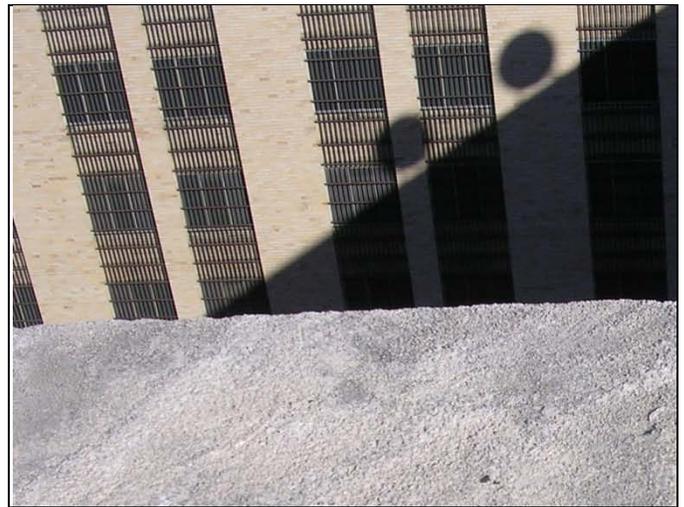
## **Condition #7 Parapet Cap Sealant**

*Observations:* Stone parapet cap joint sealant is deteriorated.

Condition 7 - North Penthouse

Condition 7 - East Penthouse

Condition 7 - South Penthouse

Condition 7 - West Penthouse

Open joints in caps allows water to penetrate walls and causes deterioration of mortar joints and shifting of outer wythe.

Provide new backer rod and sealant or replace with metal coping.

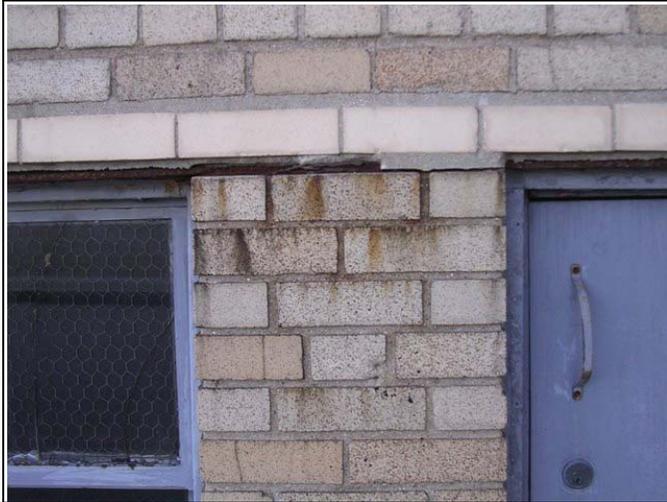
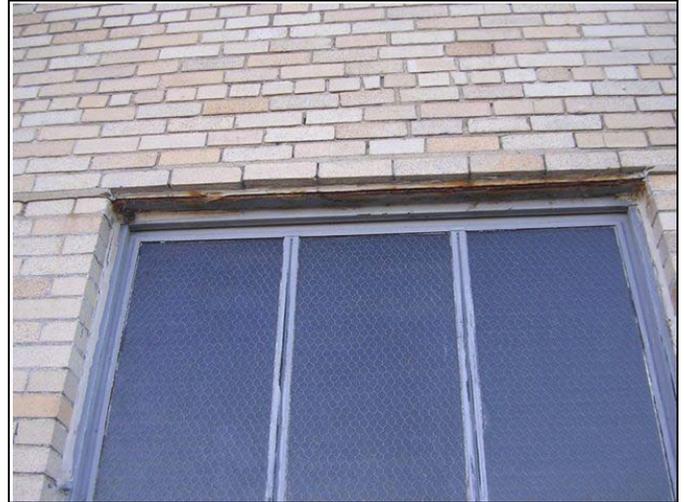
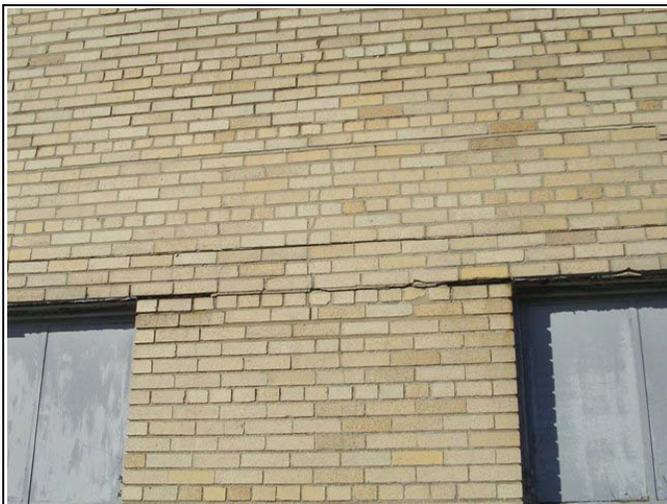
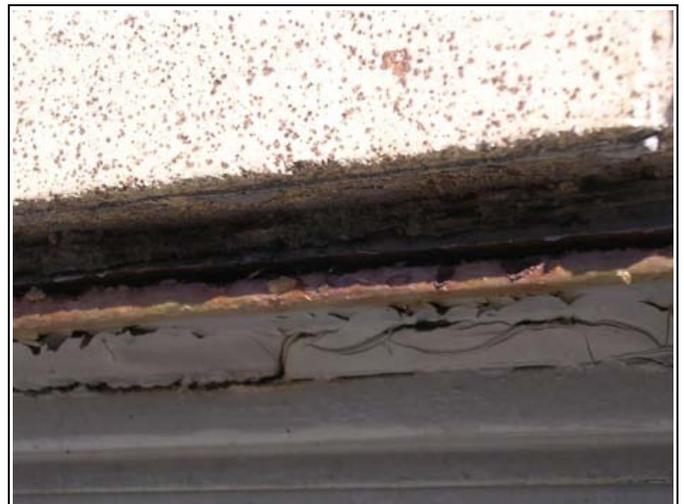
**Condition #8 Corroded Steel Lintels**

*Observations:* Thick layers of rust between steel lintel and supported brick facing.

Condition 8 - North Penthouse

Condition 8 - South Penthouse

Condition 8 - East Penthouse

Rust buildup on steel lintel jacks masonry creating open joints. (Rust-Jacking)

Replace lintels with galvanized steel. Provide new flashing and weeps.

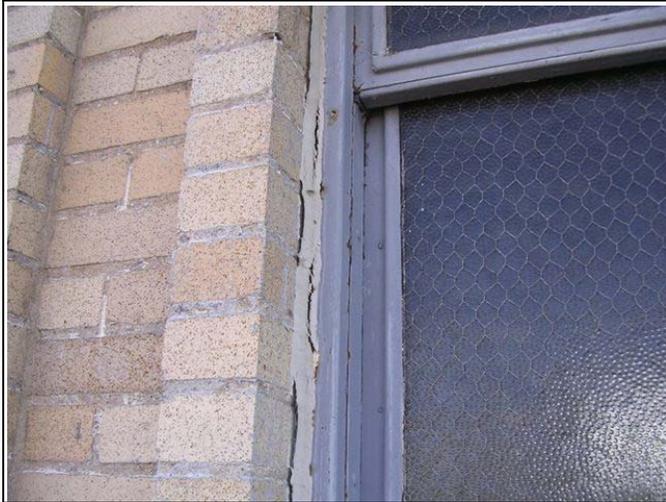
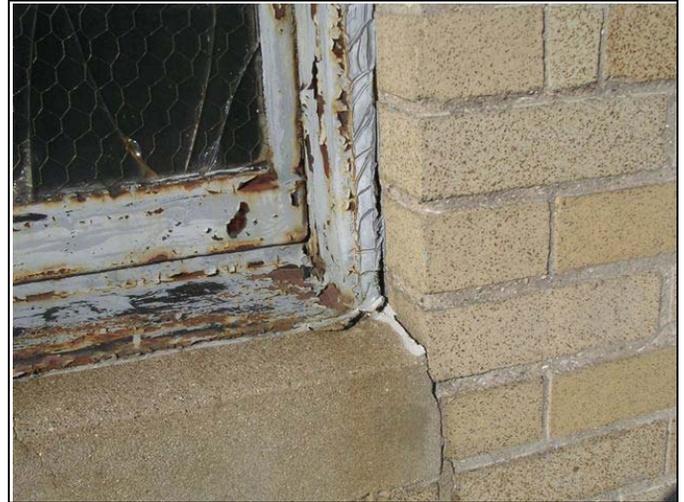
## **Condition #9 Deteriorated Widow and Door Sealant**

*Observations:* Sealants at widow and door frames are cracked, torn or missing.

Condition 9 - North Penthouse

Condition 9 - South Penthouse

*Evaluation:* Open joints around doors and windows allow water penetration which causes deterioration of brick facing below. Water trapped in metal frames can expand or cause internal corrosion that can break the glass.

*Recommendation:* Provide new sealant. Note: Many window frames are severely corroded.

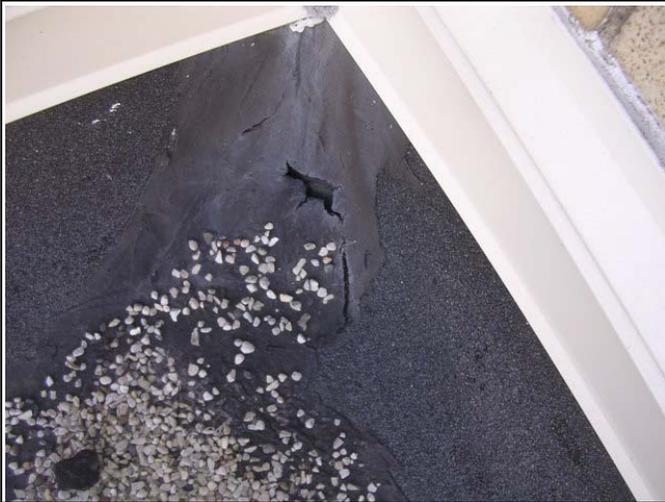
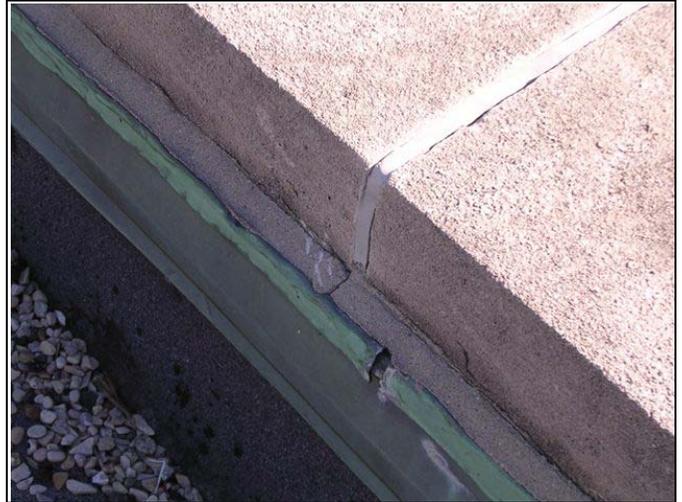
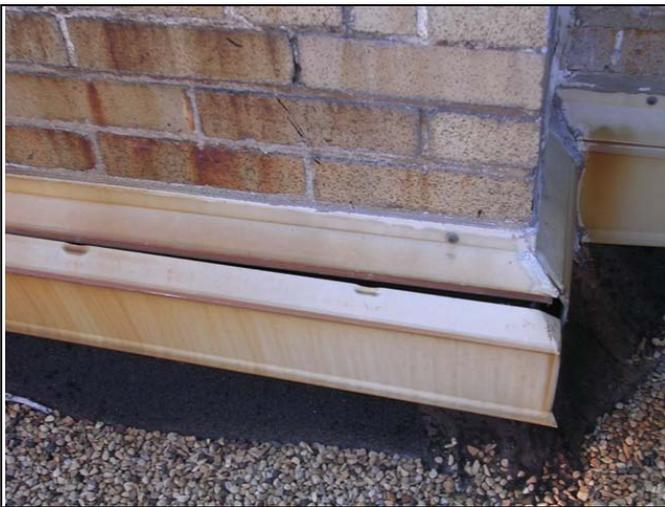
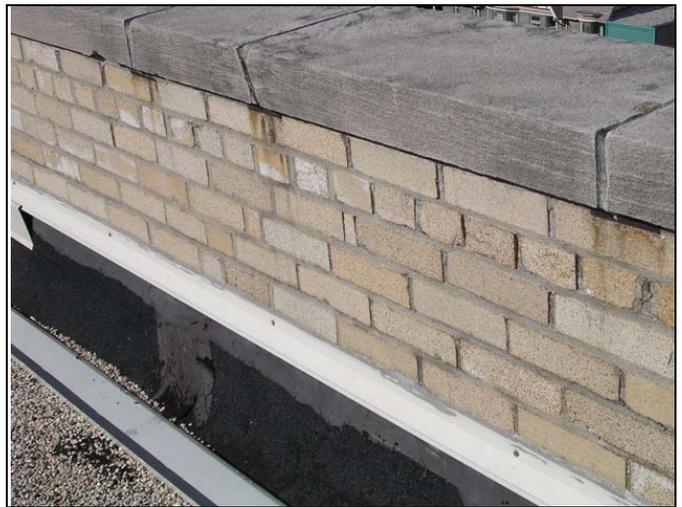
**Condition #10 Open Roof Flashing**

*Observations:* Open joints in roof flashing and counter flashing on backside of parapet walls.

Condition 10 - Spalled patches East Elevation

Condition 10 - East Penthouse

Condition 10 - North penthouse

*Evaluation:* Open flashing system allows water entry into wall cavities which cause freeze thaw damage to brick facing and mortar joints.

*Repair Recommendation:* Reseal flashing joints.
