Project: EXTERIOR FACADE RESTORATION
Milwaukee Public Museum
800 West Wells Street
Milwaukee, WI 53233-1478

Subject: **Visual Façade Evaluation Report**
By
GRAEF, Inc.
November, 2010

Visual Façade Evaluation Report

November 10, 2010

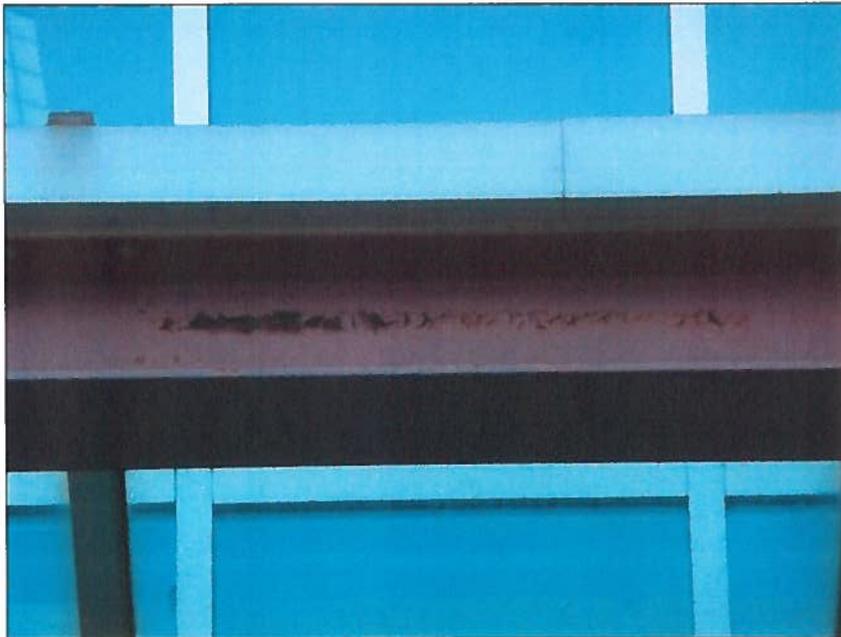
- Peeling paint and light corrosion on steel entry canopy.
- Corrosion of steel door frame. Typical throughout building.
- Cracked and patched stone panels. See Part V for additional discussion.

Figure 4-1 Peeling paint and light corrosion on canopy steel

1. Peeling paint and light corrosion on steel canopies and sign supports (Figure 4-1) should be cleaned, primed and painting within 3 years.
2. Lightly corroded steel door frames (Figure 4-2) should be cleaned, primed and painted. Heavily corroded steel door frames should be replaced. This should be performed within 3 years or sooner if the use of the door is affected by the deterioration.

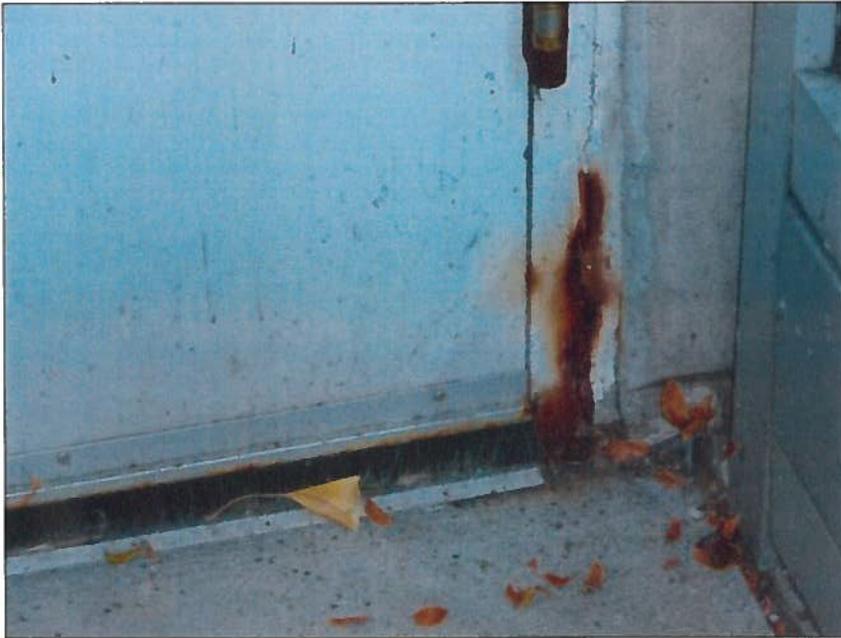
Figure 4-2 Corrosion at base of steel door frame

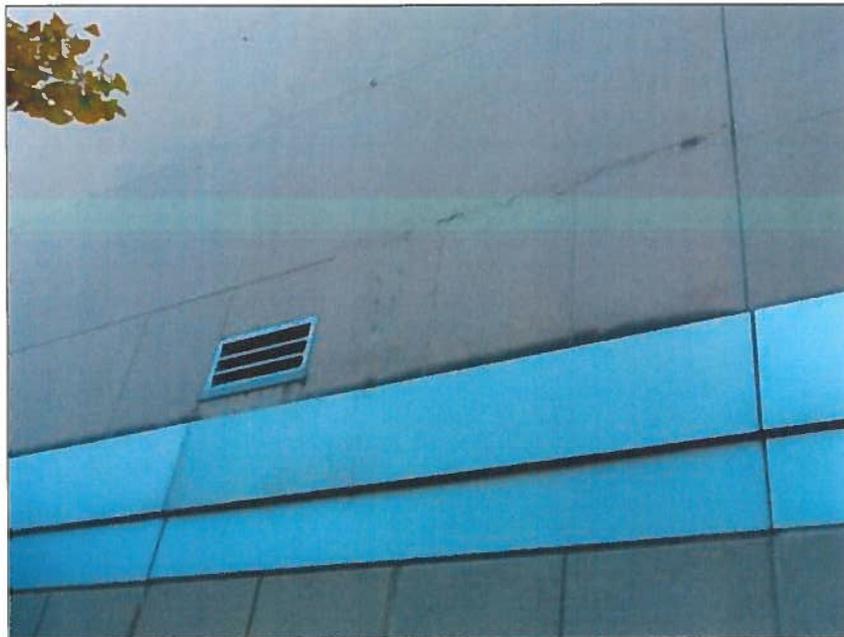
Figure 4-3 Cracking and patching of stone panels

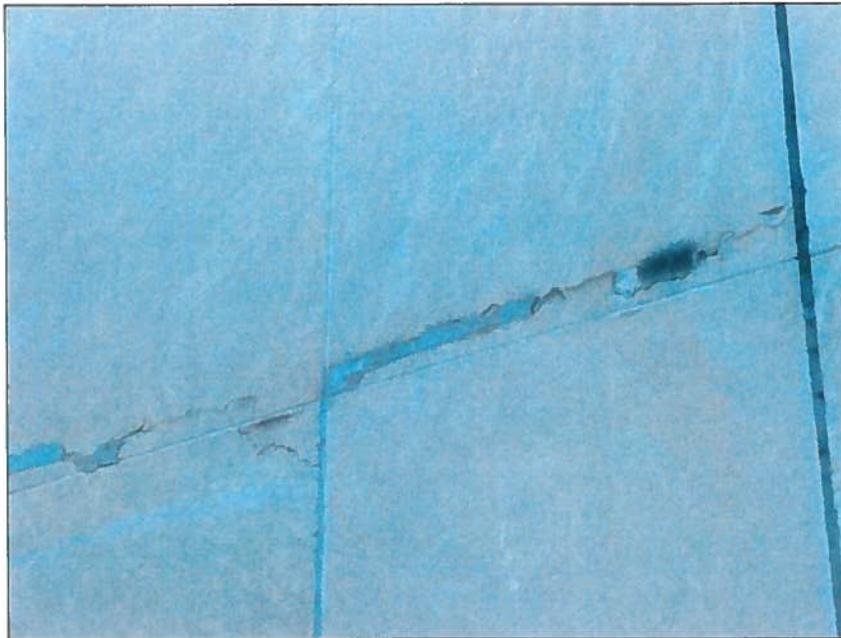
Figure 4-4 Close up of cracked and patched stone panels

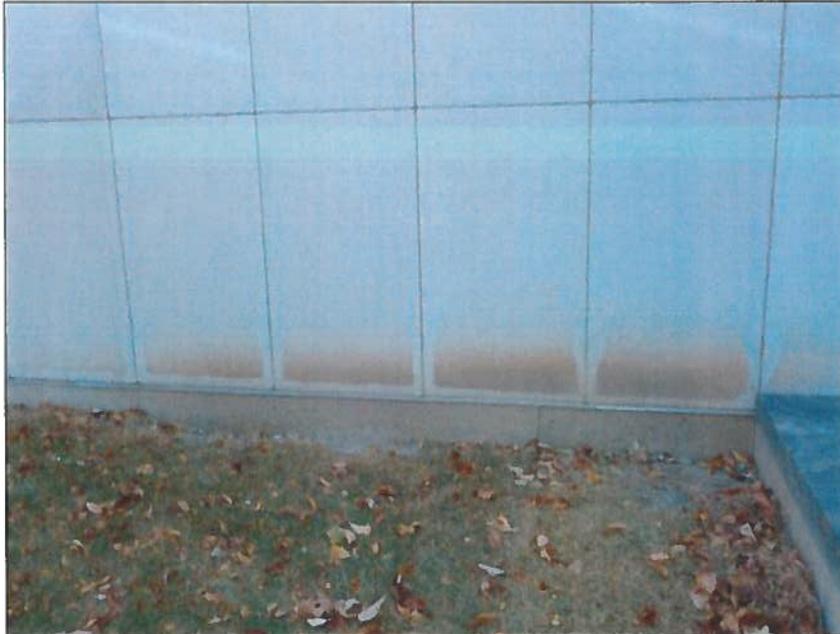
- Staining at base of screen wall may indicate unusual moisture condition.

Figure 4-5 Staining at base of screen wall

3. Unusual staining patterns were noted on the stone in various areas of the building (Figures 4-5 and 4-15). Some of these patterns may be due to air flow patterns around the building. However, in some areas, it appears that they may be due to moisture intrusion or possibly vapor drive through the wall. We recommend that the building be reviewed in the noted areas and also as a whole for stone staining to determine whether there is a source that could be causing damage to the building beyond just the surface staining. The review should be performed within 3 years or sooner if damage to the walls is noted within that time.

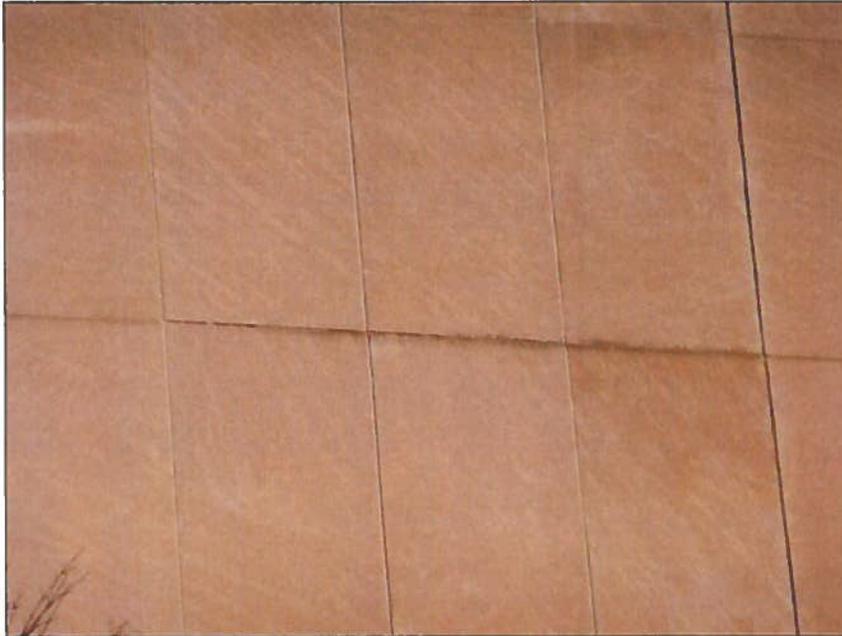
Figure 4-7 Deteriorated Mortar Joints

4. Deteriorated and cracked mortar joints between stone panels (Figure 4-7) should be repointed within 2 years.
5. Sealant joints at stone panels (Figure 4-8) should be replaced within 3 years unless mortar is found below the sealant as discussed in Condition 3 under Action Items above and Part V at the end of this report. Also, if stone spalls continue to occur (Figure 4-9) sealant should be replaced sooner than 3 years as the hardened sealant may be contributing to stone spalls.

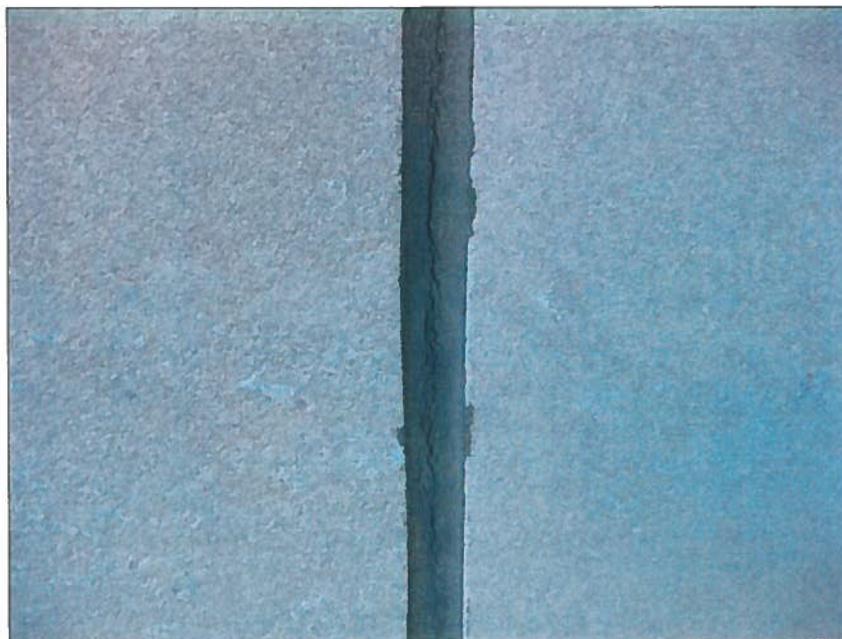
Figure 4-8 Hard and cracking sealant joints at stone panels

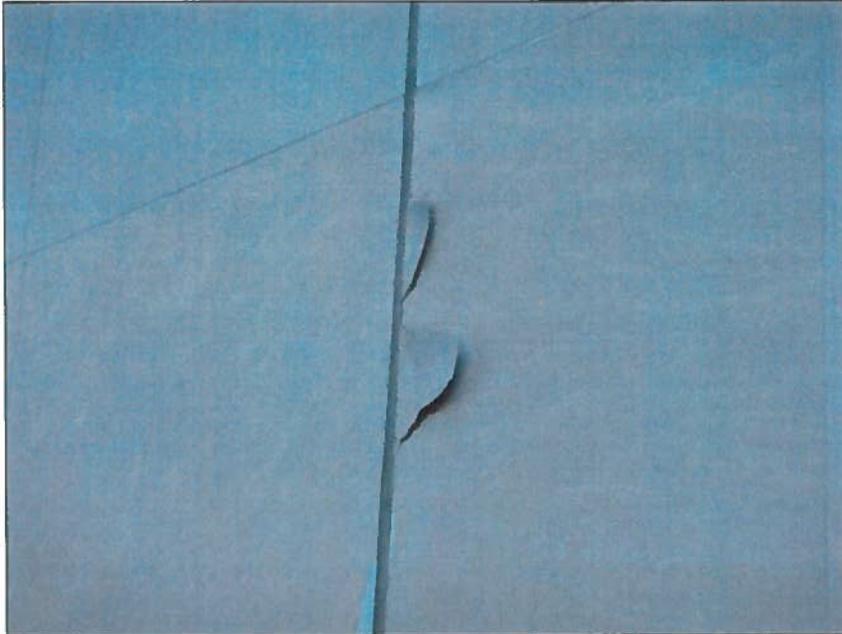
Figure 4-9 Spalled stone panels

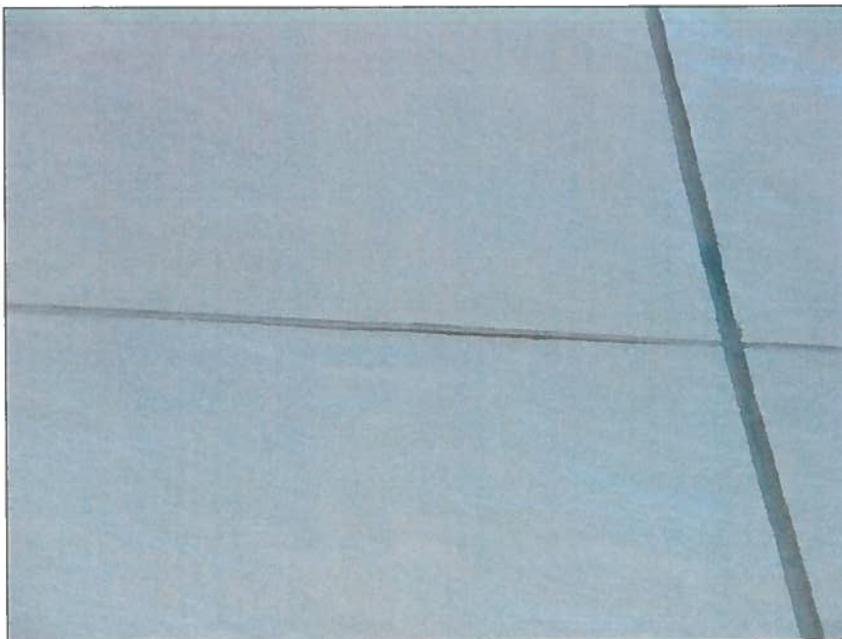
Figure 4-10 Deteriorated mortar joints

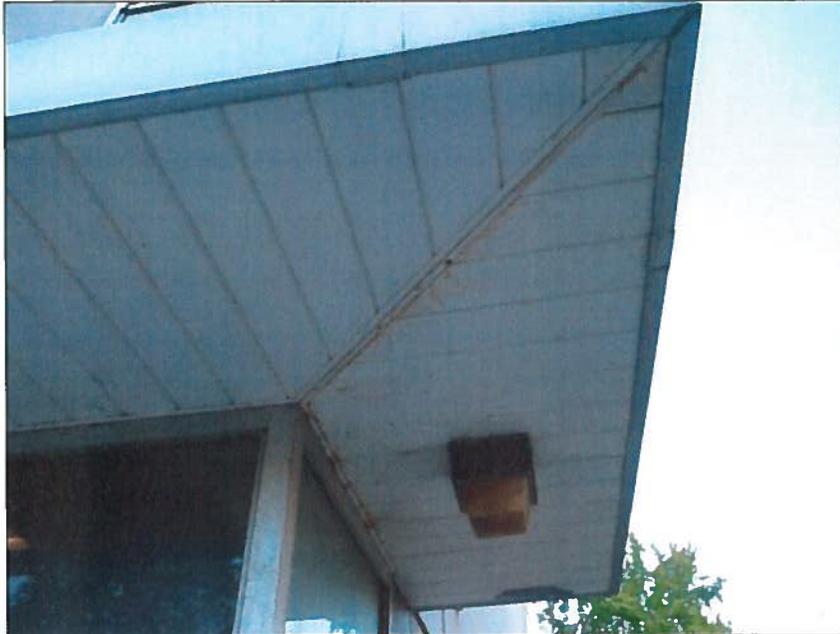
Figure 4-11 Light corrosion at metal soffit

6. The lightly corroded metal soffit at the northwest corner (Figure 4-11) should be monitored and replaced when needed. If corrosion worsens, we also recommend removing a section of soffit to determine whether it is the soffit itself or the framing above that is corroding.

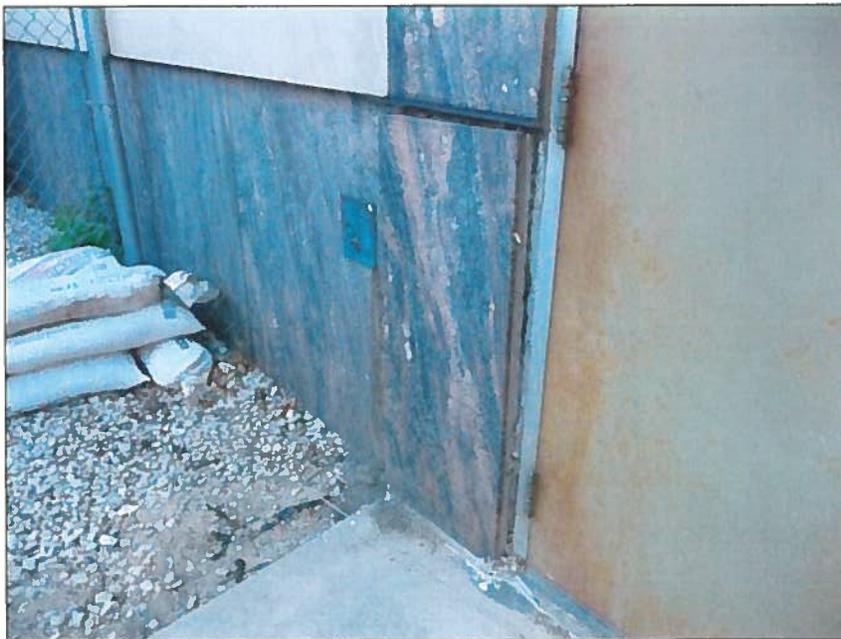
Figure 4-12 Shifted granite panel

7. The shifted granite panel at edge of door at the northwest corner (Figure 4-12) should be replaced or reset within 18 months.
8. The failing sealant at base of wall at the northwest corner (Figure 4-13) should be replaced within 18 months unless additional damage is noted in which case it should be performed at that time.

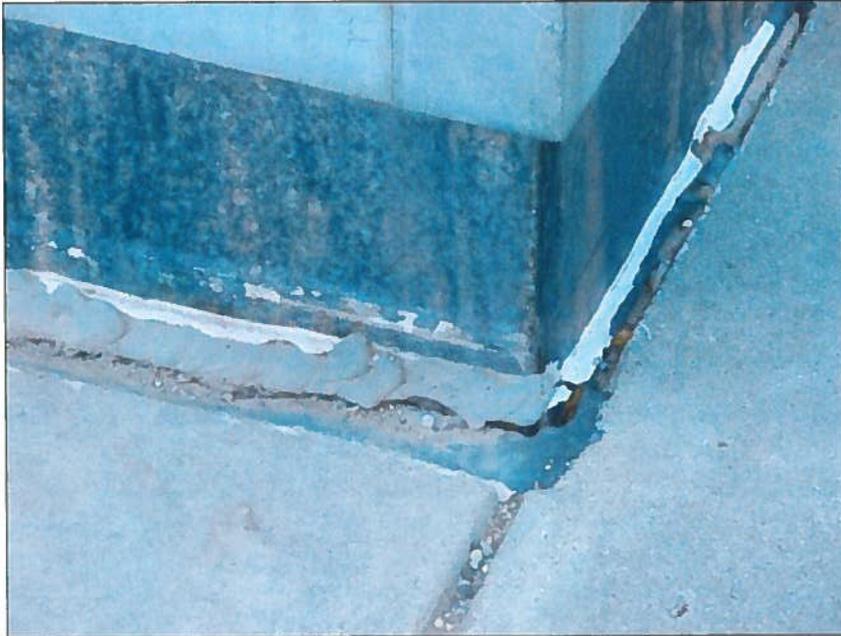
Figure 4-13 Sealant failing at base of wall

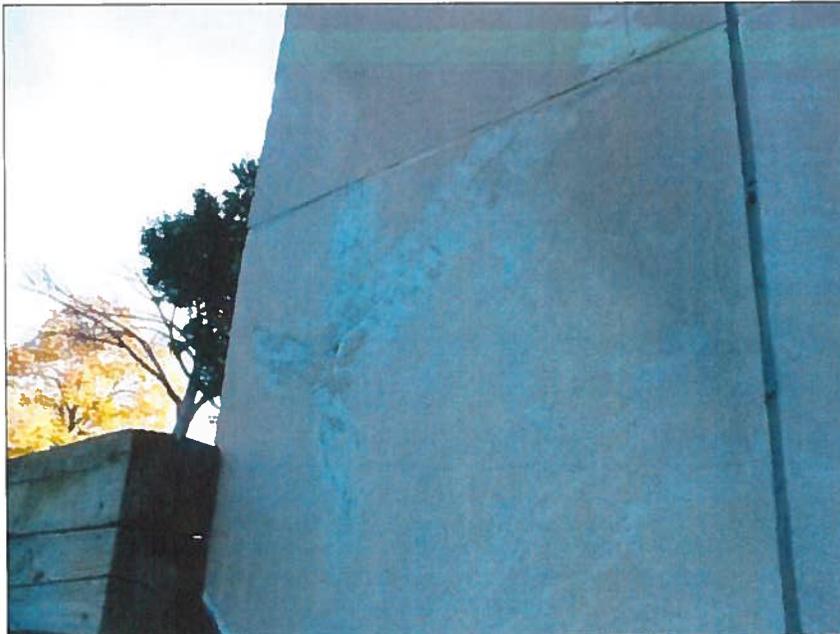
- Cracked stone panel.

Figure 4-14 Cracked stone panel

9. Cracked stone panel on Elevation 17 (Figure 4-14) should be replaced.
10. Minor spalled concrete at the soffit at Elevation 19 (Figure 4-16) should be removed.

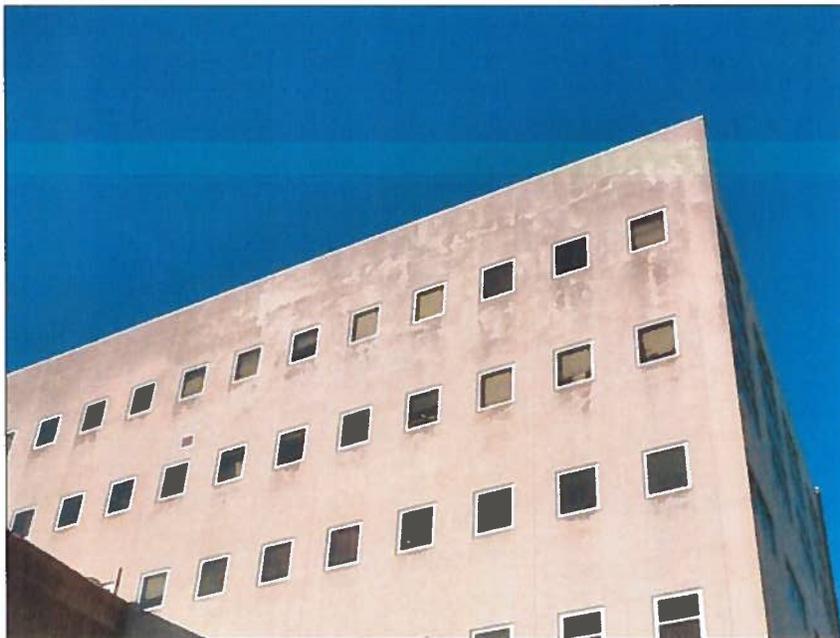
- Areas of stone panels are dirty/stained. The stone is not consistently stained throughout the building, but appears to follow certain patterns. It is unclear whether these patterns are due to air circulation around the building, or some other factor. This may be an indication of a moisture condition that may eventually affect the stability of the façade. Typical throughout building. See Part V for additional discussion.
- Minor spalled concrete at soffit.
- Cracked granite at base of wall due to previously installed anchors.
- Sealant joints in granite are losing adhesion to the stones.
- It appears that the stone sealant joints may have mortar behind the sealant. If this is the case at this location, or throughout the building, the joint will not perform as intended. See Part V for additional discussion.
- Windows do not have sill flashing. Typical throughout building.

Figure 4-15 Staining of stone panels

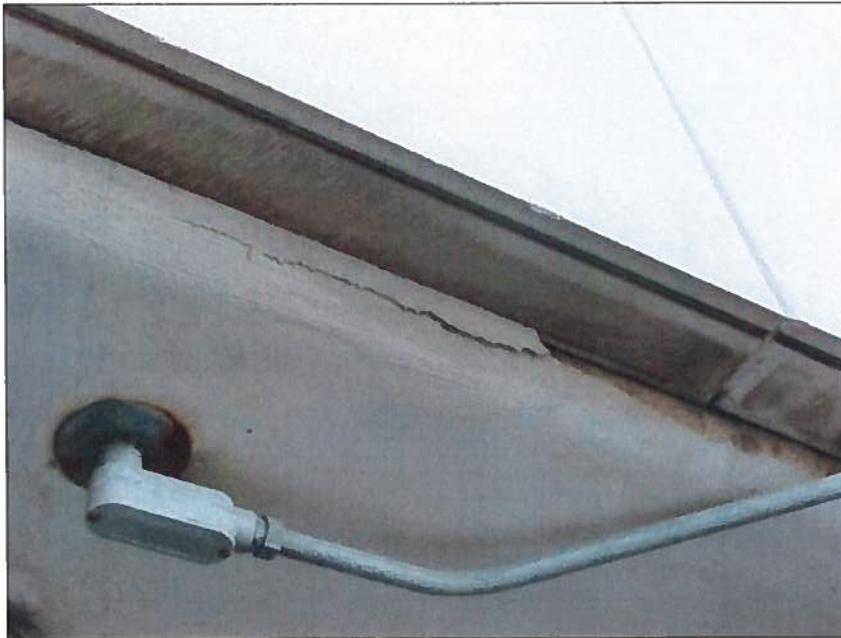
Figure 4-16 Minor spalled concrete at soffit

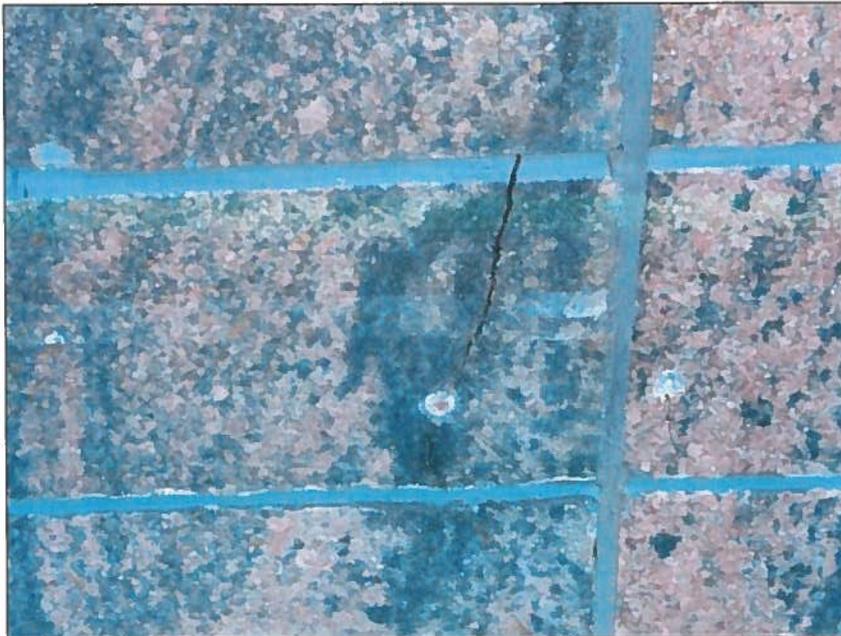
Figure 4-17 Cracked granite at fastener

11. The cracked granite at base of the wall at Elevation 19 (Figure 4-17) can be replaced. These pieces may remain in place as well, although the cracks may allow a small amount of water into the wall cavity.

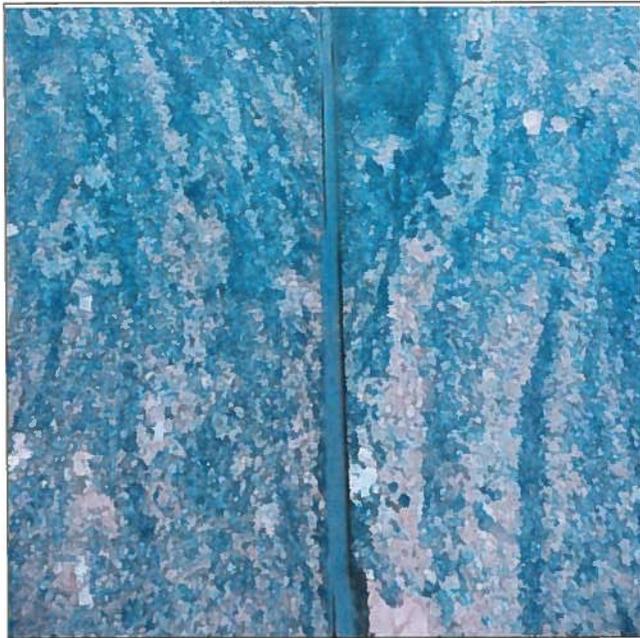
Figure 4-18 Failing sealant joint in granite

12. The sealant joints between the granite panels (Figure 4-18) should be replaced within 2 years.
13. The windows typically do not have sill flashing (Figure 4-20). Flashing should be installed if extensive work is performed at the windows, or if in the future, it is suspected that water is entering the building at these locations.

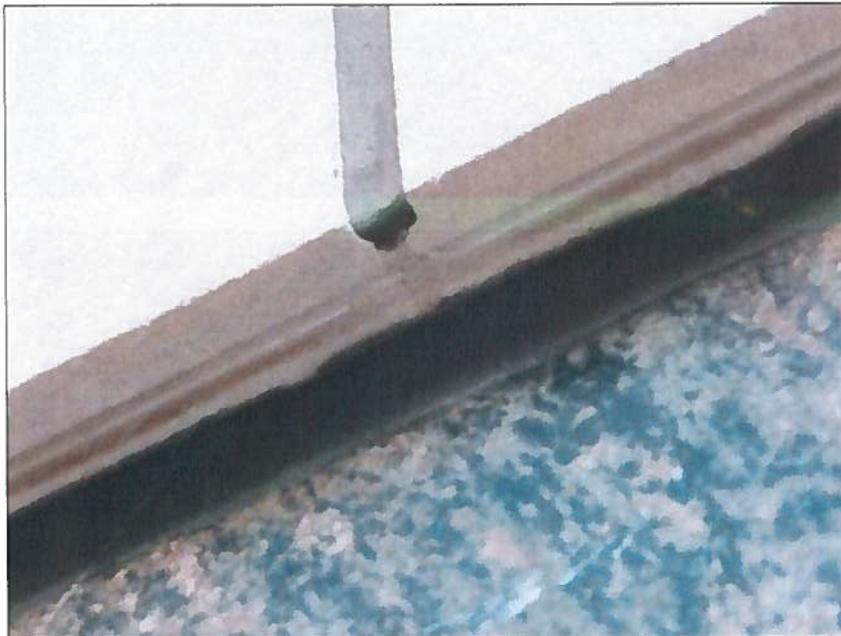
Figure 4-19 Possible mortar in stone sealant joint

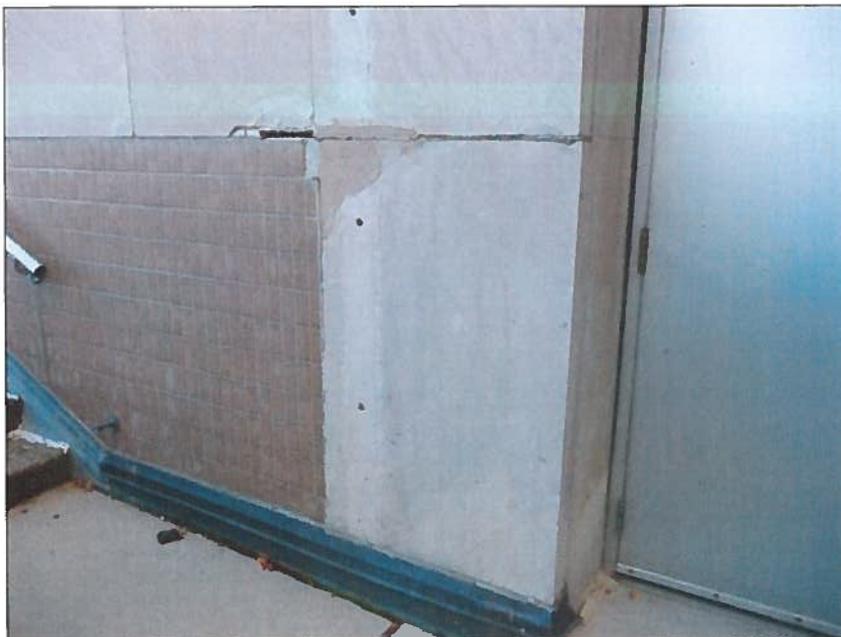
Figure 4-21 Stone damage near stairs

14. Stone damage on Elevation 20 near the bottom of the stairs (Figure 4-21) should be repaired.
15. The cracked tile near the top of the stairs on Elevation 20 (Figure 4-22) should be replaced.

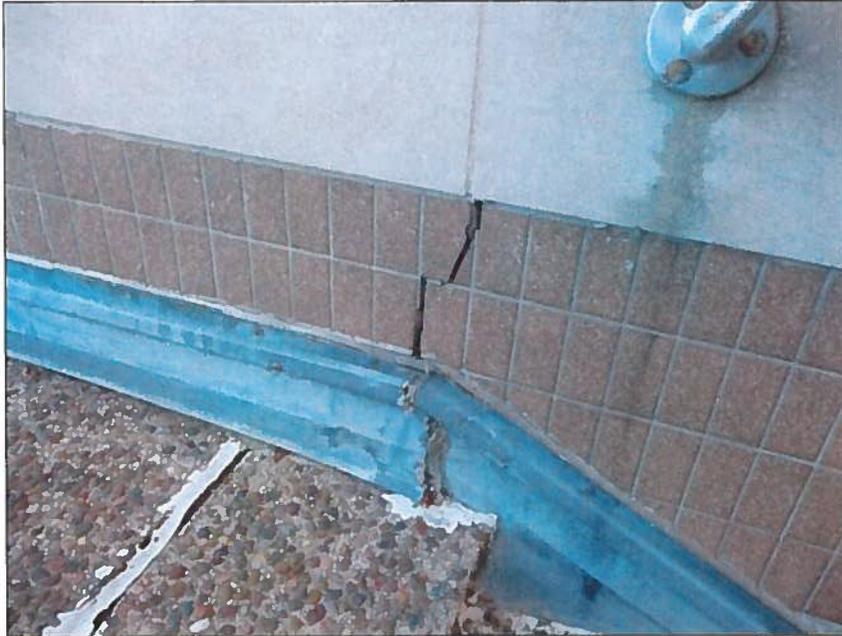
Figure 4-22 Cracked tiles at top of stairs

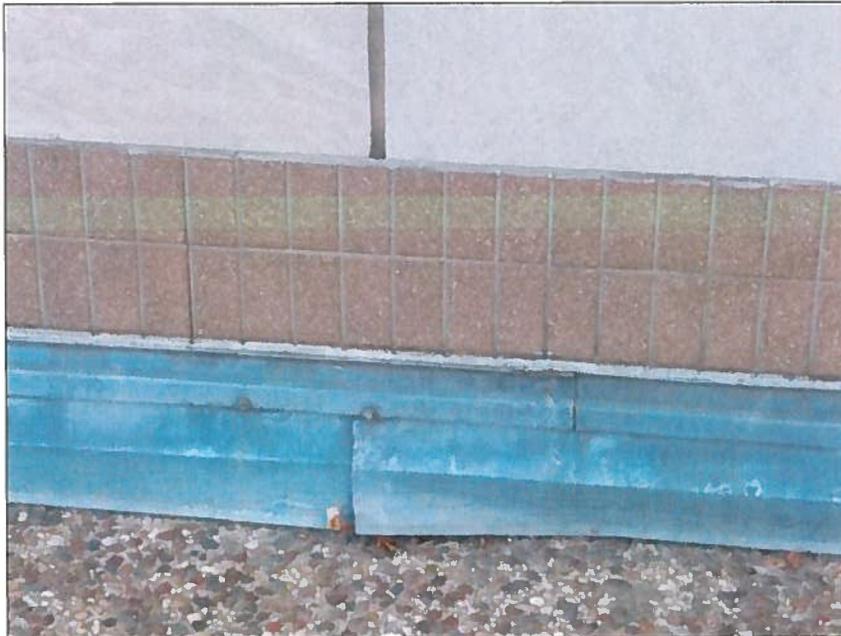
Figure 4-23 Bent counterflashing

16. The bent counterflashing around the perimeter of the garage roof (Figure 4-23) should be replaced.
17. The damaged stone panels where the east wall of the garage meets Elevation 20 (Figure 4-25) should be replaced within 2 years.

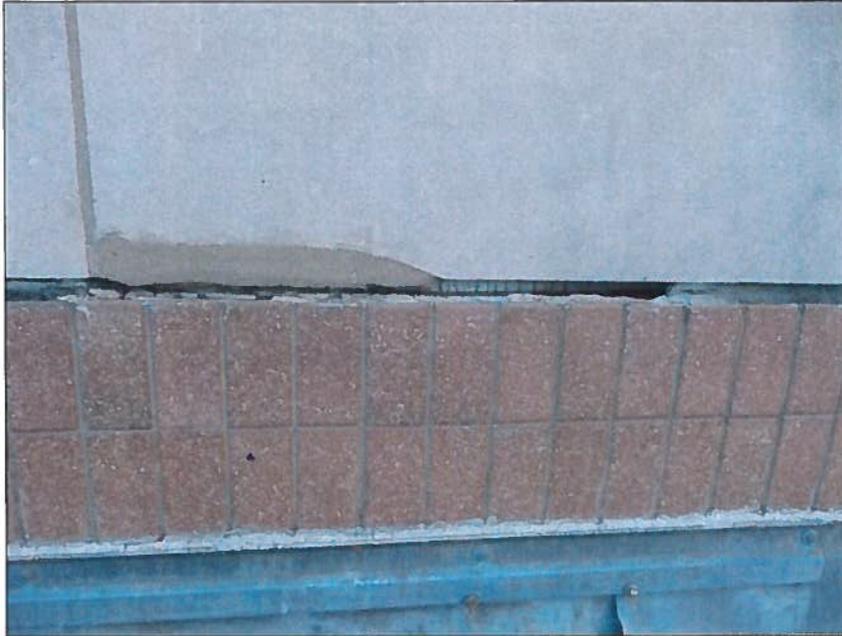
Figure 4-24 Deteriorated mortar joint at base of stone panels

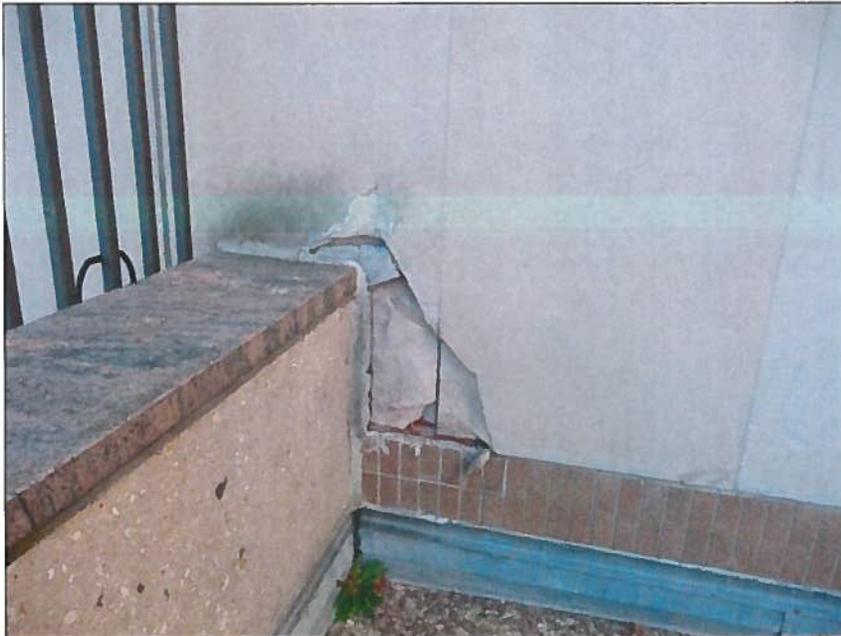
Figure 4-25 Damaged stone at garage wall intersection

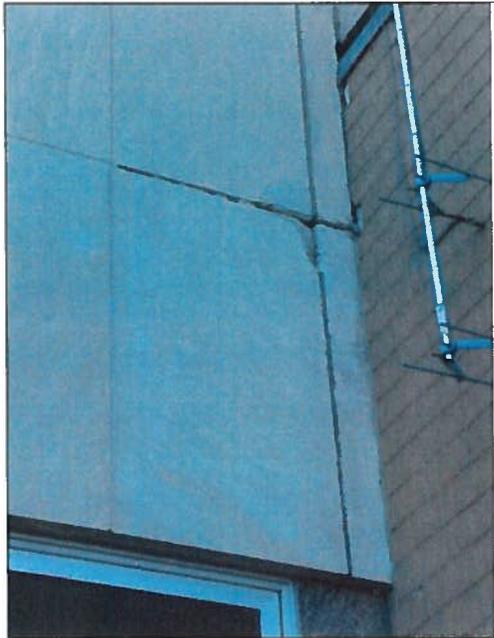
Figure 4-26 Deteriorated mortar joint at garage wall intersection

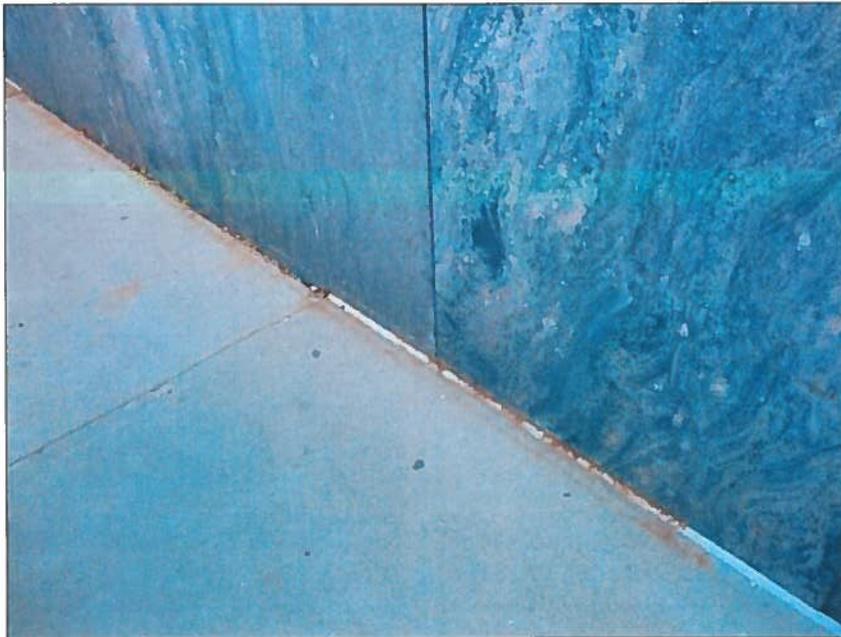
- Rust staining at the base of the granite wall. It appears that this rust may be coming from the steel supporting the stone above the granite. See Part V for additional discussion.

Figure 4-27 Rust staining on ground

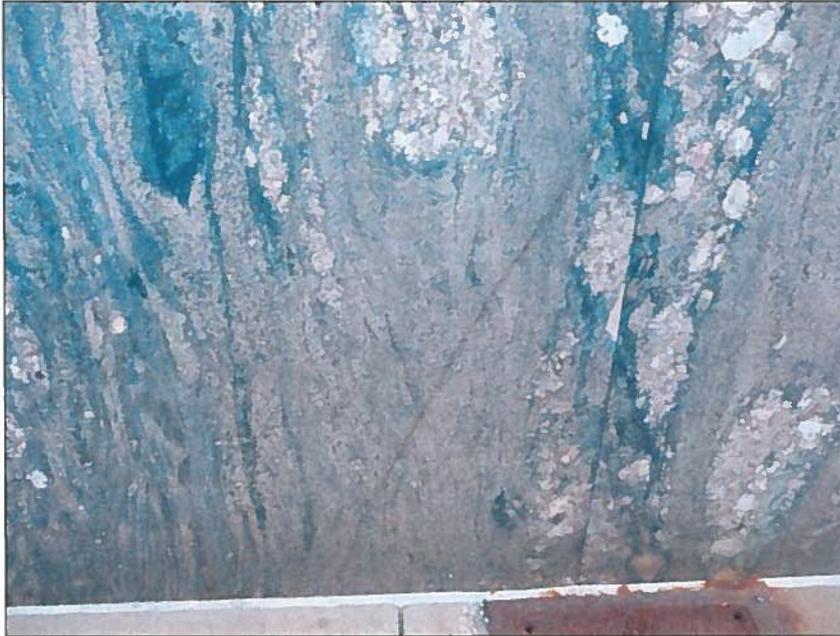
Figure 4-28 Minor crack in granite panel

18. The granite panel on Elevation 20 with the minor crack (Figure 4-28) should be replaced if work is being done with this panel or if the crack grows in size.

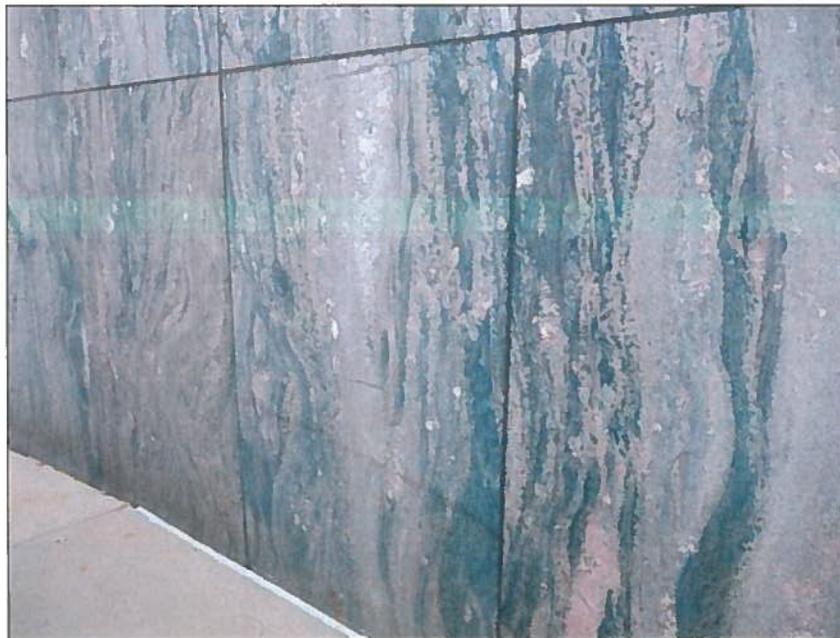
Figure 4-29 Horizontal crack in granite with bulge at crack

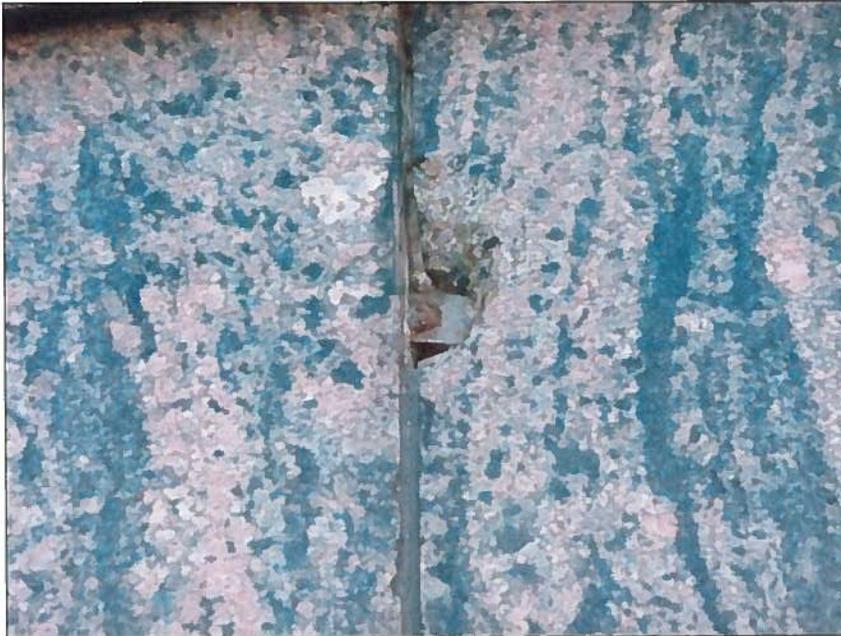
Figure 4-30 Spalled panel exposing connector

19. The spall in the granite panel on Elevation 20 which is exposing a connector (Figure 4-30) should be patched. The steel connector should be cleaned and primed prior to patching the granite.

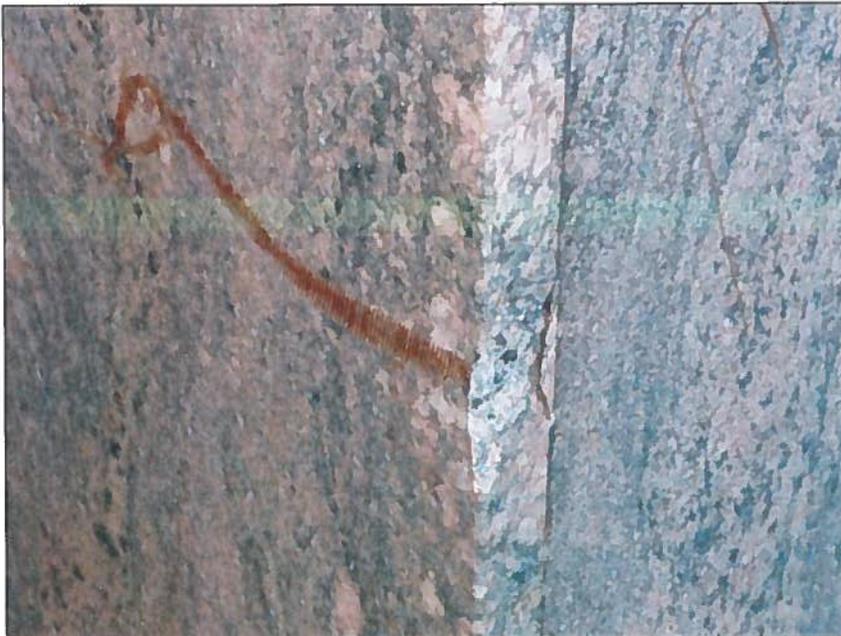
Figure 4-31 Chipped panel due to impact

20. Chips in granite due to impact (Figure 4-31) can be patched if desired.
21. Deterioration and cracking in the wall tile on Elevation 21 (Figures 4-32 and 4-33) could be repaired. It is likely that this sort of deterioration will continue to occur. This area should be monitored regularly for additional damage. When the damage gets to a more critical point, replacement of the façade finish should be considered.

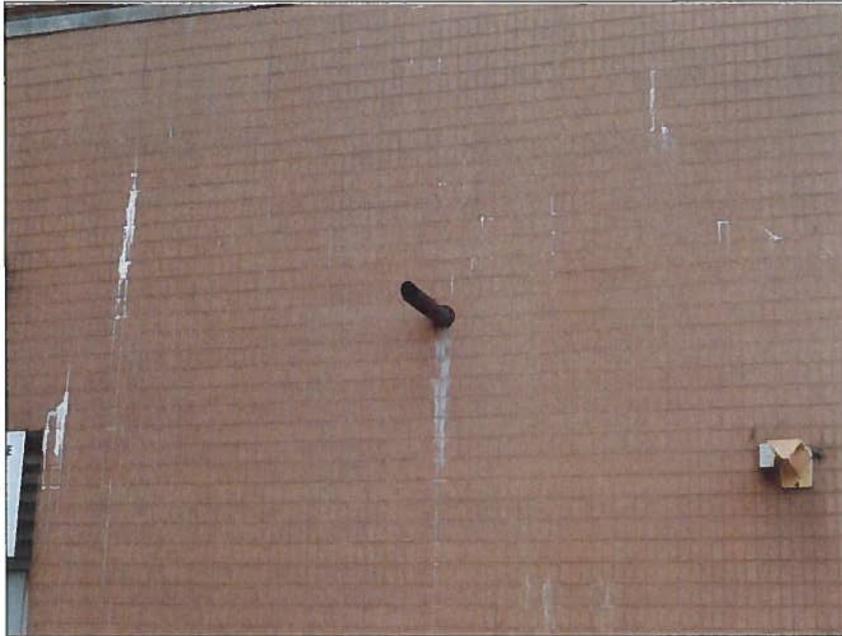
Figure 4-32 Water damage to wall tile

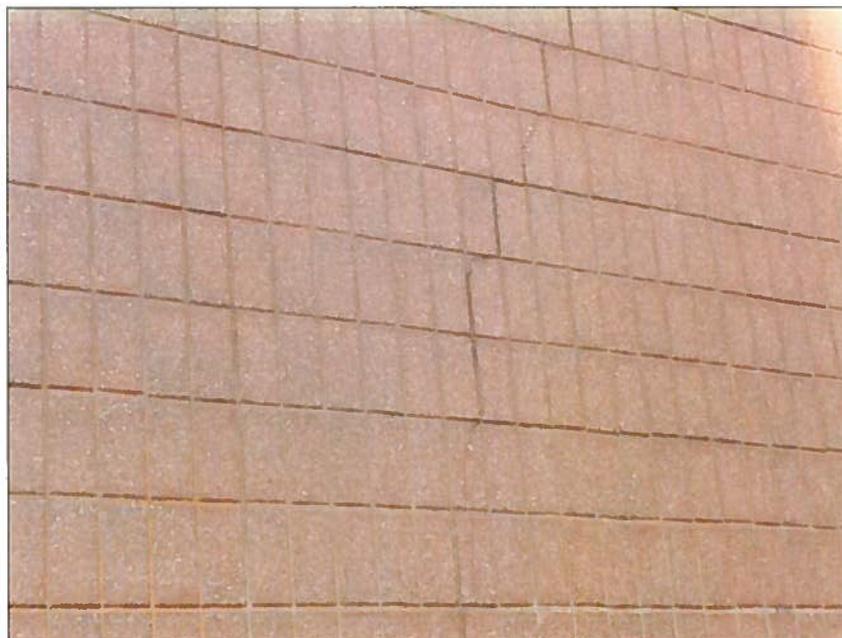
Figure 4-33 Cracking in wall tile

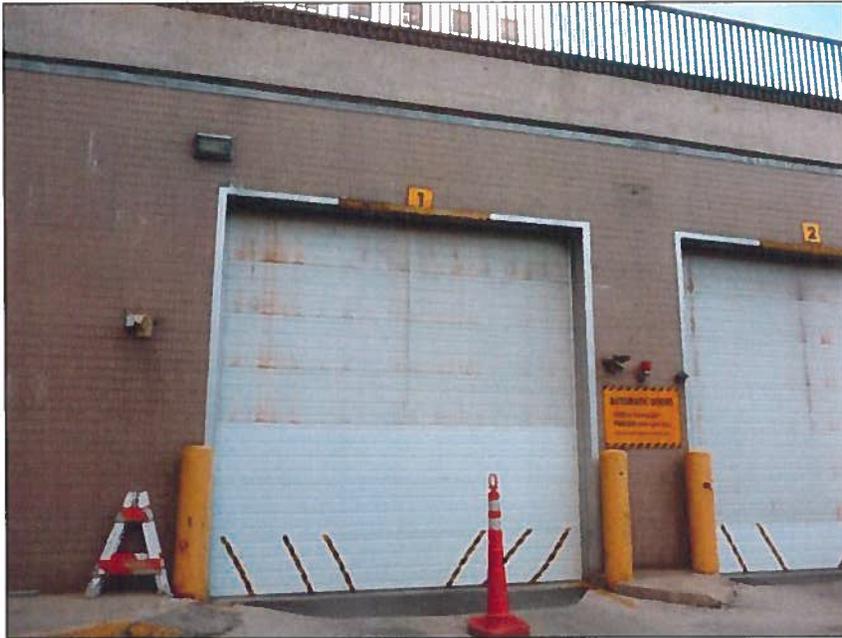
Figure 4-34 Corrosion of overhead doors

22. Corroded overhead doors (Figure 4-34) should be replaced when corrosion affects the function of the doors, or sooner if desired.
23. The deteriorated joint sealant between buildings and within the IMax building (Figure 4-35) should be replaced within 2 years.

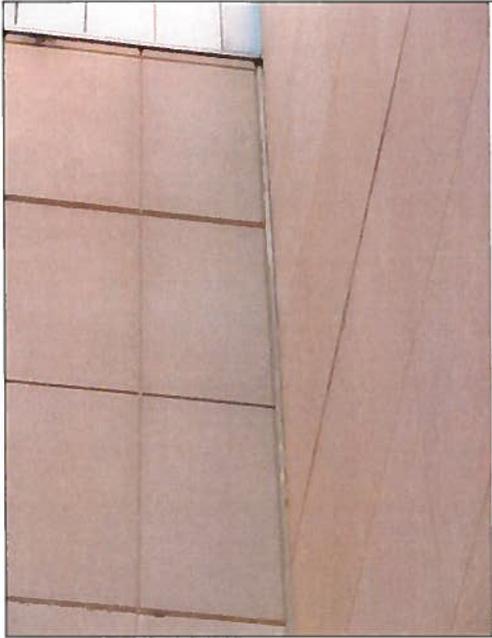
Figure 4-35 Deteriorated joint sealant

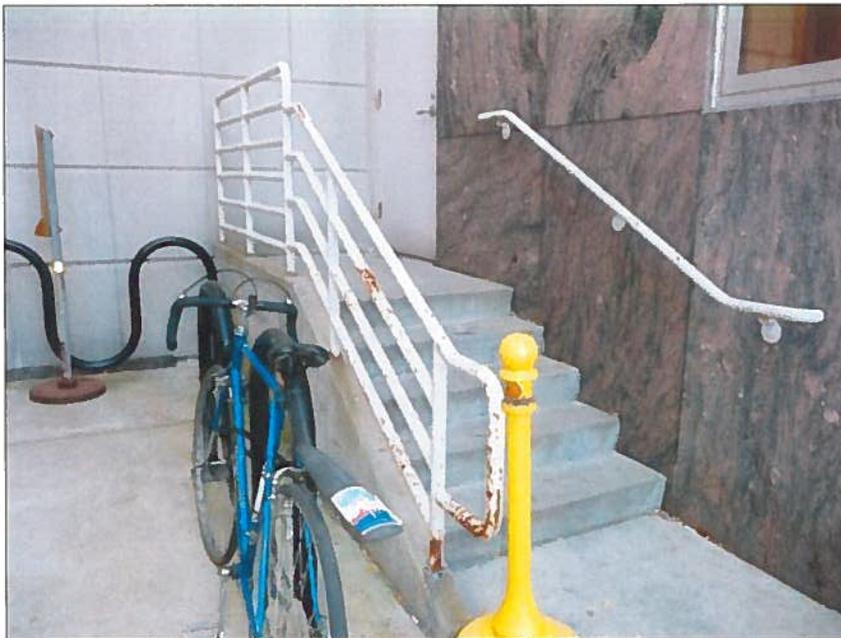
Figure 4-36 Corrosion of railing

24. The corroded steel railing (Figure 4-36) should be cleaned, primed and painted within 3 years.

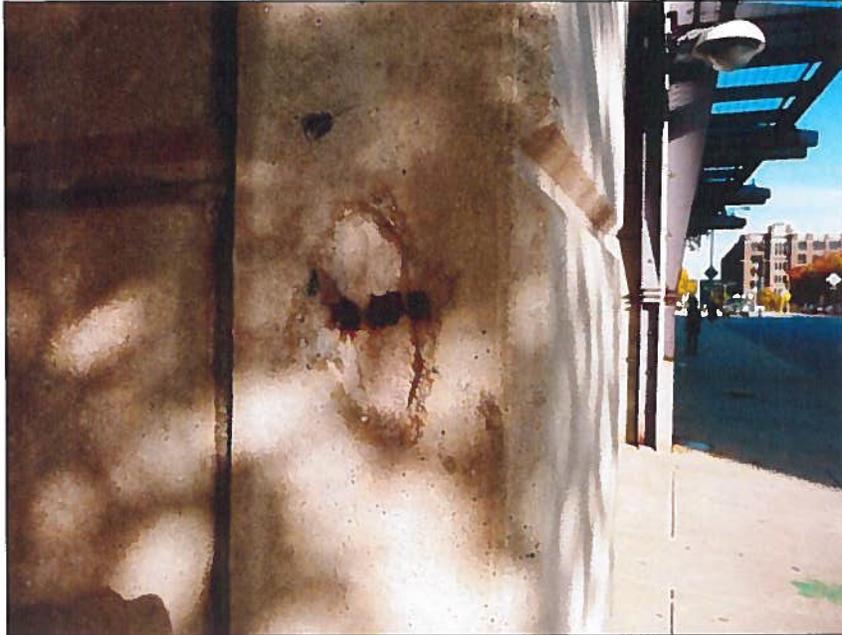
Figure 4-37 Damaged concrete panel

- 25. The spall and damage to side of the concrete panel on Elevation 23 (Figure 4-37) can be repaired if desired for aesthetic reasons or if deterioration of the steel begins to cause damage to the concrete panel.

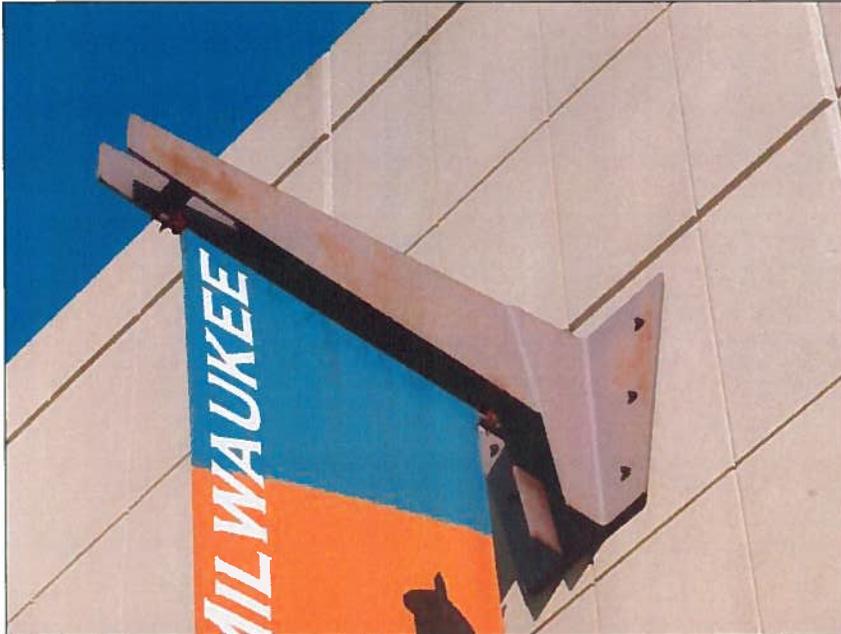
Figure 4-38 Minor corrosion of steel sign supports

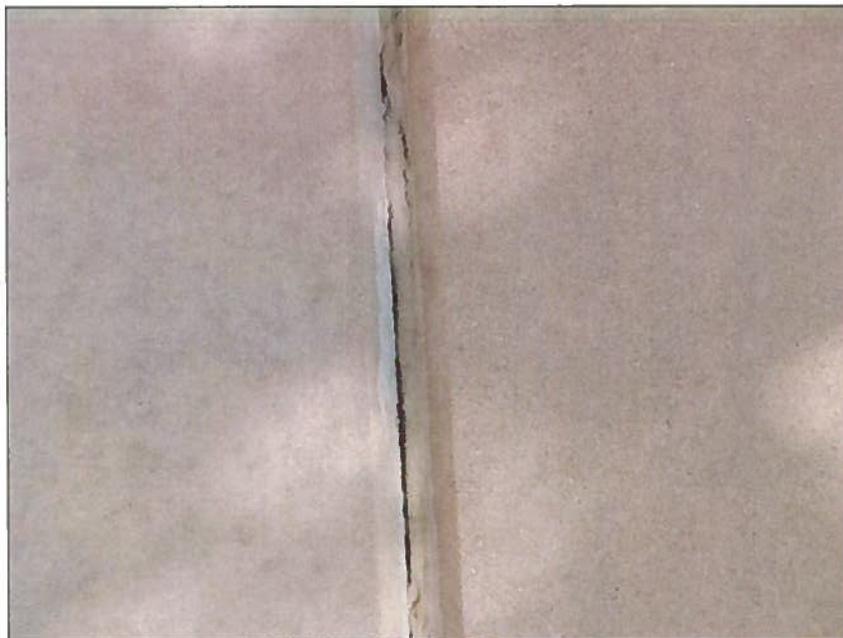
Figure 4-39 Failing joint sealant

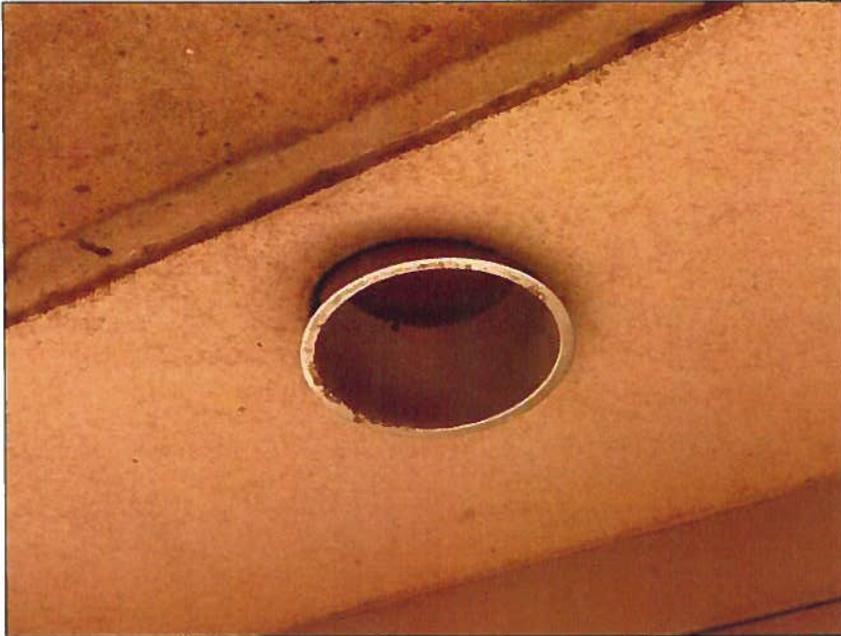
Figure 4-40 Loose recessed light in soffit

6. A loose recessed light was noted in the soffit of Elevation 24. It should be secured or removed within 1 month.
