Project: EXTERIOR FACADE RESTORATION
Milwaukee Public Museum
800 West Wells Street
Milwaukee, WI 53233-1478

Subject: **Visual Façade Evaluation Report**
By
GRAEF, Inc.
November, 2010

Visual Façade Evaluation Report

November 10, 2010

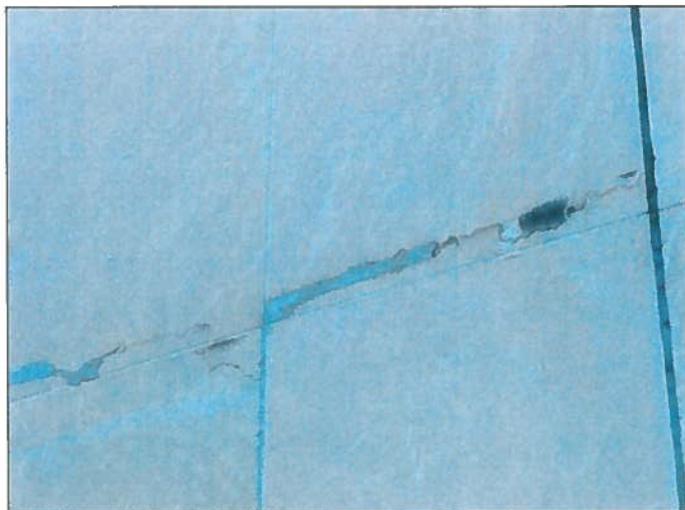
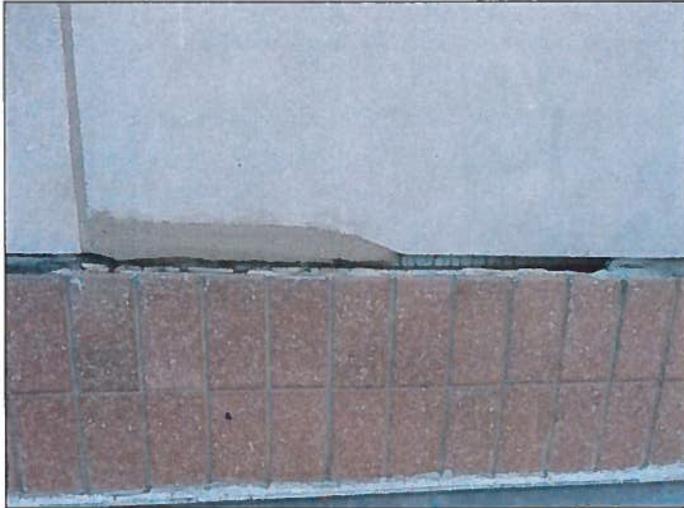
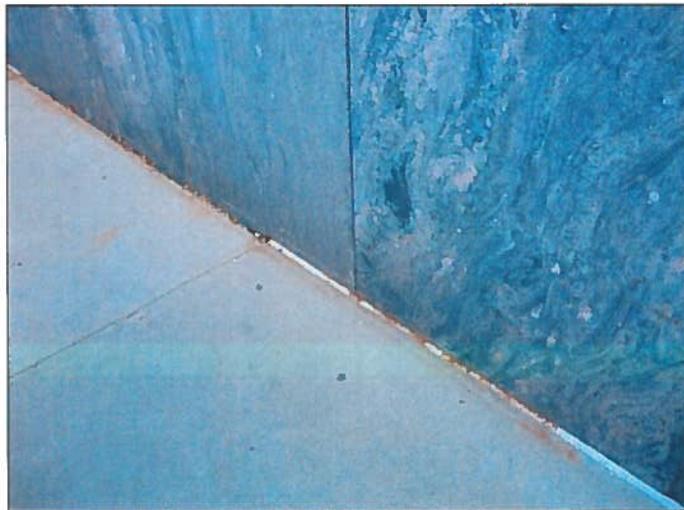
Some initial signs of possible deterioration of the stone panel steel supports were noted. Such signs include cracking of the panels near the horizontal joints (see Photo 5-1), deteriorated mortar joints near the base of the wall (see Photo 5-2), rust staining at the base of the granite wall that may be from the support angle above the granite (see Photo 5-3). None of these indicate that there is an immediate concern with stability of the façade; in fact, these indications are not necessarily each related to steel deterioration. However, if the supports are deteriorating, this is a condition which, if left unaddressed, could cause significant issues with the façade in the long term. A similar issue is currently being studied on the marble clad north and south walls of the 8 story portion of the building. The conditions found at the stone facades are not nearly as severe at this time as those found on the marble portions.

Figure 5-1 Close up of cracked and patched stone panels – Elevation 1

Figure 5-2 Deteriorated mortar joint at base of stone panels – Elevation 20

Figure 5-3 Rust staining on ground – Elevation 20

1. Signs of possible deterioration of the stone panel steel supports were noted at multiple locations around the building. We recommend that an investigation of the condition of the supports be completed within one year. This investigation should provide a timeframe for any repairs based on the findings at that time.

We recommend an investigation and study be performed for the stone panel supports. This would include reviewing the drawings to determine the types of details used for these connections. Also included would be a thorough up-close examination of select areas of the stone façade. Finally, it also might include removing the stone in small, isolated areas to examine the condition of the steel supports.

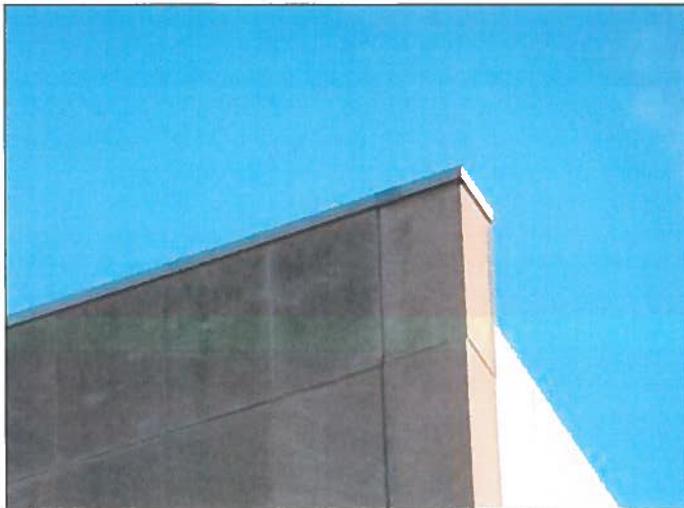
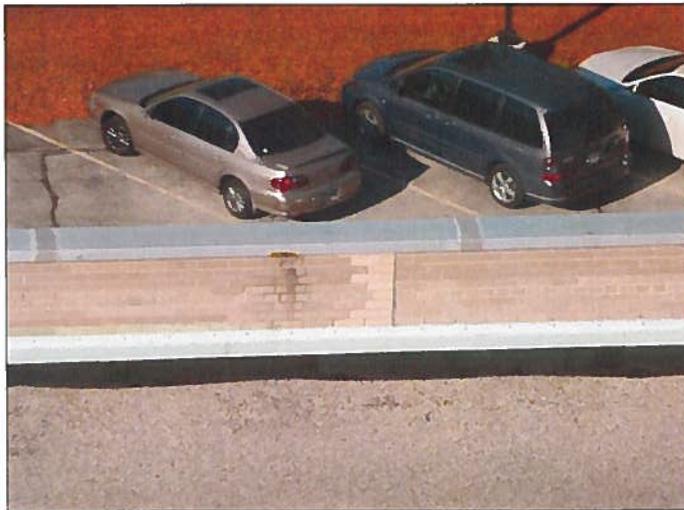
The stone panels at the parapet height have shifted a small amount in various areas around the building (Photo 5-4). Evidence of this was visible from the ground and from the roof level. None of the panels appear to be loose based on our visual evaluation; however, the cause of the movement should be further investigated. The parapets on the high roof and the east side low roof have been enclosed in metal siding and flashing (Photo 5-5). The parapet on the west side low roof has not been enclosed; however, vertical control joints have been added to the roof side face of the parapet (Photo 5-6).

The movement of the stone at the parapet is consistent with horizontal expansion of the parapet. If the parapets were constructed with brick without control joints, this may explain the expansion and movement of the stone. However, additional research into the construction of the parapets and the reasons behind installing control joints and metal enclosure is recommended.

Figure 5-4 Shifted stone panels at parapet – Elevation 13

Figure 5-6 Exposed parapet wall with control joints – Elevation 15

2. The stone panels at the parapet elevation have shifted a small amount in various areas around the building. Some of the parapets have been enclosed with metal siding and cap flashing. Others have exposed brick on the roof-side elevation. We recommend additional research into the construction of the parapets and the possible sources of movement of the stone panels within 6 months.

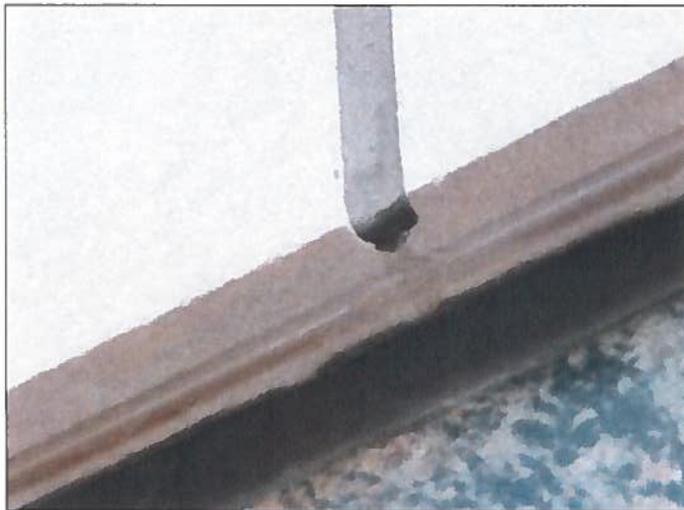
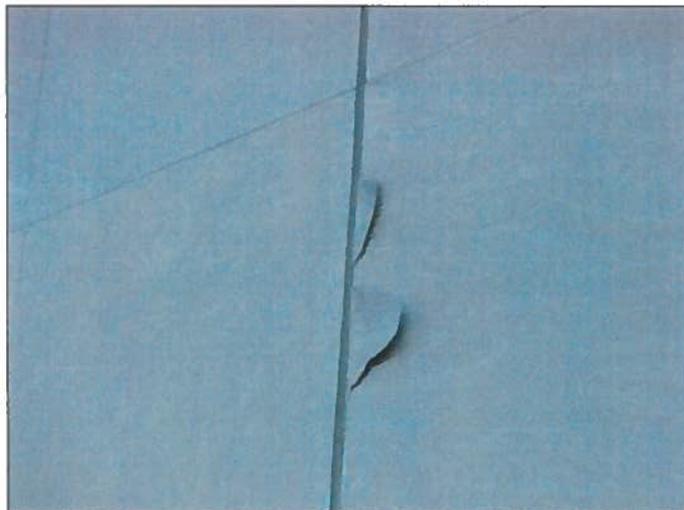
The sealant joints in the stone panels are in poor condition. The sealant is no longer flexible and in some areas is losing adhesion to the stone. On Elevation 19, a few joints were observed that appeared as though there may be mortar in the joint behind the sealant (Photo 5-7). If this is the case, the joint would be ineffective as a movement joint. Stone spalls were noted on Elevation 15 (Photo 5-8). An ineffective movement joint could cause this type of damage. We recommend that the sealant be removed in a few of these joints to determine their construction. The spalled stone pieces should be removed.

Figure 5-7 Stone joint with possible mortar behind sealant – Elevation 19

Figure 5-8 Spalled stone at sealant joint – Elevation 15

3. The sealant joints in the stone panels are in poor condition. The sealant is no longer flexible and in some areas is losing adhesion to the stone. A few joints were observed that appeared as though there may be mortar in the joint behind the sealant. Stone spalls were noted on Elevation 15 that may be related to this issue. We recommend that the sealant be removed in a few of these joints to determine their construction within 3 months and that the spalled stone pieces be removed within 1 month.

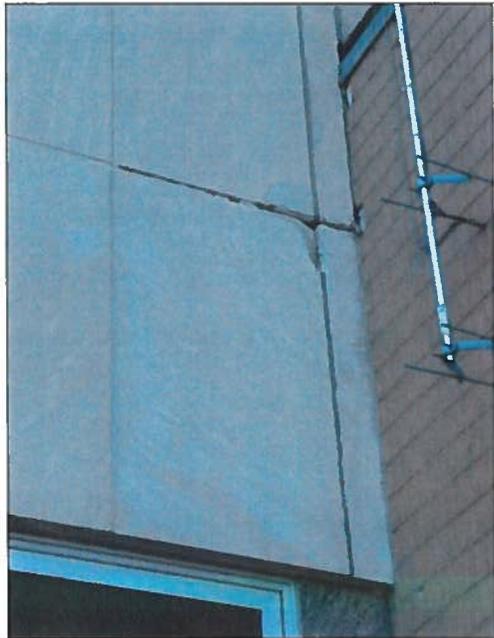
Deteriorated mortar joints were observed in the area where the garage Elevation 21 intersects with the north wall of the Museum, Elevation 20 (Photo 5-9). The deterioration appears to be significant and ongoing based on the patches in the stone in this area. It is also possible that this condition is related to Condition 1 previously discussed. We recommend further investigation of this area to determine the source of the deterioration and whether the stone panel supports are deteriorated.

Figure 5-9 Deteriorated mortar joint at garage wall intersection – Elevation 20

4. Deteriorated mortar joints were observed in the area where the garage, Elevation 21, intersects with the north wall of the Museum, Elevation 20. The deterioration appears to be significant and ongoing based on the patches in the stone in this area. It is also possible that this condition is related to Condition 1 previously discussed. We recommend further investigation of this area to determine the source of the deterioration and whether the stone panel supports are deteriorated. This investigation should be done in conjunction with the investigation performed for Condition 1, within one year.

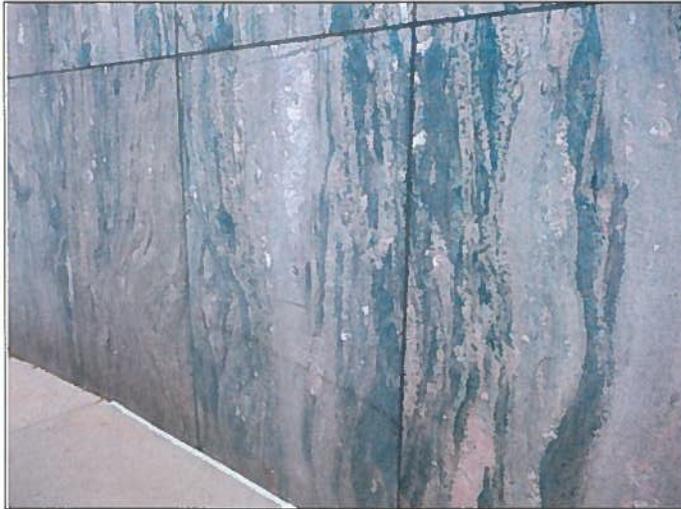
A granite panel at the base of the wall at the east end of Elevation 20 has cracked horizontally (Photo 5-10). The panel is bowing away from the wall slightly. We recommend that this panel either be replaced or stabilized in place with anchors.

Figure 5-10 Cracked granite panel – Elevation 20

5. A granite panel at the base of the wall at the east end of Elevation 20 has cracked horizontally and is bowing away from the wall slightly. We recommend that this panel either be replaced or stabilized in place with anchors within 3 months.

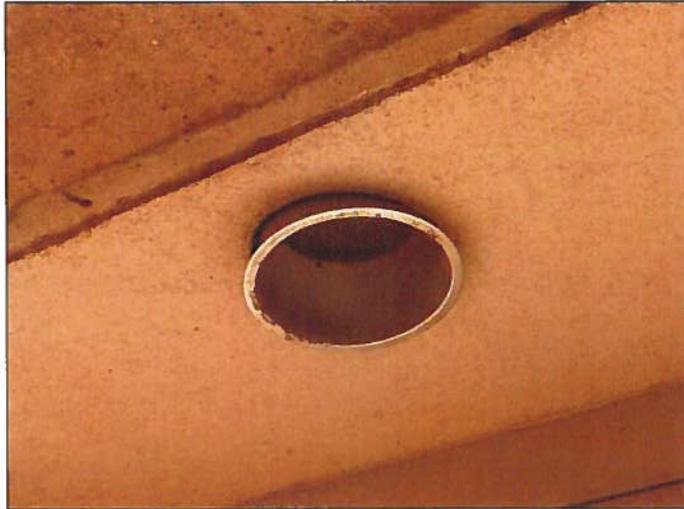
A loose recessed light was noted in the soffit (Photo 5-11). If this light is loose enough, it could be a falling hazard. It should be secured or removed.

Figure 5-11 Loose recessed light in soffit – Elevation 24

6. A loose recessed light was noted in the soffit of Elevation 24. It should be secured or removed within 1 month.
