Milwaukee County 2015 Sanitary Sewer
Rehabilitation

V009-15804

Contract 2

PAST CCTV TELEVISIONING REPORTS FOR
REFERENCE FOR PIPE REHABILITATION
WORK SCHEDULE ON **SHEET C-03**

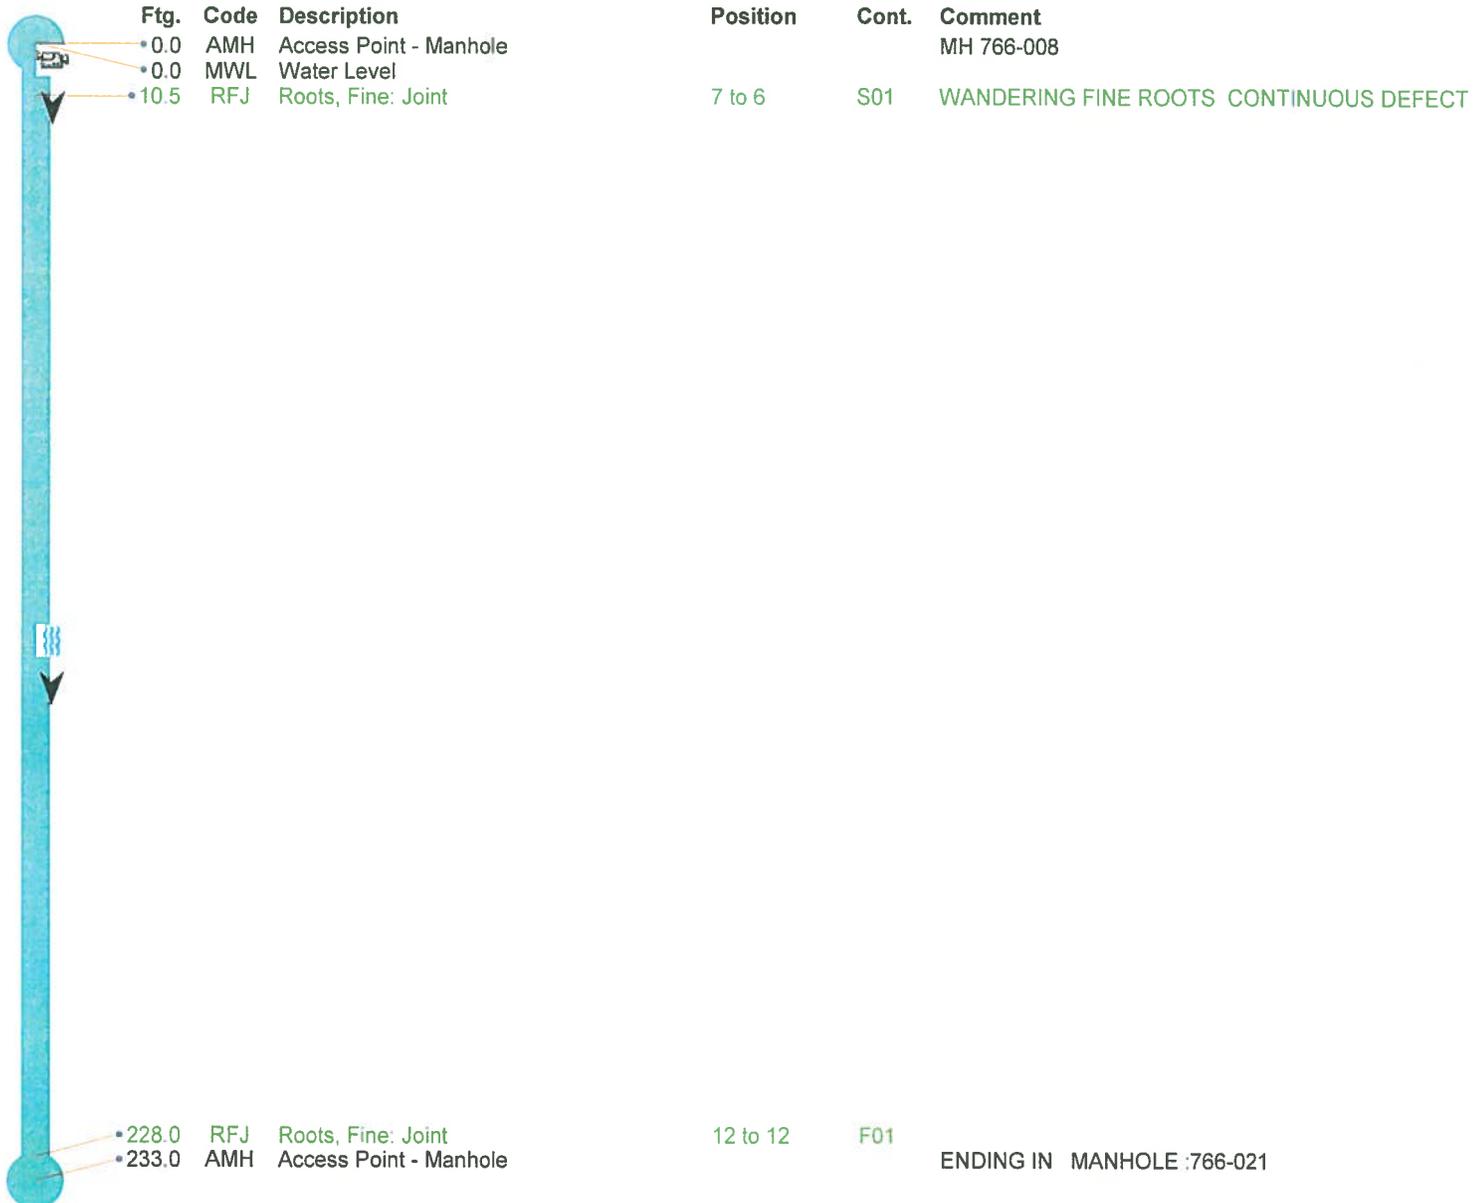
Date 02/27/2015	Time 2:13 PM	Location (Street) GREENFIELD PARK			Job Number 13007W-11
Use of Sewer Sanitary	Pipe Size 8	Material Vitrified Clay Pipe	Jt. Spacing 4	Shape Circular	Survey Direction Downstream
Pre-Cleaning Jetting	Weather Damp	Surface Grass	US MH Depth 6	DS MH Depth 6	Flow Direction E
Media No. 05	Surveyed Length 233	Total Length 233	Surveyor MICHAEL FABIAN	Certificate No. U-1109-9734	Truck No. 235

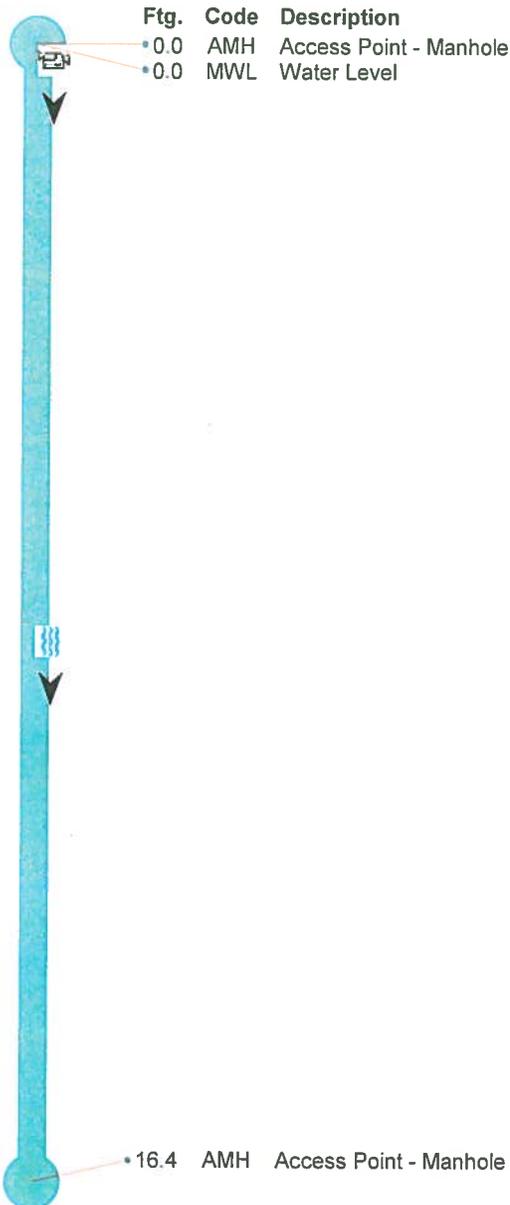
Ftg.	Code	Description	Position	Cont.	Comment
0.0	AMH	Access Point - Manhole			MH 766-009
0.0	MWL	Water Level

ENDING IN MANHOLE :766-008

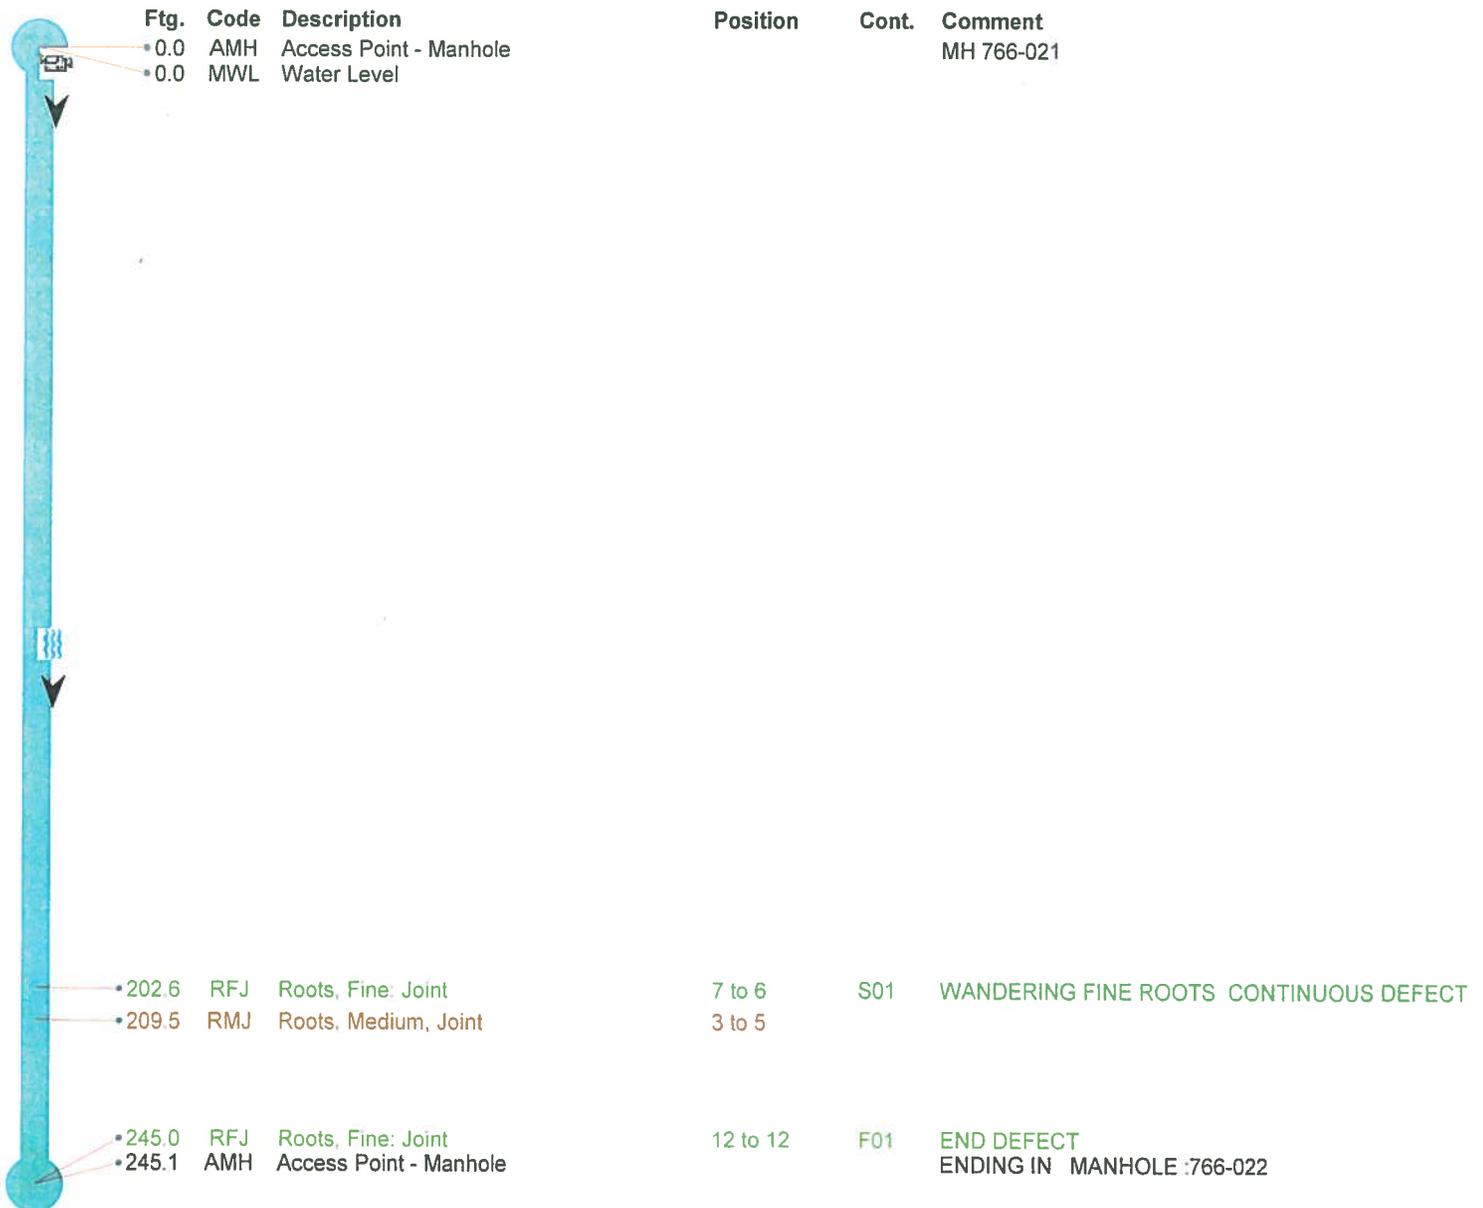
Date 02/27/2015	Time 1:54 PM	Location (Street) GREENFIELD PARK			Job Number 13007W-11
Use of Sewer Sanitary	Pipe Size 8	Material Vitrified Clay Pipe	Jt. Spacing 4	Shape Circular	Survey Direction Downstream
Pre-Cleaning Jetting	Weather Damp	Surface Grass	US MH Depth 6	DS MH Depth 14.5	Flow Direction E
Media No. 06	Surveyed Length 245.1	Total Length 245	Surveyor MICHAEL FABIAN	Certificate No. U-1109-9734	Truck No. 235

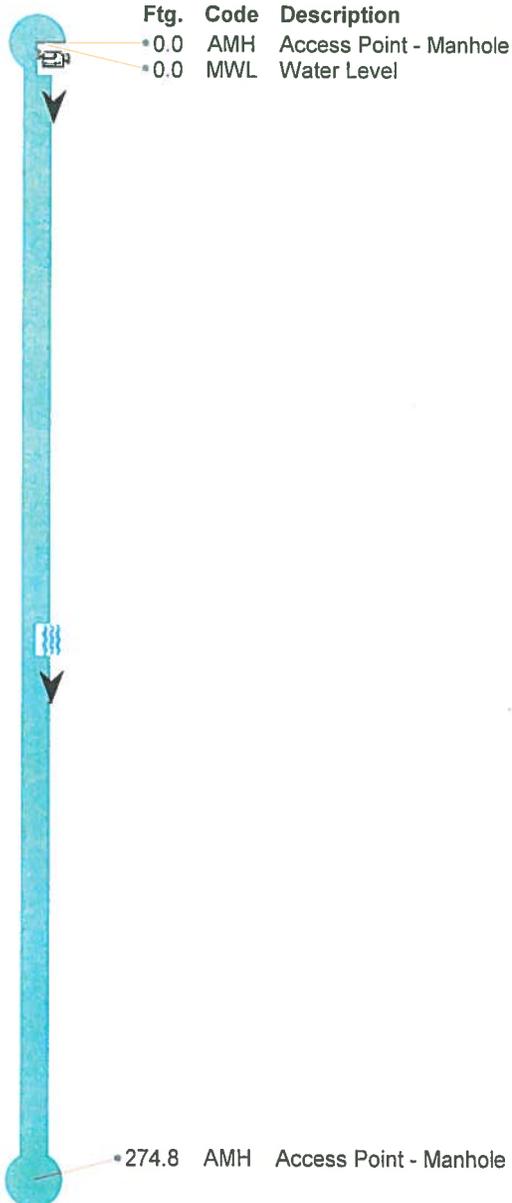
Position	Cont.	Comment
		MH 766-022

ENDING IN MANHOLE :766-024
