Milwaukee County 2015 Sanitary Sewer
Rehabilitation

V009-15804

Contract 2

PAST CCTV TELEVISIONING REPORTS FOR
REFERENCE FOR PIPE REHABILITATION
WORK SCHEDULE ON **SHEET C-04**

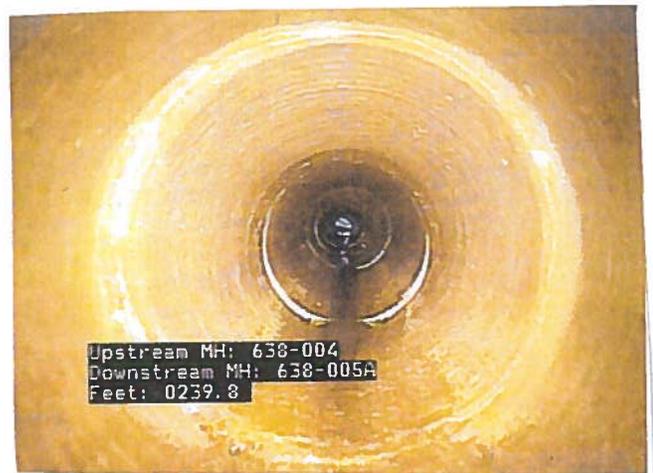
F01

Ftg.	Code	Description	Position	Cont.	Comment
•0.0	AMH	Access Point - Manhole			MH 638-004
•0.0	MWL	Water Level			
•29.6	RMJ	Roots, Medium, Joint	1 to 11		
•30.0	CM	Crack Multiple	6 to 6		
•48.2	RFJ	Roots, Fine: Joint	7 to 5	S01	ROOTS AT THE JOINTS ARE REMNANT ROOT CUTTER WENT THRU
•57.4	CC	Crack Circumferential	6 to 6		
•93.6	FM	Fracture Multiple	6 to 6		
•127.5	CC	Crack Circumferential	7 to 7		
•136.4	CM	Crack Multiple	10 to 4		
•187.0	FC	Fracture Circumferential	6 to 6		
•201.7	CC	Crack Circumferential	6 to 6		
•208.8	DSC	Deposits Settled: Compacted	5 to 7		
•212.2	DSC	Deposits Settled: Compacted	5 to 7		
•215.5	FM	Fracture Multiple	7 to 5		
•224.7	RFJ	Roots, Fine: Joint	7 to 5		
•240.5	CC	Crack Circumferential	6 to 6		
•241.1	H	Hole in Pipe	7		
•248.3	RFJ	Roots, Fine: Joint	1 to 5		
•257.7	RFJ	Roots, Fine: Joint	7 to 5		
•257.8	FM	Fracture Multiple	6 to 6		
•267.7	AMH	Access Point - Manhole			MH 638-005A

ROOTS AT THE HOLE

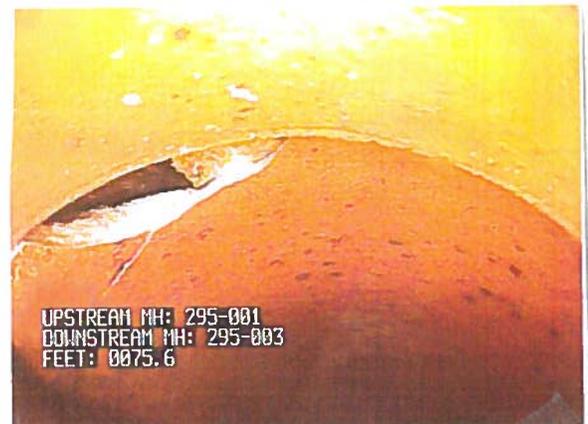
UPSTREAM MH: 295-001
 DOWNSTREAM MH: 295-003
 FEET: 0075.6

Ftg.	Code	Description	Position	Cont.	Comment
0.0	AMH	Access Point - Manhole			MH 295-001
0.0	MWL	Water Level			
4.0	VC	Vermin - Cockroach			
8.9	CM	Crack Multiple	1 to 5		
27.6	FM	Fracture Multiple	2 to 11		
30.4	OBJ	Obstacle - Object Wedged in Joint	3 to 5		PLASTIC KNIFE
39.8	CM	Crack Multiple	3 to 12		
67.2	CL	Crack Longitudinal	11		
75.6	HVV	Hole in Pipe: Void Visible	8 to 9		
80.0	AMH	Access Point - Manhole

Hole at Joint
