# Noyes Indoor Family Center Building Assessment

July 7, 2010

**Milwaukee County – Noyes Pool Building  
July 7, 2010**

**Milwaukee Project Number: P178-10606 & P178-10607  
Milwaukee Project Code: WP178012 & WP179012  
Kahler Slater Project Number: 210092.00**

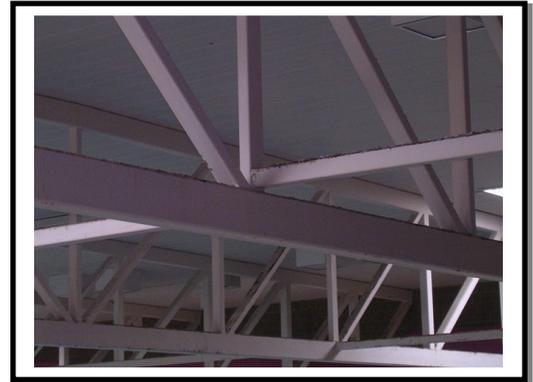
The structural system of the core building over the pool consists of custom steel tube trusses spanning 105 feet over the pool and supported on 10 inch wide flange columns. The trusses are 19'-4" on center with 4-1/2 inch deep acoustical deck spanning between them. Approximately 10 -15% of the truss have surface corrosion. However, the top surfaces of the horizontal members appear to have a higher percentage. The columns appear to be embedded in the masonry and are therefore not visible. There are small patches of the bottom plate on the acoustical deck that have surface corrosion.

From the visual inspection performed this corrosion does not appear to be severe enough to have caused any significant loss of material; however a closer inspection of the top surfaces of the trusses and the structural portion of the metal deck should be performed to determine the condition of these surfaces. At this time this condition may only be cosmetic however a program to prepare, prime and paint these members should be implemented within the next four years to halt the corrosion before it impacts the structural capacity of the roof system.

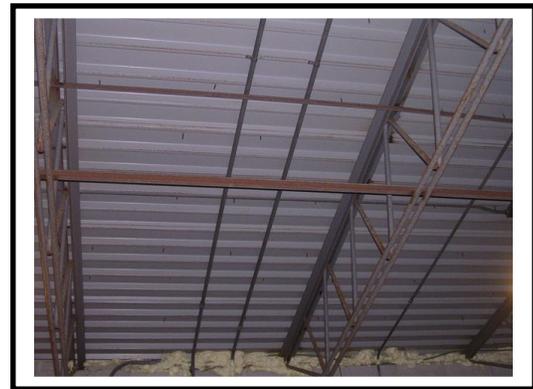
A lower one story roof is located along the north side of the main pool building. This roof is framed with 24 inch deep steel joists at 5'-0" on center spanning 38 feet in the east-west direction with 1-1/2 inch deep metal decking. The original building plans indicate these joists are supported on steel beams along the south side and bearing on the masonry wall along the north side. The majority of the roof system is not visible due to a plaster ceiling system with the exception of the storage room at the west end. In this area there is a light surface rust on the joists and the metal deck is starting to rust at the bent metal edges. This condition does not require any remedial action at this time but should be monitored.

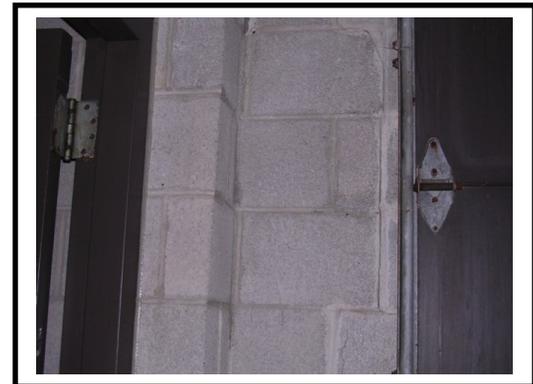
There is step cracking in the masonry on either side of the overhead door on the west wall of the storage room. It appears the door or jambs have been hit by a vehicle and the masonry repaired in the past. The jambs should be tuck pointed and filled with grout

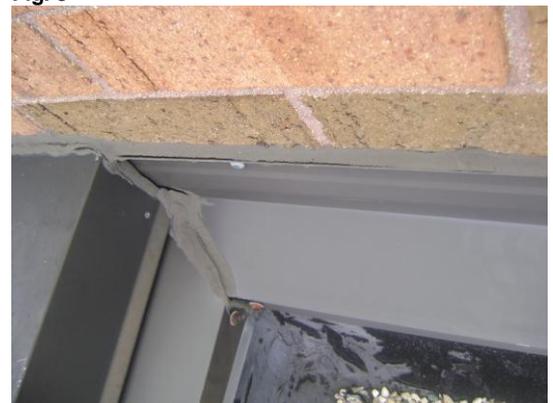
Fig. 4

Based on observation, as well as interviews with county staff, it appears that the roof at Noyes is the original roof. This roof has likely exceeded its effective lifespan. Cracks in the roof flashing can be observed in multiple locations around the roof (**Fig. 2**). Large gaps have developed in most of the coping between coping pieces, exposing the galvanized splice plates below (**Fig. 3**). In many instances, the sealants used between coping / flashing have long since dried and cracked (**Fig. 4**). All

As the exterior walls are showing signs of deterioration from water infiltration, it is recommended that the roofing be replaced at this time. At a minimum, this work should include new roofing membranes, along with new metal copings and counterflashings. When the old membrane is removed, the condition of the existing insulation can be determined. Decisions about repair or replacement of the insulation can be made at that time. Given rising energy costs, and the fact that more building cooling (summer) or heating (winter) is lost through the roof than through exterior walls, it should be noted that a roof replacement would provide an ideal opportunity to increase the amount of insulation in the roof, as the existing 2" do not meet current general construction standards. In most, if not all, instances, the heights of existing curbs and parapets would allow this increase.

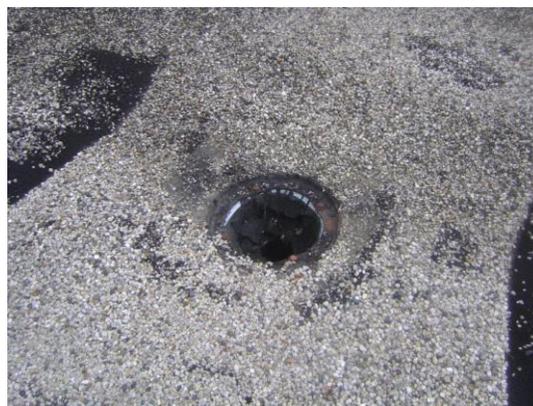
Fig. 5

of these problems are potentially allowing water to penetrate at the top of the wall into the masonry and wall cavity. A few roof drains have missing or dislodged cover baskets (**Fig. 5**), and in 2 instances it can be seen that the roof drain conduits have become clogged, resulting in water ponding on the roof until it can evaporate (or penetrate into the building). One location is the roof drain on the low roof area and centered along the SE elevation wall. The other location is the roof drain above the west exit stair (**Fig. 6**). Water here is particularly deep, with the only apparent relief being the roof edge scuppers on each side of the roof. Per existing drawings, the roof typically has 2" of rigid insulation. The condition of this insulation is unknown, though no "soft" spots were observed or felt. Short of a roof membrane replacement, one way to gain a clearer picture of the insulation condition would be roof core sample tests, which are not included as part of this report.

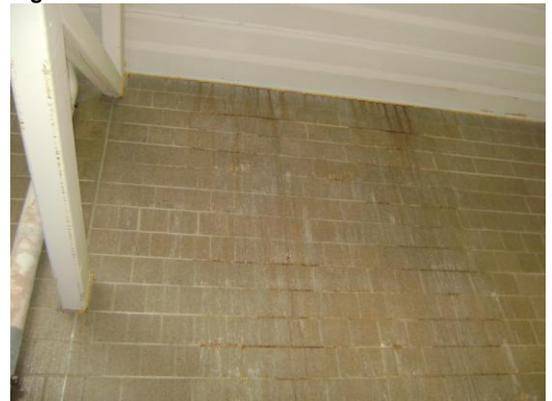
Fig. 12

As mentioned previously in this report, one particularly bad spot of water problems in the wall can be seen in the west end of the balcony, due to high humidity as well as roofing and roof drain problems. Signs of rust staining on the wall might possibly be due to corrosion of the horizontal wall reinforcing in the wall, or deposits from corroding steel above the ceiling (**Fig. 12**).

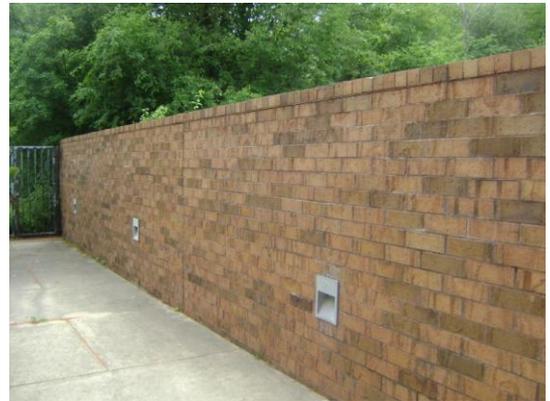
Fig. 18

The patio area is in relatively good condition. Despite the problems at Pulaski, the garden wall remains in good condition – this is due to the fact that a thru-wall membrane flashing was included below the brick cap (**Fig. 18**). The metal fence is in need of re-finishing. The same can be said of the wood benches on the patio. A few of the planter timbers are dislodged or rotting, and could be replaced. The concrete slabs are generally in good condition, and no severe heaving was seen between slabs.

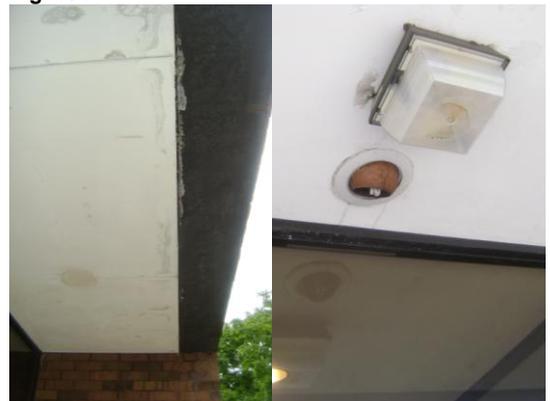
Fig. 19

The exterior plaster soffits at the entrance vestibules are showing mild signs of moisture damage (**Figs. 19 & 20**), likely the result of exterior wall issues (see previous sections.) The light fixtures are also showing surface corrosion. The radiant heat unit in the entry vestibule is in poor condition – corrosion and mis-aligned panels (**Fig. 21**). Once inside, overall, the lobby is in good condition. There's been little to no moisture damage to the finishes. Some minor corrosion is occurring on the exposed painted steel, such as the stair stringers and handrails, but these can simply be cleaned and repainted. There is a noticeable

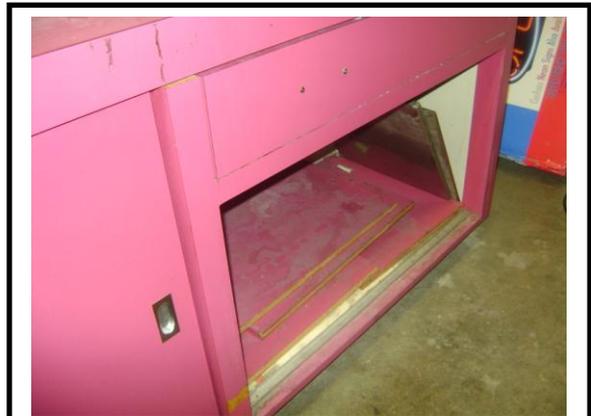
Fig. 23

The base cabinets in the staff work room behind the reception desk are in fair to poor condition (**Fig. 23**). Doors are missing and the laminate is de-laminating and/or breaking. There is an exposed back box in the wall (clock? wall sconce?) with the left over wiring exposed. This box should be covered with a cover plate. Supply/return grilles are very dirty – as a result, their effectiveness is likely compromised.

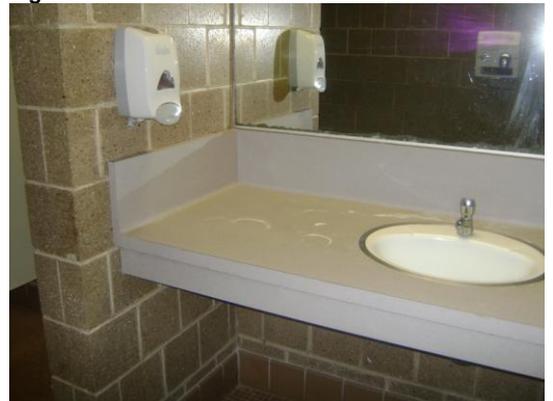
Fig. 24

The men's restroom off the lobby is in good condition. (The women's room is assumed to be in similar condition.) The plastic laminate lavatory counter is still sound (**Fig. 24**), and the walls and floor are undamaged, and simply need a cleaning. The glass mirrors have lost a small amount of silvering around the edges, but are otherwise sound (**Fig. 24**). The toilet stalls do not have any significant damage or graffiti, and the door hardware appears to be in working condition.

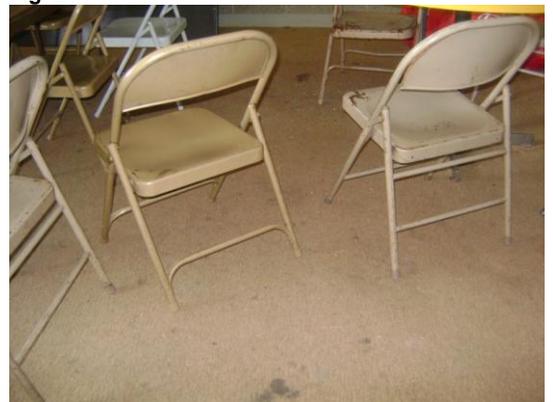
Fig. 25

The meeting room is located off the lobby space. It is a medium sized room that can hold 10 people comfortably with chair and tables in it. There is no noticeable damage on the walls or ceiling, other than some left over holes in the wall from some previous piece of equipment. The carpeting, however, is in poor condition, and should be replaced (**Fig. 25**).

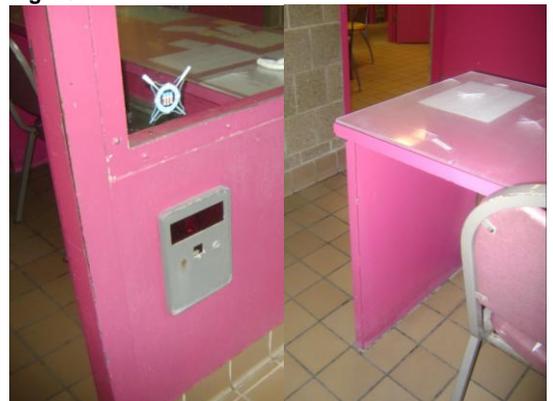
Fig. 26

poor condition (**Figs. 26 & 27**). The laminate is chipping and de-laminating, and the paint is flaking. The plywood below is also beginning to show signs of water damage. Sanding and repainting the plywood can probably buy some additional time.

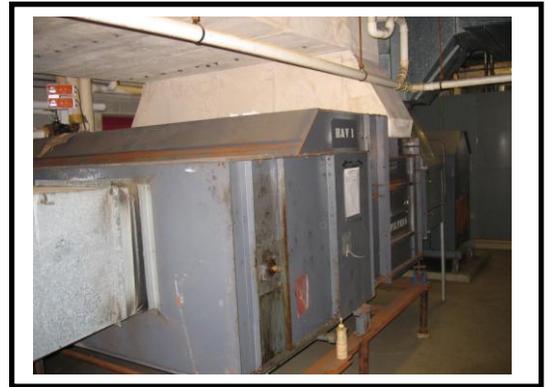
The outside air intake hood is fully corroded and needs to be replaced.

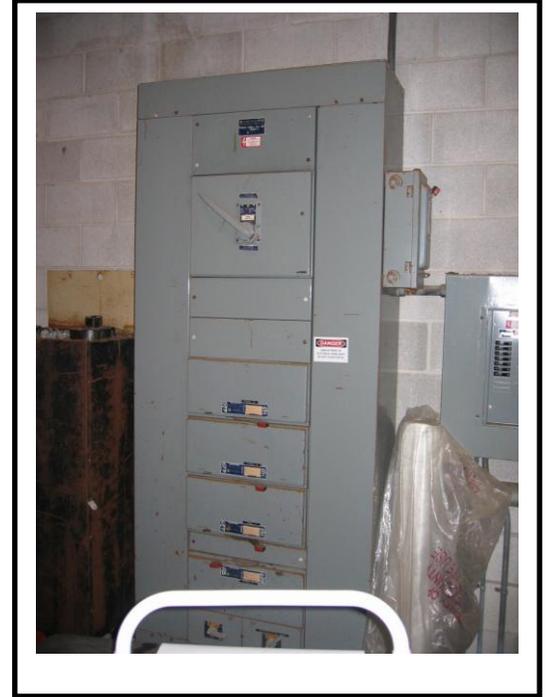
The main service equipment appears to be in good shape. There is some surface rust on the equipment housing but the equipment itself appears to be in working order.

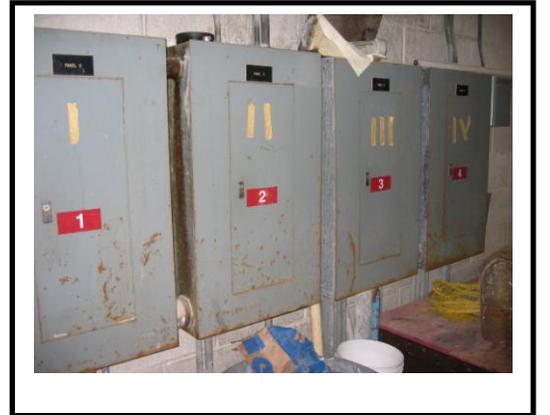
The majority of the electrical equipment located in the pool equipment room has some surface rust from the moisture and chemicals in the room. The equipment appears to be functioning properly but should be replaced and moved to a location without the pool equipment.

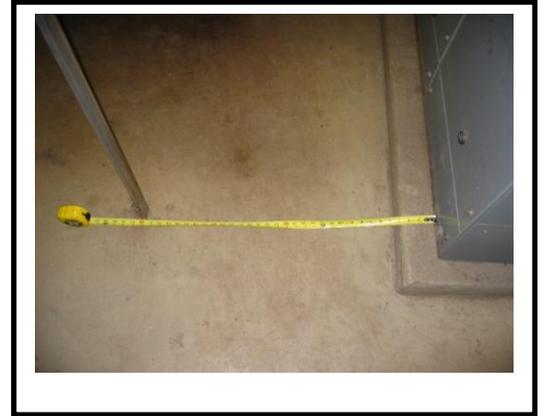
The electrical equipment in the HVAC equipment room appears to be in good condition. It was noticed that the Motor Control Center does not have the required 3ft working clearance in front of the equipment to meet code.

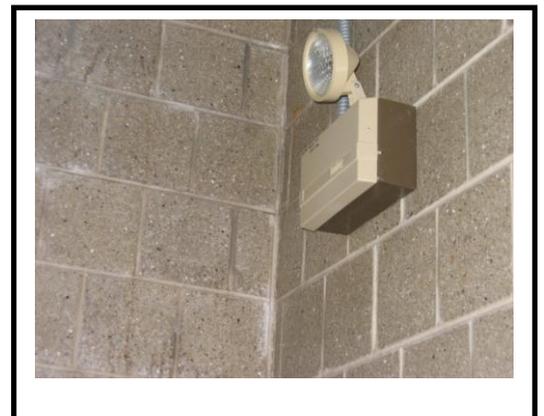
The quantity and location of emergency lights in the building appears to be inadequate in most areas to provide the code required means of egress lighting levels. Some emergency battery units located were tested and did not function.

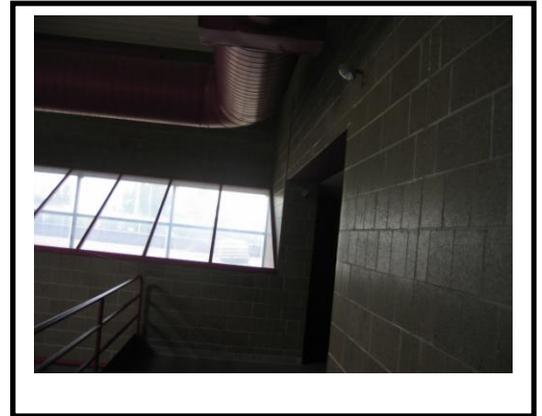
The exit signs appeared to be in good condition, but several of the signs were positioned incorrectly. They were mounted back to the wall instead of the side, so that the sign is visible to people walking toward the exit.

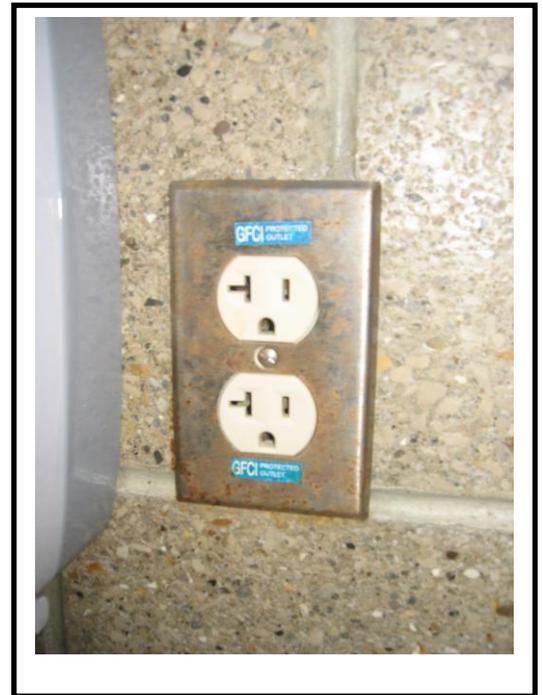
The electrical devices in the pool and pool equipment area are in need of repair. The cover plates are rusted and corroding. The electrical devices in the non-pool area appeared to be in good condition.
