**REGULATED MATERIALS  
INSPECTION AND  
SAMPLING REPORT**

**RAWSON AVENUE LIFT STATION  
RAWSON AVENUE AND WEST 6<sup>TH</sup> STREET  
OAK CREEK, WI  
Project #: V025-13807**

August 9, 2013

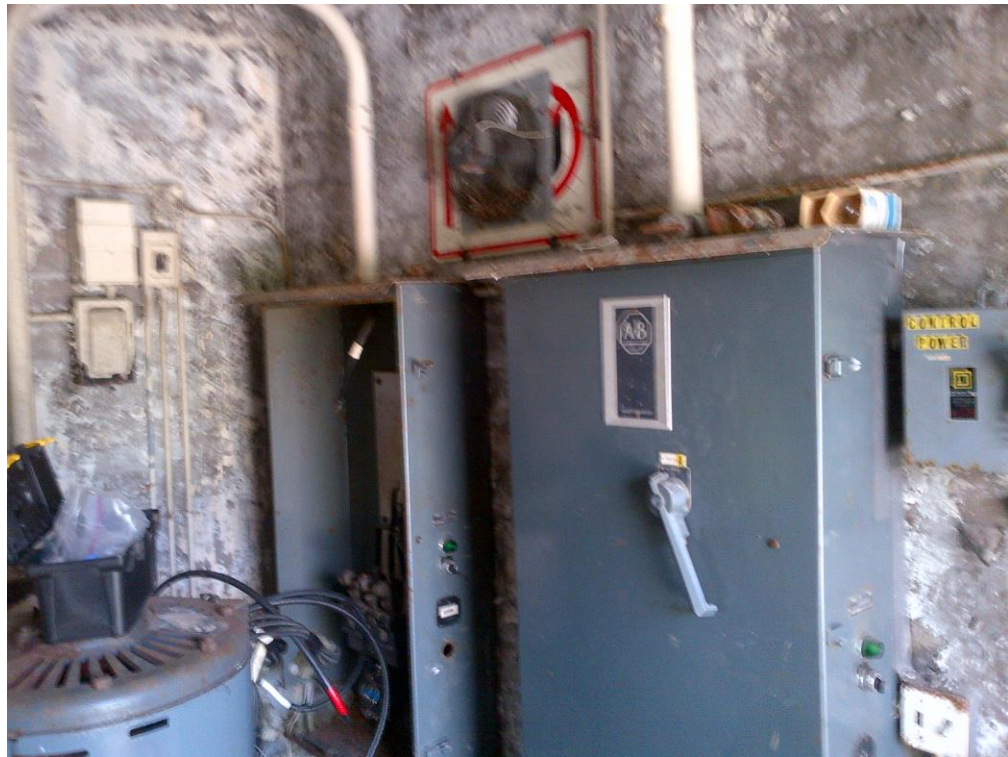
- Approximately 8 fluorescent light sets are located in the building. The fluorescent light bulb units will have ballasts within them that may potentially contain PCBs;
- No mercury lights were observed within the facility.
- There are several small and large electrical boxes within the building that may potentially contain asbestos-containing molding or back plates;
- No fire extinguishers were observed in the facility, that potentially contain carbon tetrachloride, a known carcinogen;

**PHOTOGRAPH NO. 2:** Subject Property – Electrical Boxes

- No ACM was identified in samples collected. There may be ACM within the electrical boxes. The boxes should be recycled by the demolition contractor.

- Light bulbs, mercury bulbs, and ballasts, must be collected and managed during renovation and/or demolition;
- Electrical boxes are expected to be recycled if they are removed, otherwise, they need to be properly disposed of.
- Exit signs, fire extinguishers, smoke detectors, and alarms should be properly disposed of per local regulations or recycled.

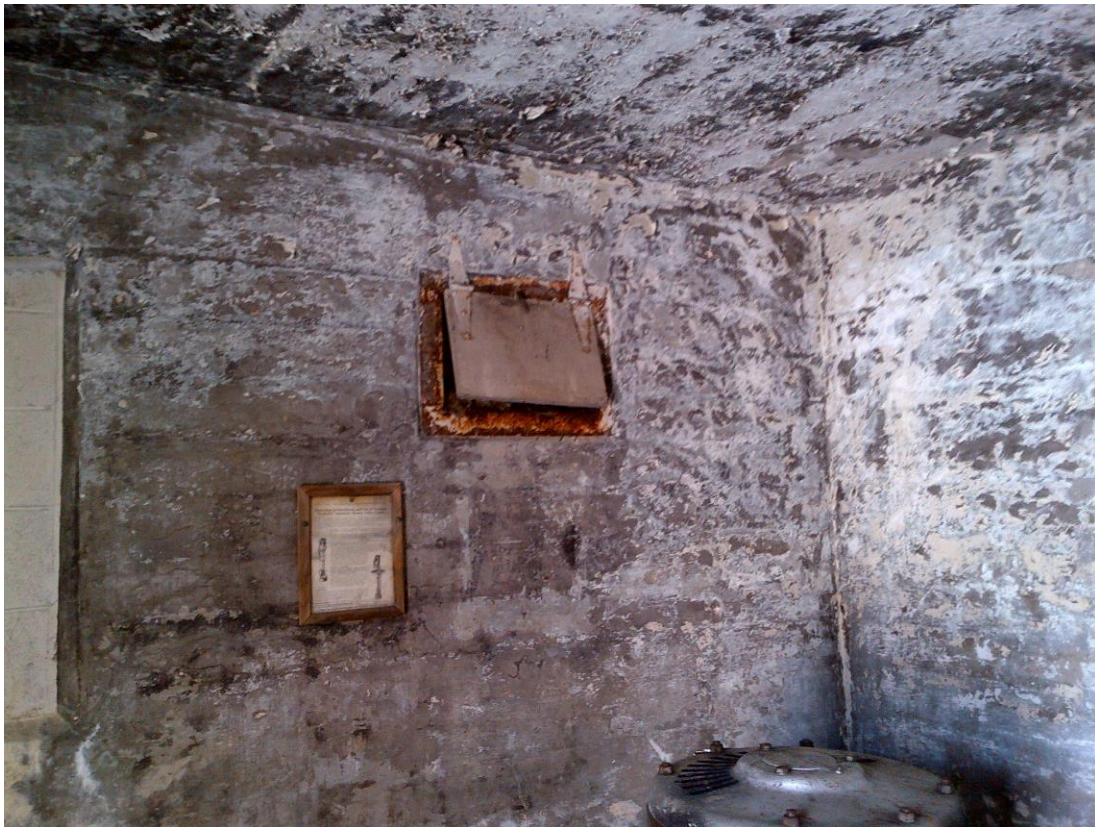
Sample #	Description	Location	Results	Condition
1	Inside exhaust	East wall exhaust fan	<b>0.201 % - Positive</b>	Poor

- Paint on the metal inside the exhaust fan tested POSITIVE for lead-based paint. The exhaust fan requires special handling and/or abatement of lead-based paint during demolition in accordance with applicable regulations.

**PHOTOGRAPH NO. 4:** Subject Property – east wall – exhaust fan
