Mitchell Park Final Report

Re: Condition Report
Conservatory, Pavilion and Wading Pool Buildings - Mitchell Park
Milwaukee, Wisconsin

We have completed a condition report of the above-referenced properties in accordance with our proposal. Site visits were completed in early September 1998.

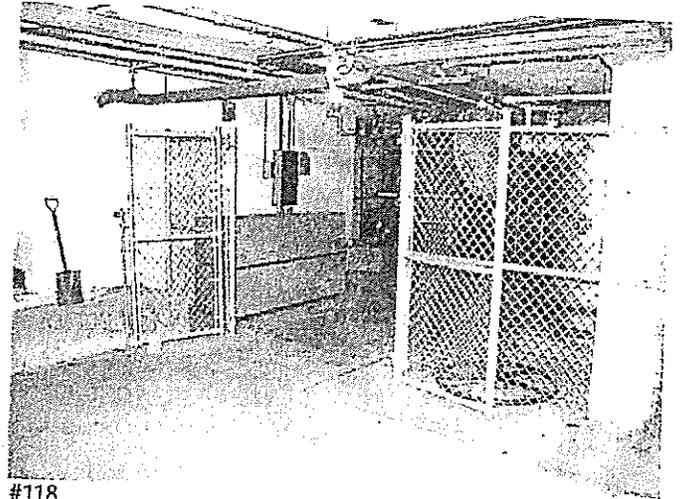
#118

The storage rooms is divided with a chain link fence. This fence has two lockable gates.

If these gates are locked, the second exit from half the storage area is eliminated. In case of fire, someone could be trapped. This is a code violation.

Remove the locking mechanism to ensure these gates are always operational.
