MITCHELL PARK HORTICULTURAL CONSERVATORY DOMES

Investigation of Structural Concrete Framing for Explosion Damage

Milwaukee, Wisconsin

April 7, 2009
WJE No. 2008.3876

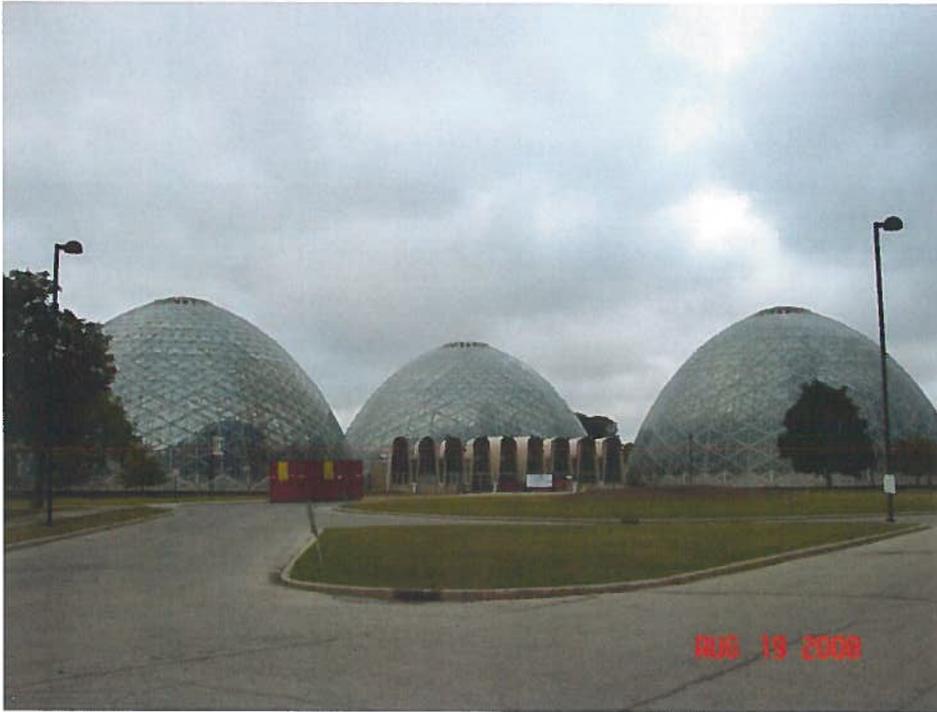
Figure 1. Overall view of the front of the conservatory complex (looking east).

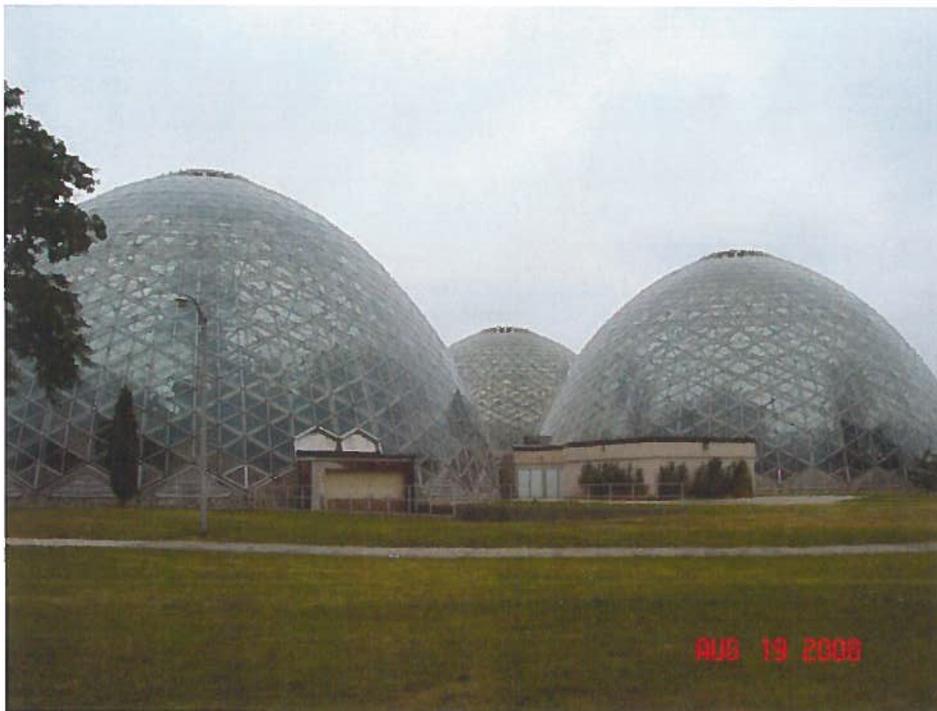
Figure 2. Overall view of the rear of the conservatory complex (looking northwest).

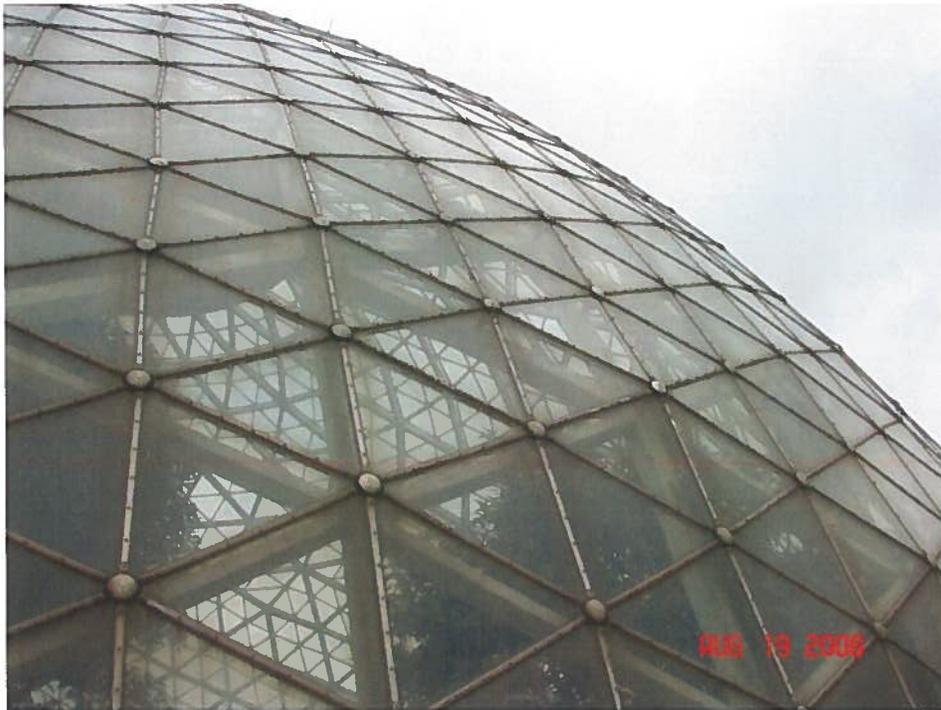
Figure 3. Aluminum-framed glass exterior.

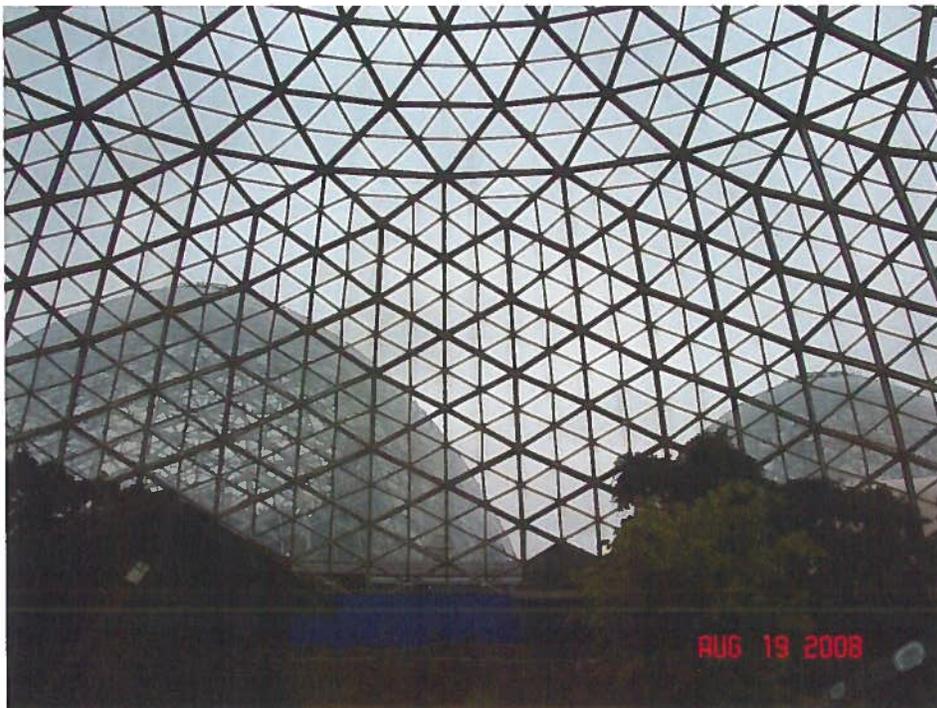
Figure 4. Arrangement of reinforced concrete structural framing members.

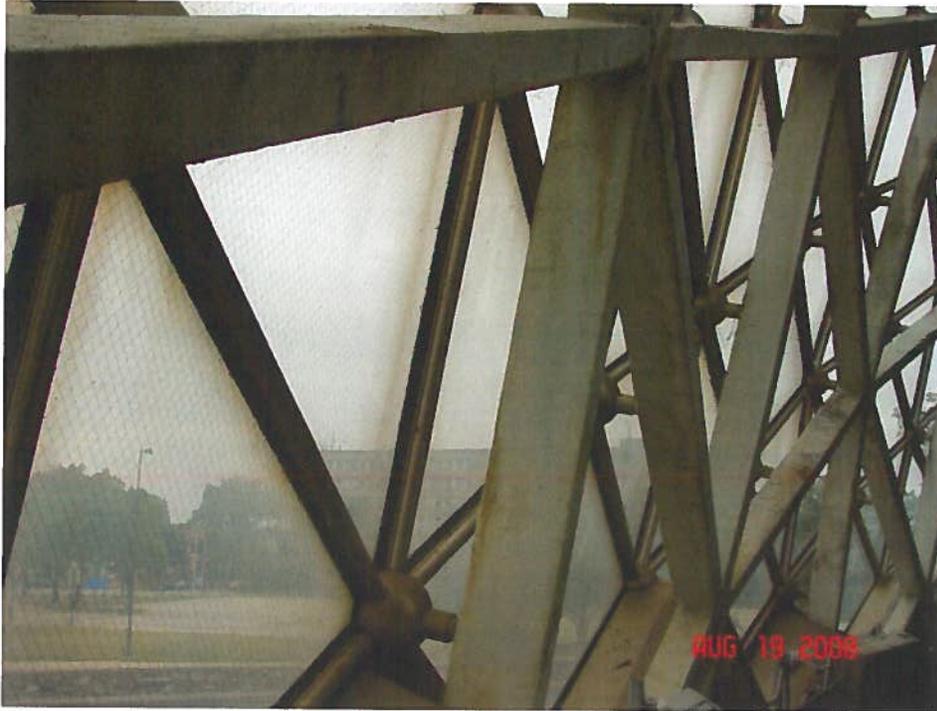
Overall, with the exception of many areas of water staining and some peeling paint, the Show Dome concrete framing appeared in generally good condition with no abnormal cracking, displacements, or deformations noted. General observations included cracks along some joints between precast sections, small concrete spall areas at a few concrete joints, and fine-width, transverse-oriented cracks spaced along the length of some members. Cracks were typically highlighted by dirt, peeling paint, and raveled edges suggesting they are old and have existed for a long time. Both the cracking at joints and transverse cracking are attributed to normal concrete shrinkage and/or stresses associated with normal structural behavior. Representative views of the Show Dome concrete framing are shown in Figures 5 through 10.

Figure 5. Representative condition of concrete framing in Show Dome from interior.

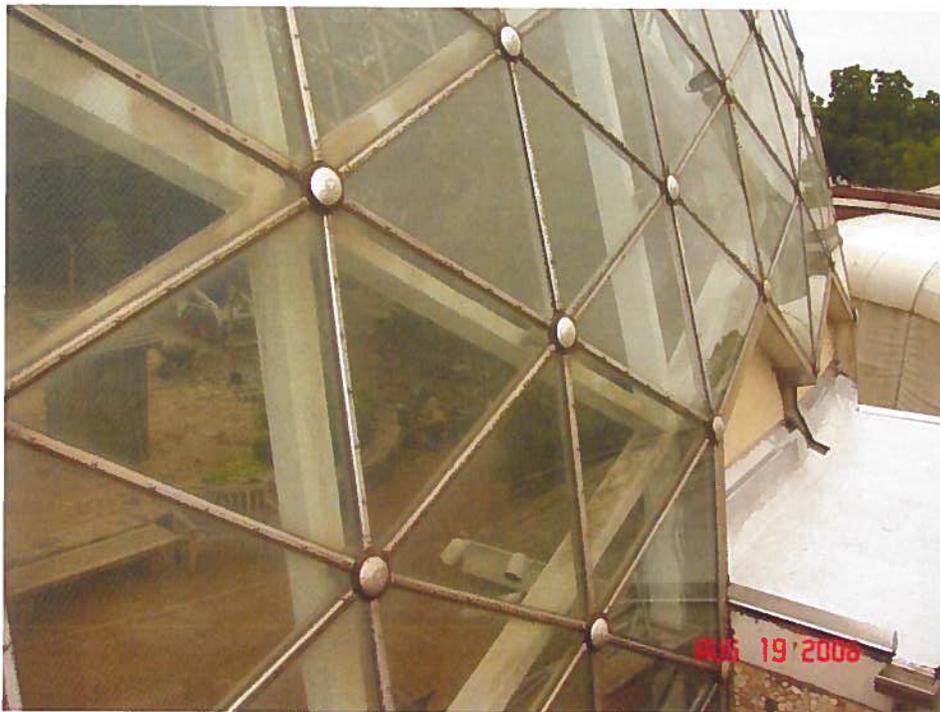
Figure 6. Representative condition of concrete framing in Show Dome from exterior.
