APPENDIX A
Limited Facility Condition Review

Limited Facility Condition Review
McKinley Marina
Milwaukee, WI

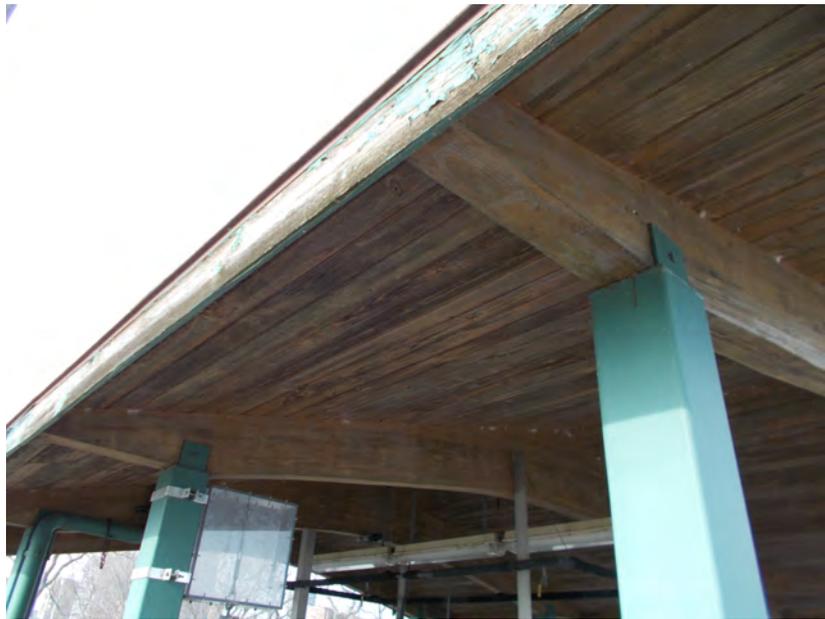
General Condition – The structure was in overall satisfactory condition. Roof shingles were in good condition. Steel columns and wood trim are in need of painting. Some minor rust was noted on steel columns.

Photo 2: Building #1 Fish cleaning station—
Weathered wood

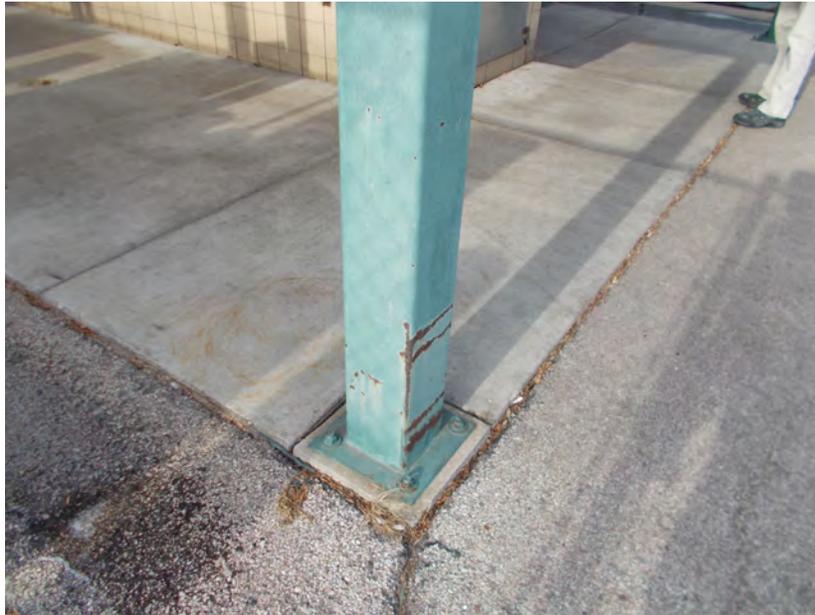
Photo 3: Building #1—Fish cleaning station
Rusted steel column

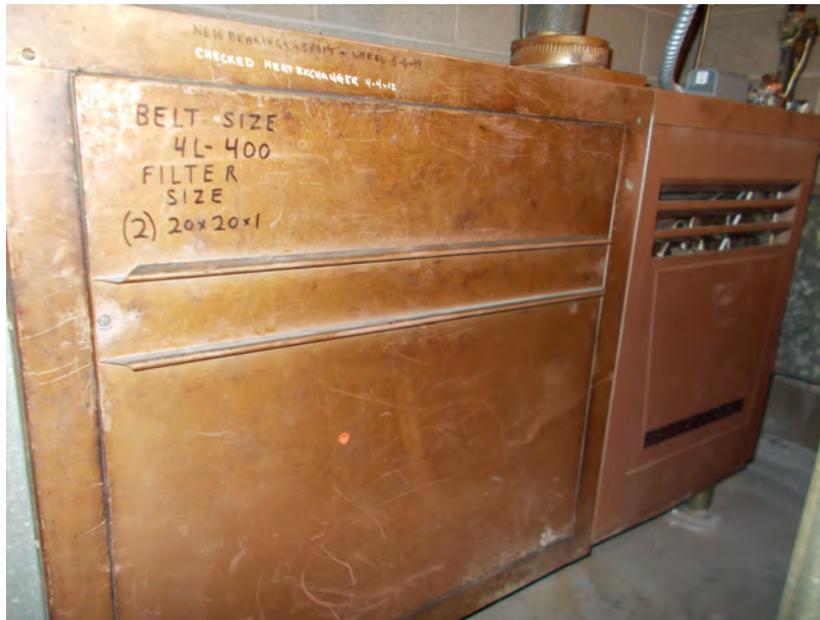
General Condition – The building was in overall satisfactory condition. The Marina Manager reported no major issues. We did note that the two air handling units appeared to be original and have exceeded their average useful life. Above average maintenance can be expected until replacement.

Photo 6: Building #2—Original Air Handling Unit

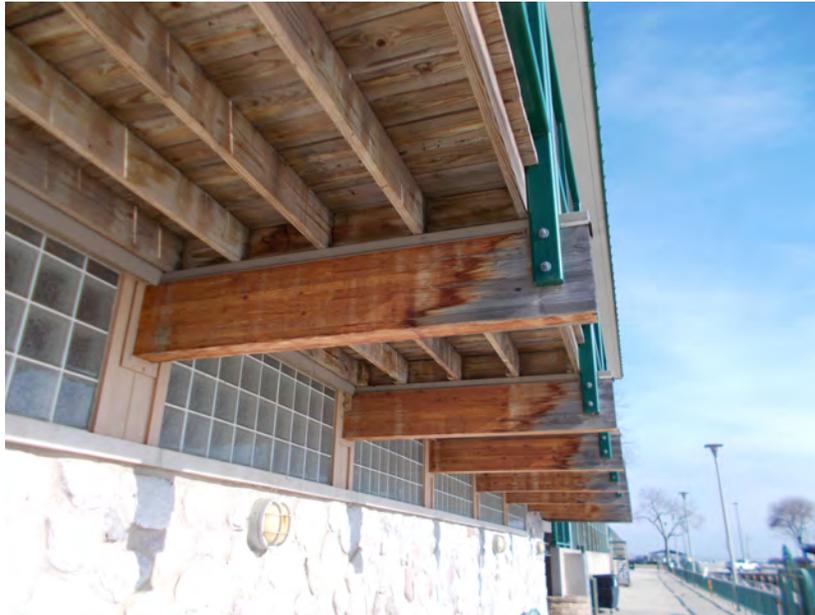
General Condition – In good condition with exception of some isolated areas of peeling paint and corrosion at Level 2 steel railing and structural steel beams supporting Level 2 exterior deck area. Exterior glu-lam wood beams were weathered and is in need of re-sealing.

Photo 9: Building #3—Weathered exterior wood beams

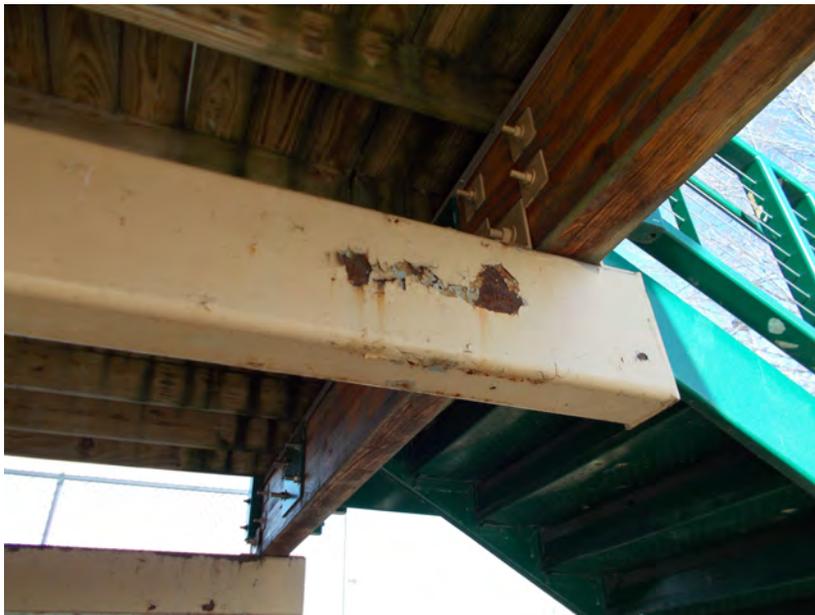
Photo 10: Building #3—Peeling paint and corrosion on exterior steel beams

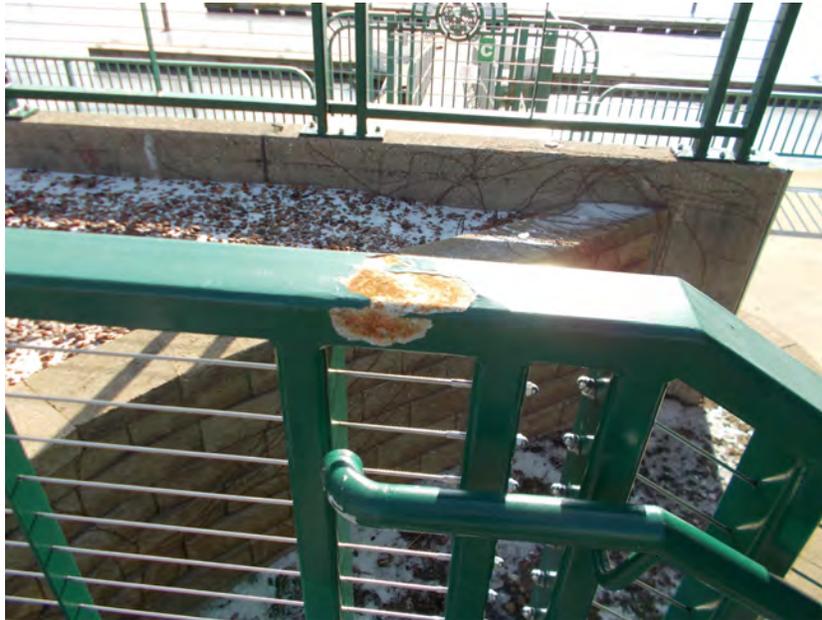
Photo 11: Building #3—Peeling paint and corrosion on steel railing

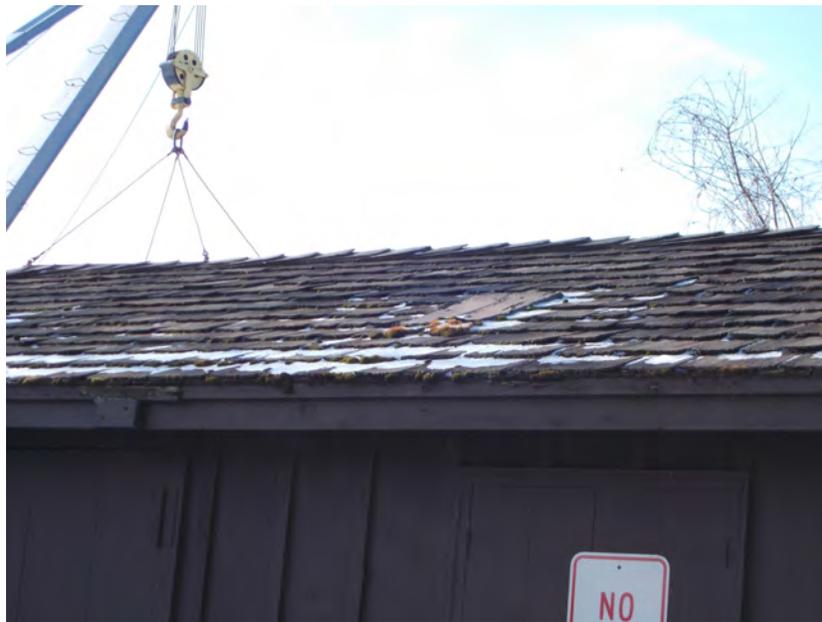
General Condition – In general satisfactory condition with exception of cedar shake roof which displayed some deterioration and was moss covered. Some deterioration at wood siding and trim.

Photo 14: Building #4—Deteriorated cedar shake shingles

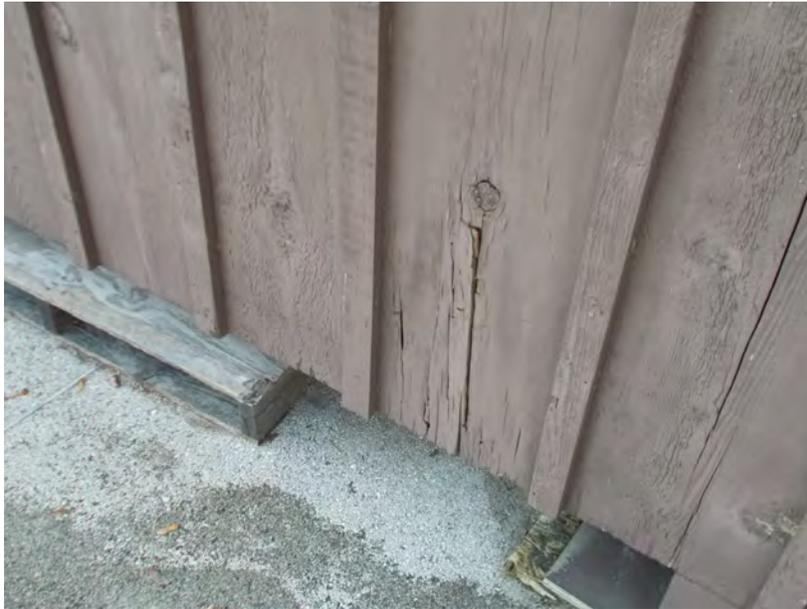
Photo 15: Building #4—Typical exterior deterioration - Isolated areas

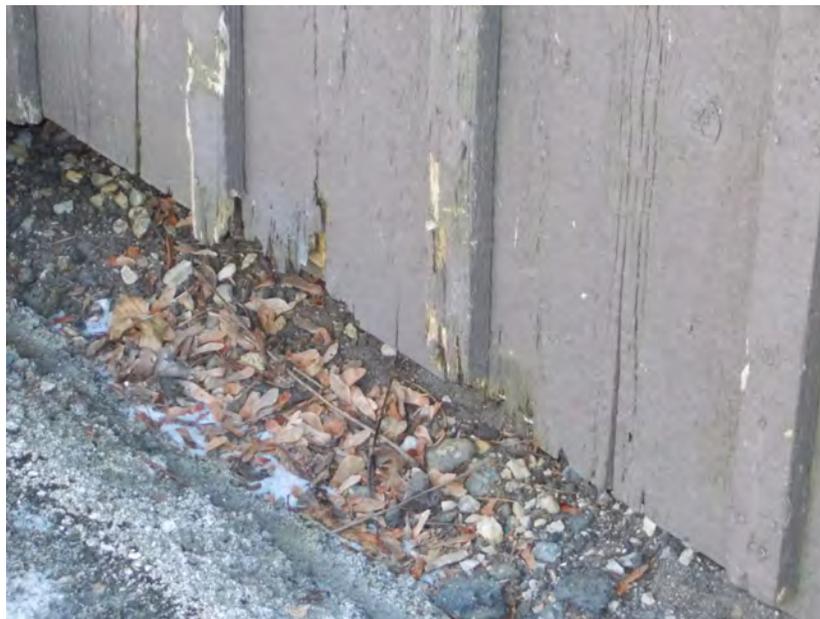
General Condition – Overall in fair condition. Wood roof structure at wood shop had moisture damage. Exterior siding had significant deterioration. Roof was in satisfactory condition.

Photo 18: Building #5—Typical exterior deterioration

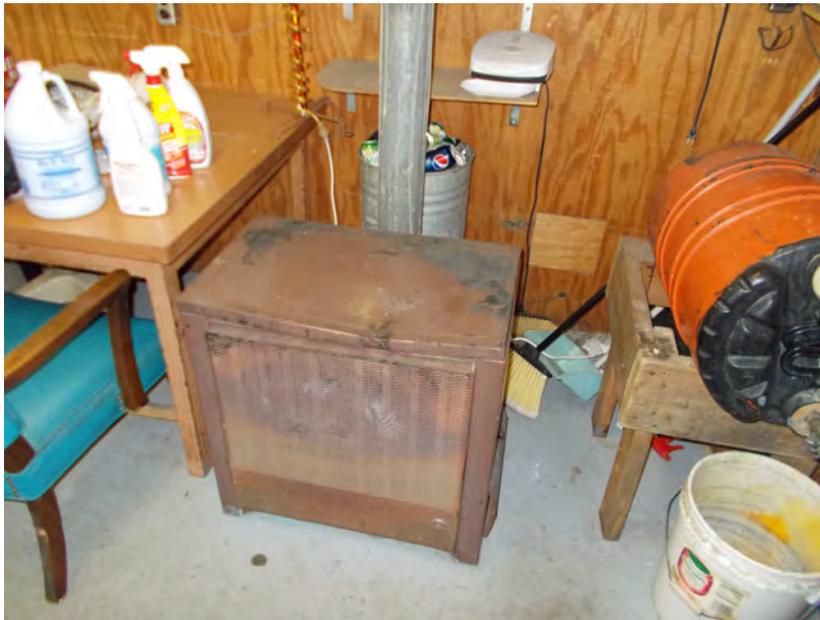
Gas-fired heater appeared to be at least 30 years old and past its average useful life.

Photo 20: Building #5—Heater

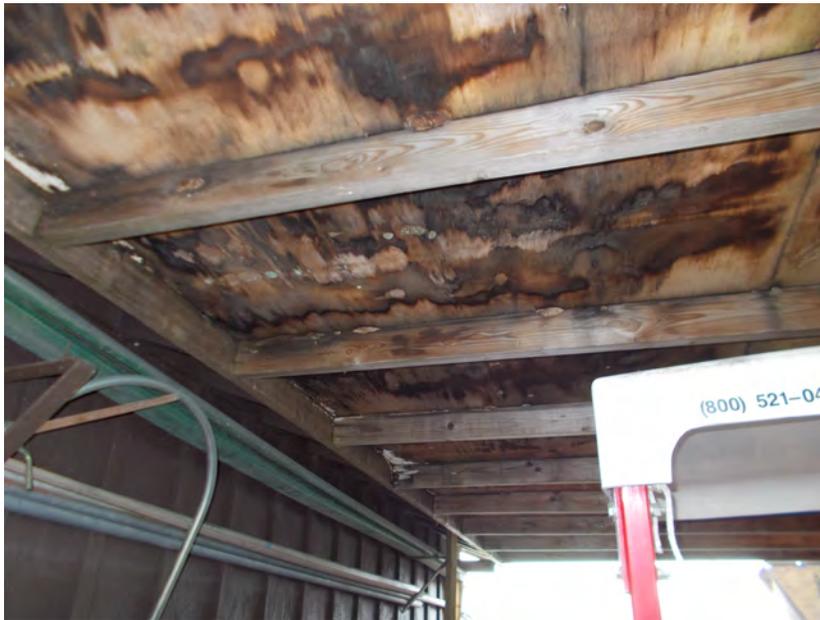
Photo 22: Building #5—Wood Shop roof deterioration
