MILWAUKEE COUNTY
PARKS

FINAL REPORT

South Shore Park
Site Investigation and Schematic Design

Project No. P298-14616

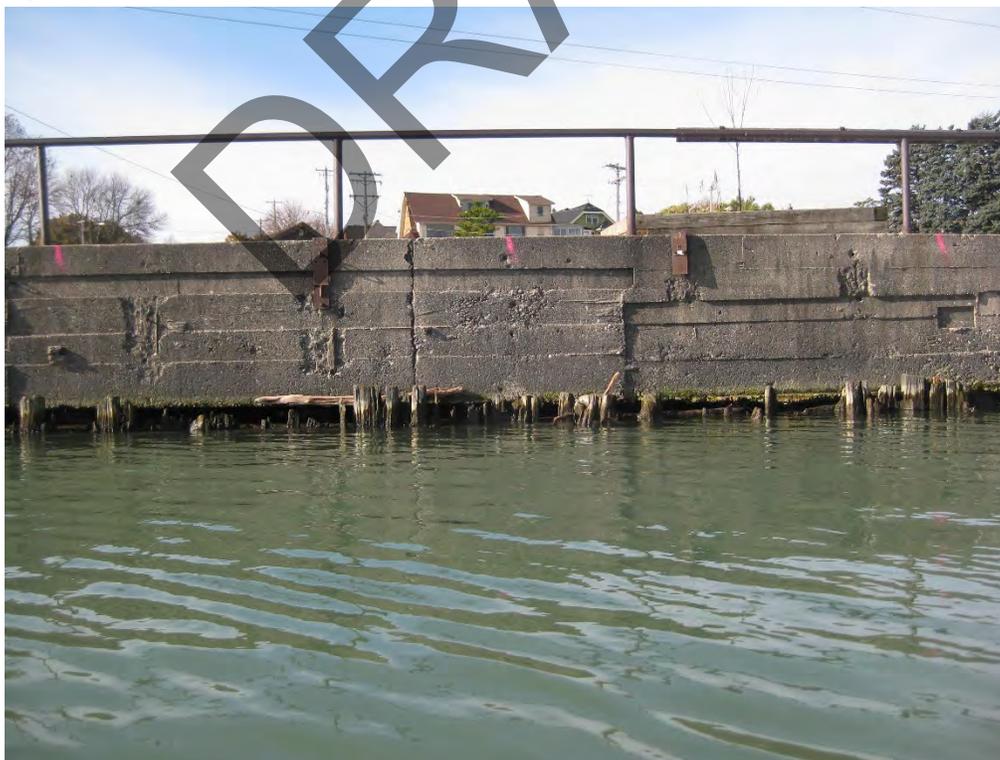
Figure 2 – Typical sheeting and timber degradation at water/ice line

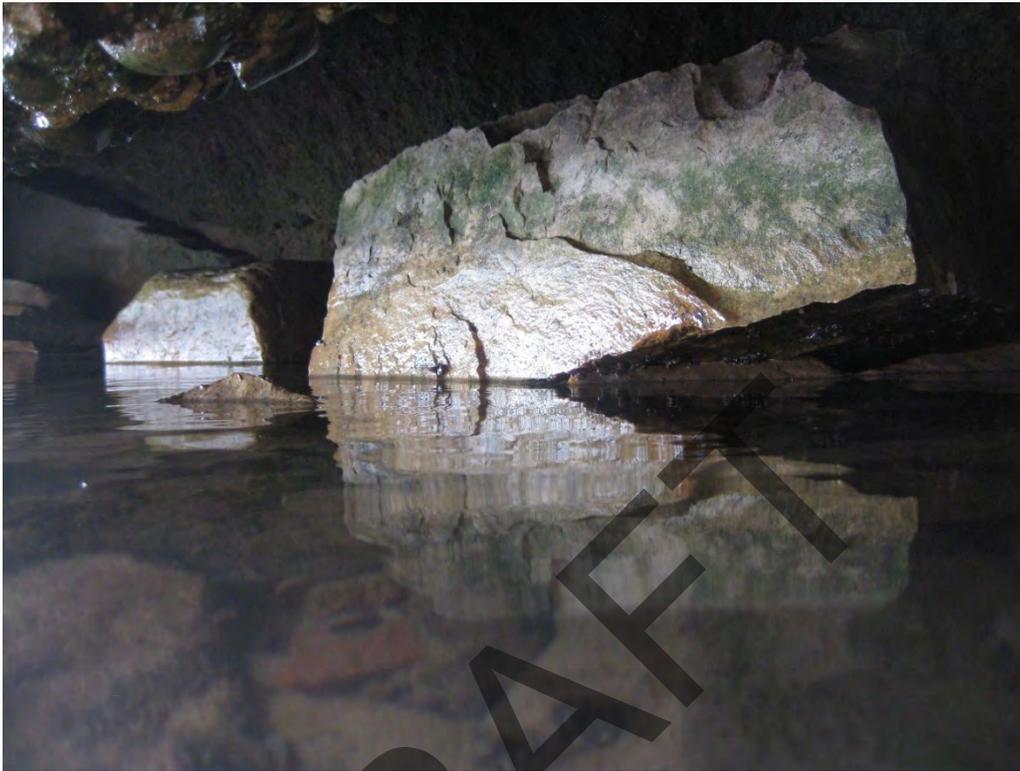
Figure 3 – Voids directly under concrete cap. Missing sheeting has allowed rubble fill to erode from crib.

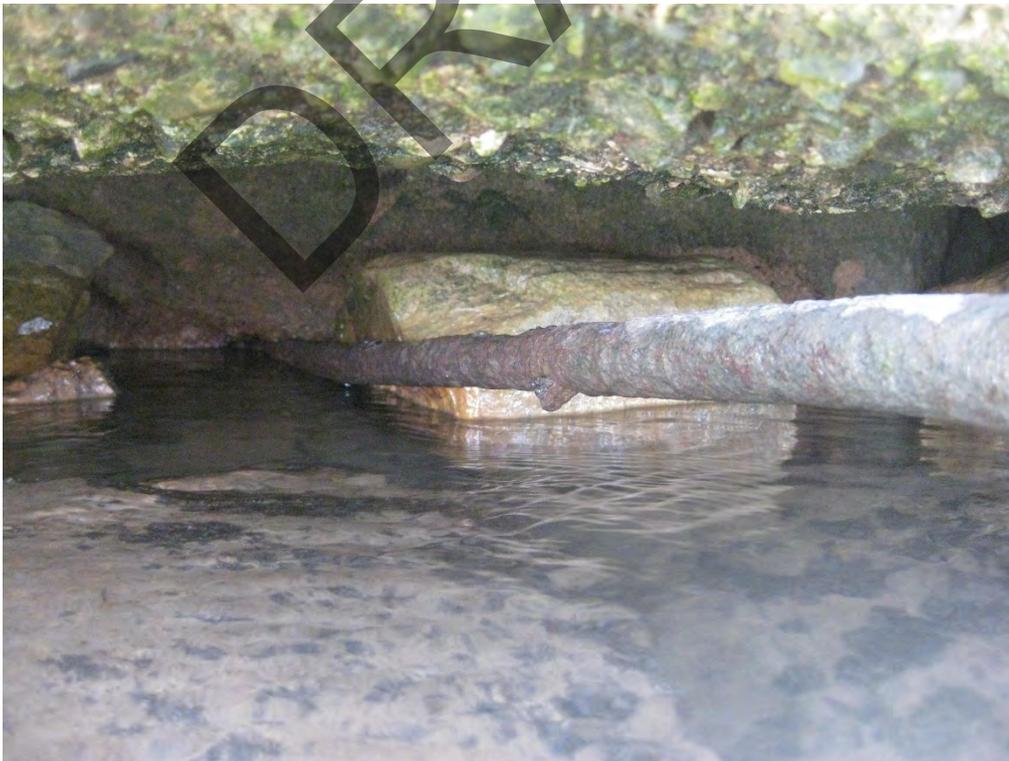
Figure 4 – Corroded tie-rods and Wakefield sheeting and whalers not present.

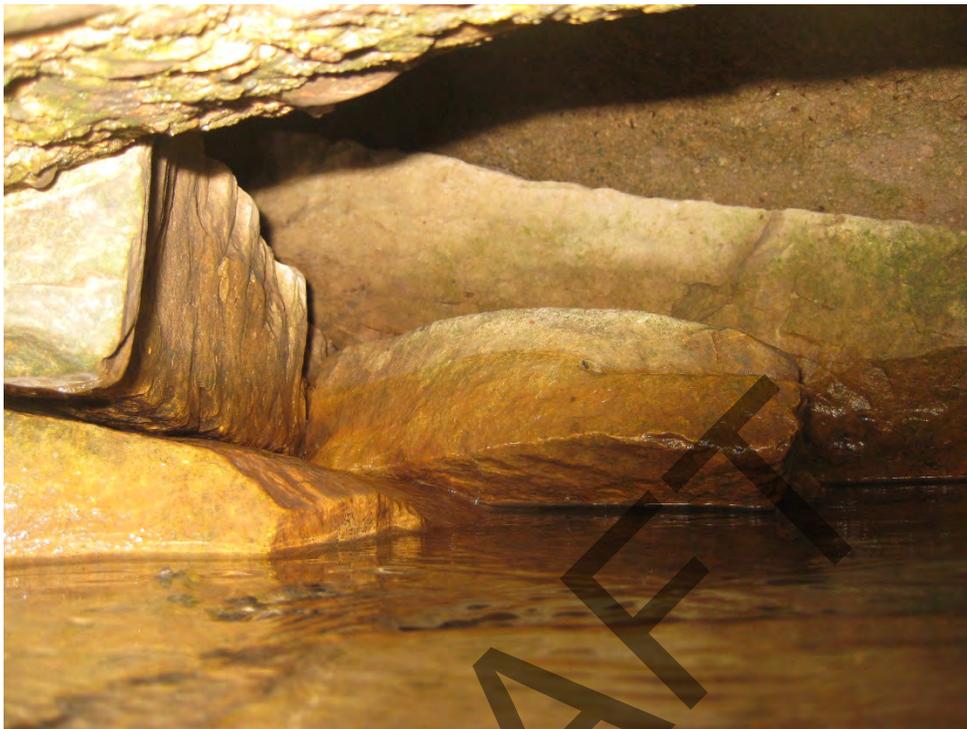
Figure 5 – Voids below the concrete cap due to deterioration of top portion of sheeting and cribs. Concrete cap is cantilevered over lake side of the crib due to missing rubble fill.

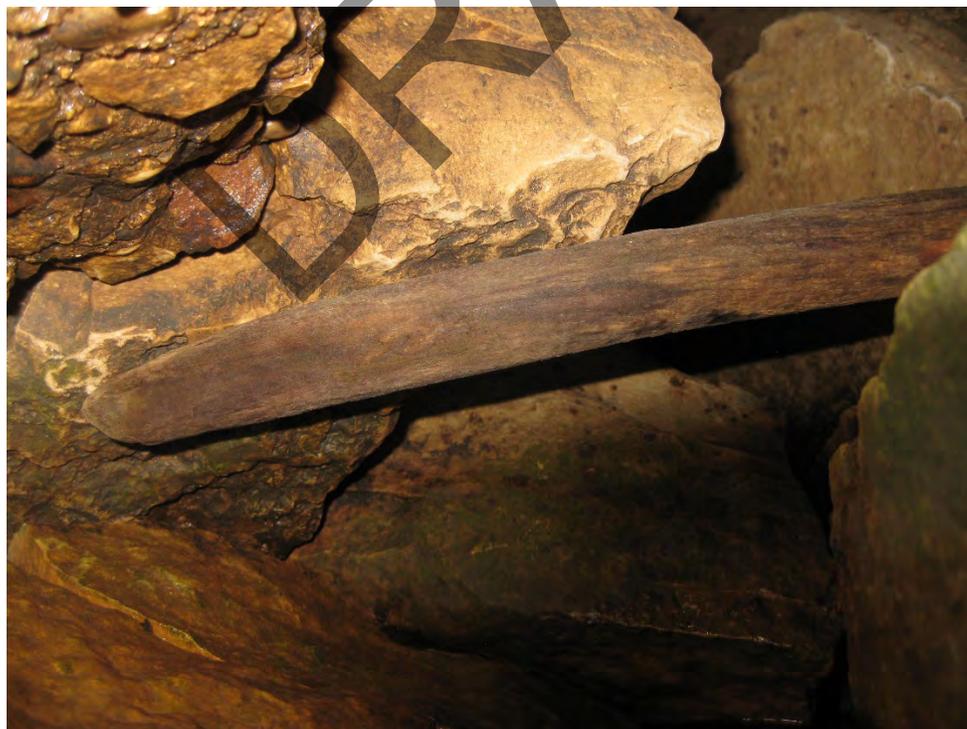
Figure 6 – Tie rod from the sheeting completely severed due to age and corrosion

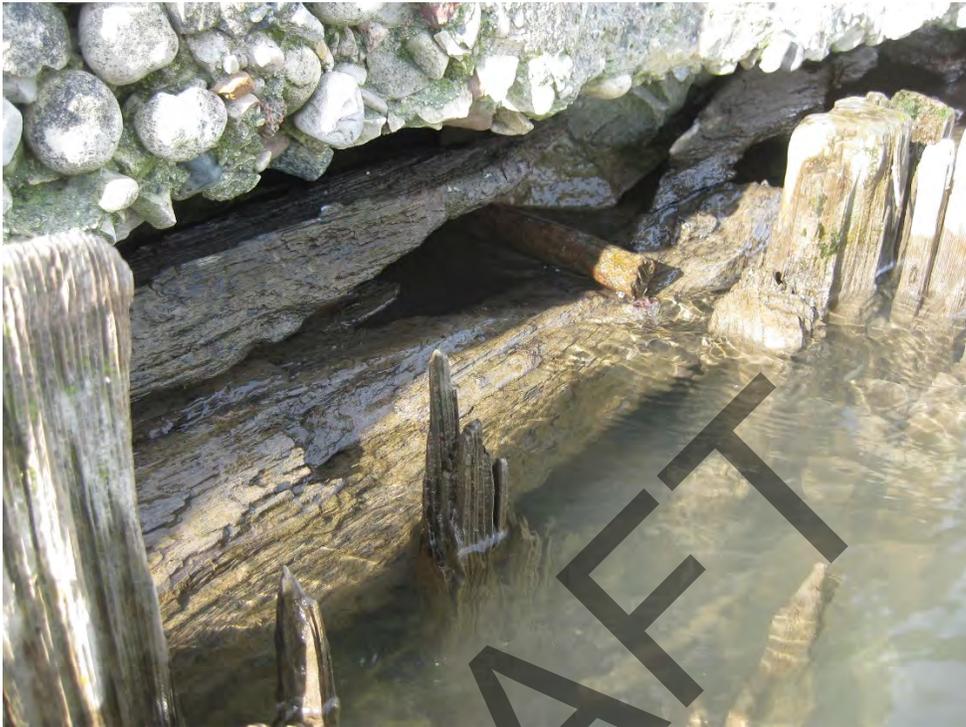
Figure 7 – Deterioration of sheeting, whalers, and corroded tie-rod.

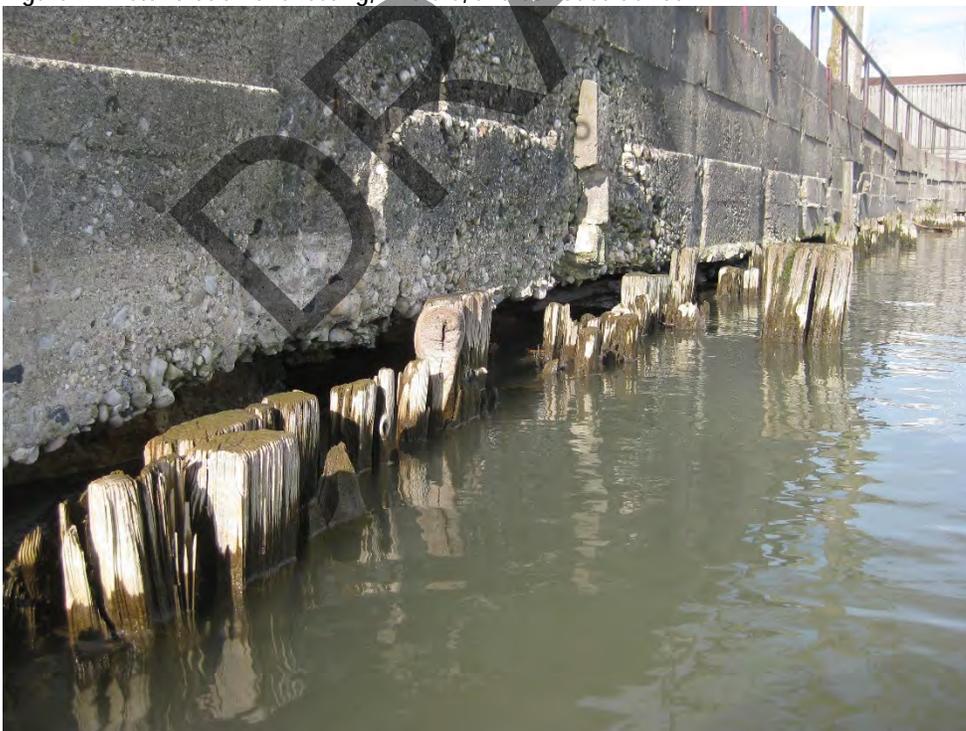
Figure 8 – Deterioration of sheeting and voids below concrete cap.

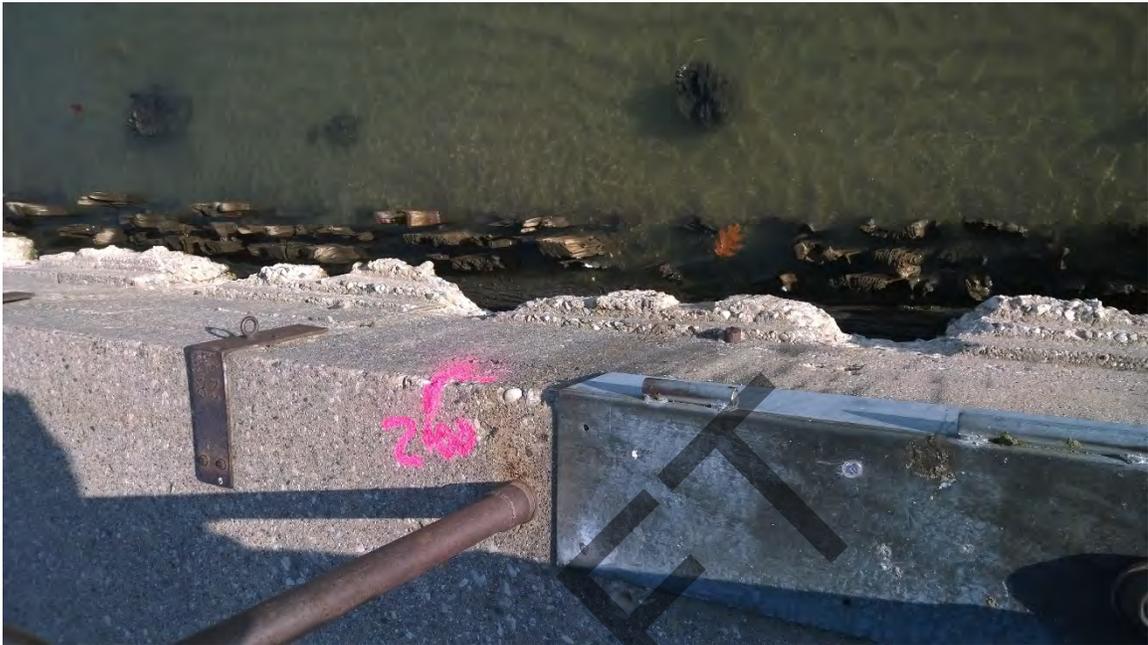
Figure 9 – Station 2+00 – deterioration of sheeting, walers and piling visible from the top of the concrete cap.

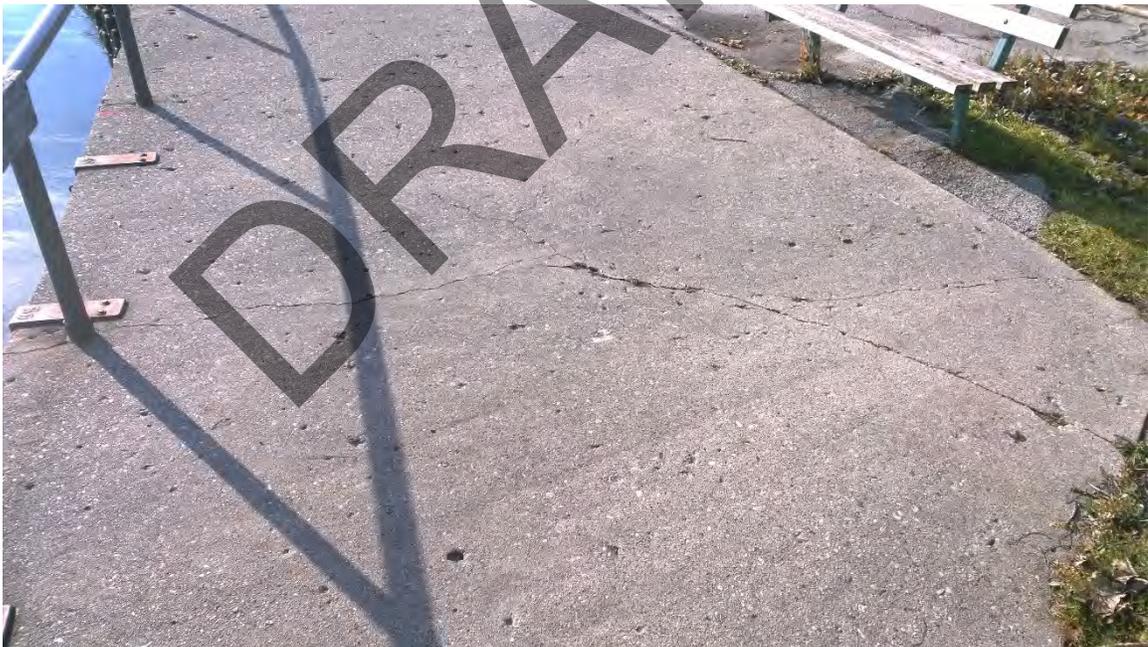
Figure 10 – cracking of concrete cap – evident throughout the length of the cap inspected.

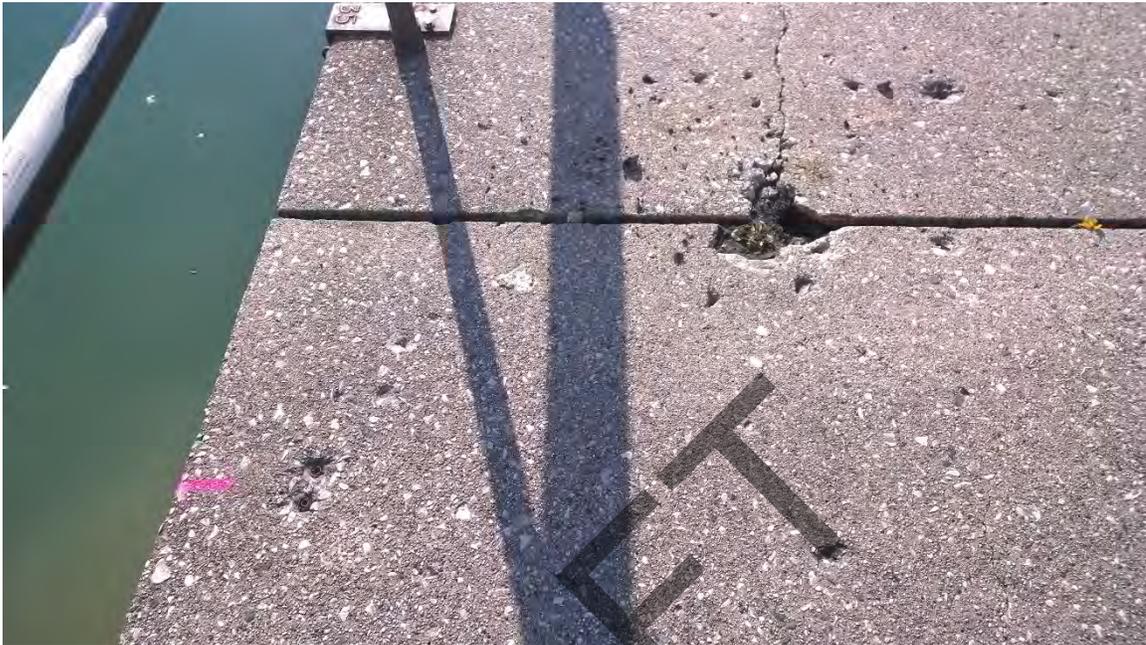
Figure 11 – Spalling, cracking and voids through cap to crib. Typical of numerous areas of cap.

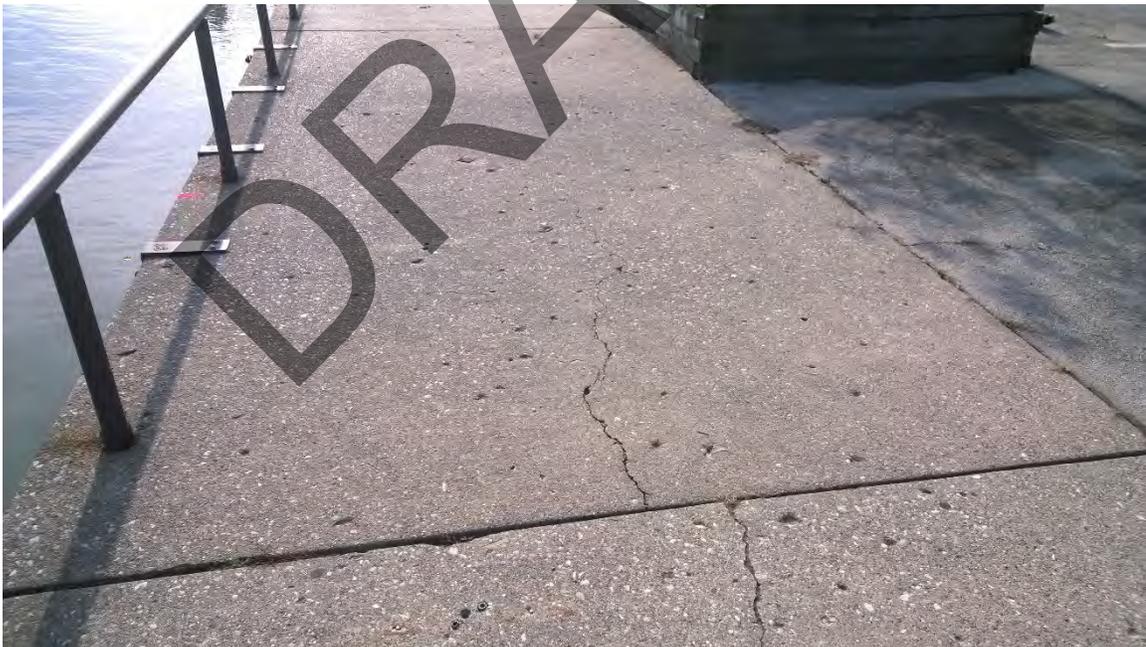
Figure 12 – Parallel cracking on cap due to cap cantilevered over voids in the crib.
