HISTORIC LAKE PARK ARCH BRIDGE OVER RAVINE ROAD IN-DEPTH INSPECTION REPORT

Structure P-40-576

Milwaukee County Project Number P484-15619

July, 2015

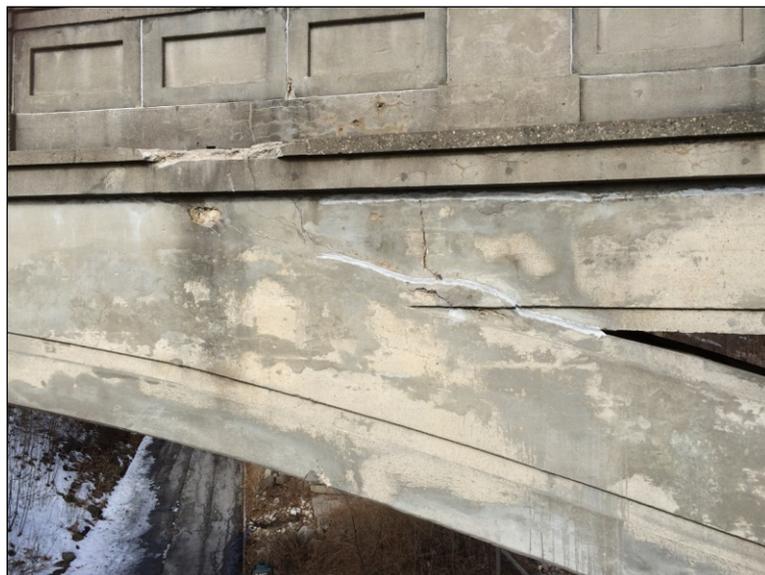
Both arch ribs contain many concrete patches. These earlier repairs are present along approximately 75% of the length of the rib soffits (bottom surfaces, Figure 3). Patches are also common on the rib soffit at all four spring lines (Figure 4). The soffit patches were apparently needed to fix spalls that had occurred at the lower corners. The rib backs (top surfaces) are exposed only along the circular and teardrop shaped spandrel openings, and patches exist along about 50% of the length of these surfaces. Fewer concrete patches were found on the rib vertical surfaces. Most were located near the arch crown between panel points 2 to 4 on the inside faces (Figure 5).

Figure 3: Concrete patches on east arch rib soffit

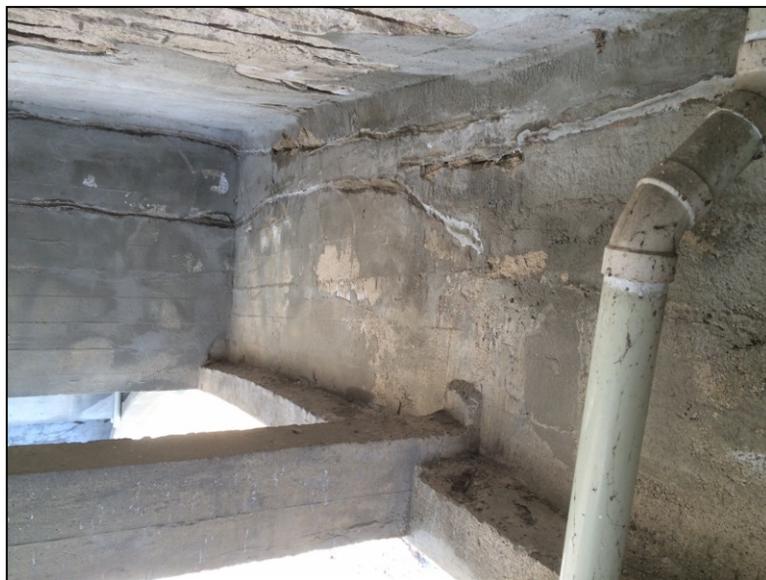
Figure 5: Concrete patches on east arch rib inside vertical face near the crown

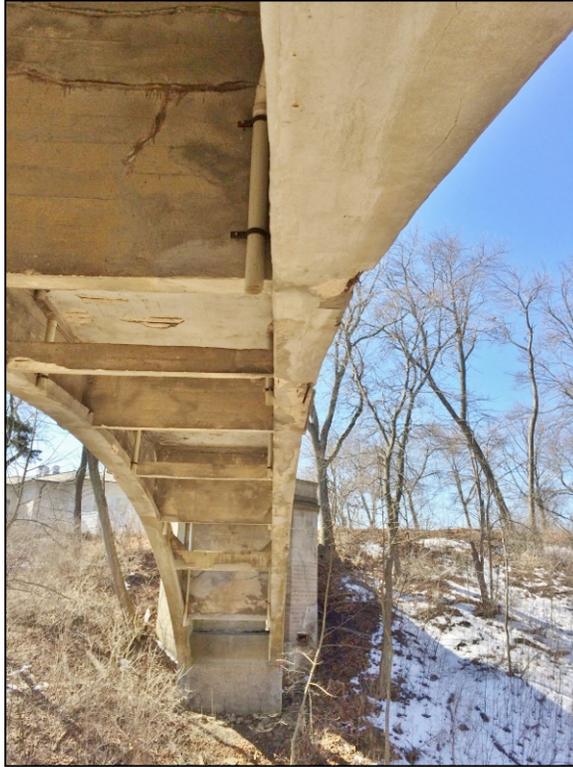
Delaminations and spalls were most prevalent on the west rib (Figures 6 and

Figure 6: West arch rib soffit with spalls and exposed reinforcing steel

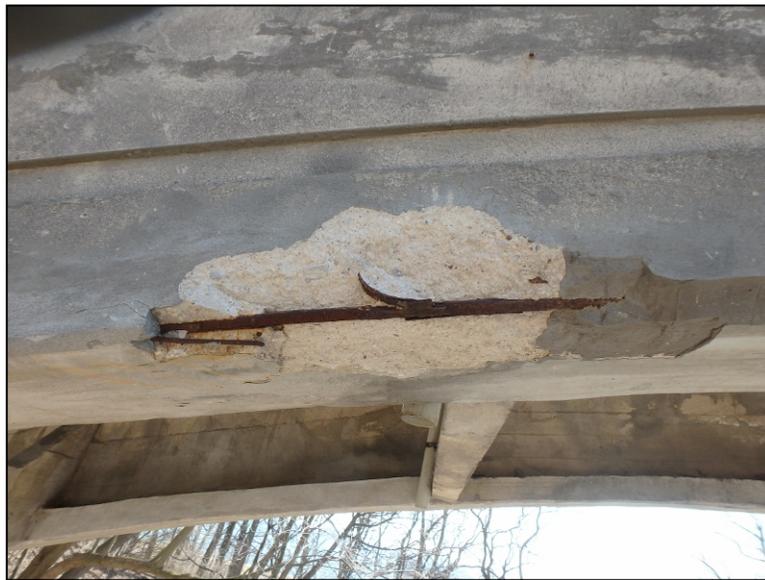
Figure 7: West arch rib spall with exposed Kahn bar reinforcement (note the bent up shear reinforcement)

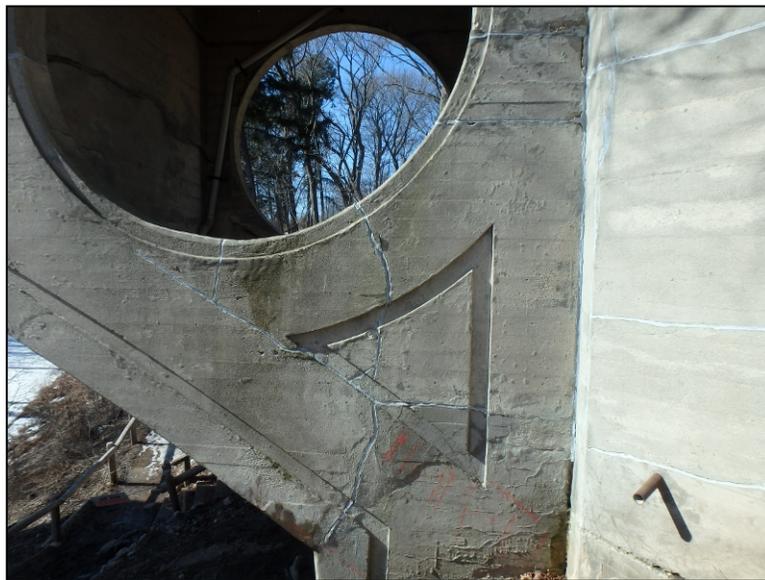
The arch ribs contain a few routed/caulked cracks, generally concentrated near the spring line (Figure 8). It is believed most of the routed/caulked cracks are at concrete cold joints. The cold joints were formed at concrete lift boundaries when new concrete was placed against cured concrete during the original construction. Most of the caulk is cracked, loose or missing and is ineffective in sealing out water.

Figure 8: East arch rib north spring line with routed/caulked cracks

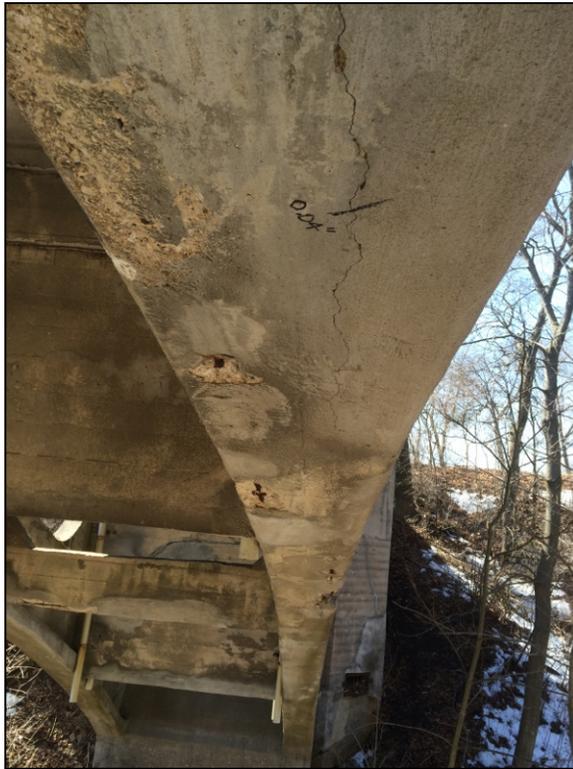
Figure 9: West arch rib soffit with unsealed 0.040" longitudinal crack in concrete patch

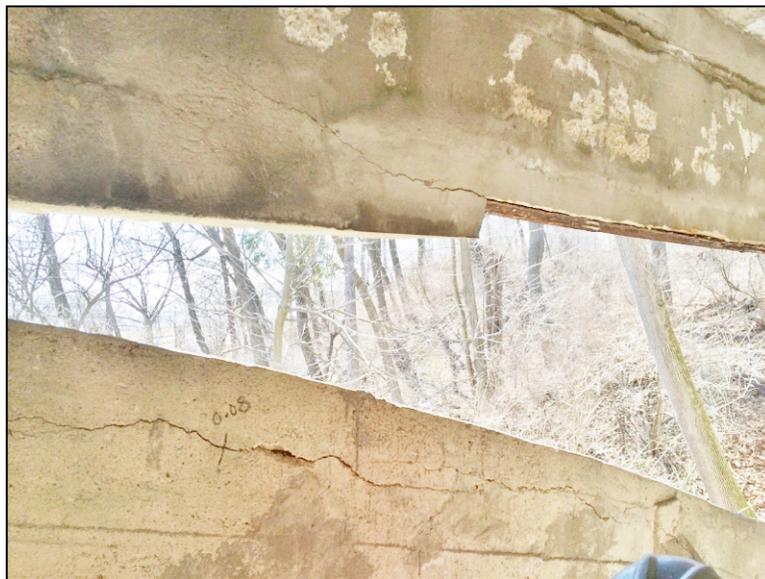
Figure 10: East arch rib inside face with unsealed 0.080" longitudinal crack near the top

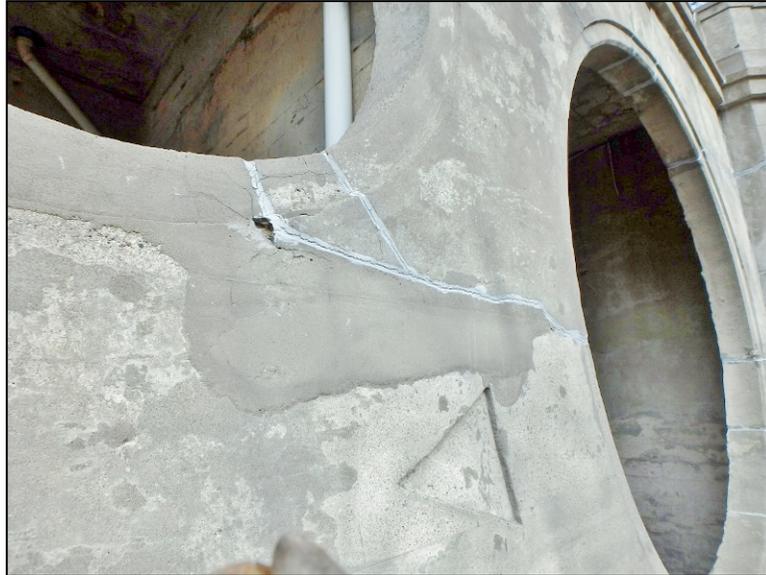
Figure 11: Concrete patch at east spandrel outside face

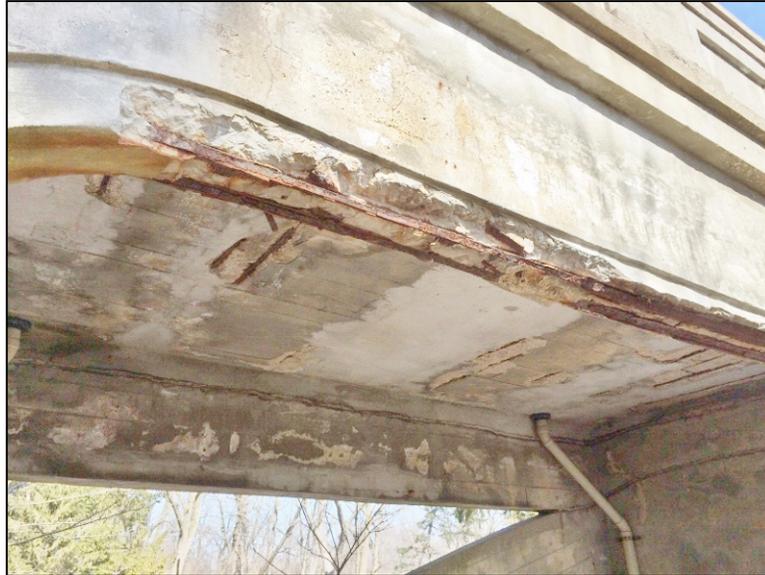
Figure 12: Large spall at east spandrel opening with exposed Kahn bar reinforcing steel

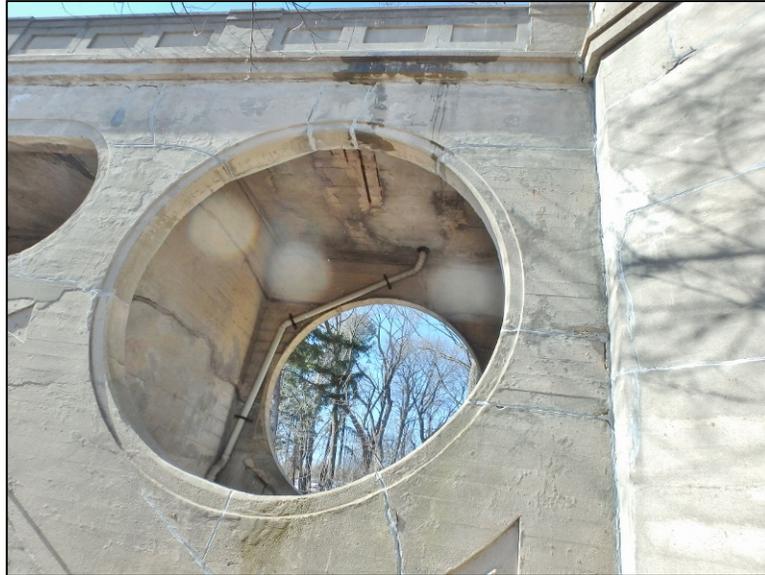
Figure 13: East spandrel routed/caulked cracks

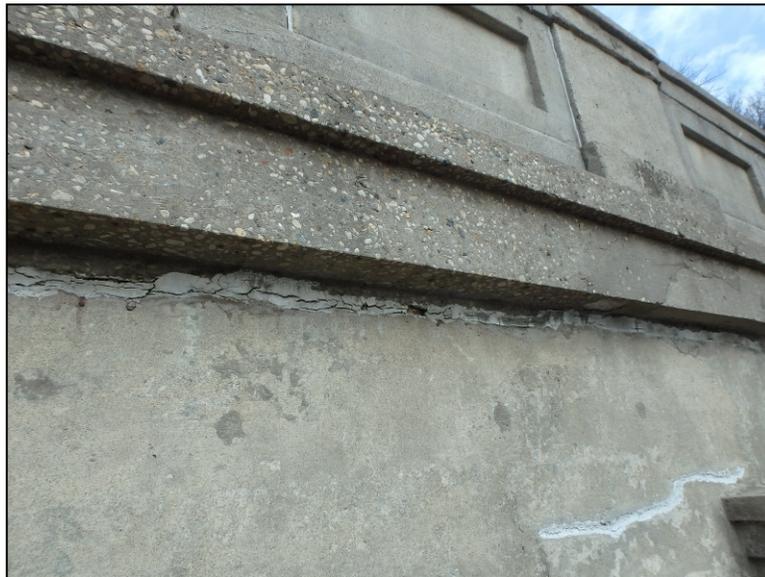
Figure 14: East spandrel routed/caulked crack between top of spandrel and deck

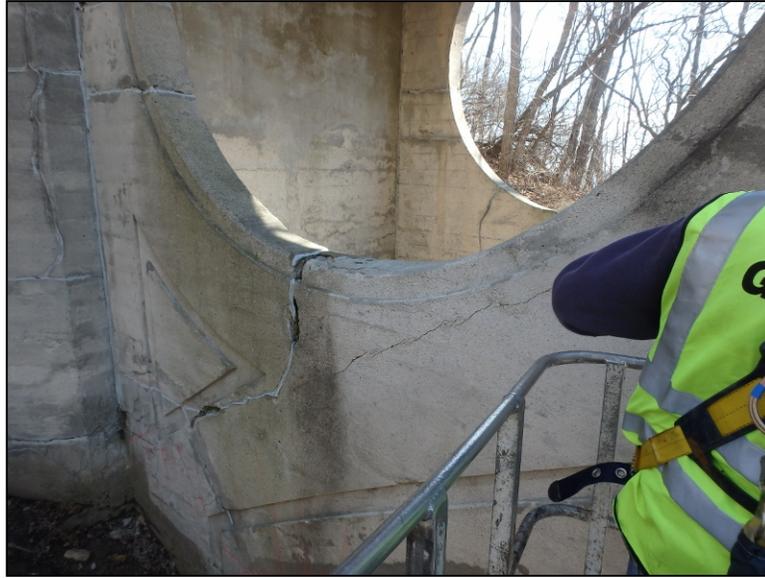
Figure 15: West spandrel with unsealed 0.070" longitudinal crack between spandrel and arch rib

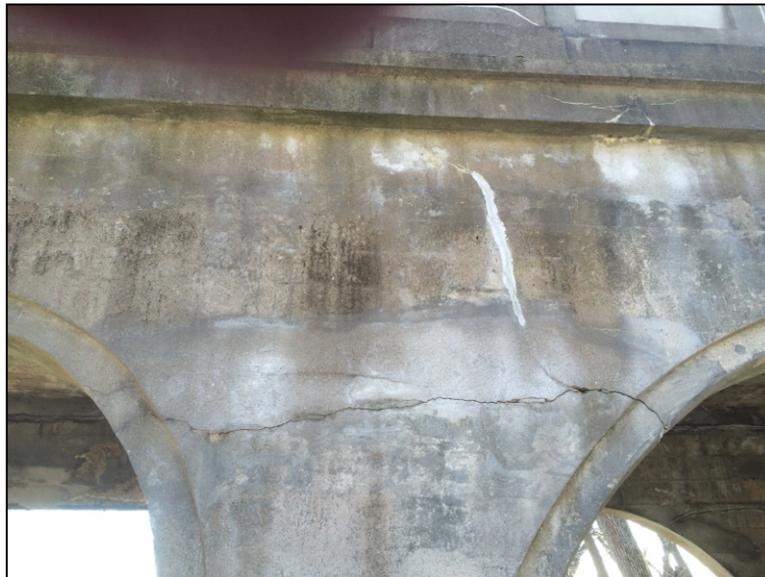
Figure 16: West spandrel south end with unsealed 0.030" crack in concrete patch between openings

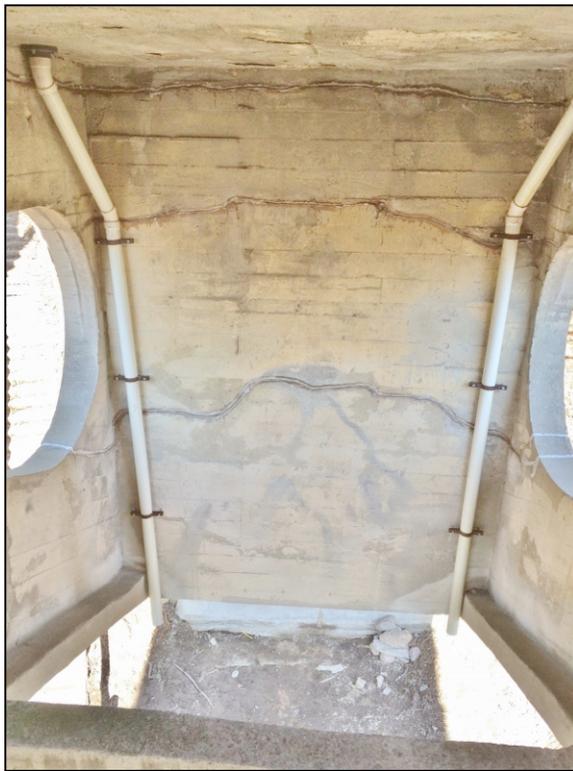
The diaphragms contain many routed/caulked cracks. It is believed the majority of these routed/caulked cracks occur at concrete cold joints (Figure 17). Earlier rehabilitation work also includes several concrete patches to both the diaphragms and struts. The patches generally occur at the bottom corners of these elements, and in some cases along the entire bottom edge. Patches were noted on all diaphragms and all struts except for strut 3.5.

Figure 17: Diaphragm at panel point 5 with routed/caulked cracks at concrete cold joints

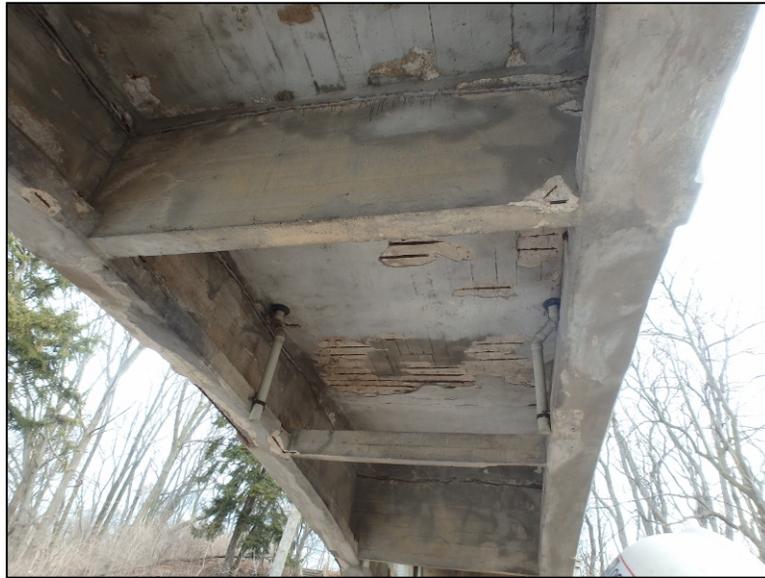
Spalls are present on several of the secondary members, typically along the bottom edges or bottom corners (Figure 18). Members containing spalls include diaphragms 3 and 4, and struts 1.5, 2.5, and 3.5.

Figure 18: Concrete patches and spalls on the crown diaphragm at panel point 3

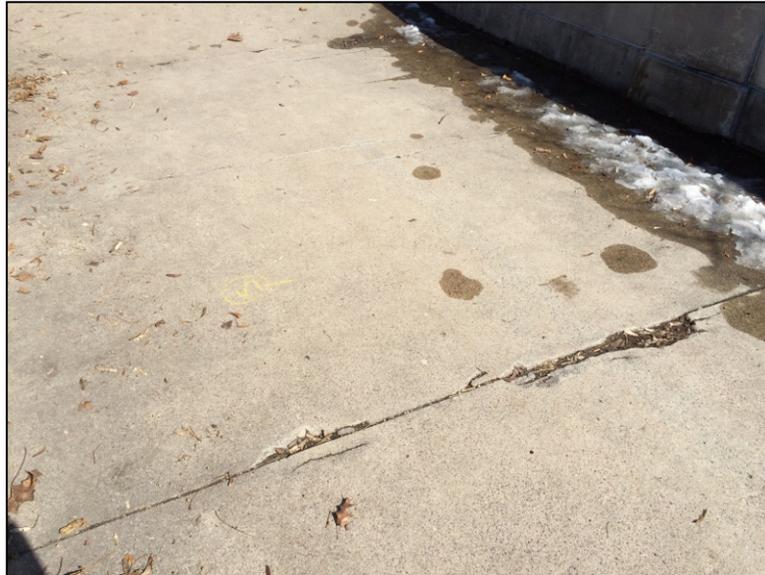
Regular transverse cracks are present along the bridge length between panel points 0 to 6, spaced at about 4' on center. Approximately half of these cracks have been previously routed/caulked, with the remainder being unsealed narrow cracks. Only four spalls are present on the top surface, and three areas of scaling were noted (Figure 19).

Figure 19: Small spalls on top of deck and typical cracks

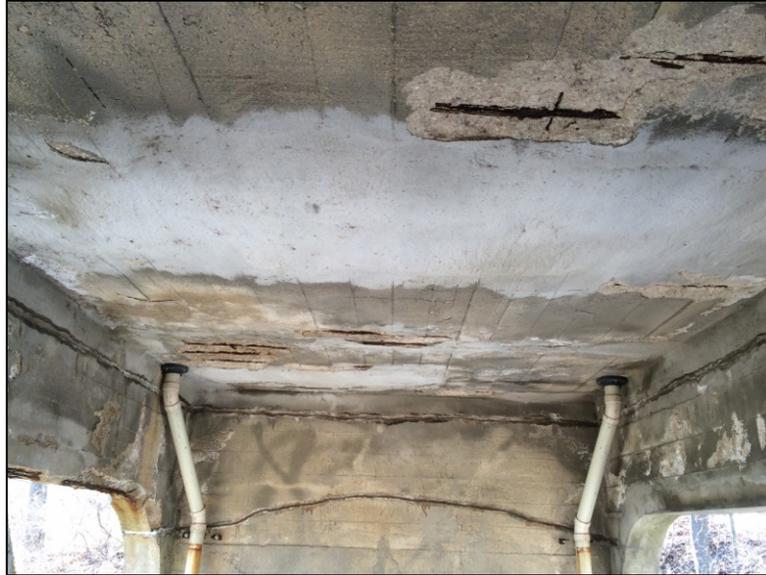
Figure 20: Deck soffit concrete patch and spalls with exposed Kahn bar reinforcement between panel points 1 and 2

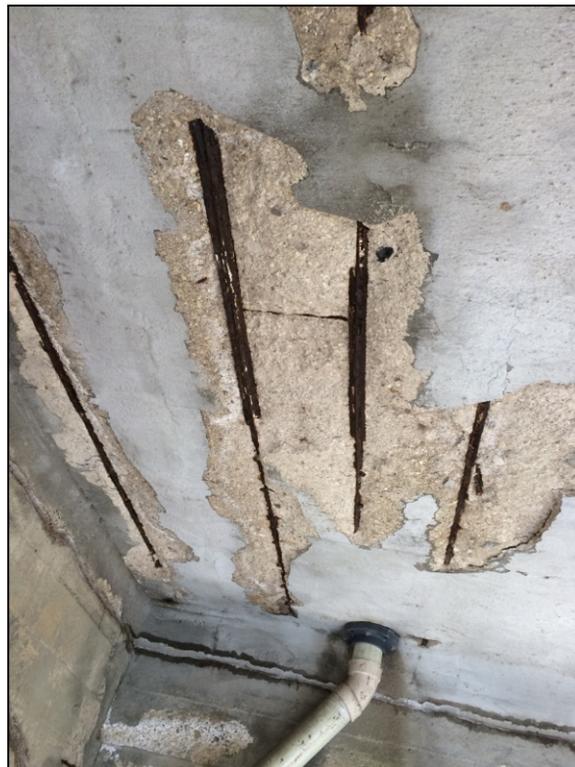
Figure 21: Deck soffit with spalled concrete patch and exposed Kahn bar reinforcement

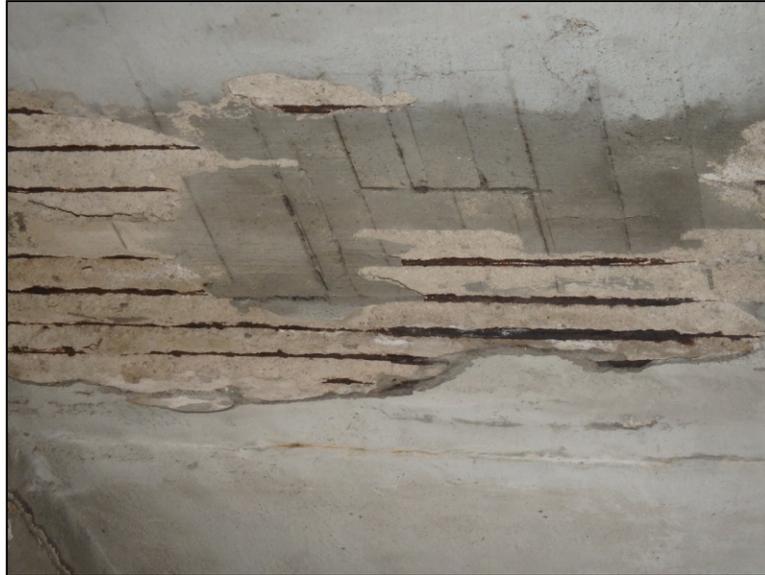
Figure 22: Deck soffit with spalled concrete patch and exposed Kahn bar reinforcement between panel points 3 and 4

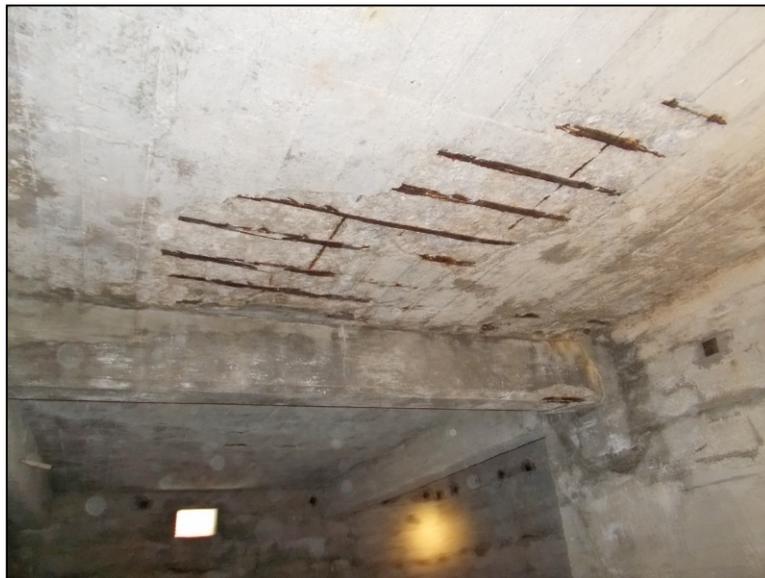
Over the substructure units, as inspected from the inside the vaulted abutments, the deck underside has spalls with exposed reinforcing steel (Figures 23 to 26). With one exception, there does not seem to have been prior rehabilitation work performed, likely due to access difficulties. The one exception occurs at the north octagonal vaulted abutment where about a 3' x 3' area of leave-in-place form work was found, possibly to repair full depth deterioration.

Figure 23: Deck soffit spall with exposed Kahn bar reinforcement between the wingwalls of the south abutment

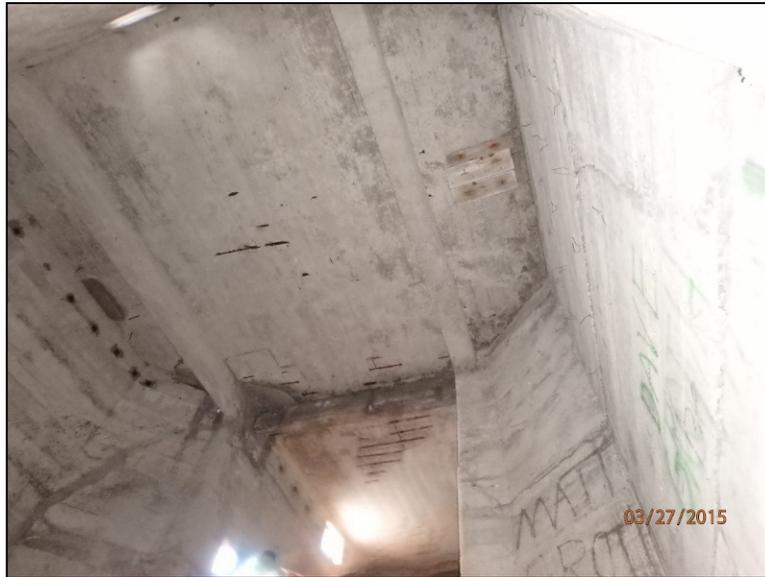
Figure 24: Deck soffit condition within the octagonal region of the south vaulted abutment

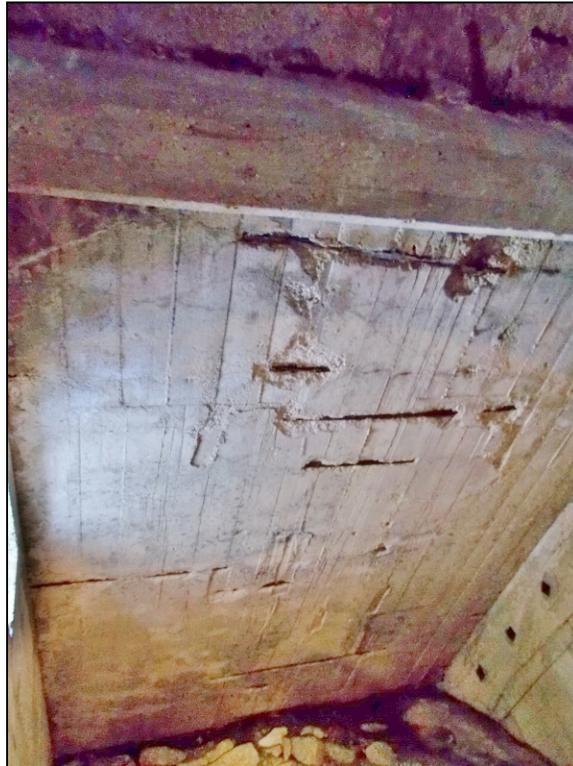
Figure 25: Deck soffit spalls with exposed Kahn bar reinforcement between the wingwalls of the north abutment

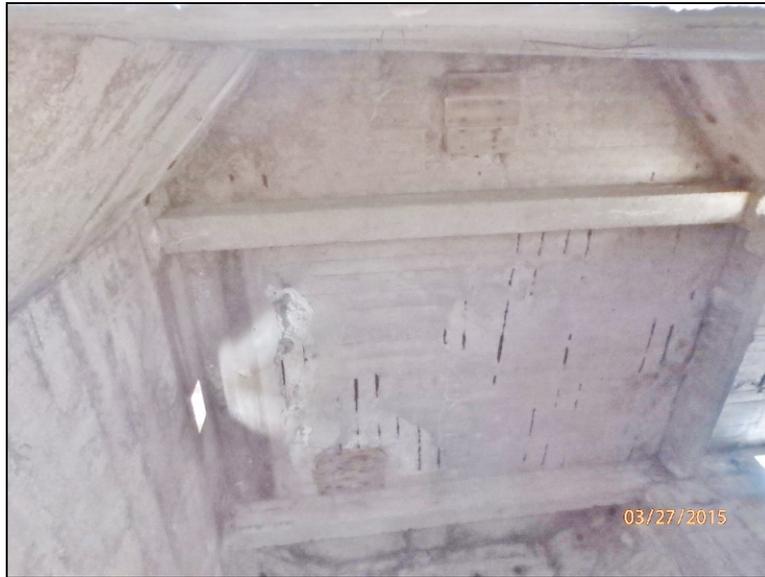
Figure 26: Deck soffit spalls with exposed Kahn bar reinforcement within the octagonal region of the north vaulted abutment

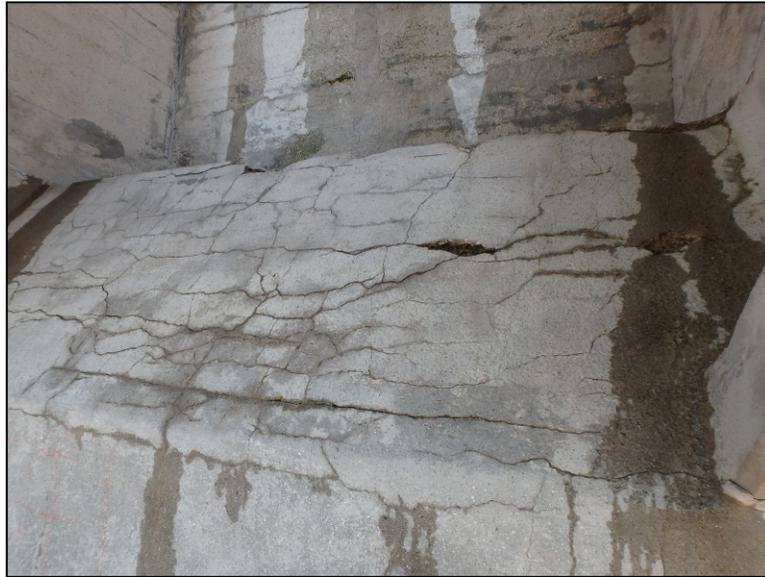
Figure 27: Extensive map cracks in the surface repair concrete at the north thrust block

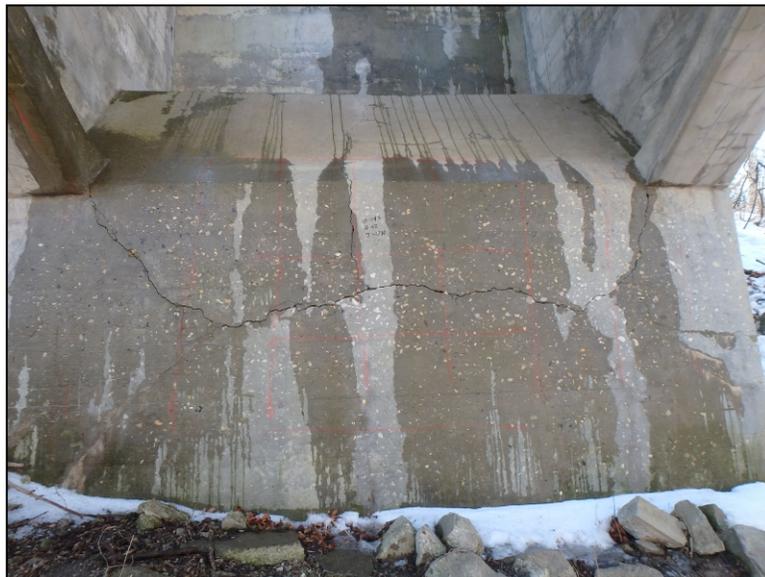
thrust block concrete facing has a 1/8" wide vertical crack and an approximate 1/8" to 1/4" wide horizontal crack (Figure 28). The east and west sides of the thrust blocks are also exhibiting deterioration in the form of cracks. On the north thrust block, map cracks are present (Figure 29), while on the south thrust block, 3 longitudinal cracks exist on the east face and 2 longitudinal cracks exist on the west face (Figure 30). The deterioration does not, however, affect the function of the thrust blocks. See Appendix A for the crack locations.

Figure 28: Wide 1/8" + cracks in the surface repair concrete at the south thrust block

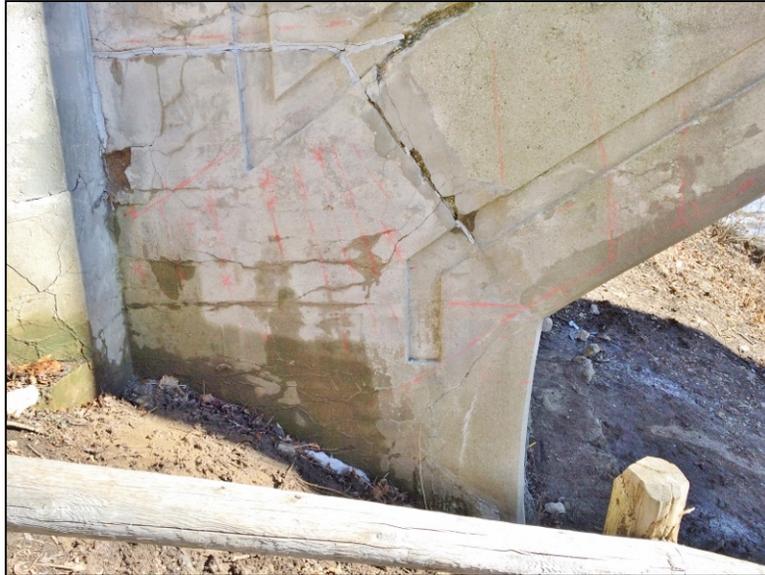
Figure 29: Map cracks in the concrete patch at the north thrust block west face

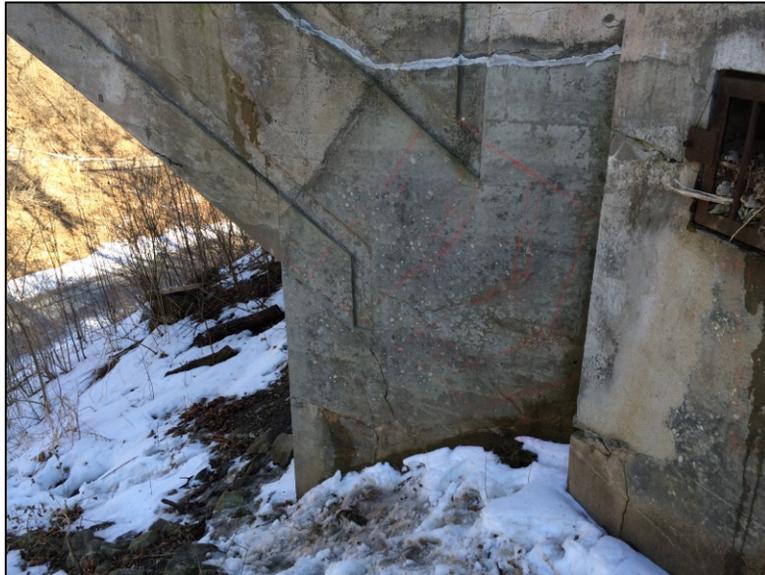
Figure 30: Longitudinal cracks in the concrete patch at the south thrust block west face

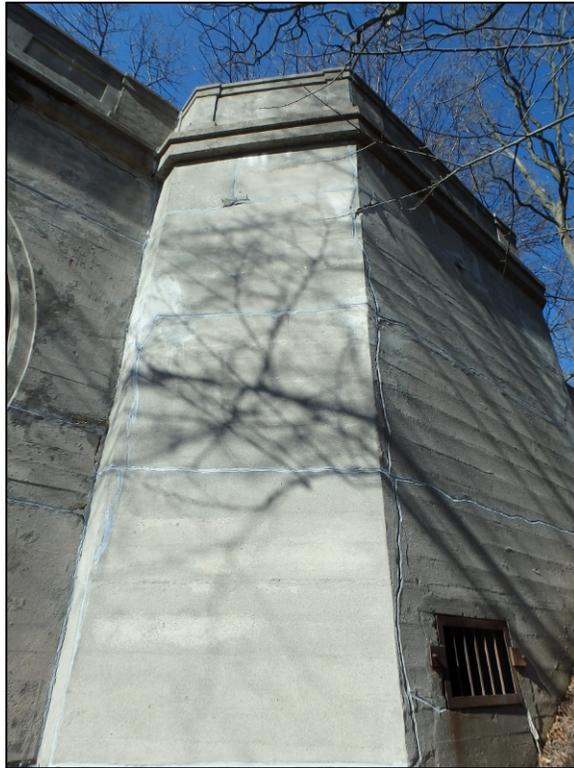
Figure 31: Extensive routed/caulked cracks on the east face of the north vaulted abutment wall

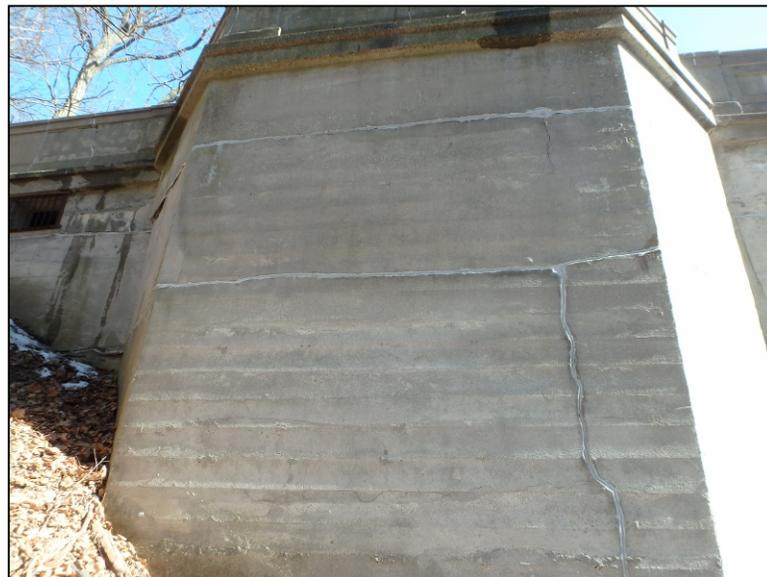
Figure 32: Extensive routed/caulked cracks on the west face of the north vaulted abutment wall

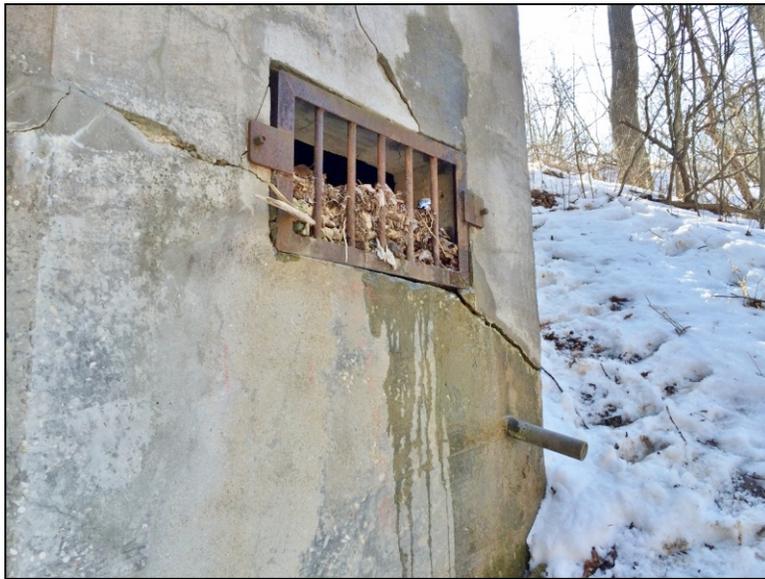
1. Southeast wingwall and south side of vaulted abutment wall – approximately 10' of erosion along the side slope has caused a localized washout hole (Figure 33). Both the erosion and washout are along the wingwall. At the washout, undermining has occurred below the wingwall access opening. The loss of vertical support has allowed a large section of the wingwall to crack and drop vertically. Active soil pressure on the exterior and lack of passive soil pressure on the interior has pushed on the wall, caused the wingwall to rotate towards the vault's interior. The top of the failed wall has moved approximately 8" horizontally and 3" vertically.

Figure 33: Washout and wall failure at the southeast wingwall (looking northwest)

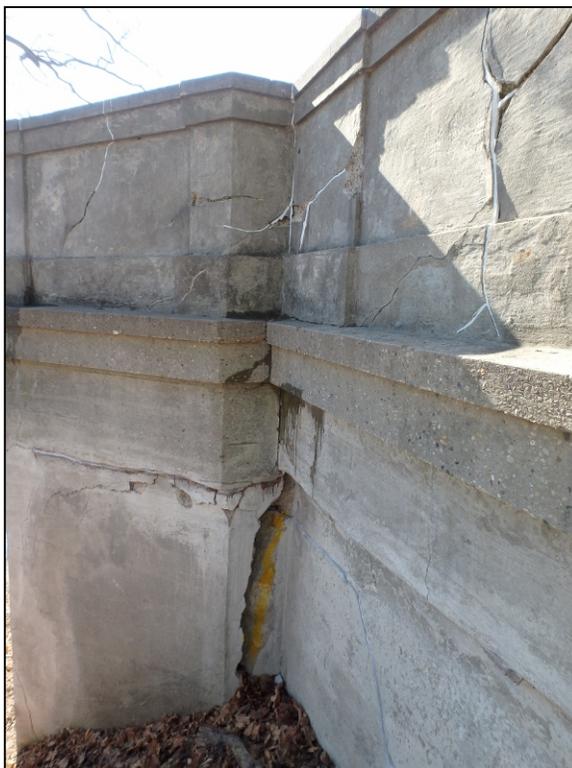
Figure 34: Wall and abutment wall failure at the northeast wingwall (looking south)

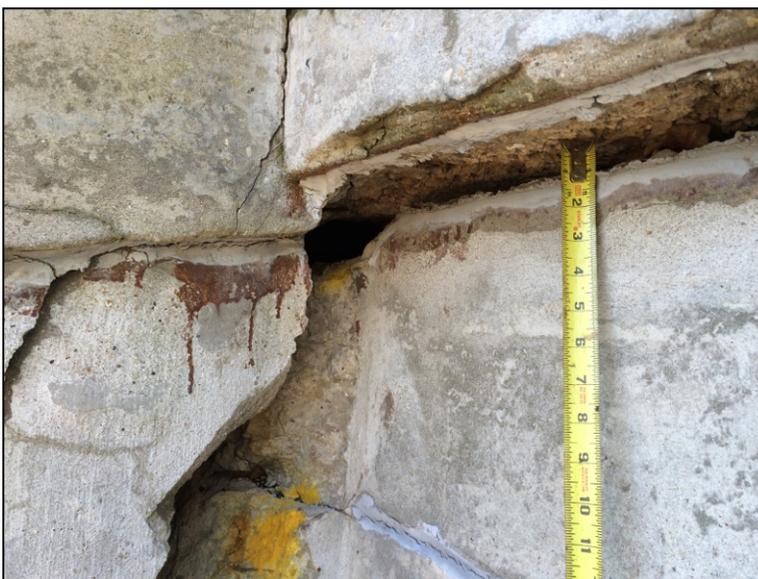
2. Northeast wingwall and east side of vaulted abutment wall – soil consolidation or erosion on the interior of the vaulted abutment interior has allowed the wingwall to settle after development of a horizontal and vertical crack (Figure 34). Though the wingwall strip footing was not exposed during the inspection to confirm this hypothesis, active soil pressure from the exterior has pushed on the wall, causing it to rotate towards the vault's interior. At the north end of the octagonal abutment, the wingwall top has moved approximately 5" horizontally and 1" vertically (Figure 35).

Figure 35: 1" gap between top of wall and deck at northeast wingwall

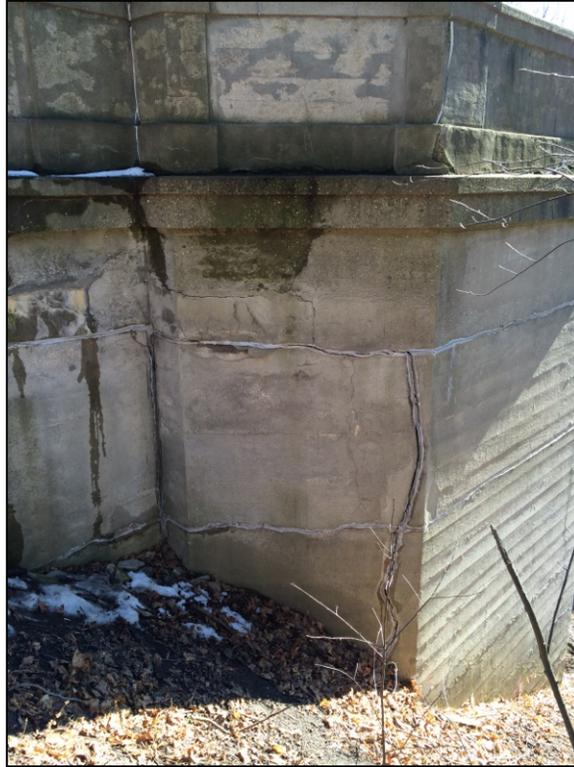
Figure 36: North abutment wall, northwest quadrant (looking southeast)

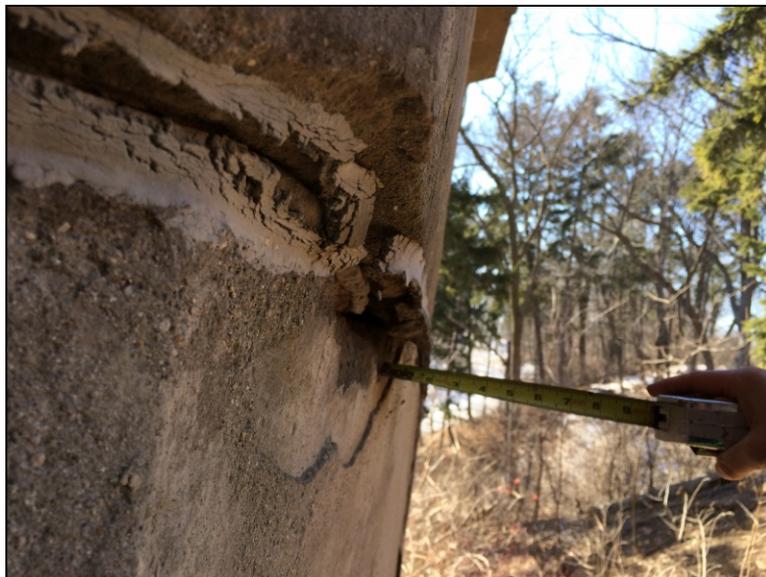
exterior has pushed on the wall, causing it to rotate towards the vault's interior. Caulk covers the width of the horizontal crack so an accurate measurement of vertical settlement could not be made. However, at the north side of the octagonal abutment, the fractured panel of wall top has moved approximately 1-½" horizontally (Figure 37).

Figure 37: 1 ½" of horizontal movement at north abutment wall northwest quadrant (looking southwest)

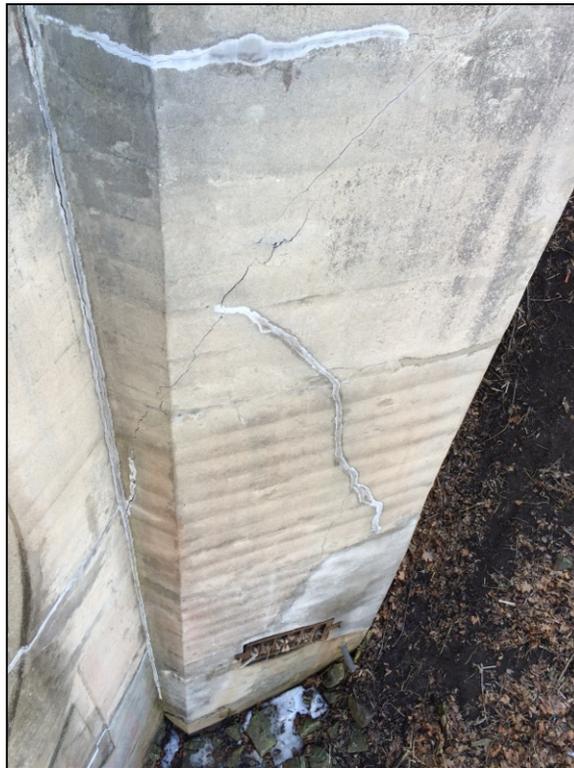
4. South abutment wall, northwest quadrant – there is a large concrete patch adjacent to the access opening that is part of an earlier repair effort (Figure 38). This area has wide unsealed vertical and horizontal cracks, and the patched region is bulged outwards. Soil aggradation inside of the vaulted abutment was evident at the grated opening. This aggradation is a result of scour along the wingwall inside faces farther upslope. Soils washed away from the wingwalls and were deposited inside of the octagonal shaped vaulted abutment. The deposited soil is imparting active pressure from the inside of the vault and causing the observed wall movement/bulging (Figure 39).

Figure 38: South abutment wall, northwest quadrant (looking southeast)

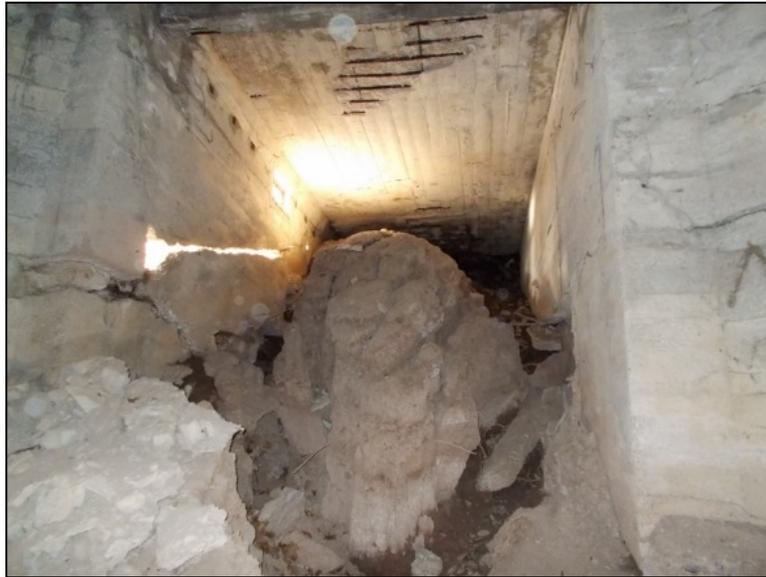
Figure 40: South abutment interior with major erosion and failure of east wingwall (looking south)

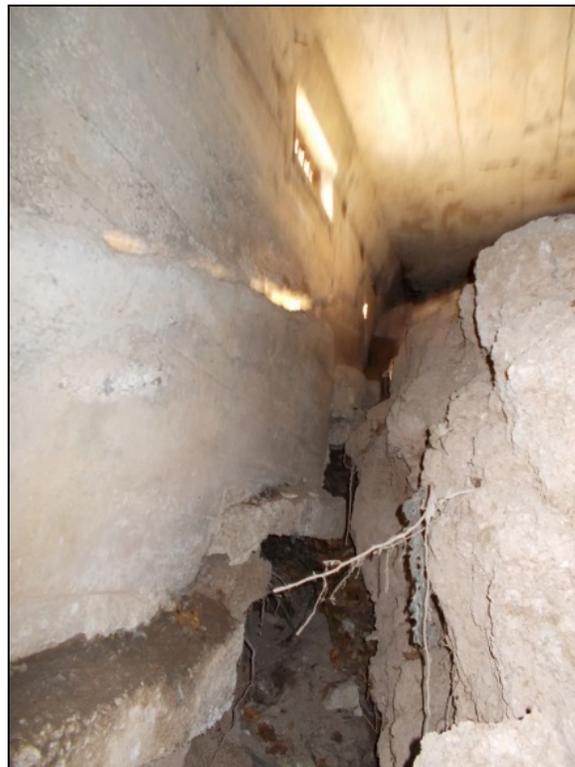
Figure 41: Erosion and undermining of exposed strip footing of the south abutment east wingwall (looking south)

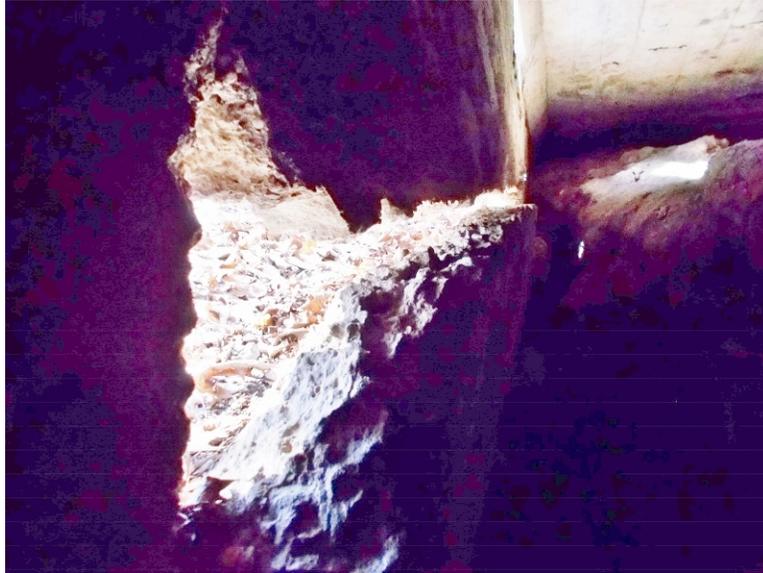
Figure 42: Top of failed portion of south abutment east wingwall with 3" drop provides no support for deck above (looking southeast)

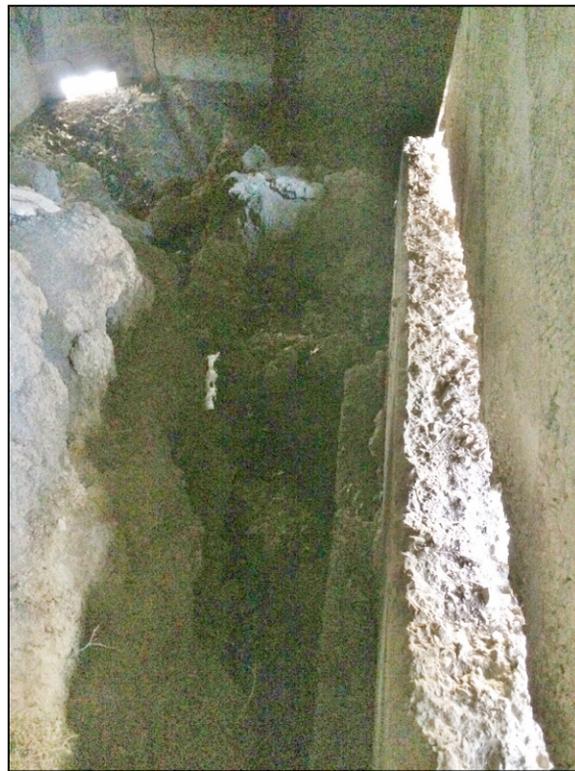
Figure 43: 8" shift in failed portion of south abutment lower east wingwall (looking north)

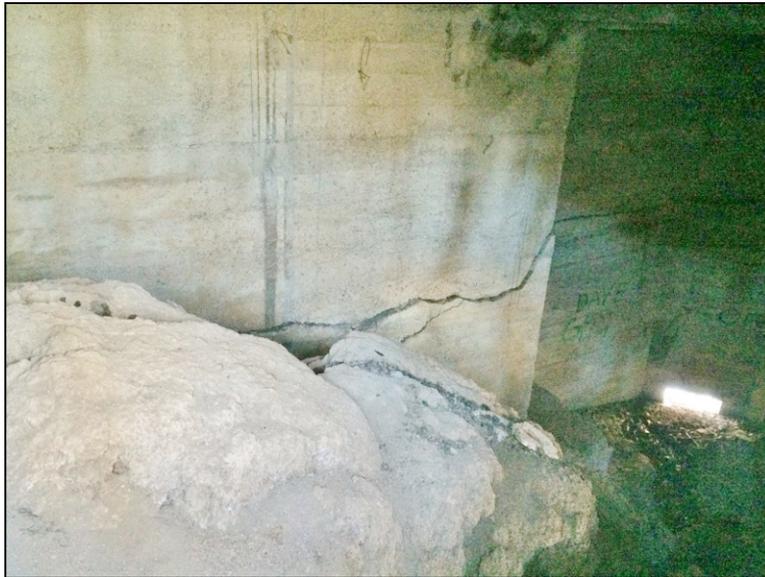
Figure 44: Wide cracks in south abutment west wingwall (looking northwest)

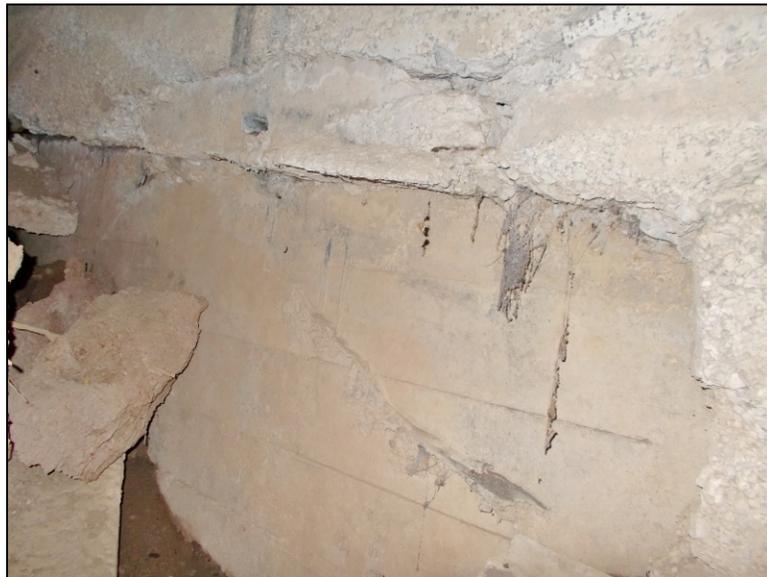
Figure 45: Apparent cast-in-place repair of west wingwall undermining at south abutment (looking southwest)

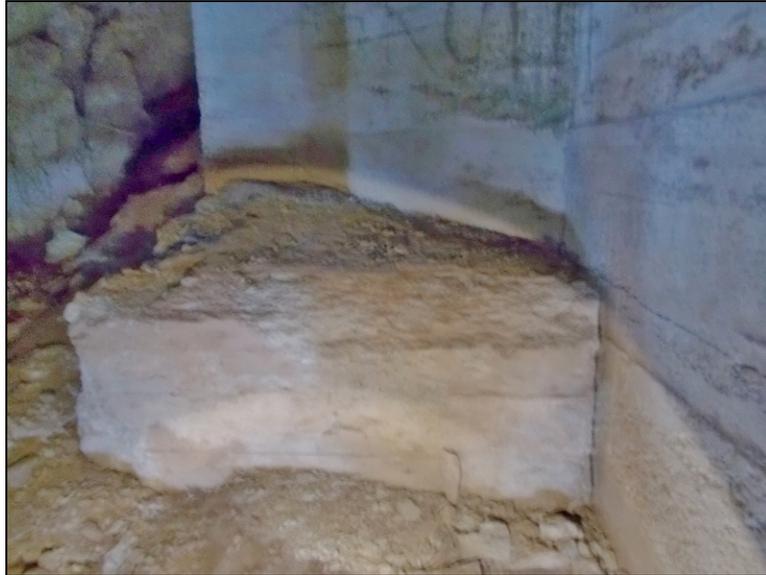
Figure 46: Apparent previous cast-in-place rehabilitation at southwest quadrant of octagonal region of the south vaulted abutment (looking south)

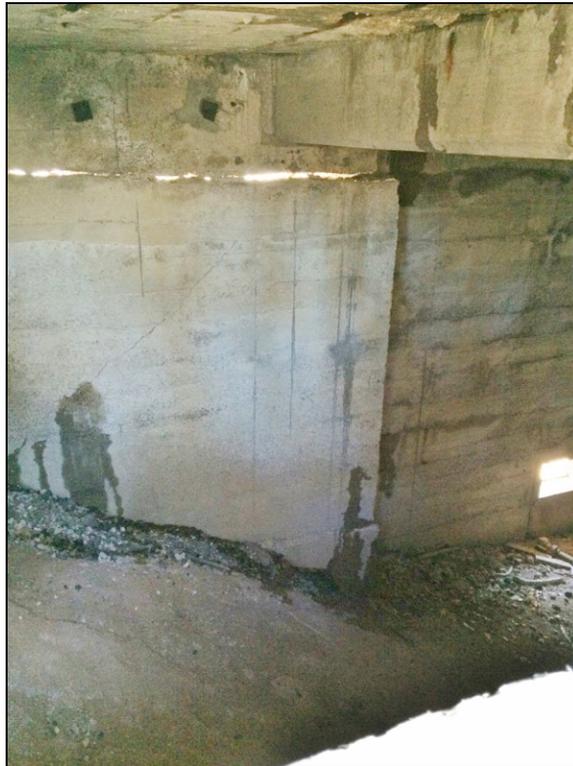
Figure 47: 1 ½" settlement of failed portion of north abutment east wingwall provides no support for deck above (looking east)

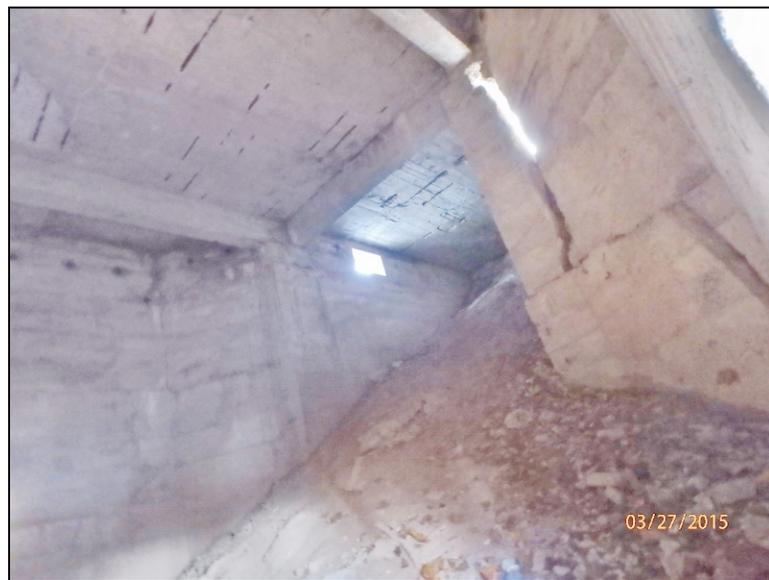
Figure 48: Interior of north vaulted abutment with 5" horizontal gap between failed east wingwall and abutment wall (looking northwest)

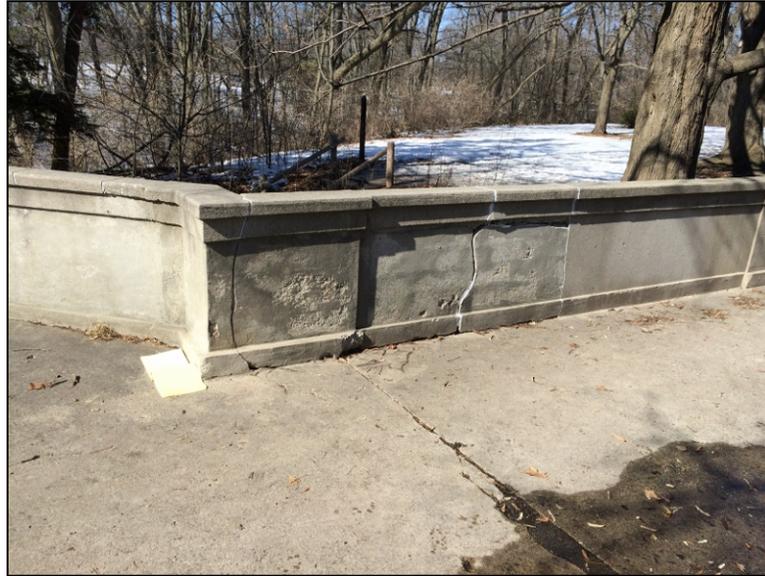
Both the east and west parapets contain routed/caulked cracks and unsealed cracks, with the heaviest concentrations occurring above the vaulted abutments and wingwalls (Figures 49 and 50). Several of the unsealed cracks contain light leaching. Cracks are primarily oriented vertically and occur on the inside and exterior surfaces.

Figure 49: Northwest wingwall parapet showing typical routed/caulked cracks on inside face

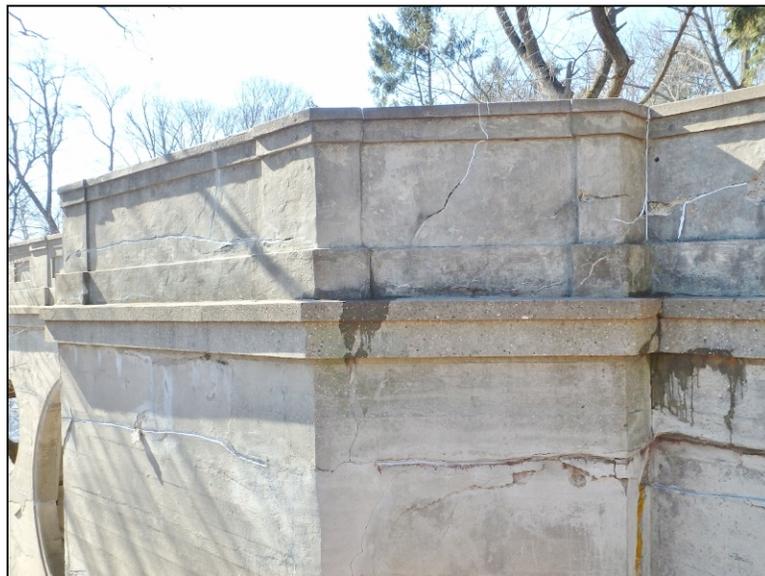
Figure 50: North abutment east parapet showing typical routed/caulked cracks
