HISTORIC LAKE PARK ARCH BRIDGE OVER RAVINE ROAD IN-DEPTH INSPECTION REPORT

Structure P-40-576

Milwaukee County Project Number P484-15619

July, 2015

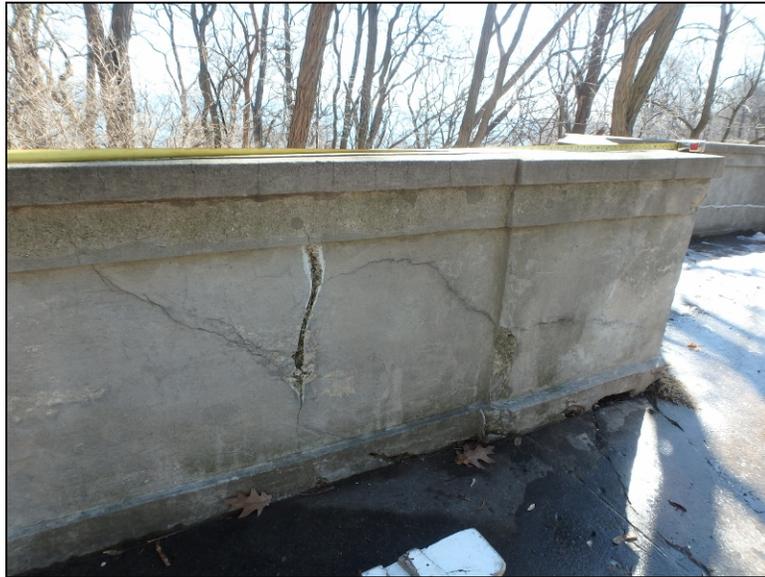
Figure 51: Northeast wingwall parapet showing typical spalls along curb line

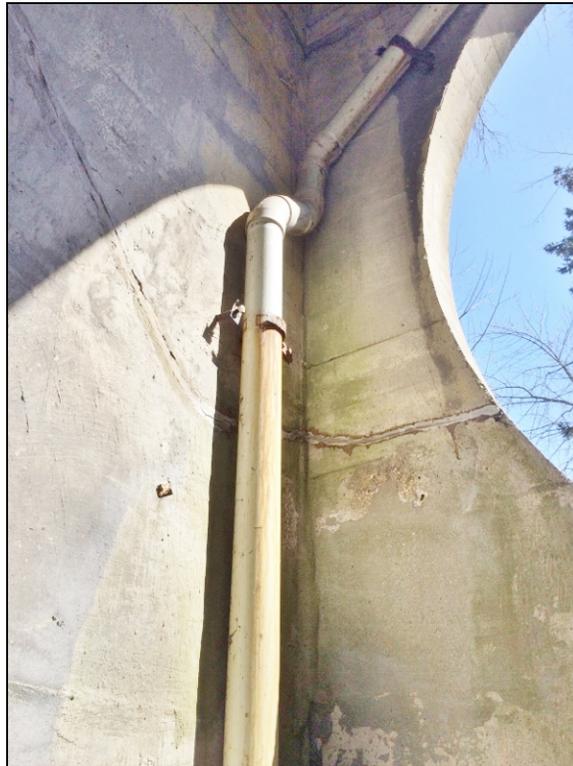
Figure 53: Failed downspout steel bracket
