2013 WRONG-WAY DRIVER ANALYSIS

23 JANUARY 2014

Re: Wrong-Way Driver Analysis

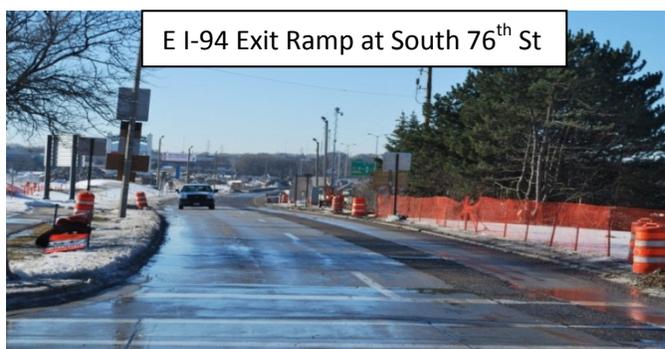
I-94 at South 76th St (temporary due to closure at 84th St.)

As seen in the above photograph, there are no “DO NOT ENTER” or “WRONG WAY” signs posted at this exit ramp.

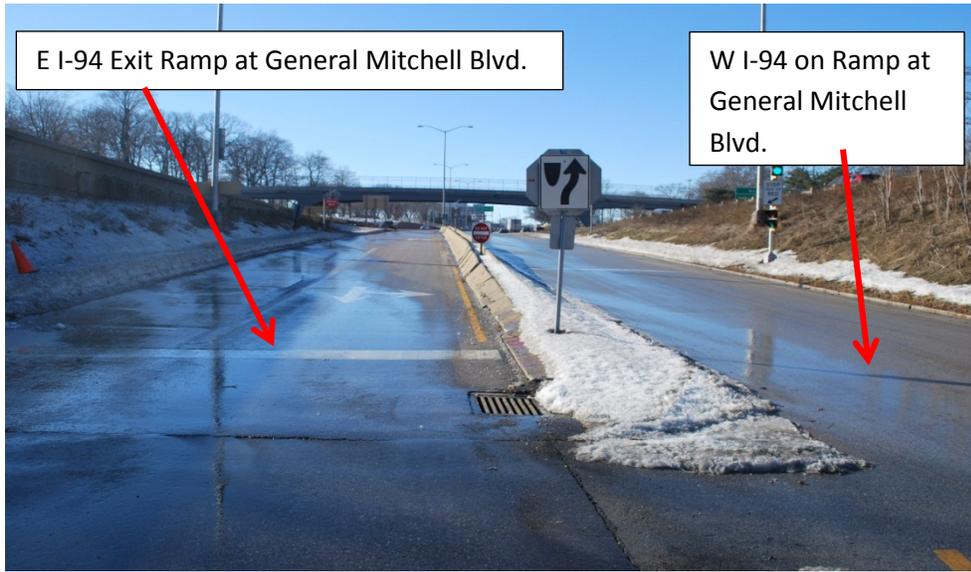
I-94 at General Mitchell Blvd.

This shows an ineffective “DO NOT ENTER” sign, as it is poorly positioned in the median with an obstructed view for motorist. As a result of the on and off ramps being parallel to one another, additional signage would clearly define entry and exit points to the interstate.

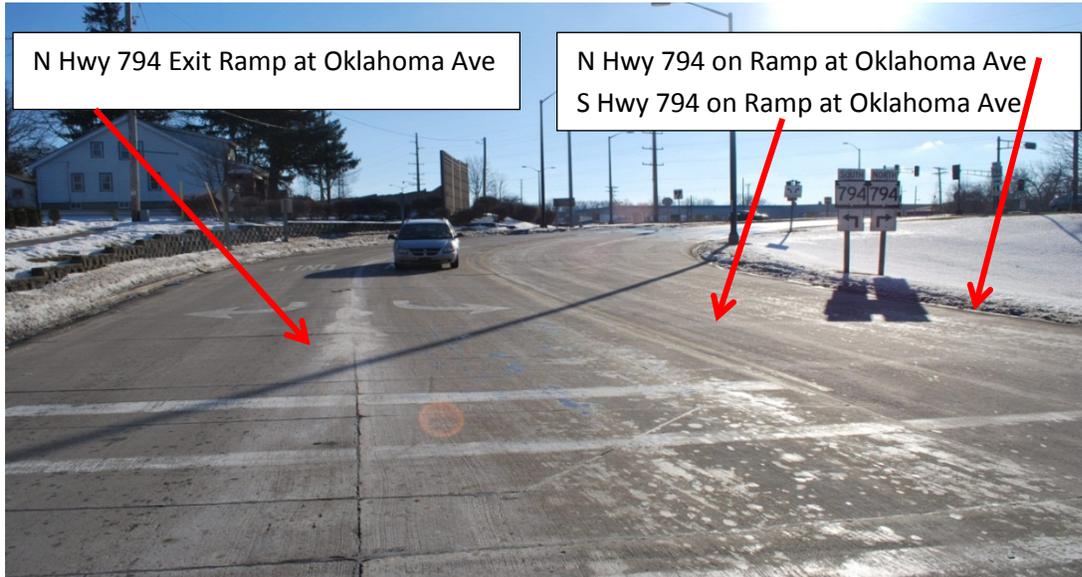
Hwy 794 at Oklahoma Ave

This ramp lacks a median divider separating the on and off ramps. Additionally, the off and on ramps are built parallel to one another. As you can see, the lane/travel markers have become faded. At night, reflective markers on the road way would assist drivers in maintaining the correct direction of travel.

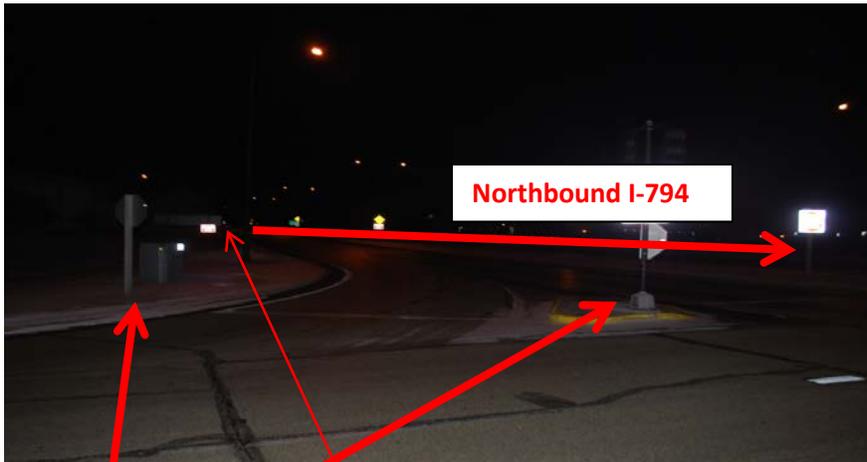
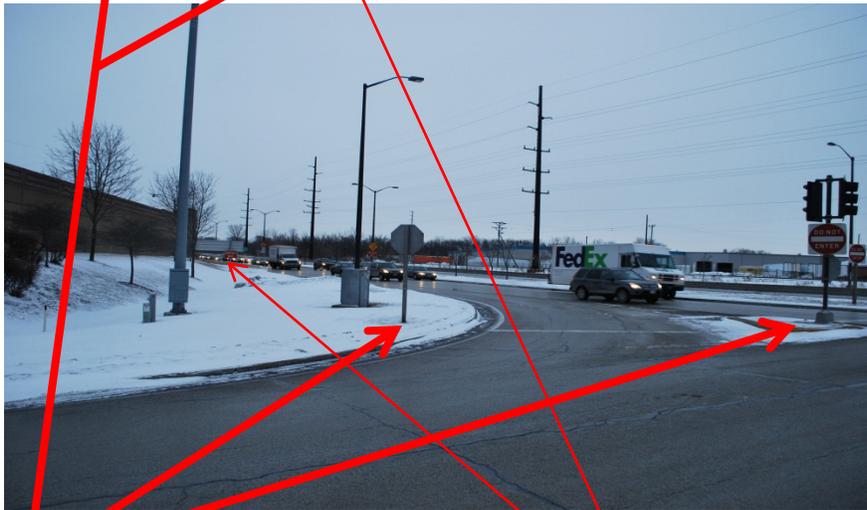
Hwy 794 at Oklahoma Ave (Night vs. Day Photo)

At the top of the two-way ramp, “DO NOT ENTER” and flashing “WRONG WAY” signs need to be installed at the mouth of the right-turn lane. The current WRONG WAY signs are placed too far down the road. These should also be double “DO NOT ENTER” and flashing “WRONG WAY” signs on both sides of the road. In addition, elephant tracks should be repainted in the intersection to direct vehicles into the proper lane of travel. The current ones have faded and are almost invisible at night or during inclement weather.

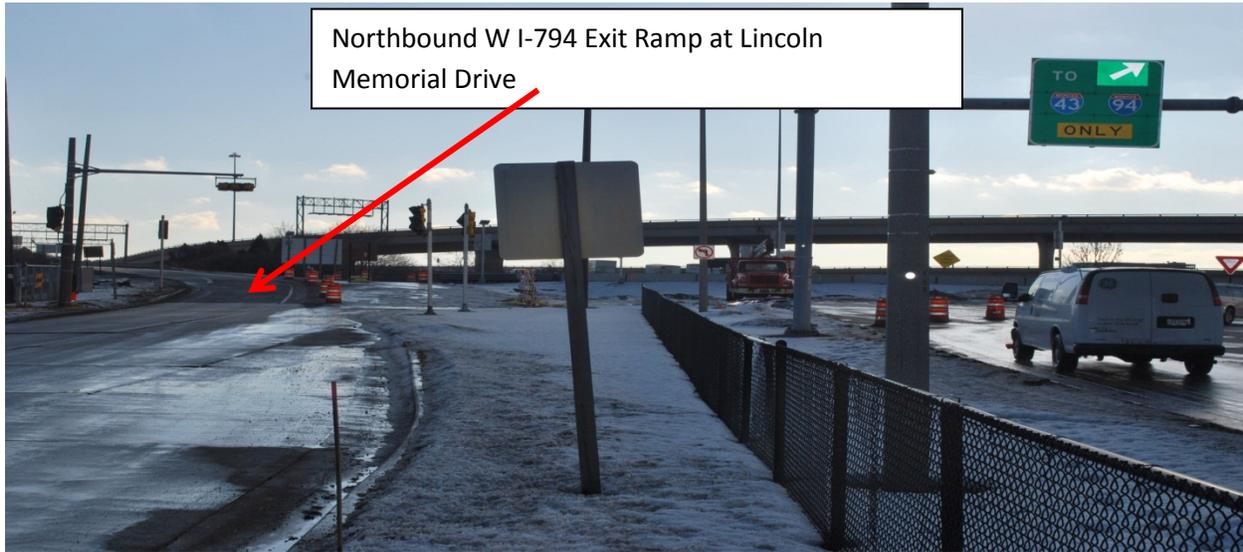
I-794 at Lincoln Memorial Drive / Michigan Ave.

Again, here we have an off ramp that has no “DO NOT ENTER” or “WRONG WAY” signs. There are also no reflective markers showing the correct direction of travel on the roadway. Due to ongoing construction on I-794, placing road signs would enable motorists to clearly distinguish entrance and exit ramps.

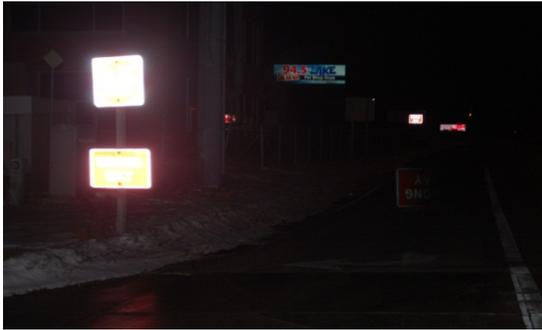
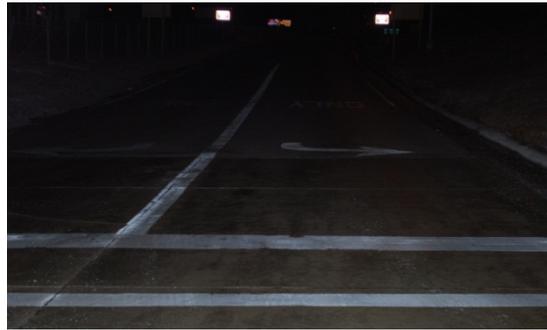
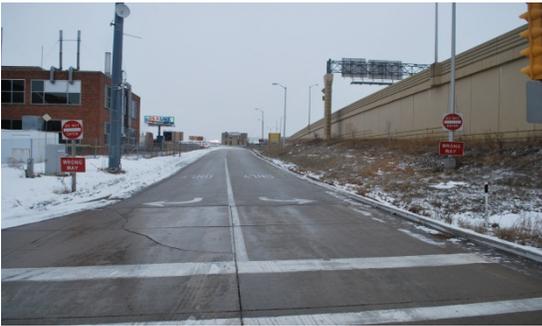
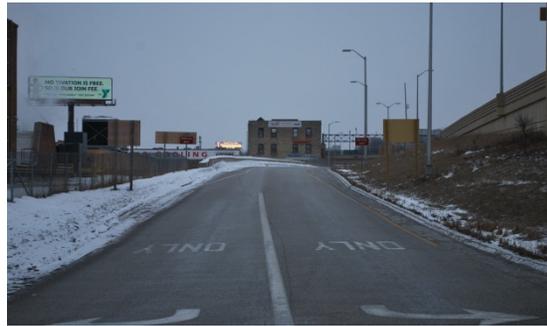
I-94 at 13th Street (Night vs. Day Photos)

Faded, obscured “DO NOT ENTER” and “WRONG WAY” signs set at different heights hinder motorists from identifying that they are traveling the wrong way, especially those impaired by alcohol and/or drugs. Impaired drivers tend to focus on the road and the lines on the road to compensate for their impaired state.
