HOAN BRIDGE IN-DEPTH INSPECTION PRELIMINARY SUMMARY REPORT

**Structure B-40-400
Units 1A/1B through S24**

Wisconsin DOT Project ID 1300-00-05

January 14, 2011

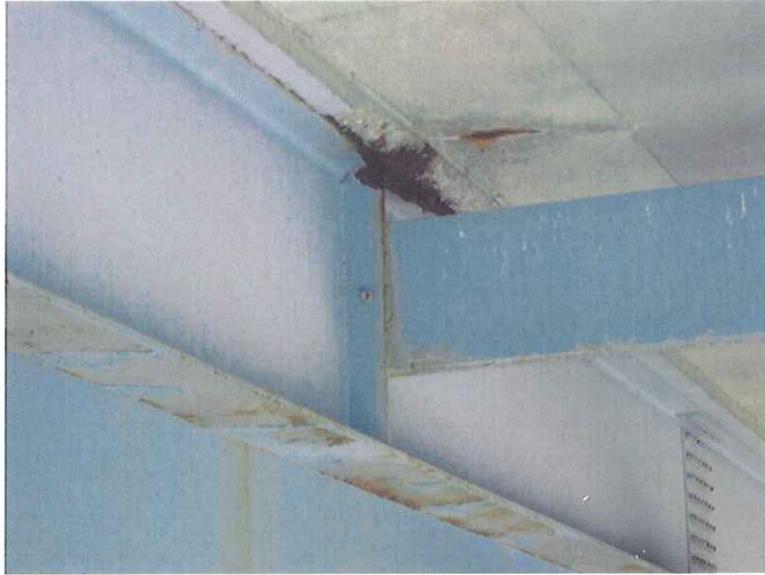
Stringers - The stringers are generally in good condition. Random blush rust is common on the bottom flanges. Local areas of surface or scaling rust exist where the paint system has failed, resulting in less than 5% section loss. These areas include the fascia stringers adjacent to the tie girders, and top flanges under leaking deck cracks (Photo 1). Scaling and laminate rust is also present at the shiplaps located under the deck compression joints. The most severe shiplap corrosion occurs at the fascia and median stringers where approximately 10% section loss

Photo 1: Main span stringer - local heavy rust at the top flange and typical bottom flange blush rust

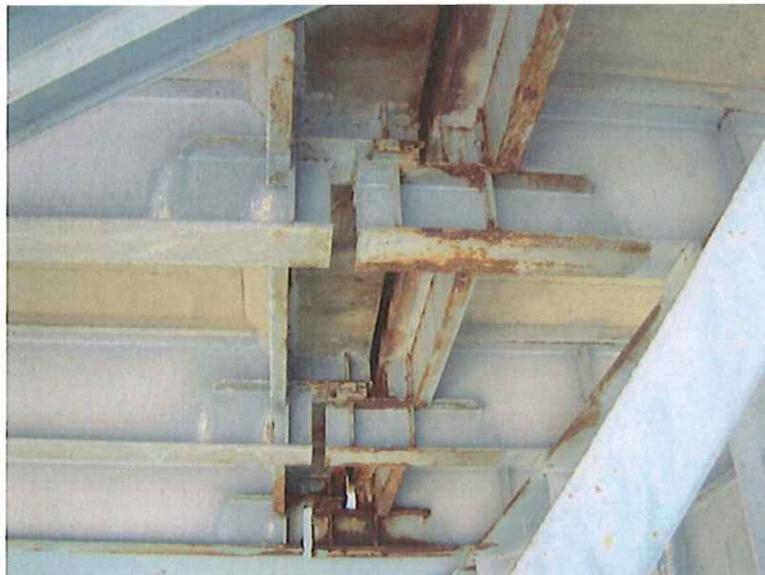
exists (Photo 2). No problems were noted at the stringer diaphragms except for the scaling rust and laminate rust present at the shiplap diaphragms. Approximately 10% section loss exists at these elements.

Photo 2: Main span stringer shiplaps - typical condition

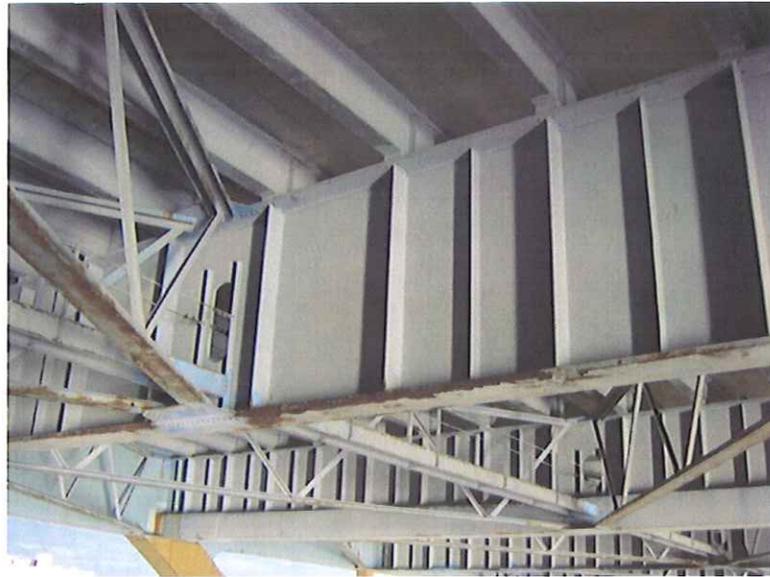
Floor Beams - The floor beams are generally in good to fair condition. Local blush rust is common on the top and bottom flanges. Paint system failure and flange scaling rust is present in random places with section loss estimates being less than 5% (Photo 3). Localized laminate rust has formed primarily on the floor beam webs and bottom flanges near the tie girder connections. These typically are found at the bottom of web stiffeners and stringer bearing stiffeners and have caused less than 5% section loss (Photo 4). Bottom flange rust pits, caused by ponded water trapped by the bottom flange/stiffener/web intersection, was observed at some of these locations. Maximum rust pit depths were estimated to be ¼-inch. Surface rust is common on the floor beam web's transverse and bearing stiffeners adjacent to the tie girders, and have produced less than 5% section loss on these elements. Some of the floor beam to tie girder connection bolts have surface rust, primarily affecting bolts attaching the floor beam bottom flange to the gusset plate.

Photo 3: Main span floor beam - local paint failure/surface rust at the bottom flange

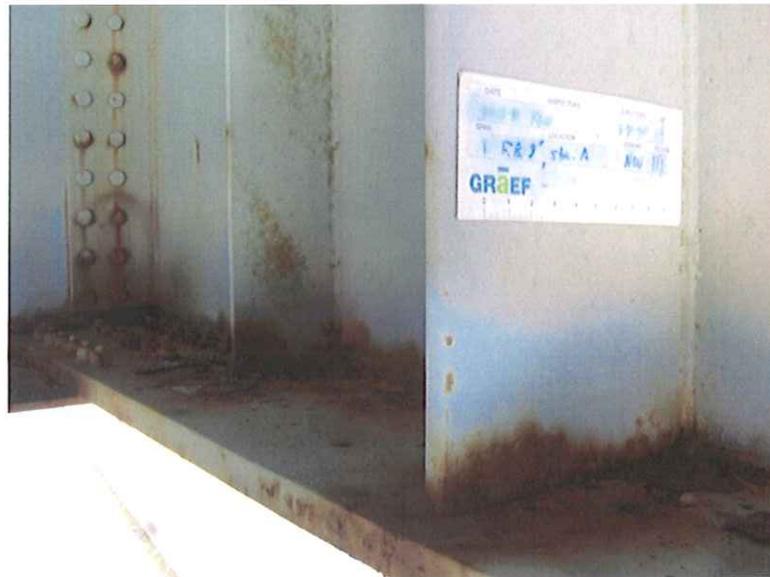
Photo 4: Main span floor beam - laminate rust near tie girder connection at stiffeners

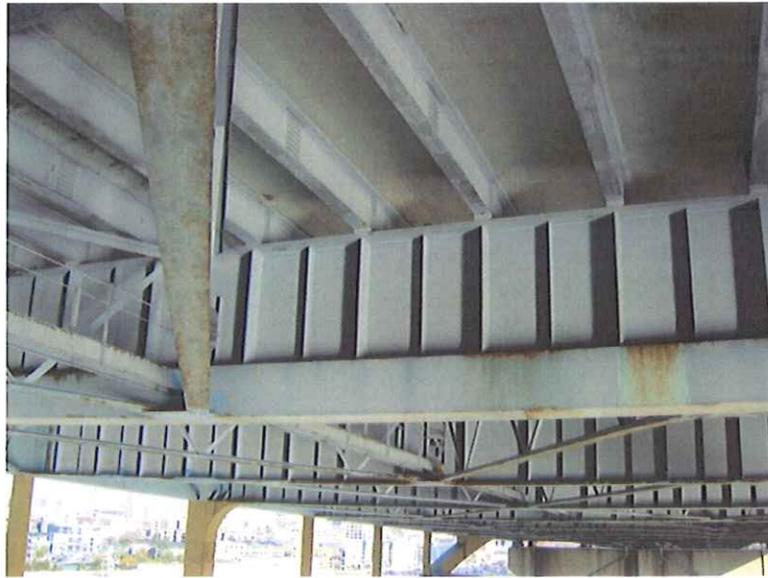
Panel points 8 and 8' are locations where the floor beam bottom flange is a steel box element that also serves as a tie between the arches. Access to the interior of these box bottom flanges is provided by midspan hatches. The bottom flange's exterior condition is generally good with blush rust occurring at localized areas on the top surface (Photo 5). This blush rust is likely caused by ponded water trapped by the floor beam bottom flange/stiffener/web intersection. Surface rust, which has caused less than 5% section loss, is also present on the top and side surfaces at the tie girder connection points (Photo 6).

Photo 5: Main span - floor beam box bottom flange local rust

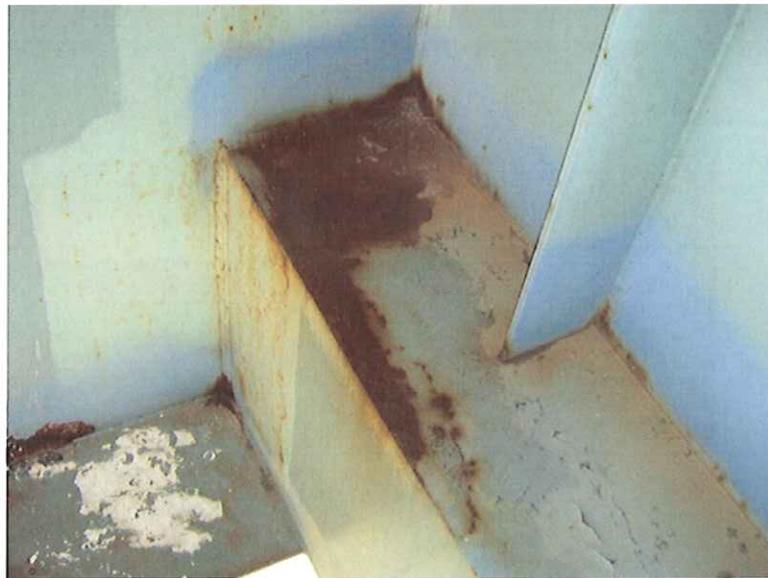
Photo 6: Main span - floor beam box bottom flange rust at the tie girder connection

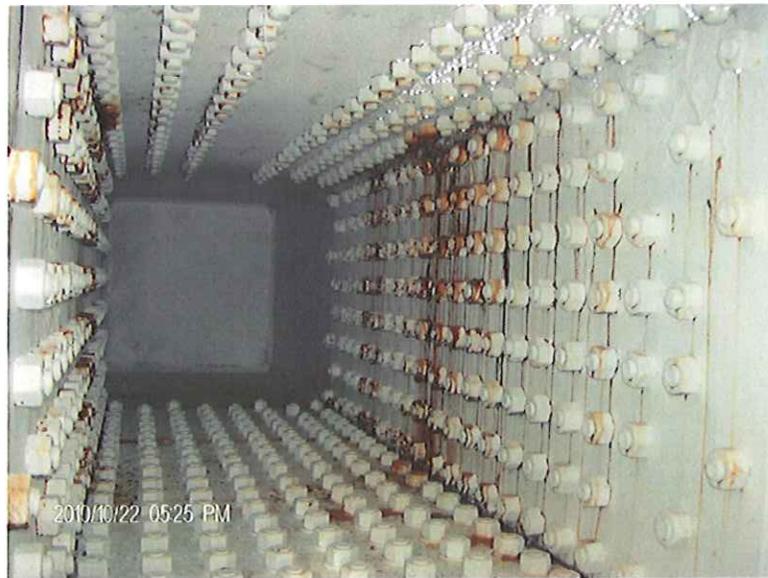
Both bottom flange boxes were entered to observe their interior conditions. Light rust stains were observed at the field splices of the north box along panel point 8'. The interior of this box was dry at the time of inspection. The south box along panel point 8 was wet inside due to condensation. This condensation is causing surface rust to form at the field splices and along the bottom plate (Photo 7). Section loss of the box element due to the surface rust is less than 5%. Rust stains have also formed from behind the splice plate bolt heads. Pigeon waste is present on the bottom plate due to the access hatch being left open at some time in the past. Closing the hatch from the catwalk at panel point 8 was difficult and posed safety concerns due to the poor accessibility in reaching the latch combined with its weight.

Photo 7: Main span - floor beam box bottom flange field splice interior w/ condensation and rust staining

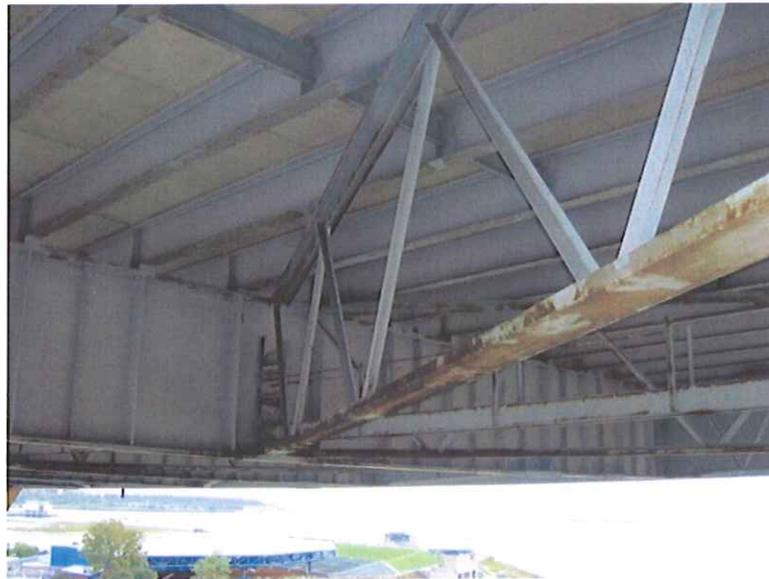
of most braces are covered with blush or surface rust and have produced less than 5% section loss to these members (Photo 8). Local paint system failures are also common. These paint failures result in scaling rust or laminate rust and are primarily located at the top and bottom chord gusset plate connections resulting in approximately 10% section loss. Approximately half of these connections, located at the tie girders and floor beam flanges, are affected by this heavy corrosion. At many connections, pack rust has formed between the gusset plate and chords, bending the chord channel flanges (Photo 9). It is estimated that connections having pack rust have caused about 15% to 20% section loss of the chord cross section area.

Photo 8: Main span - typical lateral brace condition with bottom chord surface rust

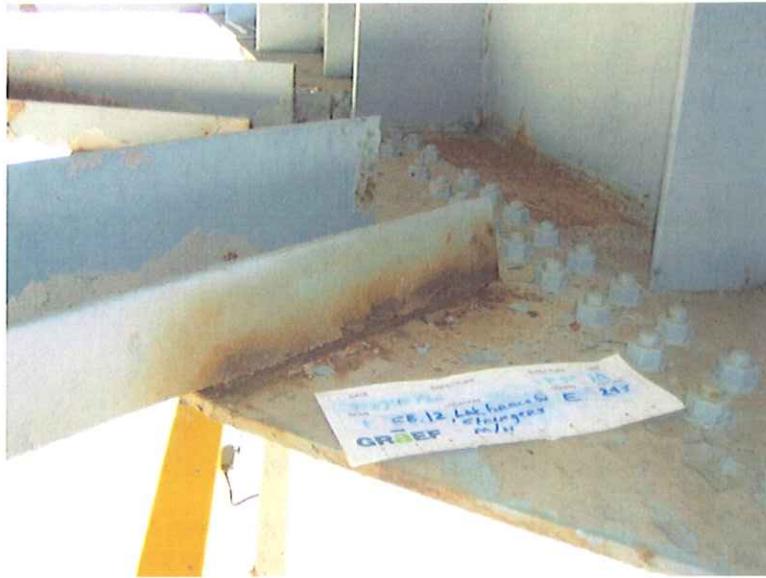
Photo 9: Main span - pack rust at lateral brace bottom chord connection to gusset

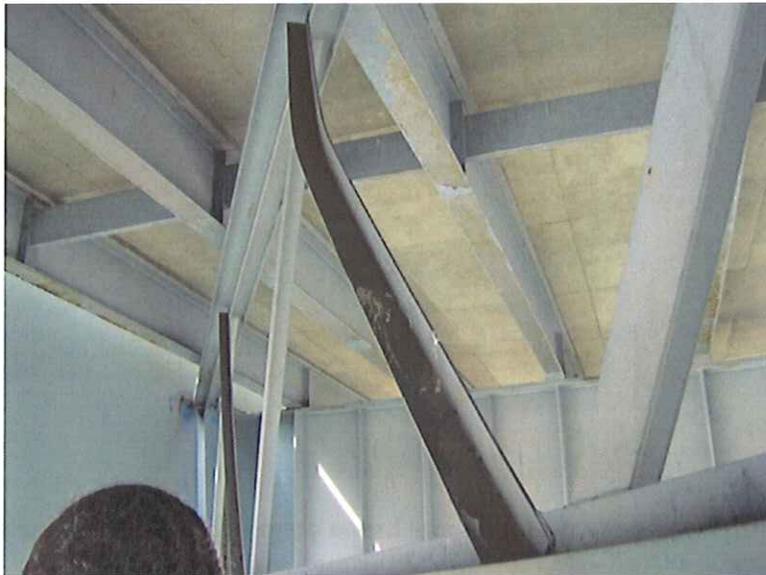
The diagonal web members are typically in good condition, with only a few exhibiting surface or blush rust. One member was found to be significantly bent (Photo 10). It is likely that this condition has existed since the bridge was first erected.

Photo 10: Main span - bent lateral brace web diagonal

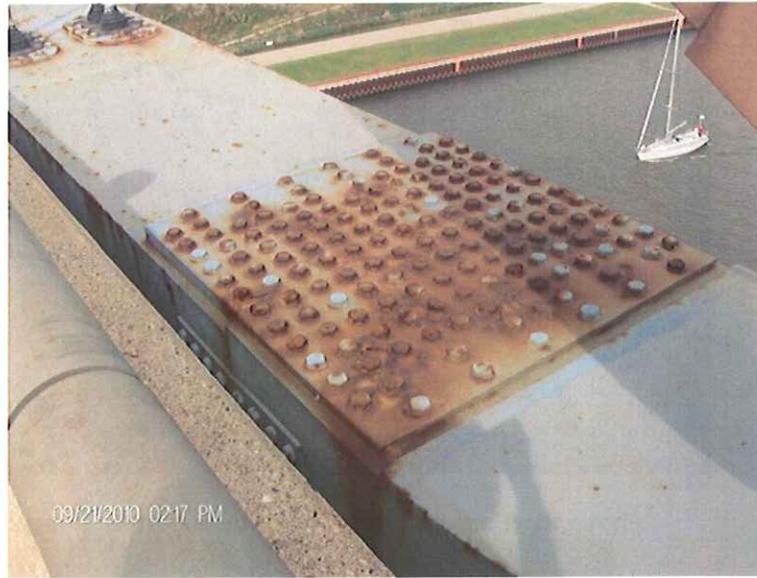
Exterior - On the tie girder's top flange exterior surfaces, freckle rust is prevalent. Local paint failure has lead to corrosion of the top flange field splice plates, bolt heads, and cable covers (Photo 11). Paint had been removed at the top flange electroslag welds for nondestructive testing during previous In-Depth Inspections. Though these were repainted at that time, surface rust has formed causing less than 5% section loss. Conditions on the bottom flange are good with only random areas exhibiting spot rust.

Photo 11: Tie girder - typical top flange corrosion at splice and cable covers

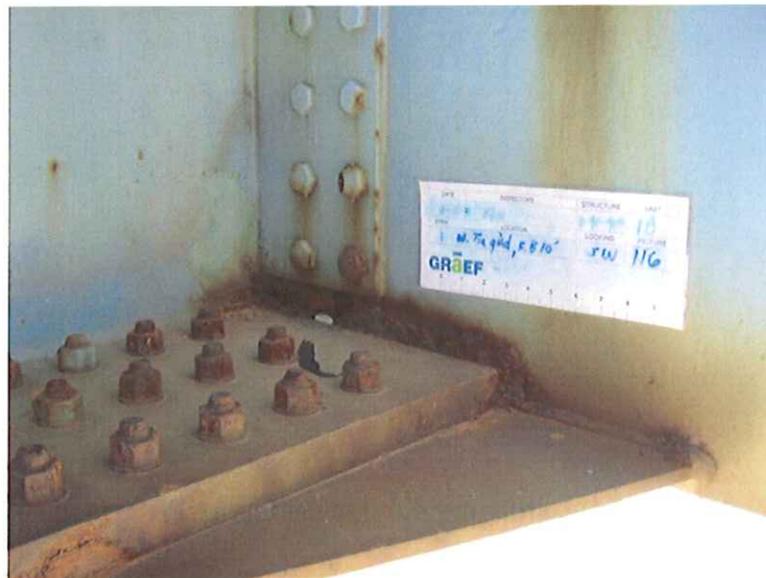
On the tie girder webs, laminate rust and rust pitting exist at about half of the floor beam/lateral brace gusset plates. Specifically, the corrosion occurs in the gap between the tie girder web and end of the floor beam bottom flange has produced less than 5% section loss of the web (Photo 12). The gap is only about an inch wide, and tends to slow the evaporation rate of moisture on these surfaces. The remaining web exterior surfaces exhibit surface rust primarily at the field splices. Freckle rust appears at random locations only. A dent on the east tie girder exists between panel

Photo 12: Tie girder web - typical laminate rust at floor beam bottom flange gusset

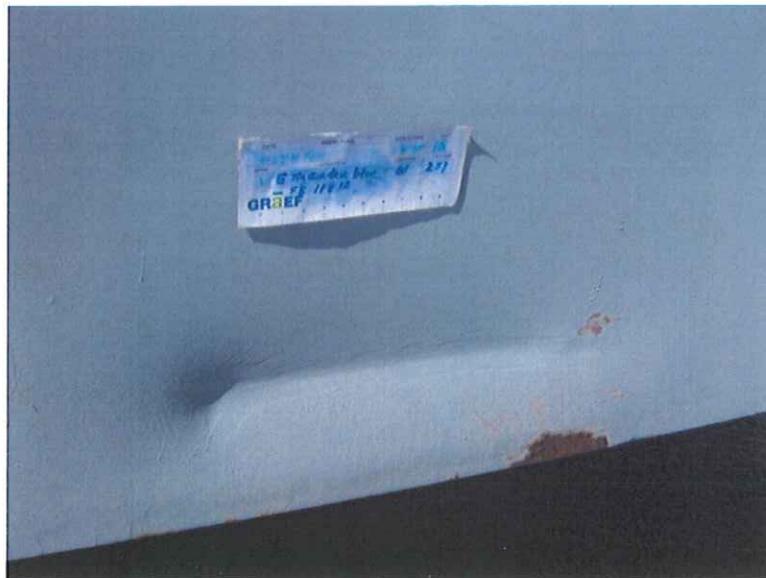
Photo 13: East tie girder - dent near bottom flange

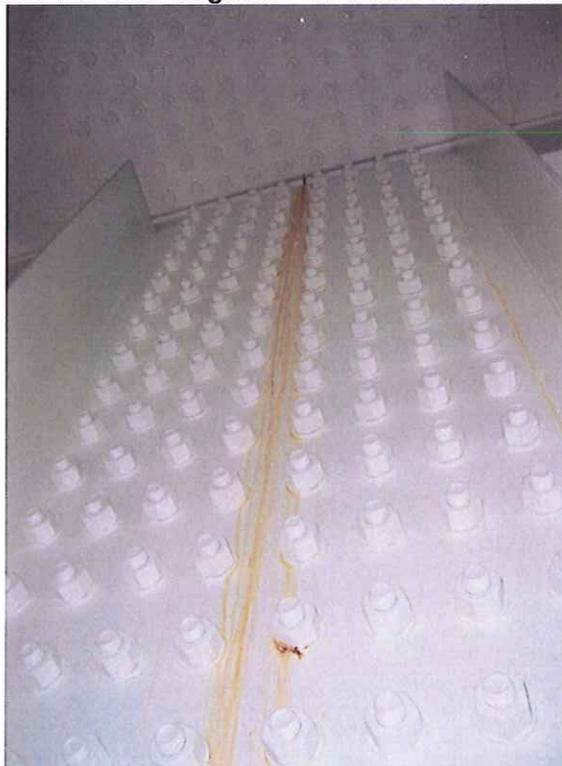
Interior - At the tie girder interiors, approximately 50% of the bolted field splices have gaps allowing water to leak through and causing rust stains to occur inside of the box sections (Photo 14). Water enters through the top corners, runs down the web splice plate, and then ponds on the bottom flange or flows down to the bottom flange drain holes. At a few field splice locations, corrosion has advanced such that the paint system has failed, resulting in scaling and laminate rust at the tie girder's bottom corners (Photo 15). This corrosion has caused less than 5% section loss to the tie girder. Fabrication or construction related irregularities noted in previous In-Depth Inspection reports, such as bent longitudinal stiffeners and weld flaws, still exist. No new problems were noted at these bent elements.

Photo 14: Tie girder interior- typical rust stains at field splice the

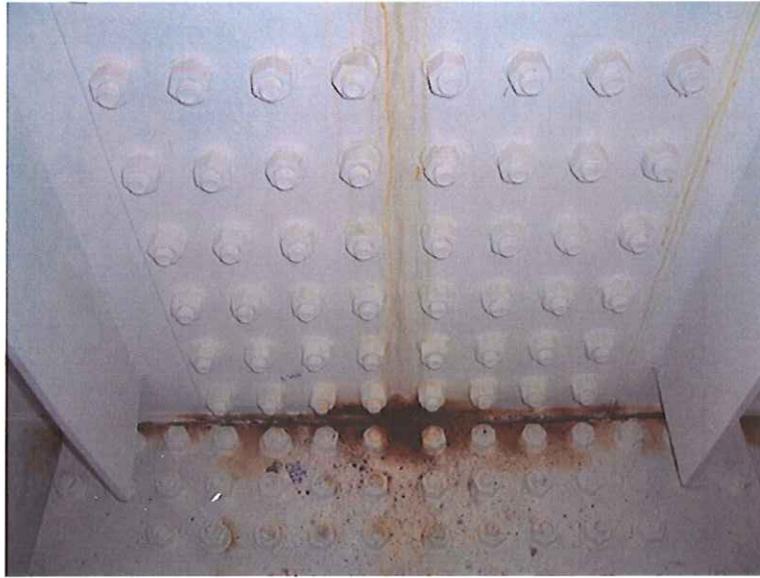
Photo 15: Tie girder splice - heavy corrosion at bottom flange corner

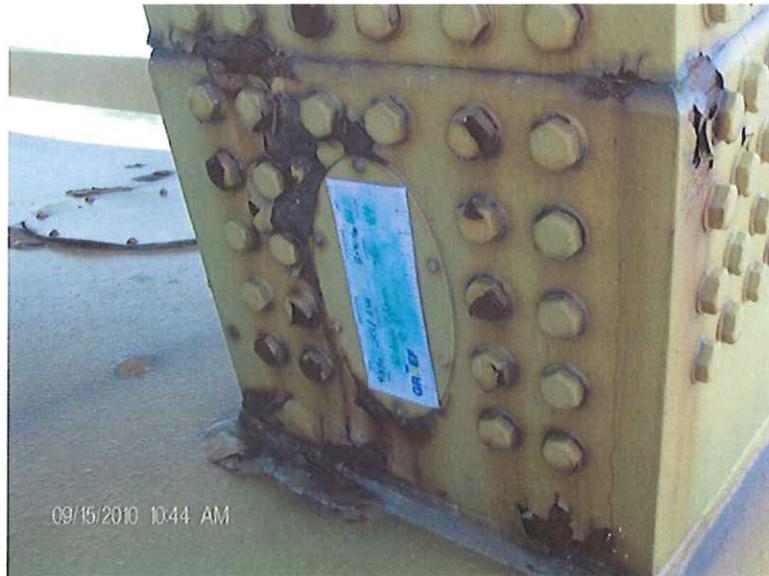
Exterior – Corrosion has formed at localized areas of the arches. Paint system failure and surface rust occur at the base of about half the columns above the lower arches, predominantly on the east arch (Photo 16). This same condition exists at many of the lower arch field splices and access hatches (Photo 17). Less than 5% section loss has occurred at these columns.

Photo 16: Lower arch column base - surface rust (note pack rust at access hatch in background)

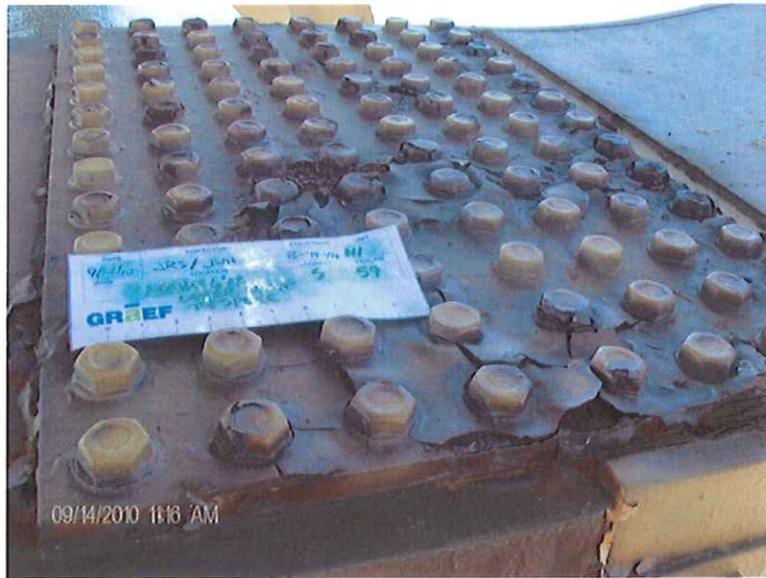
Photo 17: Lower arch - typical field splice paint failure and surface rust

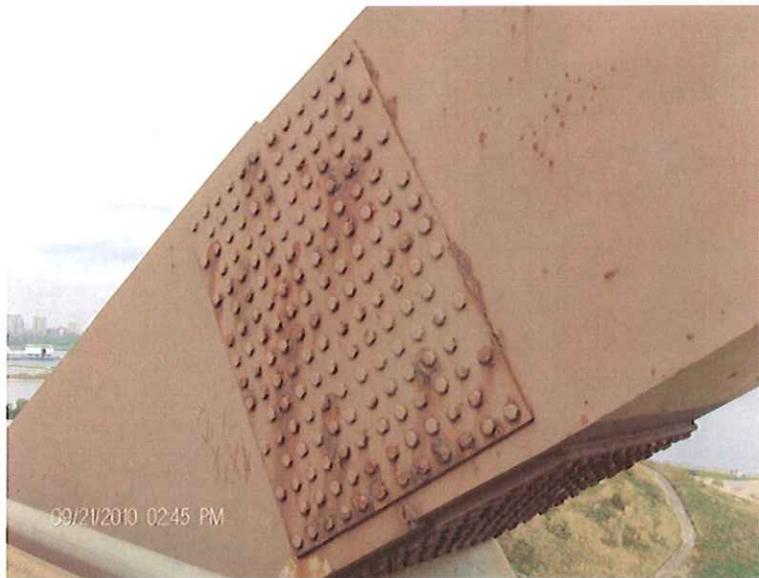
On the upper arch, corrosion is less severe. Surface rust is present on the field splice plates and bolts located just above the tie girders, causing less than 5%

section loss to the arch (Photo 18). Small areas of freckle rust exist on the cable covers

Photo 18: Upper arch - typical surface rust at field splice above tie girder

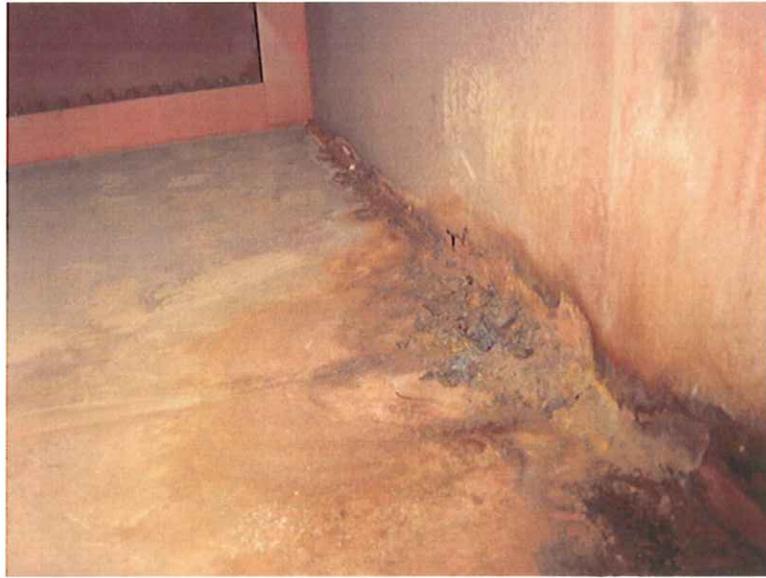
Photo 19: Lower arch interior - local laminate rust at the arch/strut fillet due to leaking hatch above

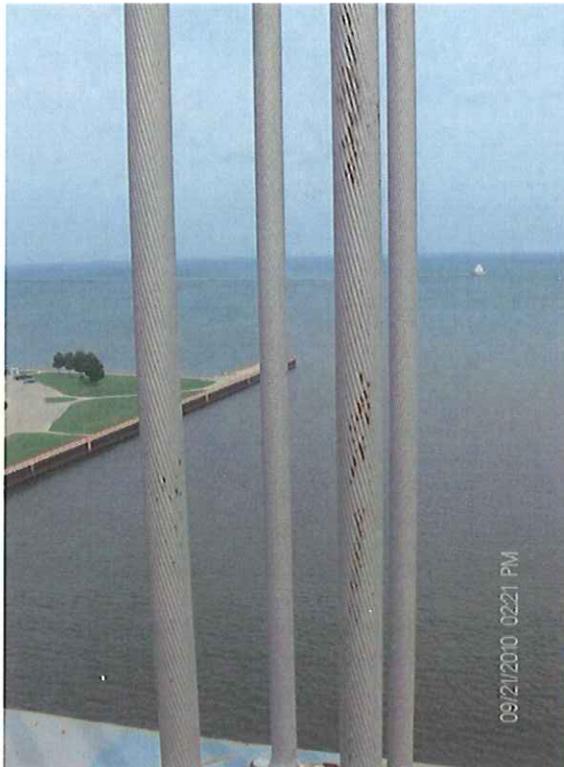
There are random local areas of surface rust along the length of the cables exposed to the elements (Photo 21). Approximately 5% to 10% of the surface area is rusted, resulting in less than 5% section loss. Inside of the tie girders, rust staining is present on about 20% to 30% of the cable end fittings. On about two cables, one broken wire was found near the lower anchorage due to corrosion. The broken wire accounts for less than 5% section loss of the cable element. Pack rust was found between the shim plates at approximately 10% of the cable end fittings/anchorage castings (Photo 22). Varying degrees of surface rust were noted at most of the cable covers inside of the tie girders (Photo 23).

Photo 21: Hanger cables - spot rust and typical condition

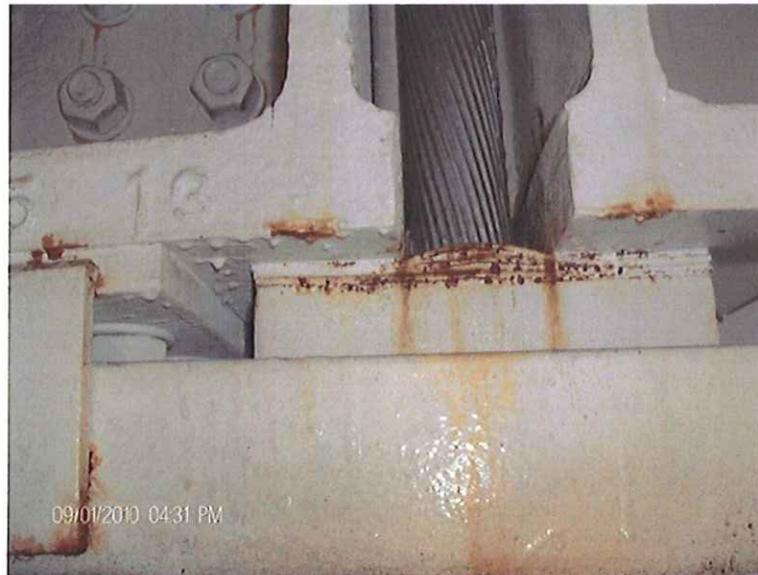
Photo 22: Hanger cable anchorage - pack rust between shim plates

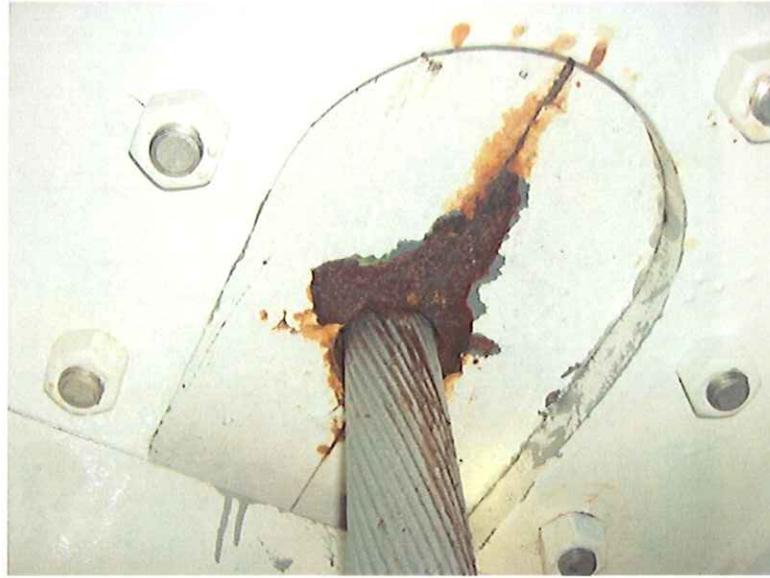
Photo 23: Leaking tie girder cable cover - corrosion causing rust stains on hanger cable (typical condition)

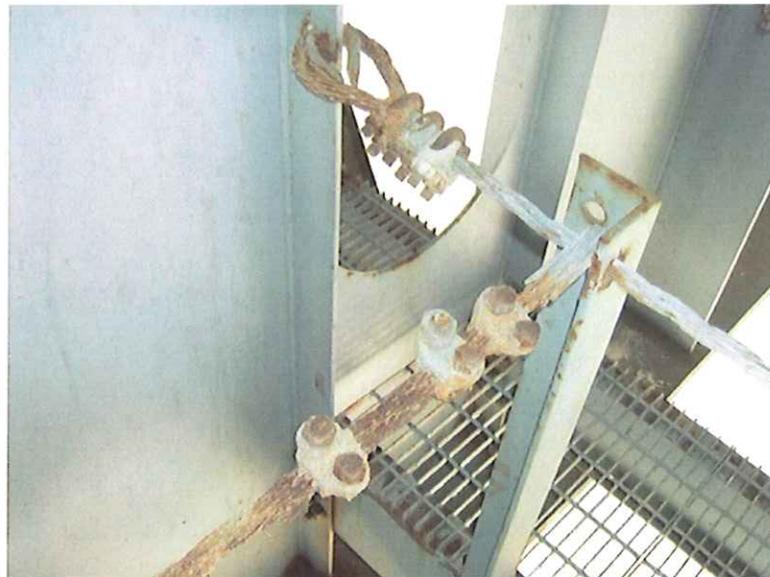
The main span catwalks deflect an excessive amount laterally when used. This occurs at both the main catwalk located under the roadway median, and at the secondary catwalks leading to the tie girder access hatches. This is a potential safety issue such that a worker may be thrown off balance should the catwalks resonate. Laminate rust exists near the end anchorage points of the catwalk cable guardrails (Photo 24).

Photo 24: Catwalk guardrail - laminate rust at anchorages

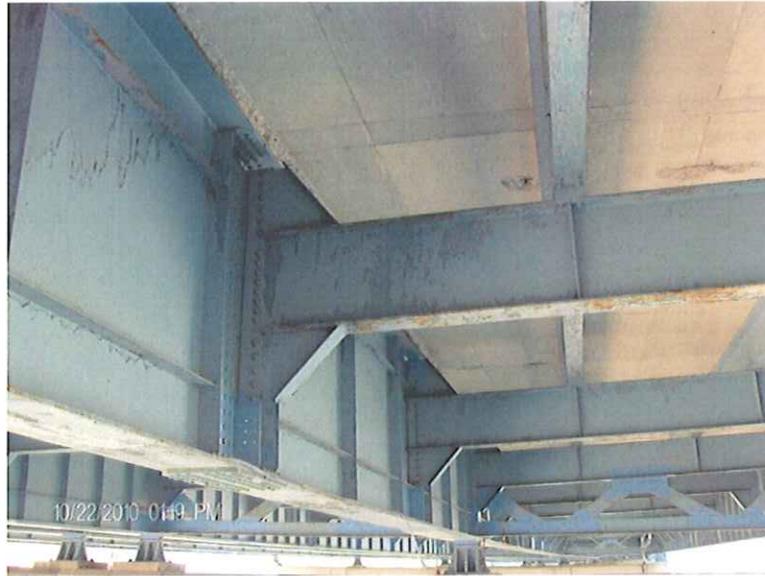
In general the top coat of paint is peeling, and blush rust is common in random areas (Photo 25). The prime and middle coats of the paint system are typically intact, although local failures and scaling rust are present in random locations. This scaling rust has resulted in less than 5% section loss, and is normally located below or adjacent to leaking cracks, spalls or delaminations in the deck. Local paint failure with surface or scaling rust was also observed at locations of previous steel retrofits (mousehole drilling, grinding, magnetic particle testing, etc). These locations were field painted at the time the repairs were made, but the paint in these locations is generally in poor condition (Photo 26). Section loss is less than 5% of the element area.

Photo 25: Peeling Paint on girder webs and flanges.

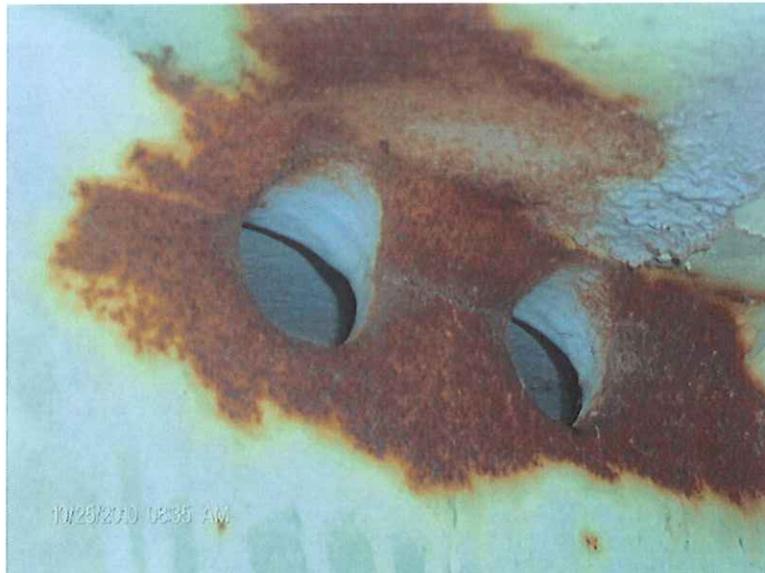
**Photo 26: Failed paint at previous girder repair
(mouseholes at top of web)**

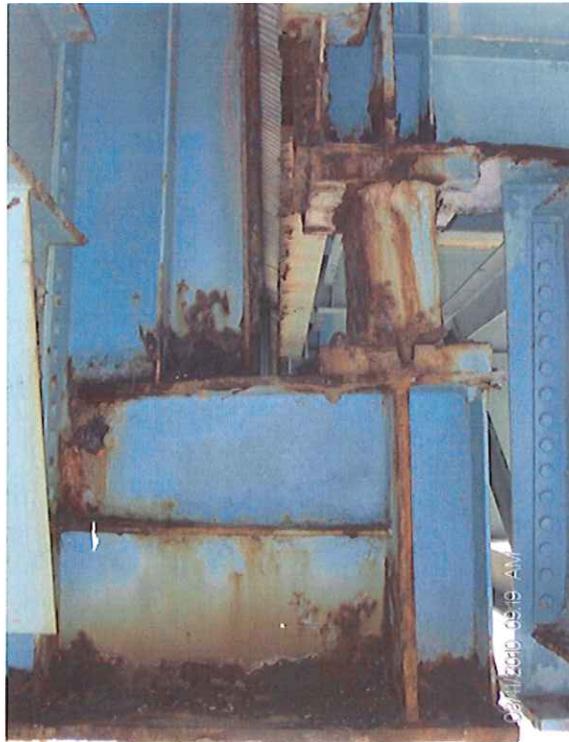
Scaling and laminate rust is typical at the girder shiplaps below the finger plate joints (Photo 27). Section loss was measureable, approaching 50% in localized areas of some stiffeners. In general, it is estimated that 1/16" of section loss has occurred on all surfaces of the shiplaps. A structural analysis of the ship laps,

accounting for the section loss, is warranted to determine the remaining load capacity. Other elements near the shiplap and finger plate joints have scaling rust and laminate rust as well. This corrosion is present on the transfer beams, end diaphragms, bearings and cross frames. Section loss to individual elements of the members is estimated to be 15% to 20%. The presence of scaling rust and laminate rust made visual crack detection very difficult in these areas.

Photo 27: Laminated rust (typical) at girder in shiplap.

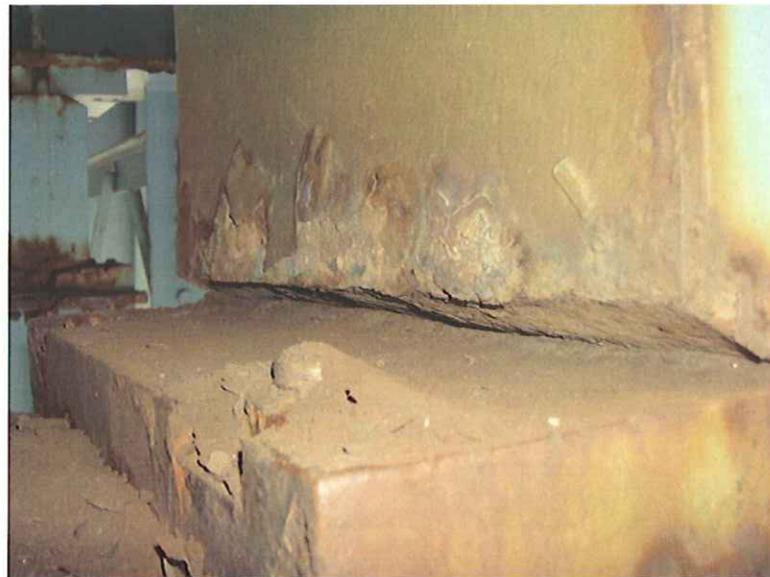
At the shiplap joints the curved surfaces of many of the rocker bearings had rust pits, resulting in higher than designed bearing stresses and pockets for moisture and debris to accumulate (Photo 28). Maximum rust pit depths is estimated to be 1/8". A few rockers appeared excessively tilted for the measured temperature. In general, however, most of the rockers were observed to be moving as designed and were tilted within an acceptable range.

Photo 28: Corrosion and pitting on rocker bearing in shiplap.

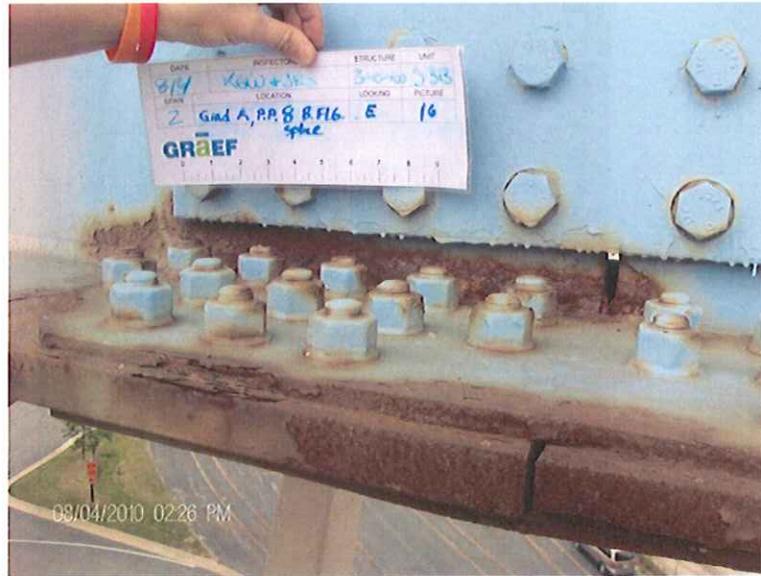
About 50% of the fascia girder bolted field splices are experiencing scaling rust and laminate rust on the bottom flange, on the bottom flange inside splice plate, and at the base of the web (Photo 29). Local rust pitting up to 1/4" deep was observed in some locations. Section loss to the bottom flange is less than 5%. On some of the corroded field splices, pack rust is bending the bottom flange splice plates, causing unintended prying forces on the splice bolts (Photo 30). Missing splice bolts were noted in a few locations, but slip between the plates was not observed.

Photo 29: Corrosion at fascia girder field splice at bottom flange and base of web.

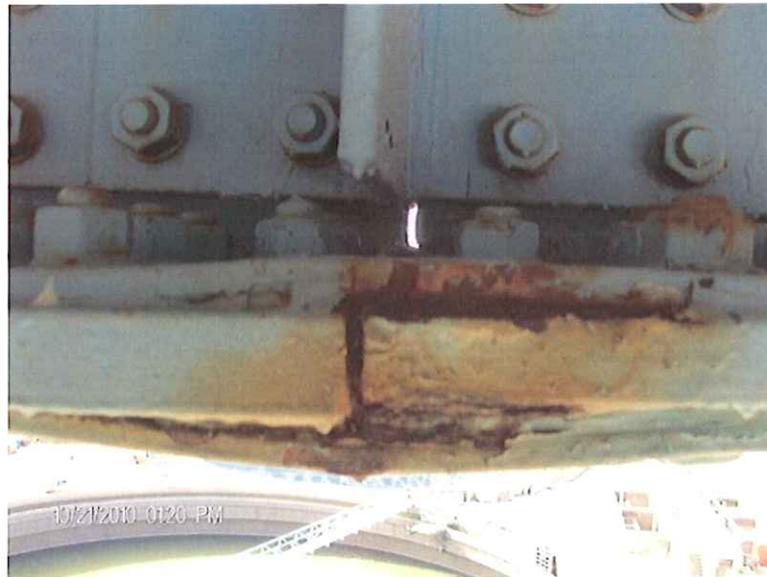
Photo 30: Pack rust at fascia girder bottom flange field splice

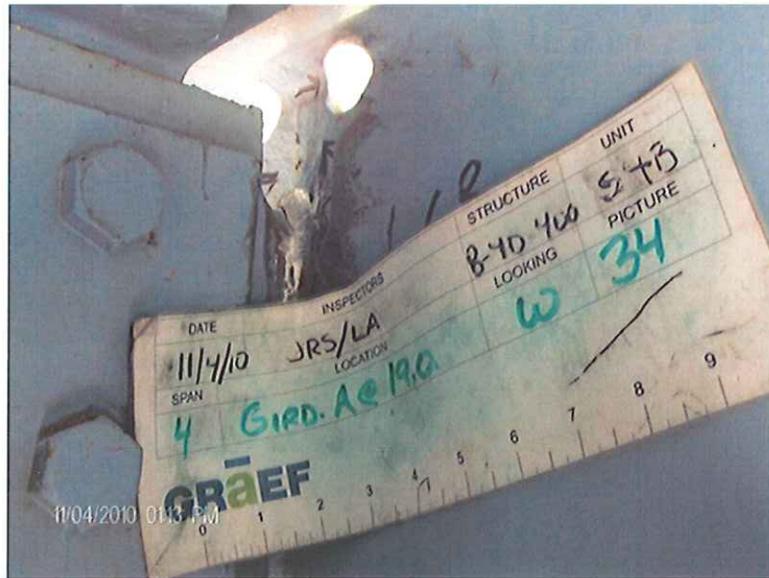
Some fatigue cracks were observed on the girders, and confirmed with NDT (grinding and magnetic particle, Photo 31). The cracks typically appear to be the result of distortion induced fatigue. Girder web out-of-plane bending is occurring at floor beam connection plates as the floor beam ends rotate under live loads. Some of these cracks were ground out and removed during the NDT, but others were too deep for complete removal. All confirmed steel cracks on the bridge were located within the plate girder/floor beam/stringer system approach spans (Units N2-N4 and S2-S4). A separate, detailed NDT report describing the findings is being prepared by a sub-consultant.

Photo 31: Fatigue crack at top of girder connection plate after completed NDT.

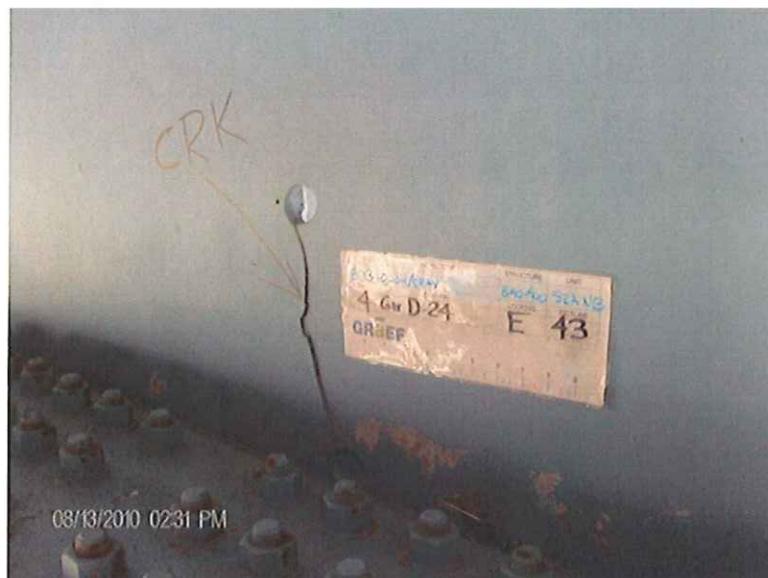
During earlier retrofit work in 2001, mouseholes were drilled through steel elements to arrest cracks and intersecting welds were ground out in regions of tensile stress. In other areas, bolted splice plates were installed to replace steel area lost due to the formation of large cracks (Photo 32). The strengthened areas were inspected to confirm they are performing as intended. No problems were observed at the previously repaired locations other than paint failure and minor corrosion.

Photo 32: Large existing crack through web of girder arrested by mouseholes and bottom flange splice plates.

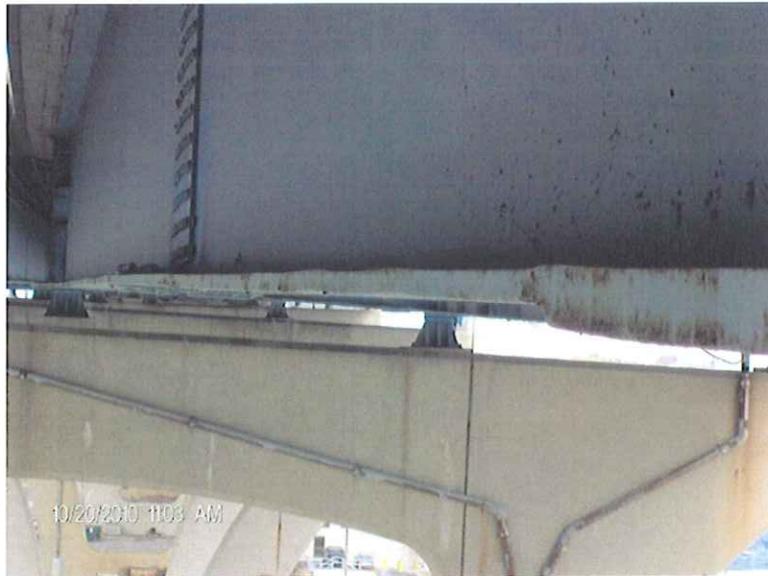
Bent or dented flanges, webs and stiffeners were observed in many locations. These appear to be the result of the original steel erection and have a low probability of developing into significant problems. Wavy bottom flanges were observed near the piers (Photo 33), but symmetry of the flanges in adjacent girders indicates this was likely a fabrication issue.

Photo 33: Wavy bottom flange of girder near pier.

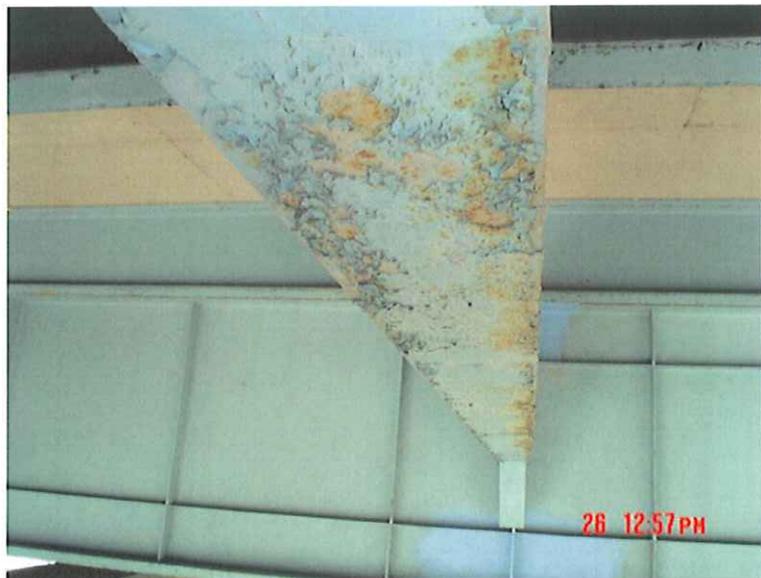
The floor beams are hot-rolled steel W sections and are typically in good to fair condition. Blush rust is common on the bottom flanges (Photo 34). The paint system is generally intact, although local areas of failure and scaling rust are present in random locations. These areas are typically located below or adjacent to leaking cracks, spalls and delaminations in the deck. The resulting section loss is estimated to be less than 5% of the element area.

Photo 34: Blush rust on underside of floor beam bottom flange (typical).

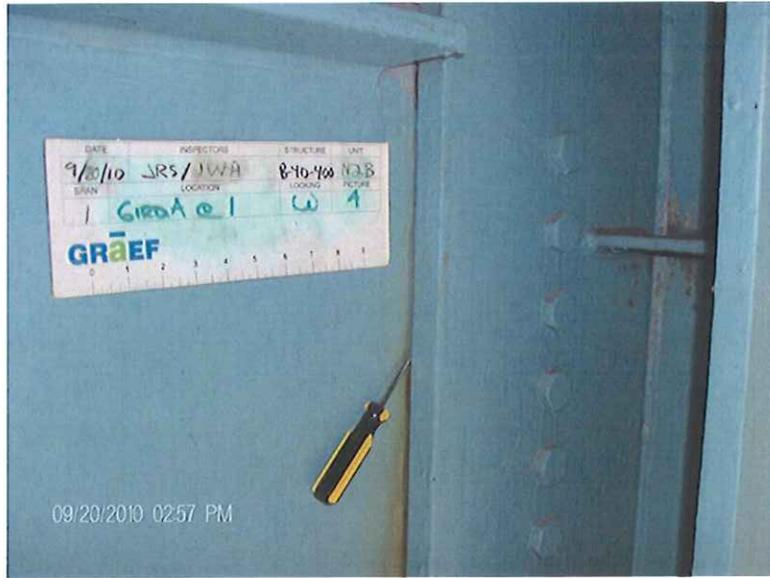
The floor beams are bolted to the girder connection plates. In some locations a small gap between the floor beam web and the connection plate was observed, suggesting that the bolts were not tightened properly during construction or fabrication tolerances were not maintained (Photo 35). In all cases, however, the connection appeared to be performing adequately. Rust caused by the fretting of the metal surfaces was also observed at random locations between the connection plate and floor beam web, indicating relative plate movement (Photo 36).

Photo 35: Gap between floor beam and girder connection plate.

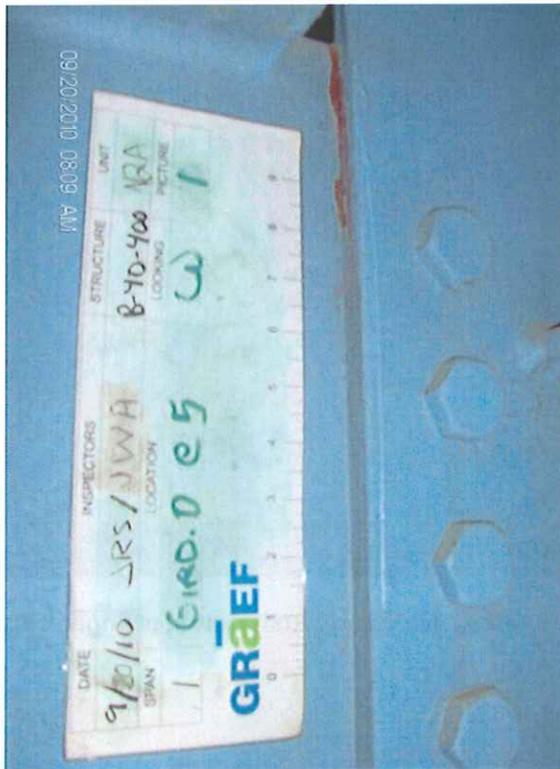
Photo 36: Fretting rust between floor beam and girder connection plate.

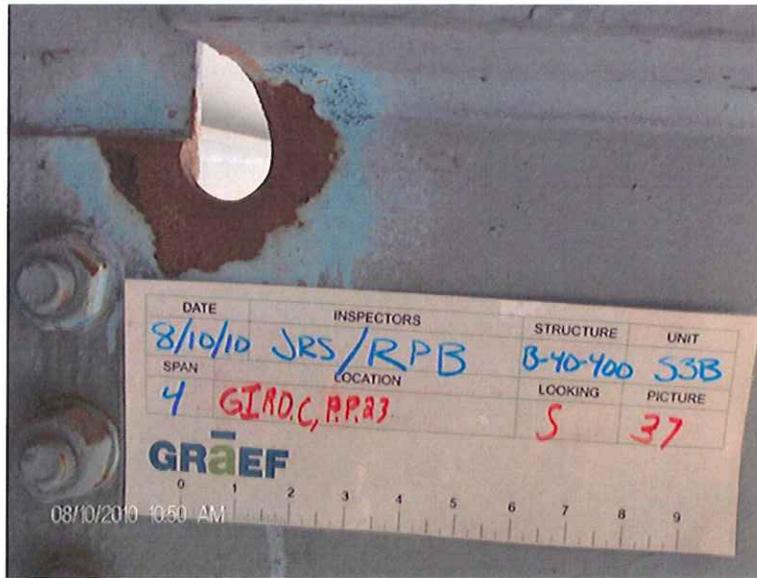
In some locations the floor beam top flange was coped at the connection plate to allow for easier steel erection. Prior to the repairs in this area, cracks were observed at some of these copes, and the cracks were subsequently ground out (Photo 37). No issues were noted at any of the copes, including those which have been previously repaired.

Photo 37: Ground out area at floor beam top flange cope.

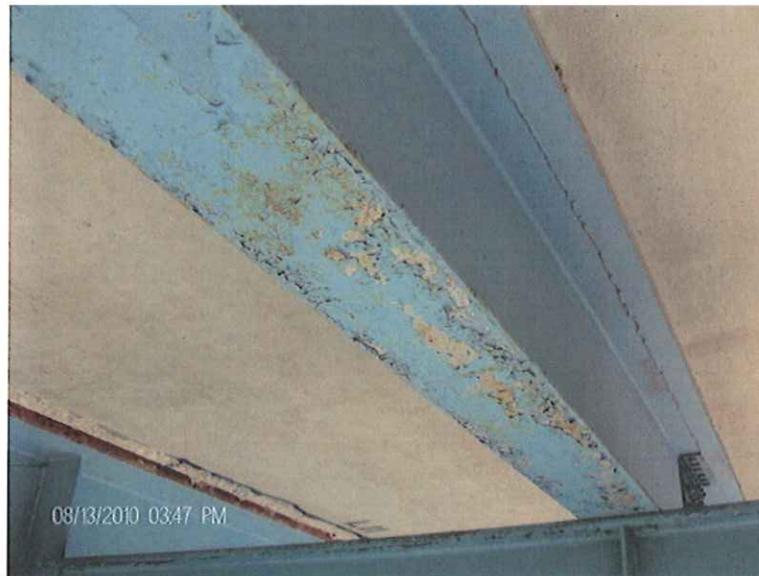
The stringers are generally in good condition. Random blush rust is common on the bottom flanges (Photo 38). Local areas of scaling rust or laminate rust exist

Photo 38: Peeling paint and blush rust at stringer bottom flange (typical).

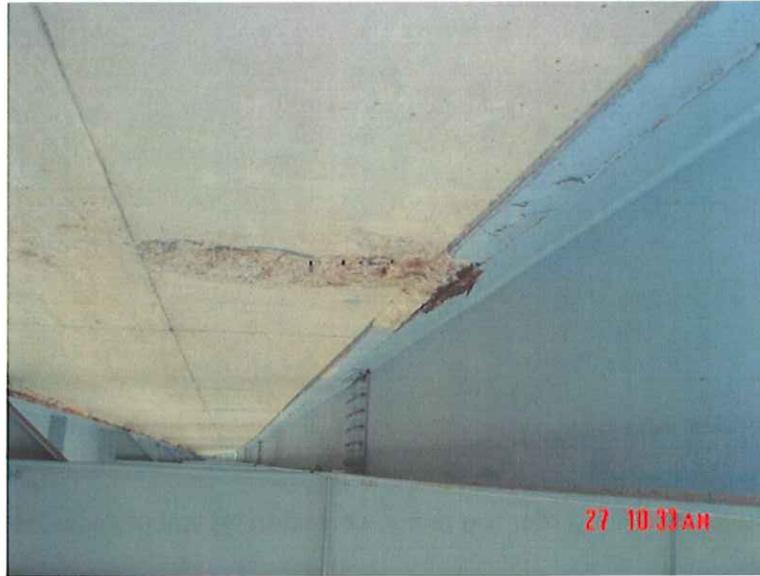
where the paint system has failed (Photo 39). These areas are typically located on the top flange, below or adjacent to leaking cracks, spalls and delaminations in the deck. The corrosion is generally limited to lengths of one to two feet, and accounts for less than 5% section loss of the flange element. No problems were noted at the bolted field splices.

Photo 39: Local laminate rust on stringer top flange at deck spill.

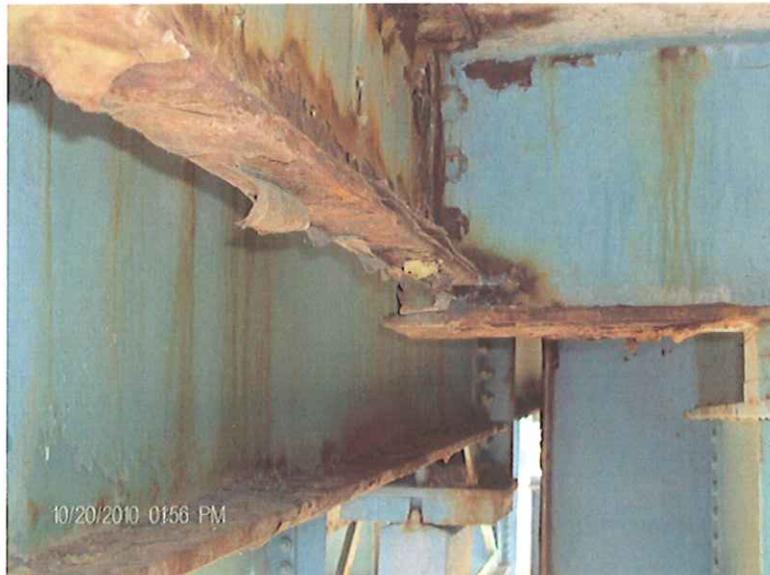
Photo 40: Laminate rust at end of stringer and end diaphragm in shiplap below finger plate joint.

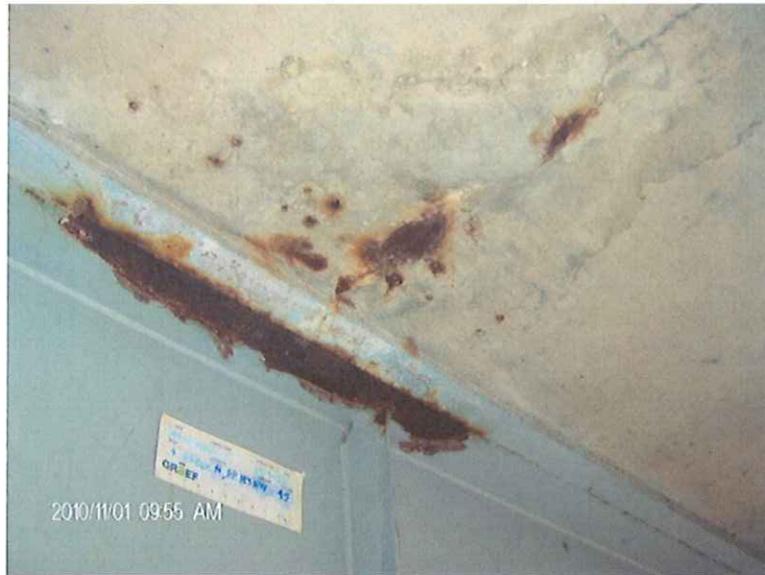
Photo 41: Multigirder top flange corrosion typical at deck delaminations

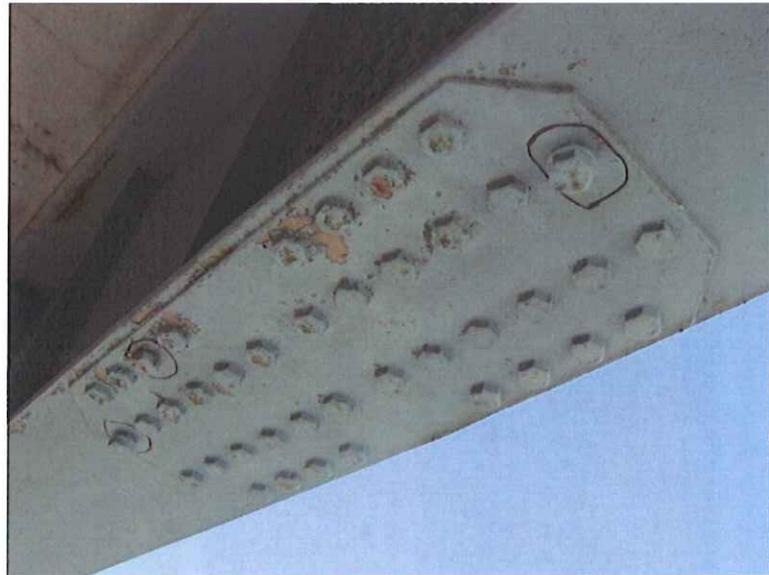
Photo 42: Three loose bolts on bottom flange splice plate
