HOAN BRIDGE IN-DEPTH INSPECTION PRELIMINARY SUMMARY REPORT

**Structure B-40-400
Units 1A/1B through S24**

Wisconsin DOT Project ID 1300-00-05

January 14, 2011

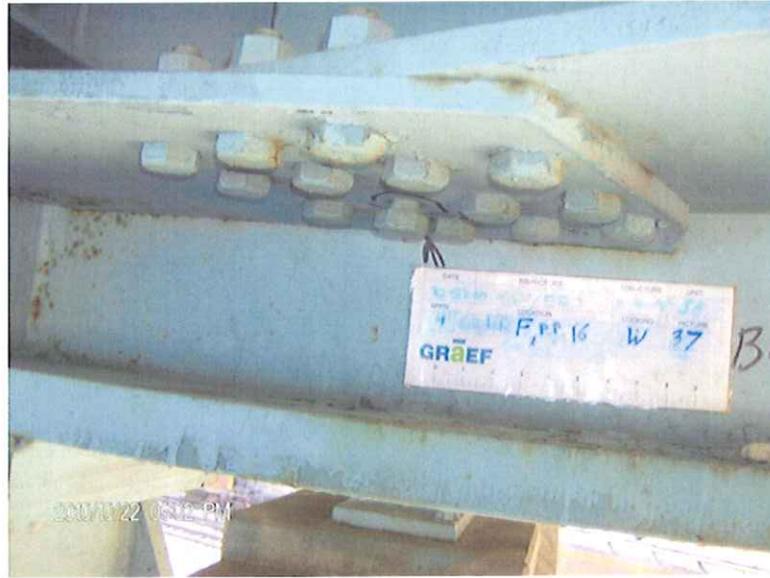
Photo 43: Loose bolt on lower lateral brace gusset plate

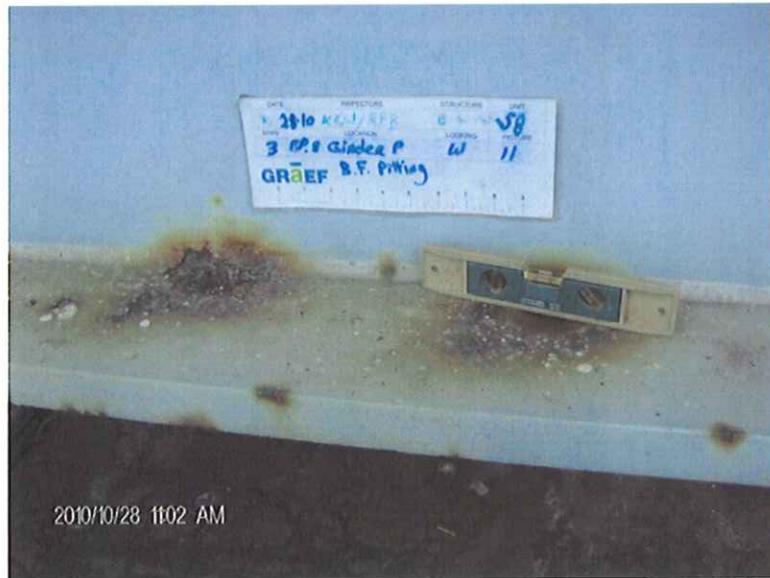
Photo 44: Fascia girder in multigirder approach spans – bottom flange pit due to corrosion

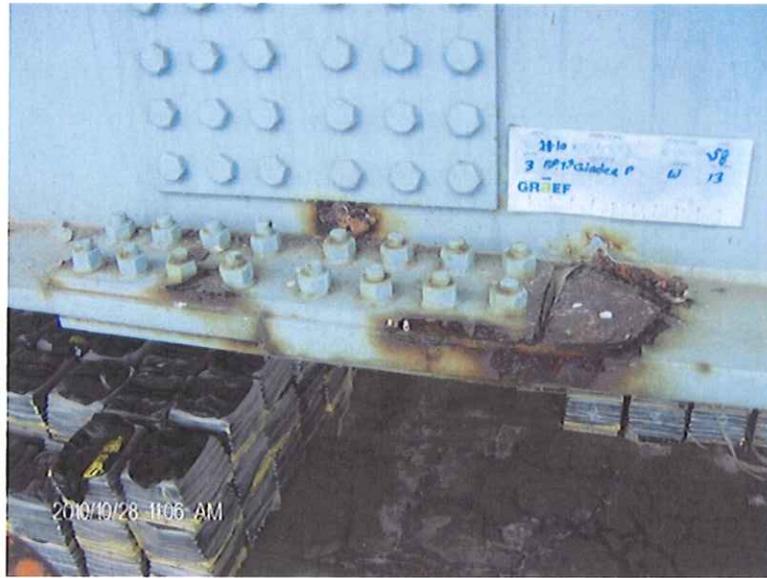
Photo 45: Multigirder fascia - laminate rust at bottom flange splice plates

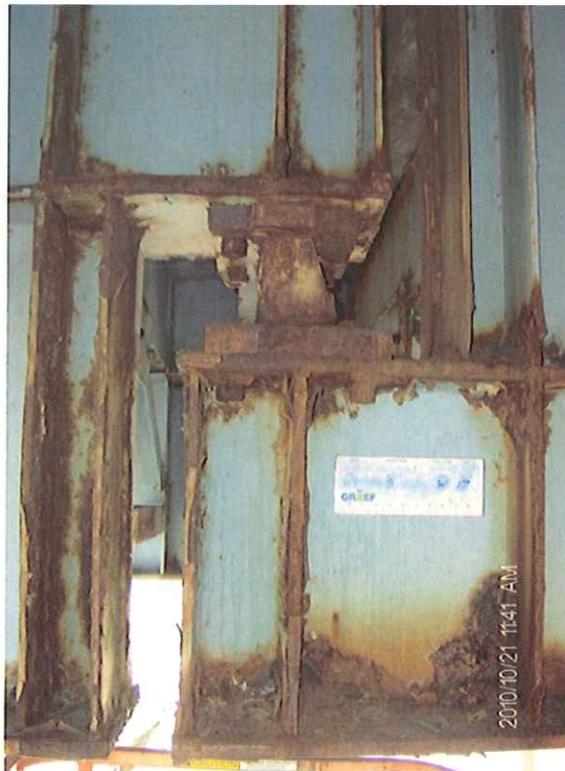
Photo 46: Typical rust at multigirder unit shiplap

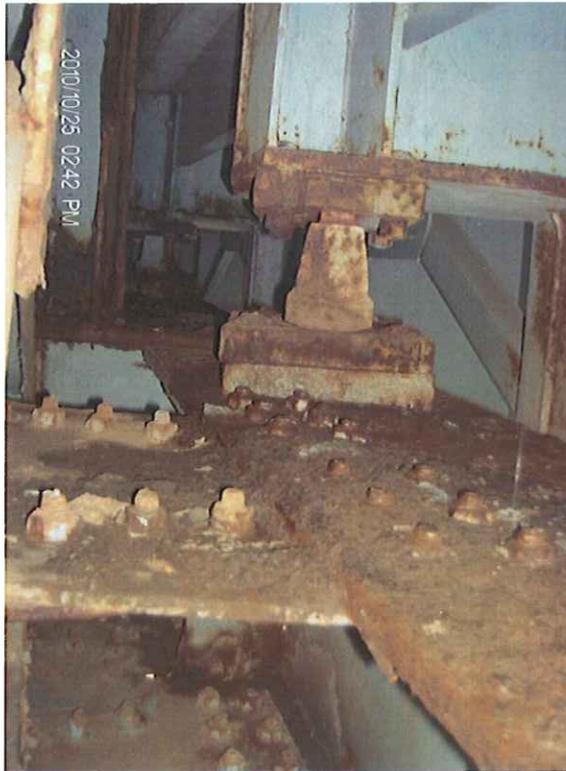
Photo 47: Heavy surface rust at shiplap transfer girder top flange

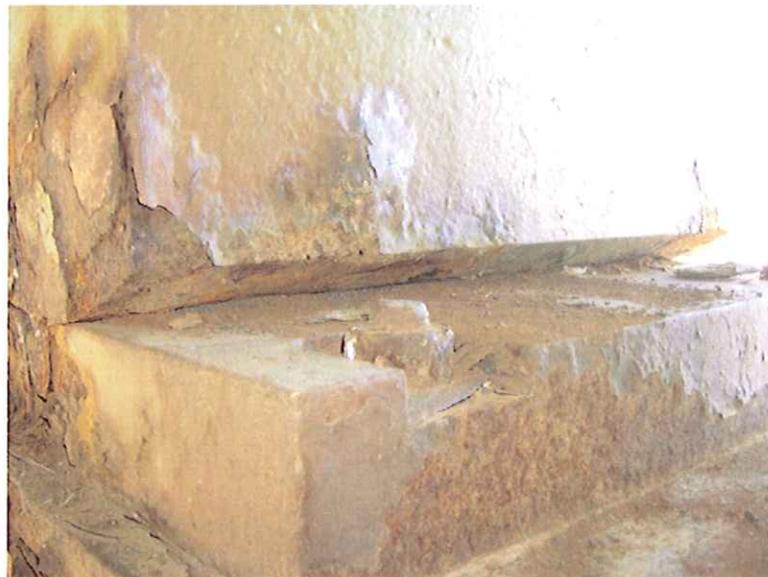
Photo 48: Multigirder unit rocker bearing with pitting on curved bearing surface

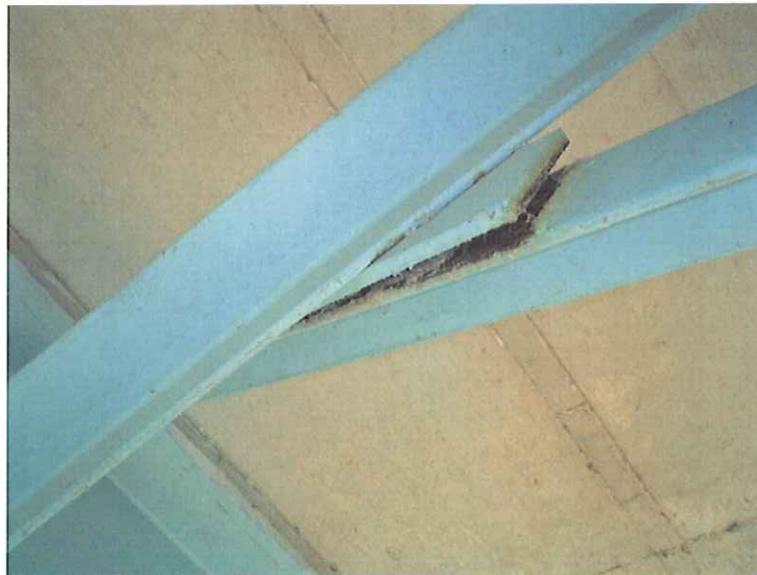
Photo 50: Cross-frame broken weld at diagonal spacer plate to angle

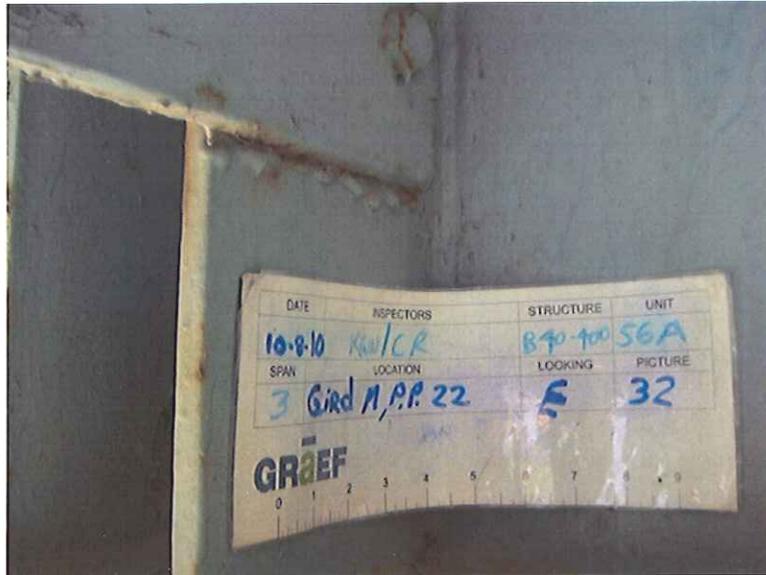
Photo 51: Incomplete fusion at cross-frame bottom chord to connection plate

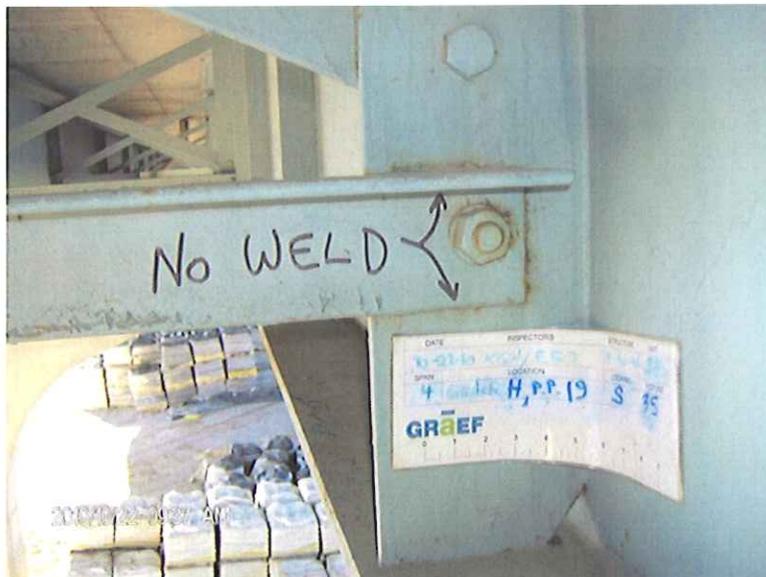
Photo 52: Missing weld at cross-frame bottom chord to connection plate

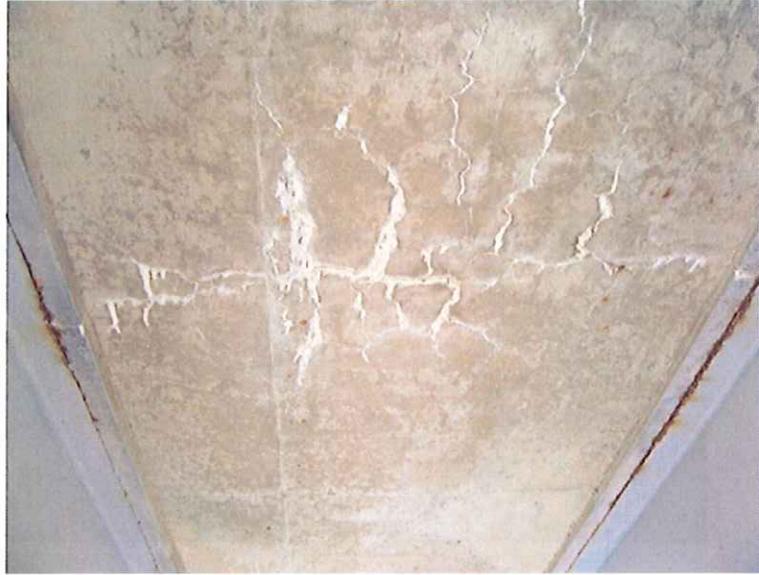
Photo 53: Deck underside - typical cracks with leaching and stringer top flange corrosion

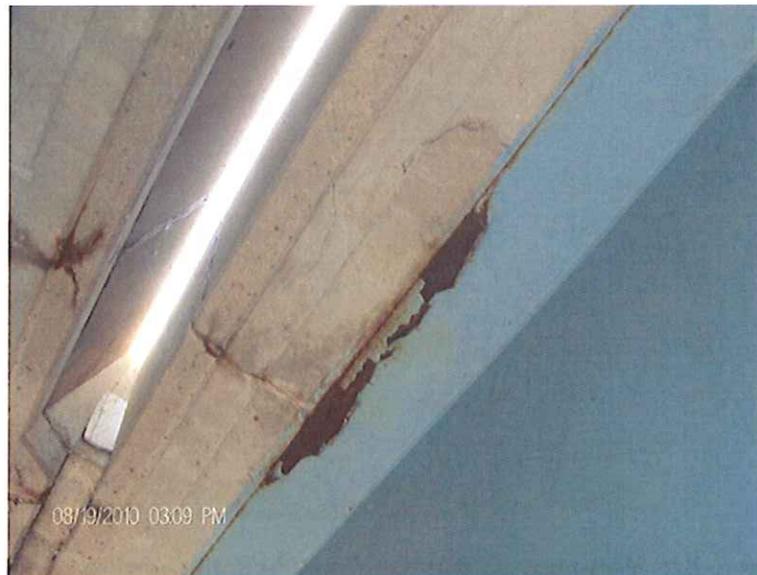
Photo 54: Deck underside – typical overhang delaminations with corrosion at girder top flange

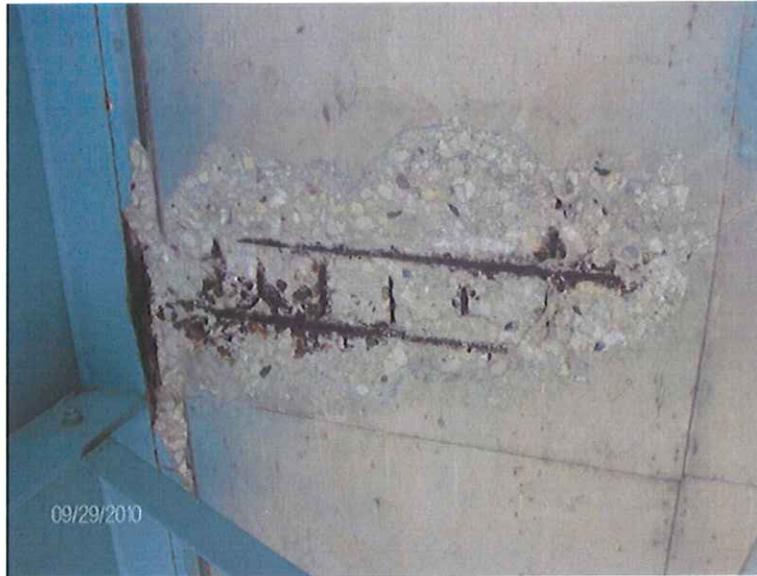
Photo 55: Deck underside - spall with 2 layers of bottom mat reinforcing steel exposed

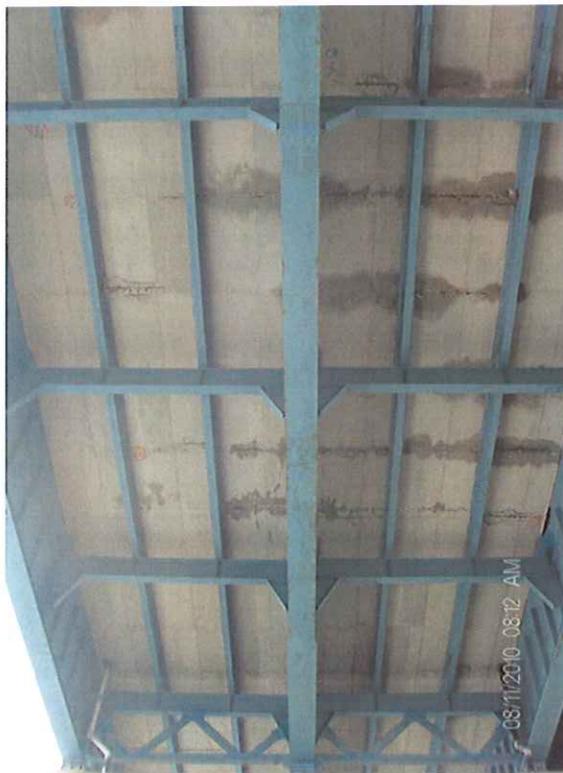
Photo 56: Deck underside - typical condition with delaminations and spalls

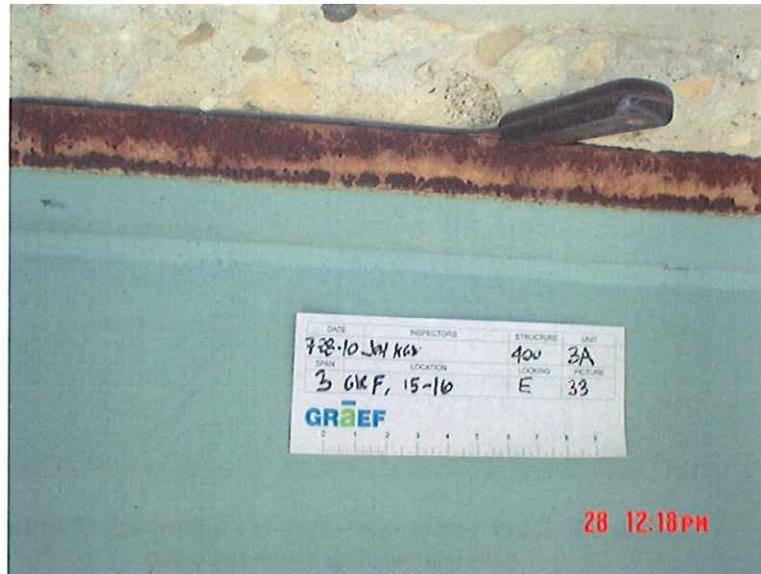
Photo 57: Deck underside - typical deck gap at girder

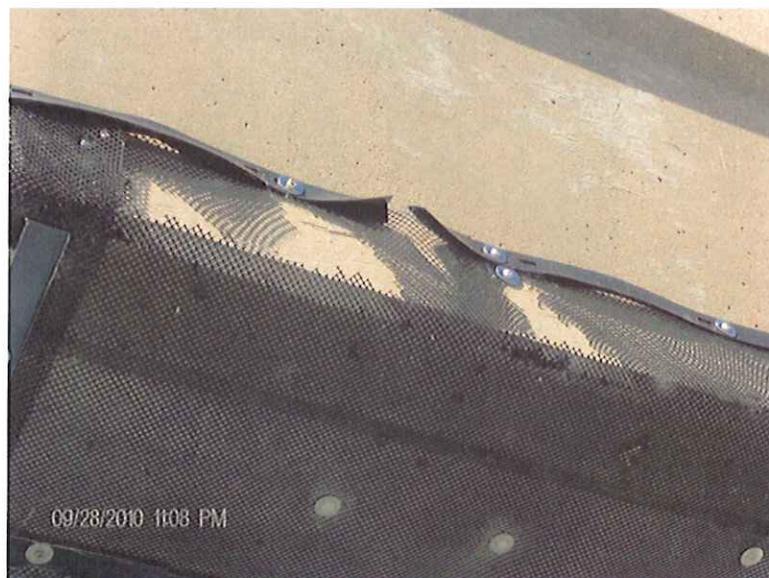
Photo 58: Deck underside - deteriorated netting over Maier Festival grounds

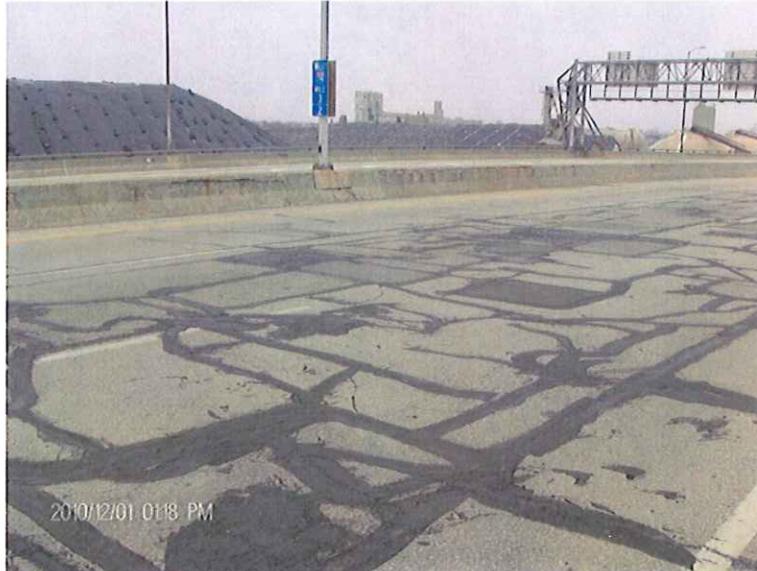
Photo 59: Deck top side - heavy asphalt overlay repair on south end, northbound units

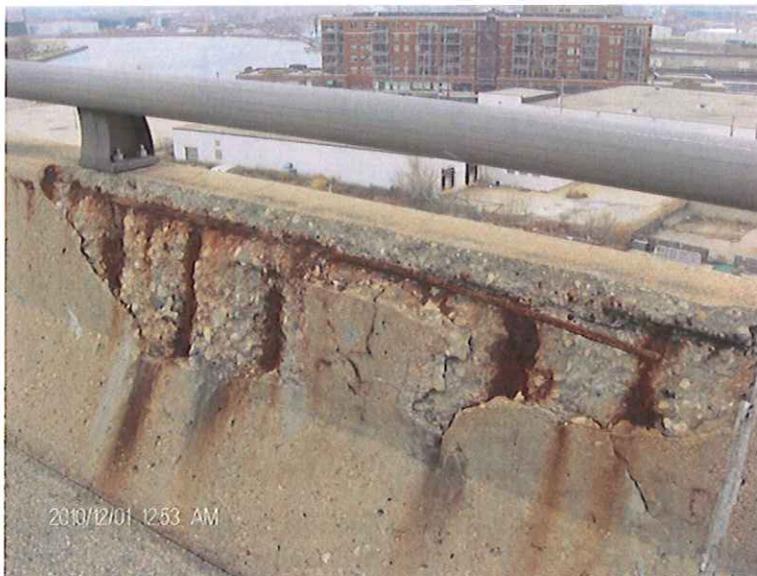
Photo 60: Parapet – typical spall with exposed reinforcing steel on the front face

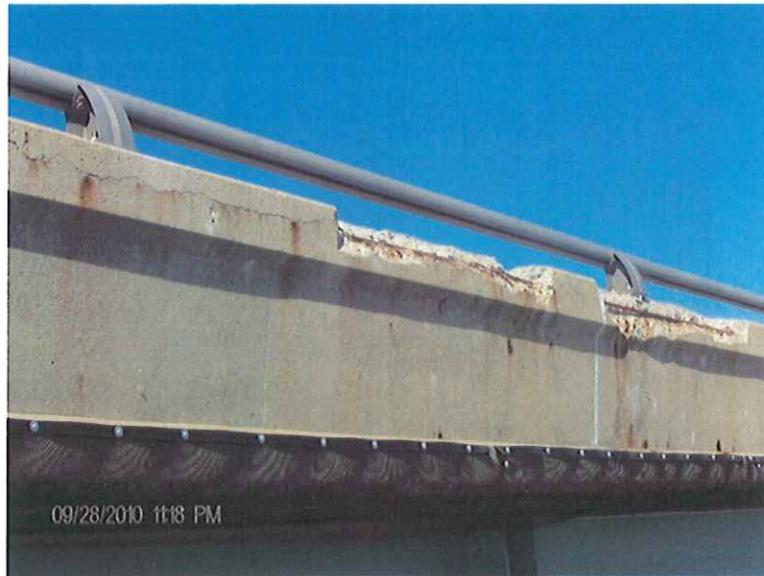
Photo 61: Parapet - spalls with exposed reinforcing steel on the exterior face

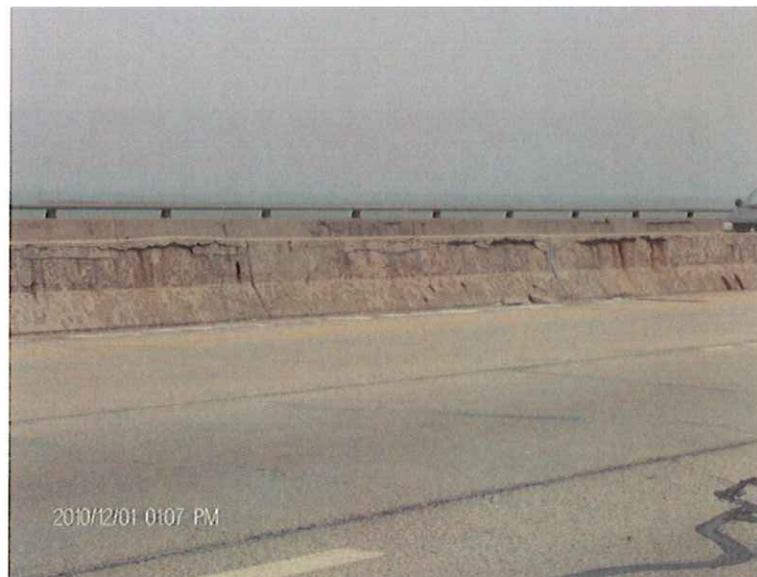
Photo 62: Parapet - typical horizontal cracks and delaminations on the median parapet

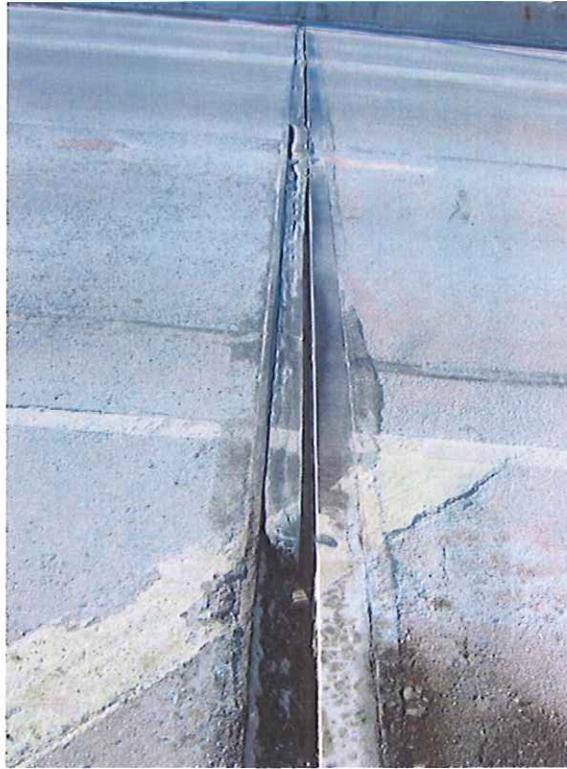
Photo 63: Sliding plate joint - poured sealant failure (typical)

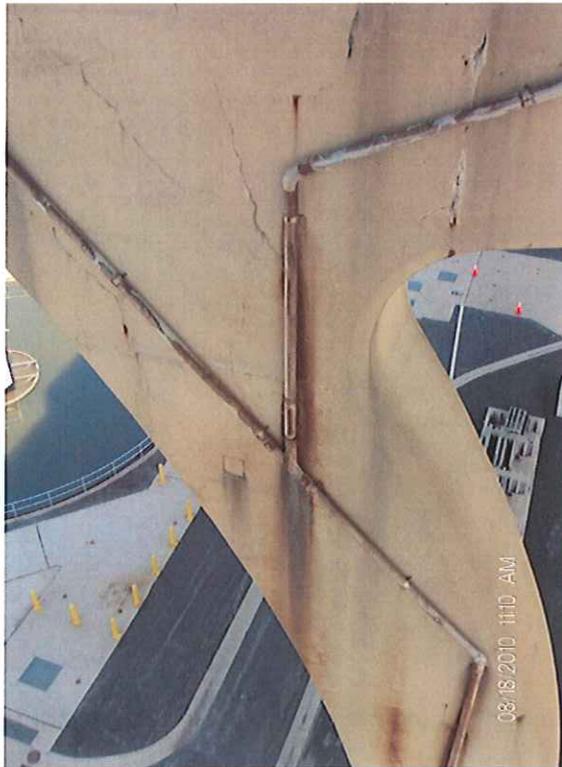
Photo 65: Pier 2S - cracks and leaking downspouts

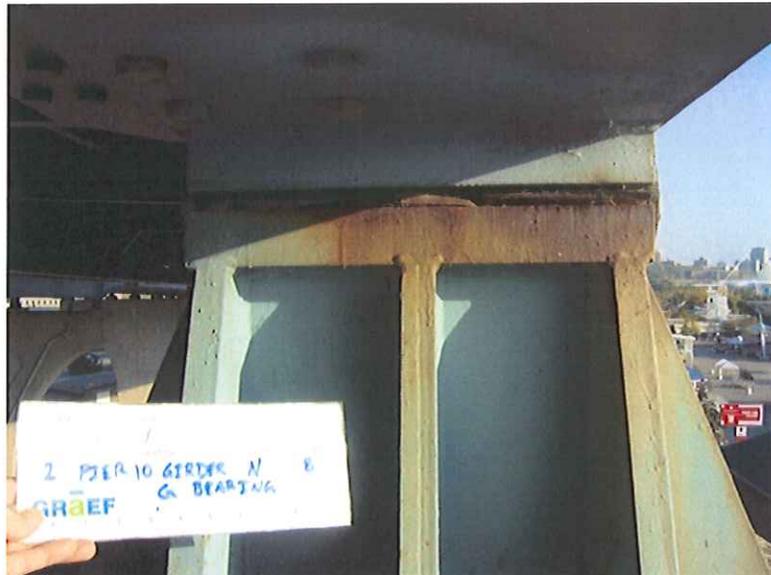
Photo 68: Laminate rust on fixed bearing pin
