Pulaski Indoor Family Center Building Assessment

July 7, 2010

Pulaski and Noyes Indoor Family Aquatic Center Planning

**Milwaukee County – Pulaski Pool Building
July 7, 2010**

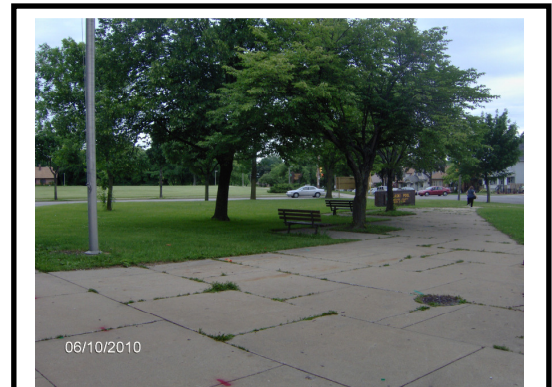
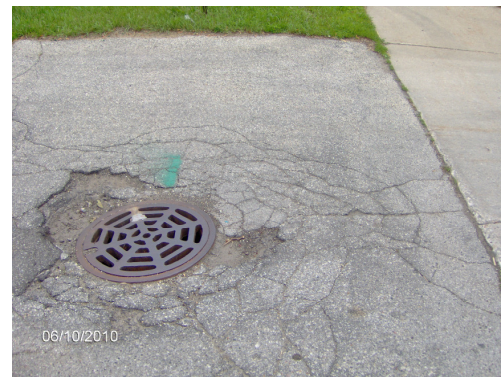
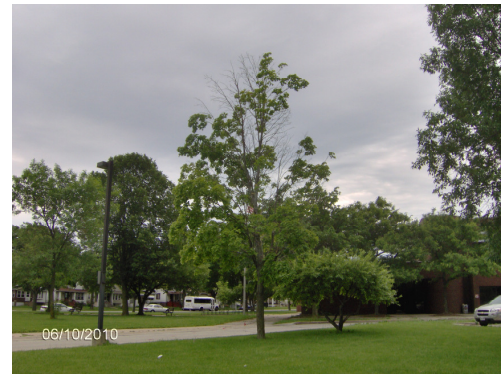
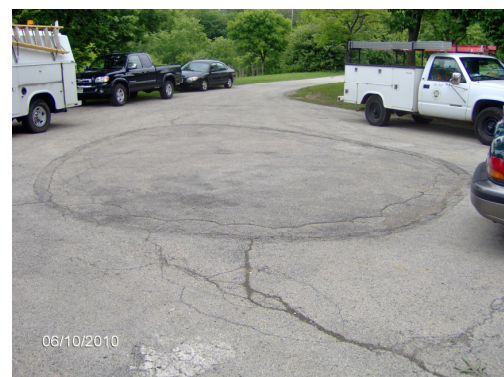
The existing concrete sidewalks at the building entrances are in relatively good condition. The exception to this is the sidewalk along the east side of the building where settlement has occurred in the first slab adjacent to the building, creating a tripping hazard. If this sidewalk will be used as part of the new site plan it is recommended to replace or mudjack this section.

The existing parking lot is located on the north side of the building with a separate entrance and exit drive from and to West Cleveland Avenue. The parking lot pavement is in poor condition and in need of repair or replacement. The pavement has multiple areas of failure with potholes developing around the storm inlets. Additionally there is an area in the loading dock with a circular staining/ cracking pattern that was observed.

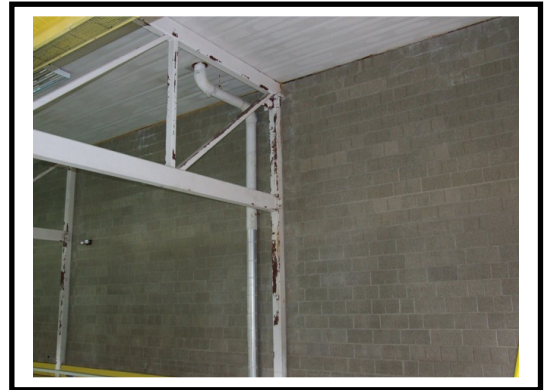
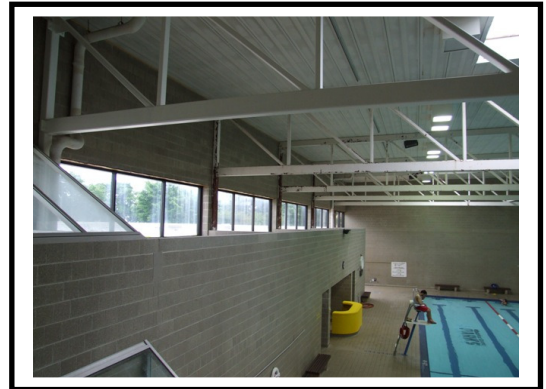
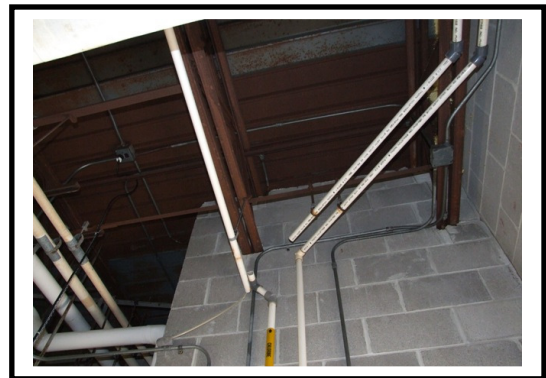
The structural system of the core building over the pool consists of custom steel tube trusses spanning 105 feet over the pool and supported on 6 x6 tube columns. The trusses are 19'-4" on center with 4-1/2 inch deep acoustical deck spanning between them. Approximately 20 -30% of the truss have surface corrosion. The exposed portions of the columns have 50-60% surface corrosion and there are small patches of the bottom plate on the acoustical deck that have surface corrosion.

From the visual inspection performed this corrosion does not appear to be severe enough to have caused any significant loss of material of the sections, however a closer inspection of the top surfaces of the trusses and the structural portion of the metal deck should be performed to determine the condition of these surfaces. A program to prepare, prime and paint these members should be implemented within the next two years to halt the corrosion before it impacts the structural capacity of the roof system.

The joists in this area have light surface rust which has not progressed enough to cause any structural concern. However the surface corrosion on the metal deck has progressed to a point that remedial action is warranted. The surface should be sandblasted clean, primed and painted.

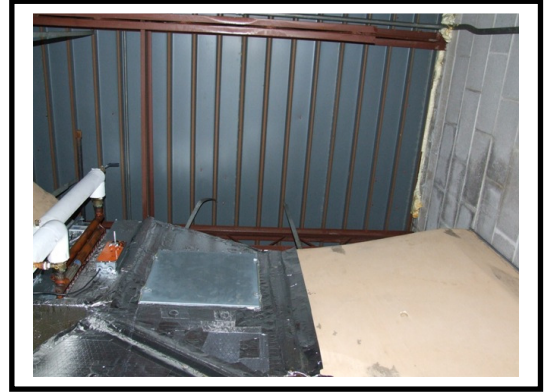
Along the north side of the pool building is a two story steel framed wing with a single story bay at the west end. The upper floor is a mechanical room that houses the heating and ventilation equipment. The roof structure over this portion is comprised of 12 inch open web steel joists spanning east-west in direction with a 1-1/2 inch metal deck. This roof framing is supported on 21-inch deep beams supported on wide flange columns. The joists are in good condition and the deck has a light surface rust on the bottom of the ribs. This condition is mainly cosmetic at this time and should be monitored.

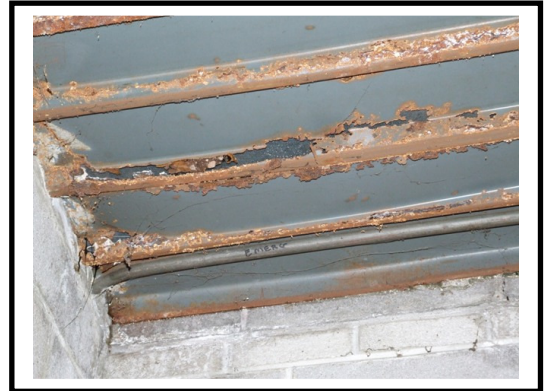
The floor construction under the mechanical room is steel joists at 2'-0" on center spanning east west with a 9/16 inch deck and 2-1/2 inch concrete floor slab. The plans indicate the floor is supported on 14 inch deep steel beams and wide flange steel columns. This system was not visible due to the plaster ceilings.

The roof of the single story bay at the west end is framed with 18 inch deep steel joists at 4'-0" on center and 1-1/2 inch metal deck. The system is in good shape with the exception of a 4 foot by 8 foot section in the southwest corner. The deck in this area has corroded completely thru due to roof leaks in this corner. This section of deck should be replaced prior to next winter.

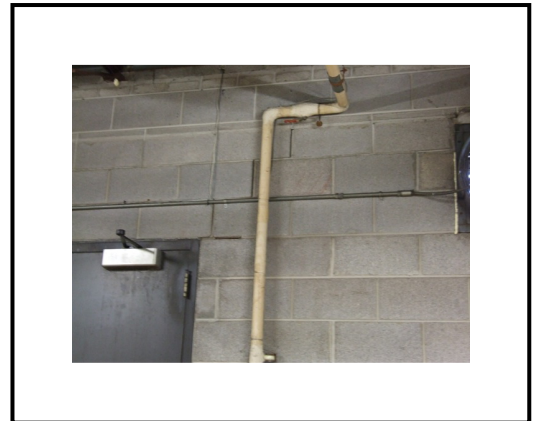
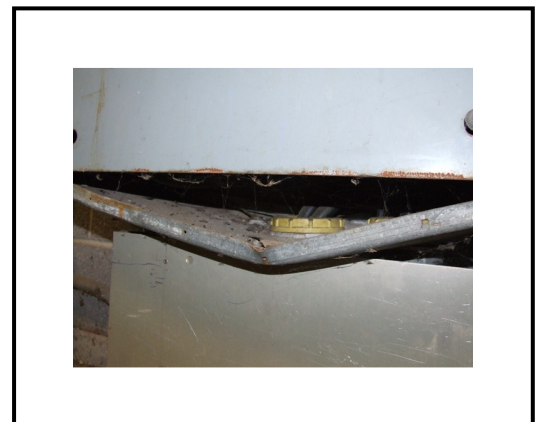
The masonry walls at the west and north sides of the mechanical room appear to have settled creating step cracks in the walls. The 5 inch thick concrete floor slab appears to have settled in the northern half of the storage room. The main electrical feed lines running below the slab have moved along with the slab and have been pulled out of the bottom of the electrical cabinet located midway along the north wall. These settlements may have been caused by poorly compacted soils, poor underlying soils or a loss of soils due to a break in the drainage lines in this area. Monitoring and further investigation is required to determine the cause and the appropriate repairs. If poor soils are found, the slab could be partially removed and underpinning piles could be placed under the foundation wall and new floor slab.

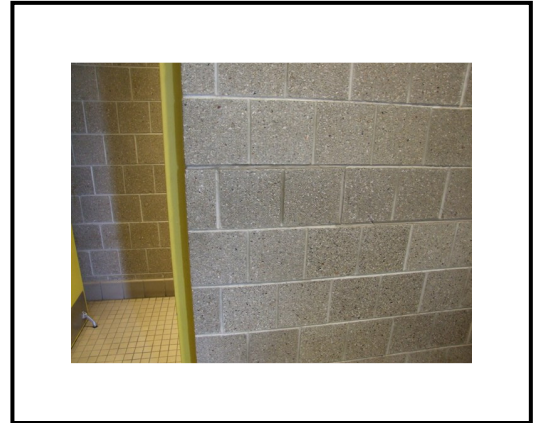
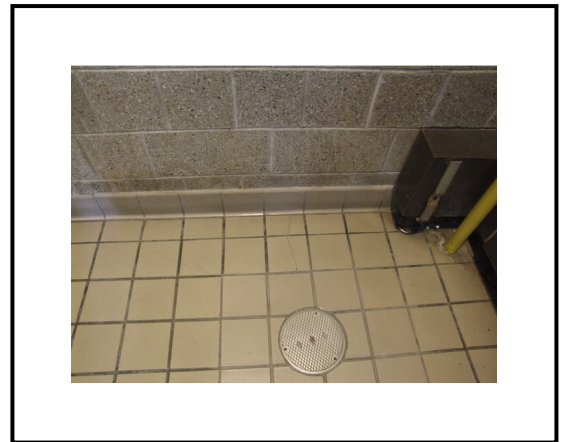
There are two doors to the toilet rooms in the northeast corner of the lobby. Cracks in the masonry walls and floor slab indicate settlement in this area. A review of the original construction drawings indicate a load bearing wall running in the north-south direction was constructed on a footing between the toilet rooms. The east-west wall appears to have been built on top of the floor slab without a footing. Differential settlement between the floor slab and the footing accounts for the cracks in the walls, floor slab and tile floor covering. These cracks should be monitored. If no further movement is detected the cracks in the walls could be tuck pointed and the floor tile replaced. If the cracks continue to move a footing may be required under the east-west walls.

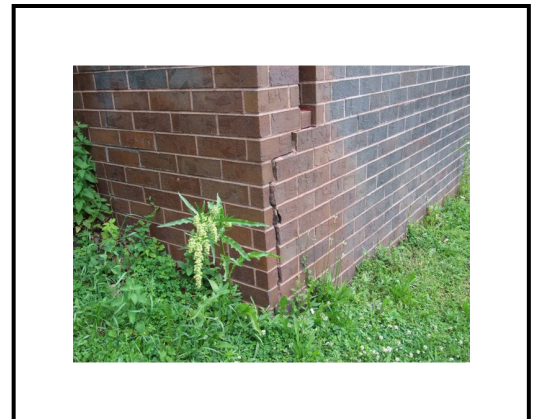
The exterior foundation wall for the brick terrace wall has shifted. This is usually caused by water collecting behind the wall or poor foundation soils. The original building drawings indicate the concrete retaining wall was revised during construction. An un-grouted masonry wall may be collecting water or water may have collected behind the brick facing. Further investigation requiring partial removal of the brick face and a review of the soils will be required to determine the actual cause. Repairs are expected to include removal of the patio slab excavation of the wall and reconstruction of the retaining wall and brick facing.

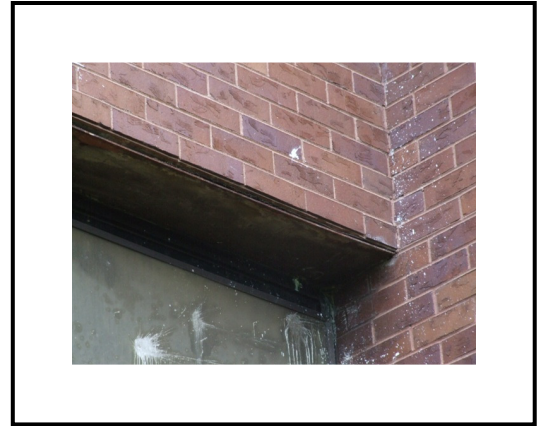
The masonry walls over the windows on the north and south sides of the observation deck are supported by steel beams. A steel plate fastened to the beam extends to the exterior face of the wall to support the brick façade. The steel plate has corroded causing a buildup of rust which has bent the plate. This condition is known as rust jacking and is usually caused by a lack of or improper flashing behind the brick façade. This condition can also be caused by ineffective weep hole that are provided to allow moisture build up behind the brick to drain. A permanent repair for this condition would be to remove the brick façade, clean prime and coat the plate and install flashing. Similar conditions may exist along the clearstory windows along the east wall of the pool area. These windows were not accessible for inspection.

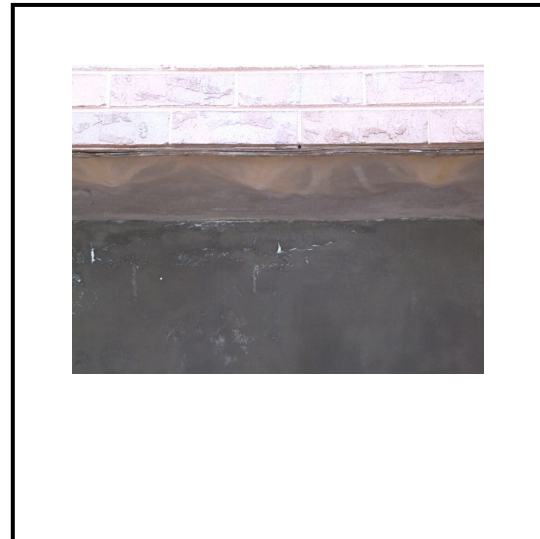
Similar corrosion of the lintel plates is present at the patio doors along the west side of the pool and the conference room windows along the north wall. Similar conditions may exist along the clearstory windows along the east wall of the pool area. These windows were not accessible for inspection.

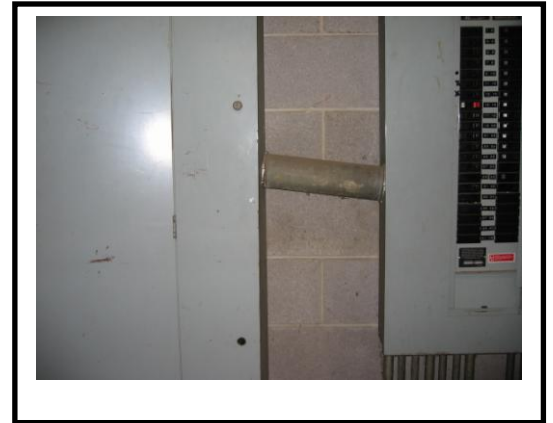
The floor underneath the electrical service entrance panel has settled causing the conduits to become separated from the bottom of the distribution panel. This has also caused the distribution panel itself to move. The electrical equipment in the back receiving/electrical room is in good shape.

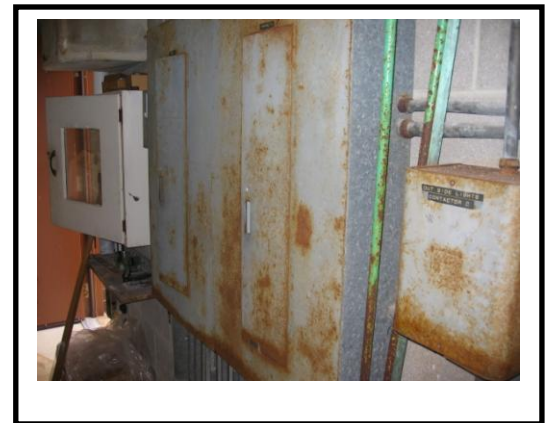
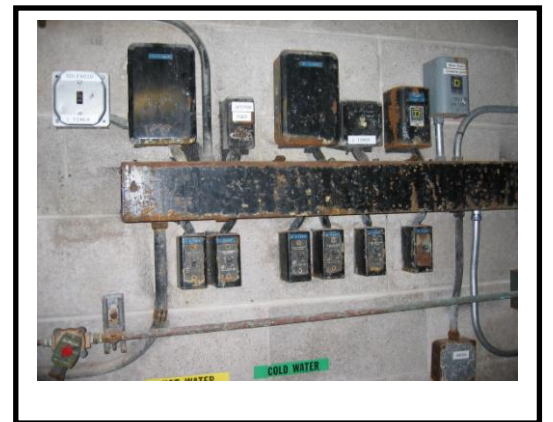
The majority of the electrical equipment located in the pool equipment room is rusted and corroding. There were some conduits, junction boxes and relays in the room that were not rusted or corroding, but they appeared as if they were installed within the last 5 years. Everything that was installed before that is rusted from exposure to the moisture and chemicals in the room.

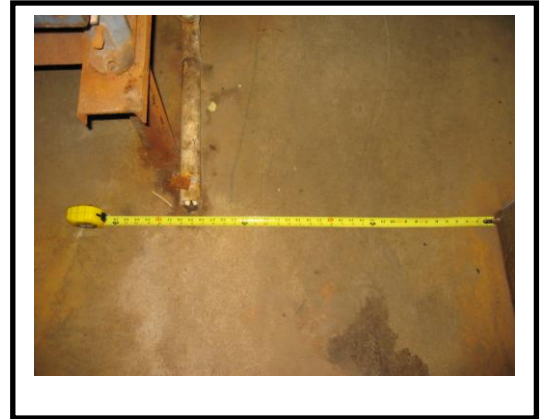
The electrical equipment in the HVAC equipment room appears to be in good condition. It was noticed that the Motor Control Center does not have the required 3ft working clearance in front of the equipment to meet code.

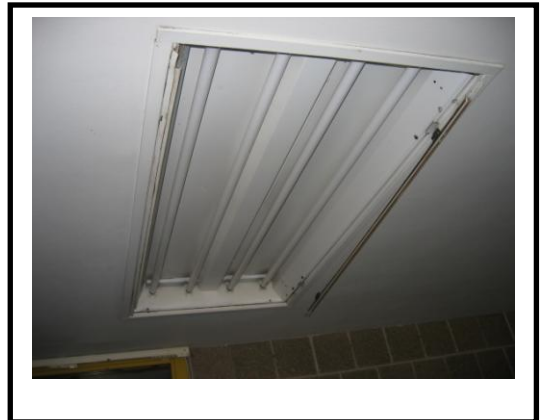
The lighting underwent energy audit upgrades in the last 2 years. All of the fixtures received new ballasts and upgrades to T8 fluorescent lamps or compact fluorescent bulbs. So the internal parts of the fixtures are in good condition. Most of the fixture housings are in good shape with some visible rust on the trim. A couple of fixtures were missing door frames and lenses.

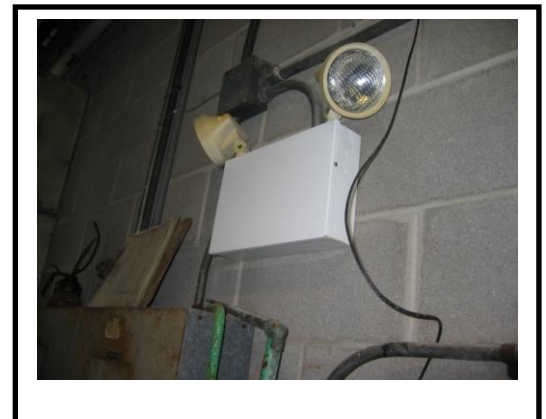
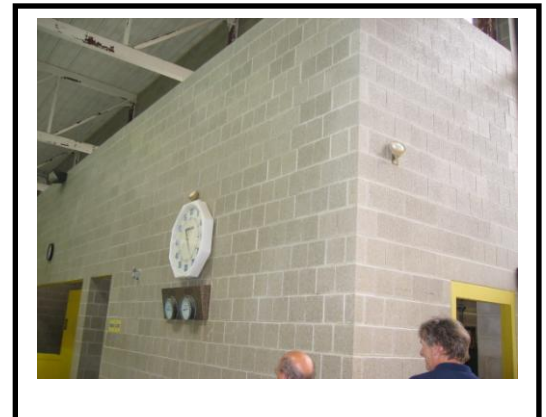
The quantity and location of emergency lights in the building appears to be inadequate in most areas to provide the code required means of egress lighting levels. The emergency battery units located in the pool equipment room and the HVAC equipment rooms were tested and did not function. Some of the existing emergency lights were aimed incorrectly.

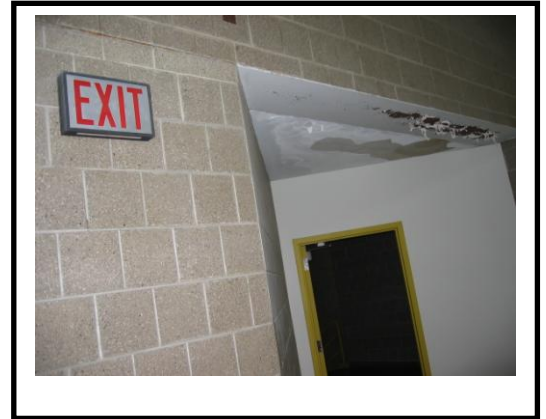
The exit signs appeared to be in good condition, but several of the signs were positioned incorrectly. They were mounted back to the wall instead of the side, so that the sign is visible to people walking toward the exit.

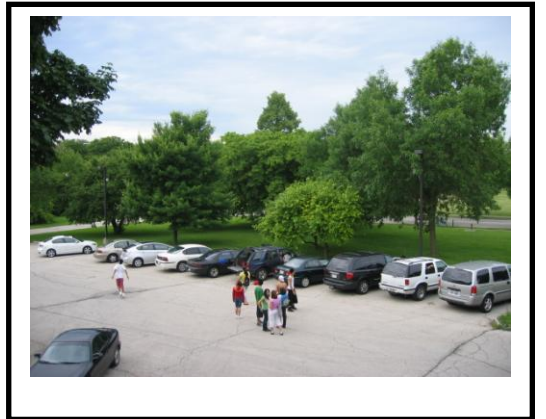
The parking lot lighting appears to be inadequate. There are only 2 light fixtures to cover the whole parking lot. The fixtures and the poles appear to be in good condition and would just require additional lights to what is currently present.

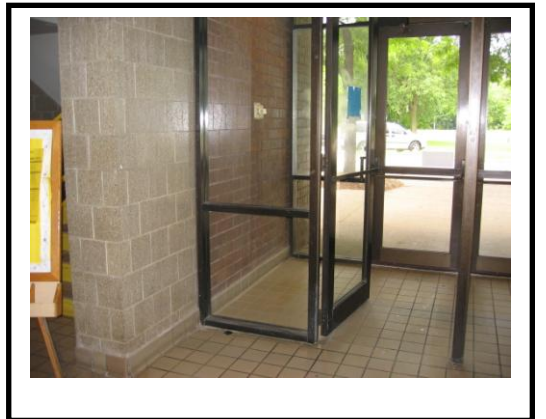
There is no fire alarm system installed in the building. It is not required to have a fire alarm system in the building because it is under 300 occupants, but it is recommended to install a fire alarm system due to the public nature of the building. If the building is expanded to 300 or more occupants a fire alarm system will have to be installed.

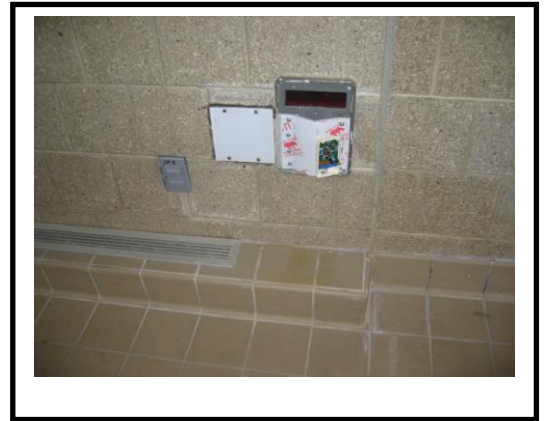
The security system is in need of some minor repair, such as covers. Some individual components appear to be not functioning or in need of replacement.

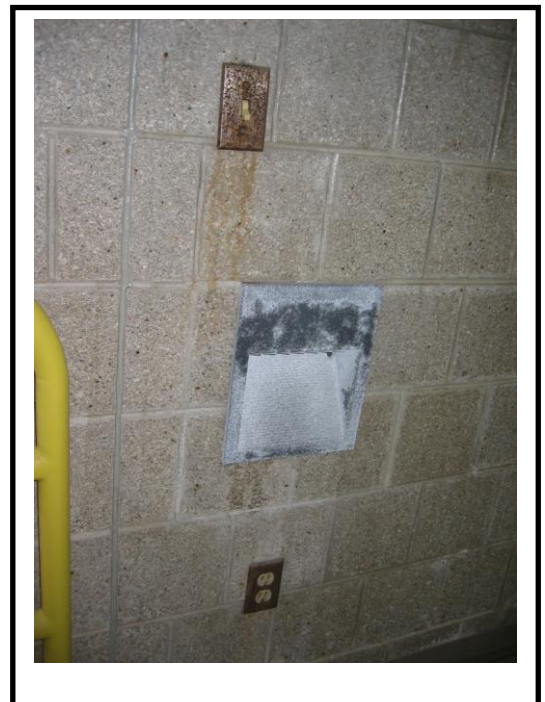
The electrical devices in the pool area are in need of repair. The cover plates are rusted and corroding. The electrical devices in the non-pool area appeared to be in good condition.

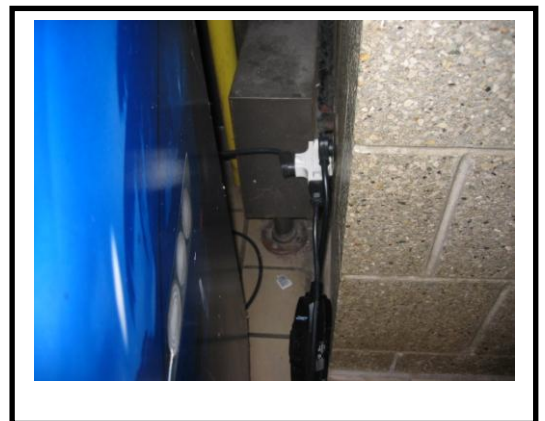
There are a couple of areas where too much equipment was plugged into one outlet. The equipment should be moved to lower the possibility of overloading the circuit or additional circuits and receptacles provided.
