Milwaukee County Coastal Resources Inventory

Milwaukee County, Environmental Services Unit

Milwaukee County Project 5741-19805

OCTOBER 7, 2020

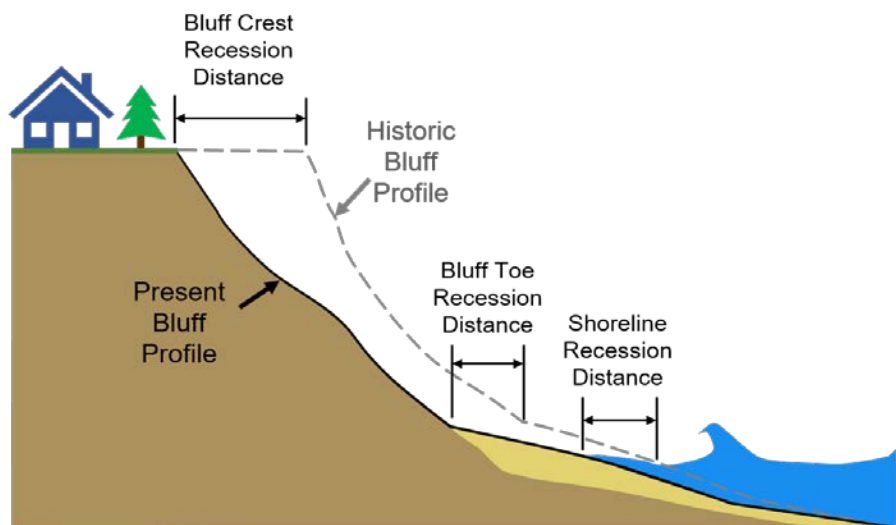
Figure 7. Bluff Changes⁴

The volume change compares the same bluff area between 2010 and 2015, using GIS's cut fill tool. This is summarized in Table 9. Bluff sites not only had sections with volume lost but also gained. These were summed in total volume lost and gain. The total volume change is the difference between gained and lost. The additional volume could only come from areas upland of the bluff crest, with the 2010 crest and underlying soil eroding down the face of the bluff by 2015 as shown in Figure 7. This suggests the upland area is similarly vulnerable to erosion as in the bluff face.
