ADDENDUM NUMBER: Addendum - One

PROJECT TITLE: Milwaukee County Parks Department
CENTRAL SERVICES MAINTENANCE GARAGE
Roof Replacement
Site Number: 240
Building Number: 4250
1150 North 68th Street
Wauwatosa, Wisconsin 53213

PROJECT NUMBER: P251-12613

Re: 1150 N. 68th St.

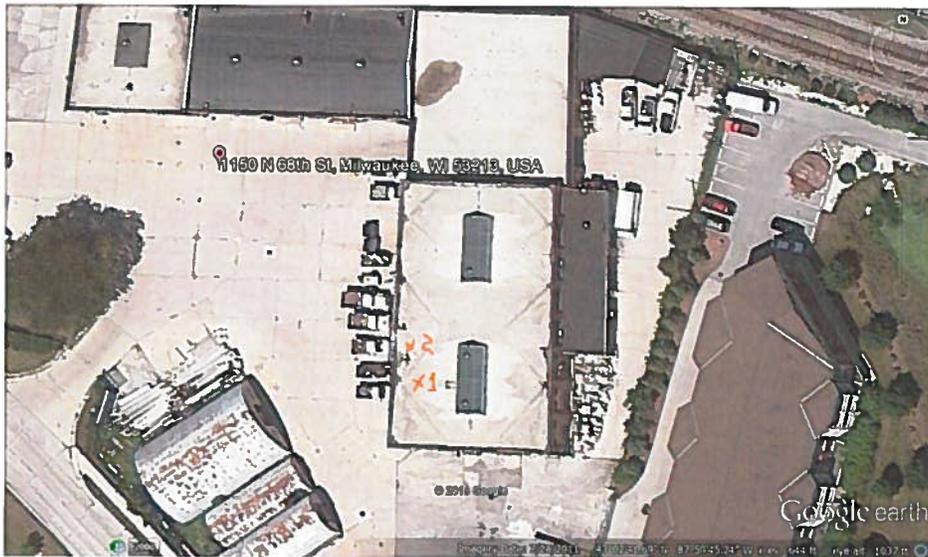
Per your request we inspected the roof over the maintenance garage at the above location. During our inspection we cored the roof at two separate locations (see the above photo). The following is a brief summary of our findings. You stated that your environmental person would be pulling roof samples and we would be available to assist them in that project.

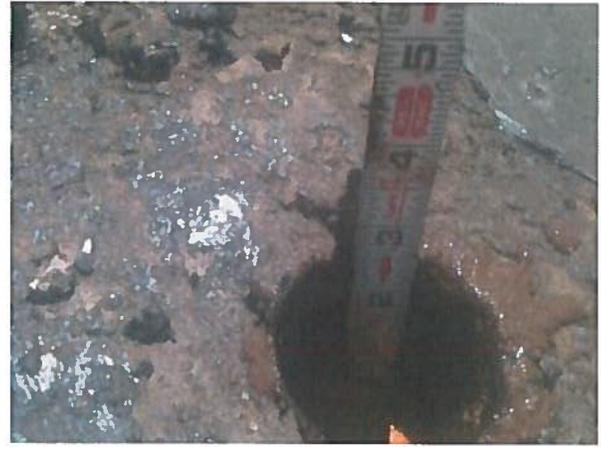
Photo #1
Test cut #1

The roof system on the above on the above facility consist of a wood deck, red rosin paper, 2 layers of 1" perlite and a built up gravel surface roof system. The total depth at test cut #1 was 2 ½" with an R-value of 5.56 (see photo #2). In the valley area there are tapered saddles consisting 2 layers of 1" perlite and tapered EPS insulation. The depth of test cut #2 was approximately 8" (see photo #3). This roof has been leaking for quite a while and test cut #2 the insulation was saturated. I have also included a picture of one of the skylights.
