WASHINGTON PARK
Repair of Service Drive Bridges

MILWAUKEE COUNTY DEPARTMENT OF PUBLIC WORKS
PROFESSIONAL SERVICES DIVISION

SURVEY BY		DRAWN BY	JRK	DATE March 1985	SHEET 1 OF 1
NOTES		TRACED BY			
DATE		CHECKED BY		FILE NO. 162-B-41	PROJ. NO. 06-3946

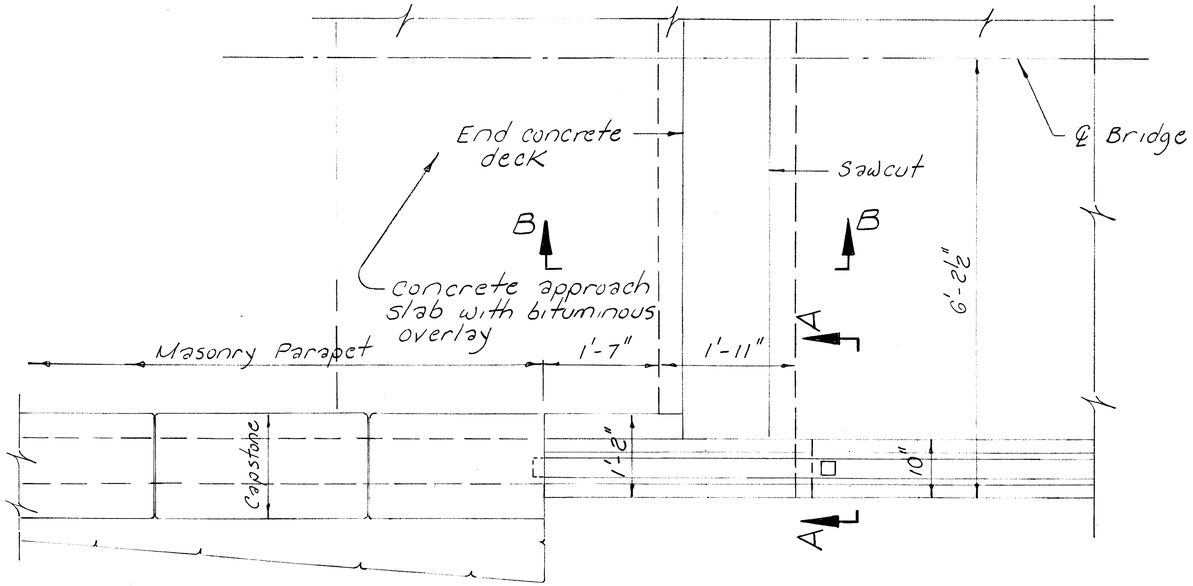
PLAN VIEW
(One-Half Abutment)
Scale: 1" = 1'-0"

1. Shaded areas represent typical deteriorated concrete to be repaired on two service drive bridges.
2. Remove bituminous overlay as required and sawcut to define repair areas.
3. Remove deteriorated concrete down to sound concrete as directed by the Engineer.
4. Repair with concrete bonding grout and topping as specified.
5. Pay limits shall be based on total surface area repaired as indicated. This work is designated as Item No. 1 in the Schedule of Prices.
6. Replace bituminous pavement as required. This work is designated as Item No. 2 in the Schedule of Prices.
