Project: EXTERIOR FACADE RESTORATION
Milwaukee Public Museum
800 West Wells Street
Milwaukee, WI 53233-1478

Subject: **Visual Façade Evaluation Report**
By
GRAEF, Inc.
November, 2010

Visual Façade Evaluation Report

November 10, 2010

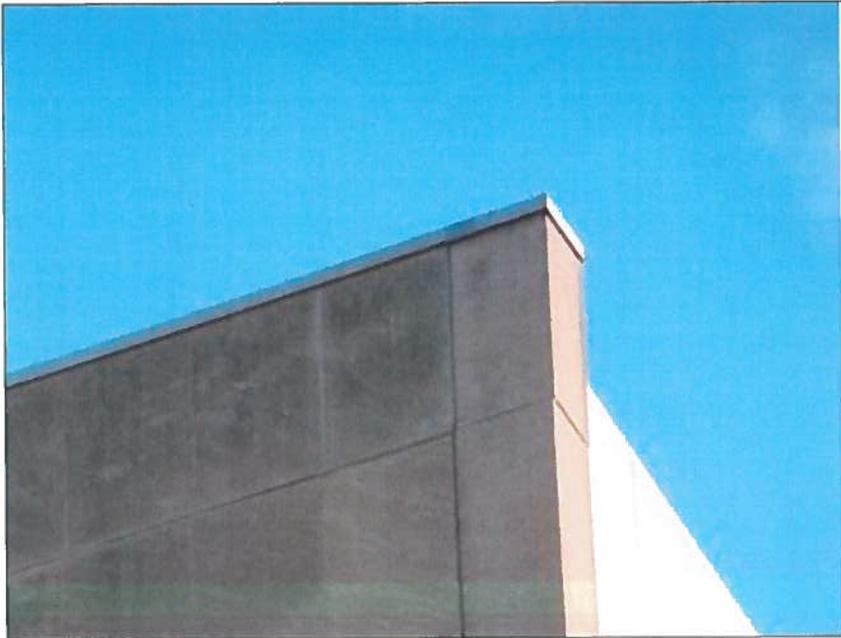
- Stone panels at parapet appear to have shifted slightly. Typical throughout building. See Part V for additional discussion.

Figure 4-6 Shifted stone panels at parapet

2. The stone panels at the parapet elevation have shifted a small amount in various areas around the building. Some of the parapets have been enclosed with metal siding and cap flashing. Others have exposed brick on the roof-side elevation. We recommend additional research into the construction of the parapets and the possible sources of movement of the stone panels within 6 months.

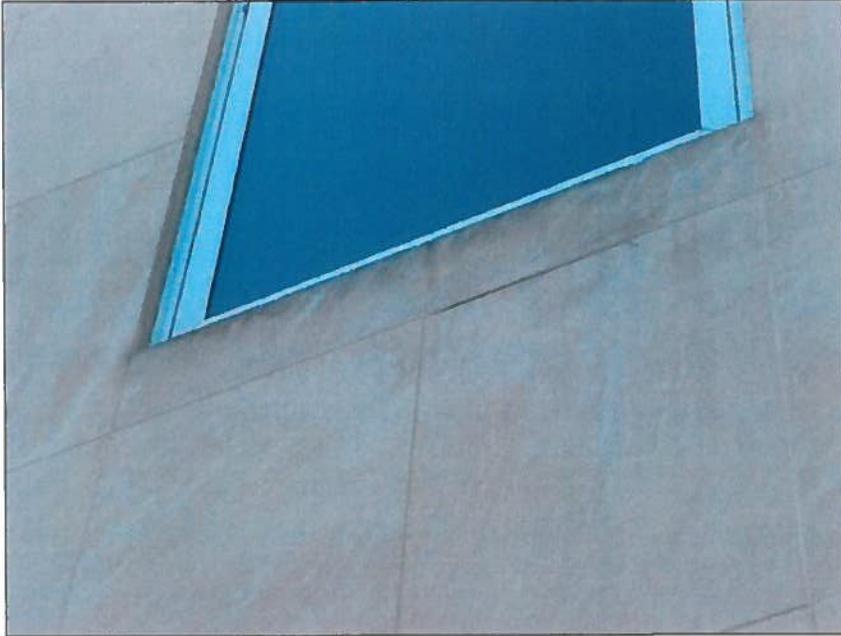
Figure 4-20 No sill flashing at windows

12. The sealant joints between the granite panels (Figure 4-18) should be replaced within 2 years.
13. The windows typically do not have sill flashing (Figure 4-20). Flashing should be installed if extensive work is performed at the windows, or if in the future, it is suspected that water is entering the building at these locations.

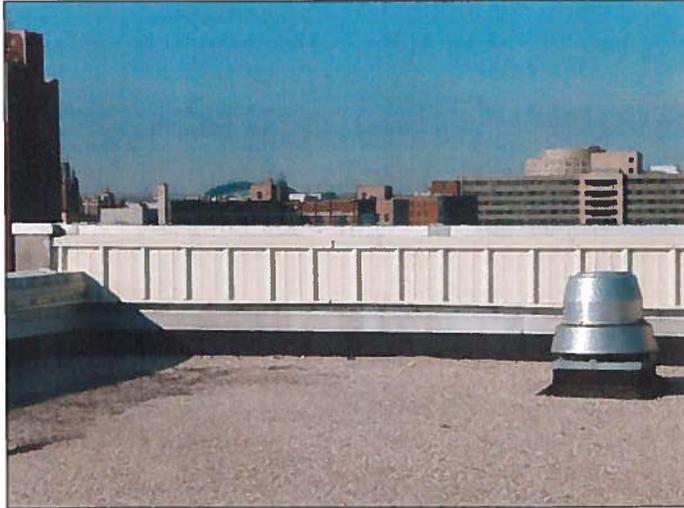
The stone panels at the parapet height have shifted a small amount in various areas around the building (Photo 5-4). Evidence of this was visible from the ground and from the roof level. None of the panels appear to be loose based on our visual evaluation; however, the cause of the movement should be further investigated. The parapets on the high roof and the east side low roof have been enclosed in metal siding and flashing (Photo 5-5). The parapet on the west side low roof has not been enclosed; however, vertical control joints have been added to the roof side face of the parapet (Photo 5-6).

Figure 5-5 Enclosed parapet wall – Elevation 13
