Milwaukee County 2015 Sanitary Sewer
Rehabilitation

V009-15804

Contract 2

PAST CCTV TELEVISIONING REPORTS FOR
REFERENCE FOR PIPE REHABILITATION
WORK SCHEDULE ON **SHEET C-04**

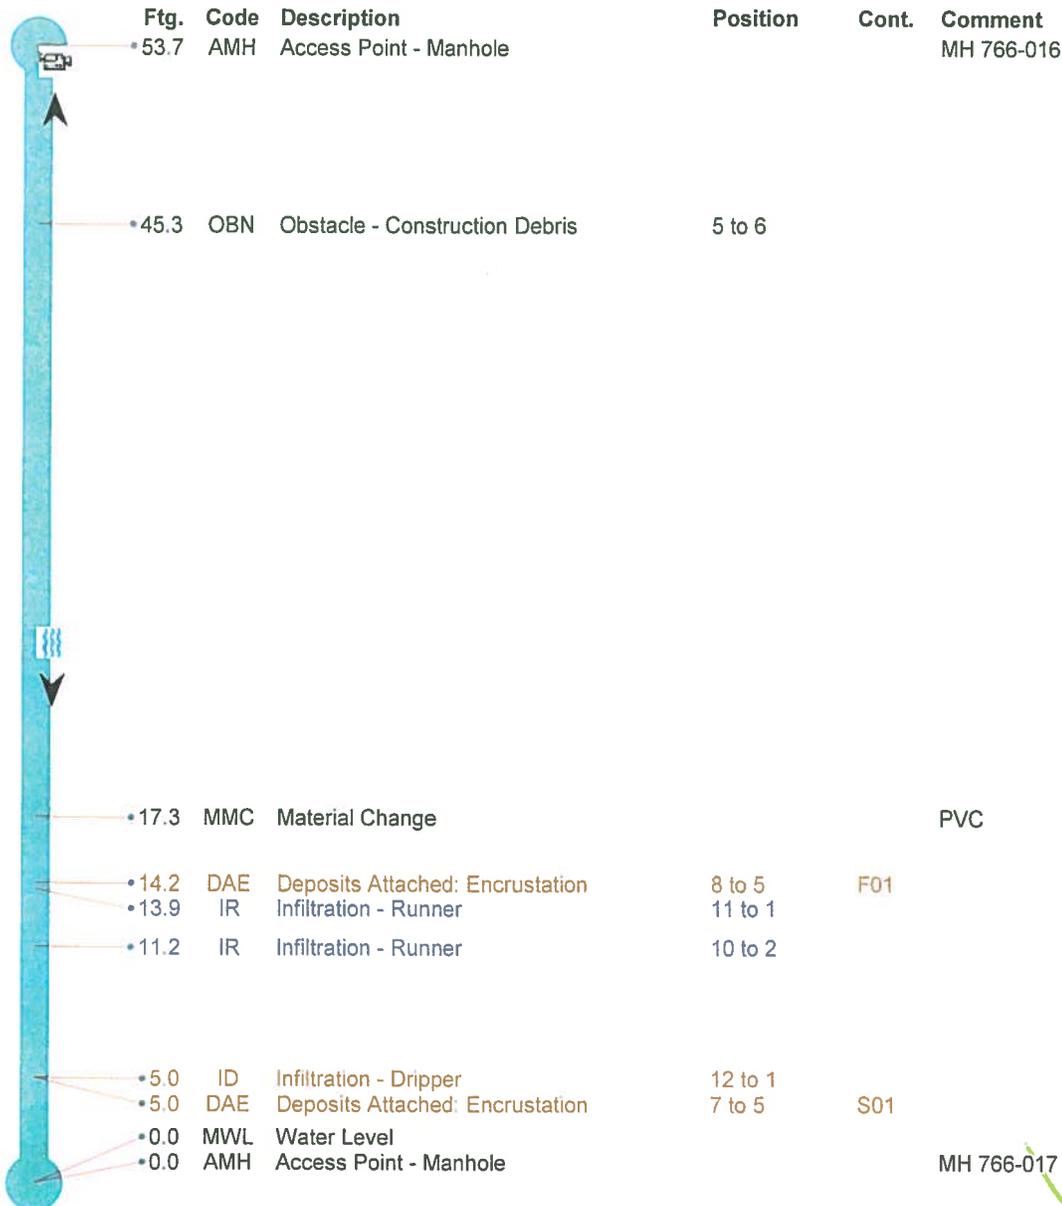
Date 03/2/2015	Time 11:33 AM	Location (Street) MAIN ST EASEMENT		Job Number 13007W-11	
Use of Sewer Sanitary	Pipe Size 8	Material Vitrified Clay Pipe	Jt. Spacing 3	Shape Circular	Survey Direction Upstream
Pre-Cleaning Jetting	Weather Dry	Surface Asphalt	US MH Depth 6.5	DS MH Depth 6.6	Flow Direction N
Media No. 06	Surveyed Length 53.7	Total Length 53.7	Surveyor MIKE BRIGHT	Certificate No. U-1014-06022507	Truck No. 205-I

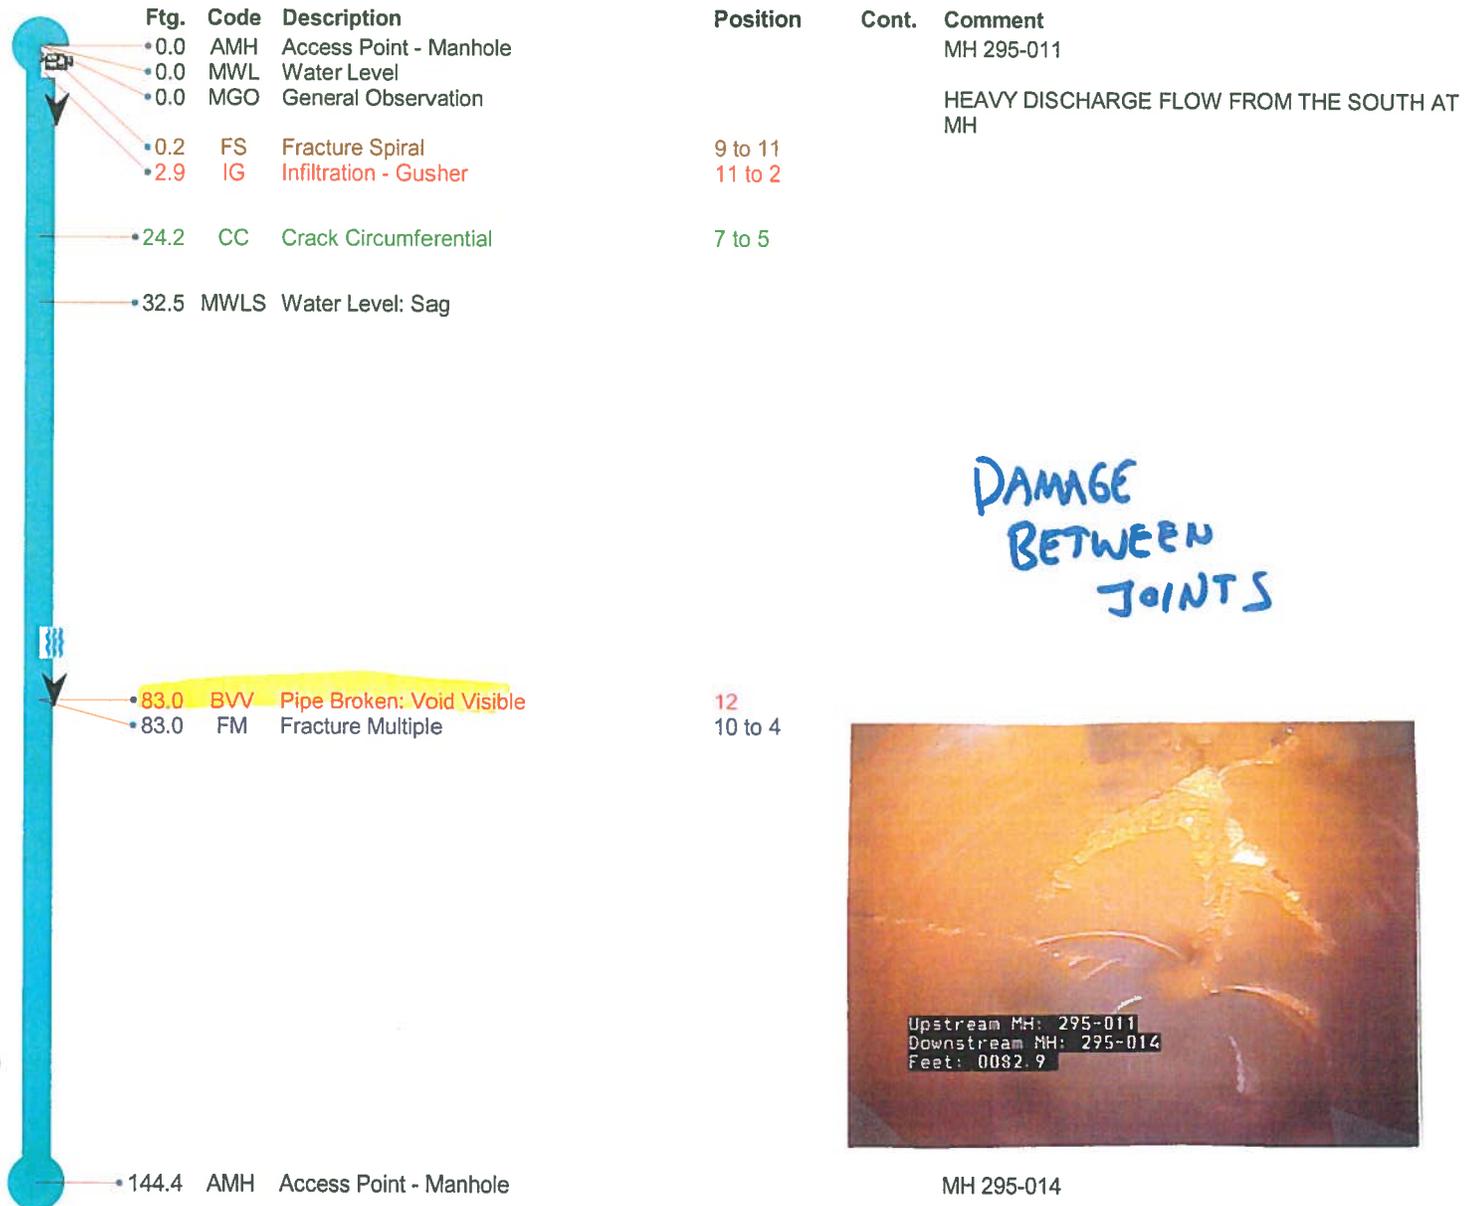
Date 03/28/2013	Time 11:43 AM	Location (Street) 68TH ST-HOUSE OF CORRECTION GROUNDS			Job Number 12364W-01
Use of Sewer Sanitary	Pipe Size 8	Material Vitrified Clay Pipe	Jt. Spacing 3	Shape Circular	Survey Direction Downstream
Pre-Cleaning Jetting	Weather Dry	Surface Grass	US MH Depth 16.2	DS MH Depth 6	Flow Direction E
Media No. 03	Surveyed Length 144.4	Total Length 144.4	Surveyor RG	Certificate No. U-1202-438	Truck No. 221
