# Noyes Indoor Family Center Building Assessment

July 7, 2010

**Milwaukee County – Noyes Pool Building  
July 7, 2010**

**Milwaukee Project Number: P178-10606 & P178-10607  
Milwaukee Project Code: WP178012 & WP179012  
Kahler Slater Project Number: 210092.00**

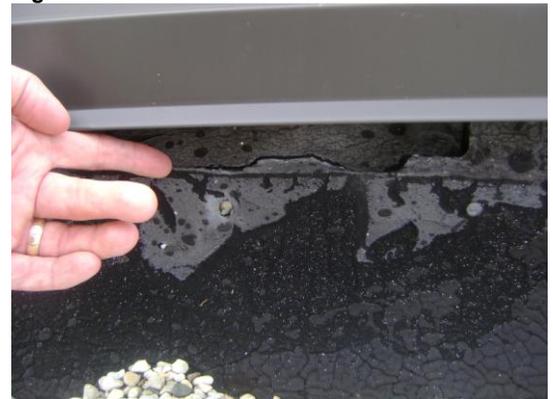
Fig. 2

Based on observation, as well as interviews with county staff, it appears that the roof at Noyes is the original roof. This roof has likely exceeded its effective lifespan. Cracks in the roof flashing can be observed in multiple locations around the roof (**Fig. 2**). Large gaps have developed in most of the coping between coping pieces, exposing the galvanized splice plates below (**Fig. 3**). In many instances, the sealants used between coping / flashing have long since dried and cracked (**Fig. 4**). All

As the exterior walls are showing signs of deterioration from water infiltration, it is recommended that the roofing be replaced at this time. At a minimum, this work should include new roofing membranes, along with new metal copings and counterflashings. When the old membrane is removed, the condition of the existing insulation can be determined. Decisions about repair or replacement of the insulation can be made at that time. Given rising energy costs, and the fact that more building cooling (summer) or heating (winter) is lost through the roof than through exterior walls, it should be noted that a roof replacement would provide an ideal opportunity to increase the amount of insulation in the roof, as the existing 2" do not meet current general construction standards. In most, if not all, instances, the heights of existing curbs and parapets would allow this increase.

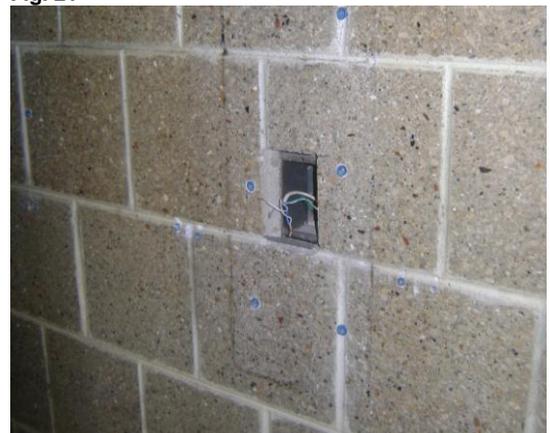
Fig. 22

bare spot on the wall adjacent to the stair where, presumably, a pay phone has been removed (**Fig. 22**). The wiring is exposed, and at a minimum, a cover plate should be provided.

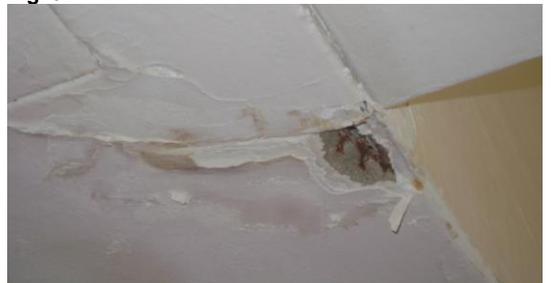
Fig. 33

condition, but need to be cleaned. Some spots of water damage can be seen on the plaster ceilings, and should be repaired (**Fig. 33**). The hollow metal door frames are severely corroded at the base, and the painted wood doors are showing signs of damage at the bottoms from prolonged exposure to the moist environment. The plastic laminate lavatory counter is in very poor condition, and one sink is missing (**Figs. 35 & 36**). This should be replaced with a solid surface countertop, preferably with integrated sink bowls. The glass mirrors have lost a small amount of silvering around the edges, but are otherwise sound. The reception counter just inside the locker entry is also delaminating, and is completely unused. If this was removed, perhaps some other program function could use that floor space. The lockers appear to be the original prefinished metal lockers (**Fig. 34**). The floors of many of the lockers appear to be rusty, some lockers are dented, and a few pieces are missing (**Fig. 37**). Likewise, the floor bases of the fixed benches are quite corroded (**Fig. 38**). Overall, however, the lockers and benches appear to still be in serviceable condition. The private shower stalls are not ADA compliant due to the tall curb, but otherwise appear sound. The group shower room is in good condition, and is sized adequately to accommodate ADA requirements. The existing shower pedestals are also in good condition, but the controls do not meet ADA requirements. The plastic laminate toilet room stalls are still in serviceable condition, and relatively clean. The last stall, however, does not meet ADA size requirements.

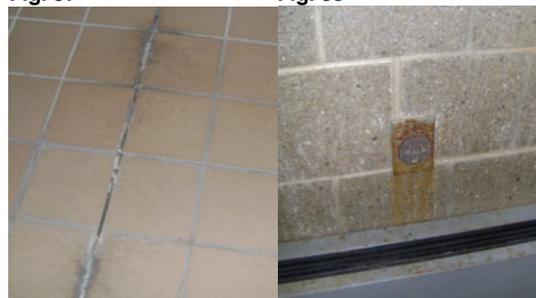
Fig. 39

The tile deck of the pool room is in good condition, with only a few spots needing re-grouting (**Fig. 39**). The walls are exposed, burnished concrete block, and these are also in mostly good condition. Throughout the space, stainless steel outlet and cover plates are severely corroded, and light fixtures are also showing signs of corrosion (**Fig. 40**). The same can be said for the exposed steel lintels – these are all showing signs of corrosion (**Fig. 41**). Some of this can be attributed to the wall moisture problems discussed previously, and the rest can be attributed to the high humidity environment. The paint on the steel trusses is flaking and peeling, and the steel pipe handrails at the balcony are showing corrosion as well (**Fig. 42**). Numerous spots of corrosion can be seen on the roof/ceiling deck as well – some of this is due to roof issues, and some to the humid environment (**Figs. 43, 44, 45 & 51**). In all cases, all exposed metal in the pool room should be cleaned,

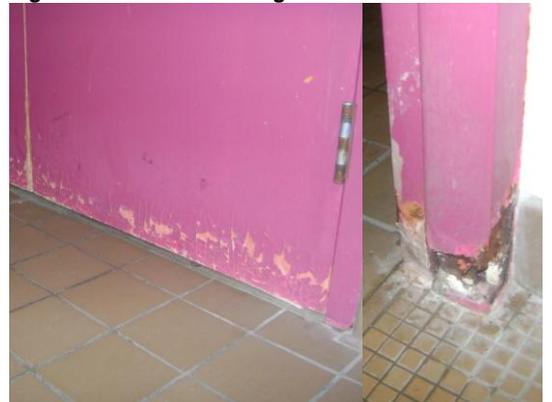
Fig. 47

Doors and frames in an around the pool room are in fair to poor condition. The finishes on wood doors are peeling, and the wood is becoming damaged. Hollow metal frames are corroding, and much of the door hardware is corroding as well (**Figs. 46, 47 & 48**).

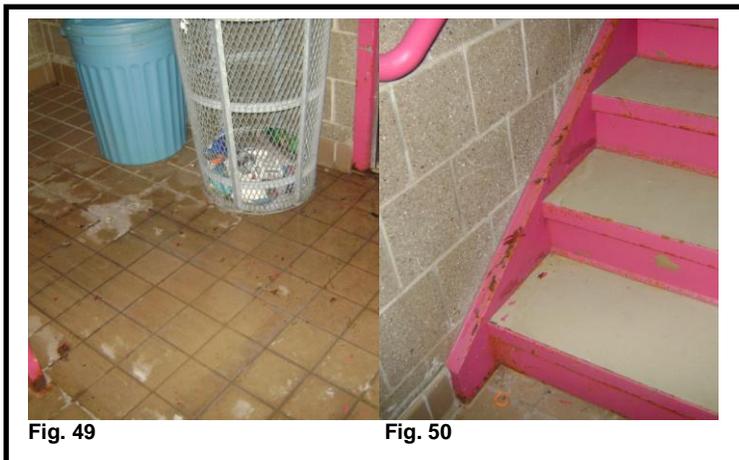
Fig. 49

There is a lot of water on the floor of the stairwell (**Fig. 49**). This could be from the pool, but it is more likely the result of the ponding water on the roof due to the clogged roof drain. Corrosion of the stair stringers and handrails is a bit worse in this space than in other similar spaces, and these should be cleaned and re-painted to slow further corrosion (**Fig. 50**). The tile wall base has delaminated from the block wall, presumably do to the potential water problems in the walls.

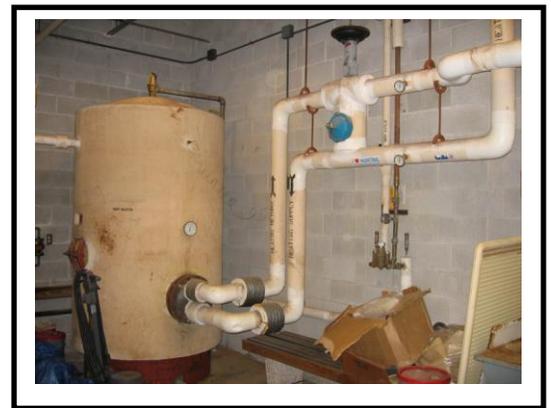
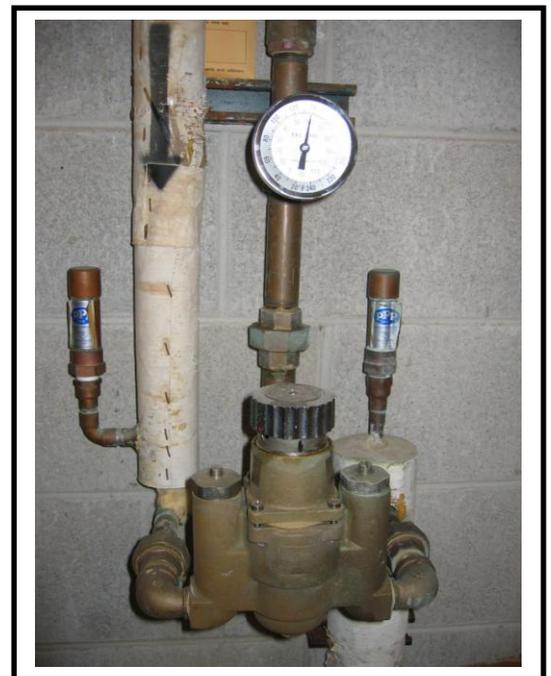
The plumbing system consists of a steam heat exchanger in the original storage tank (approx. 600 gal capacity). The control valve appears to have been replaced. The hot water recirculation pump was also replaced. The mixing valve is not maintaining the set temperture all the time. Either rebuilding the existing valve or a replacement should correct this issue. Regular maintenance should provide many more years of service. A few years ago a project was started and not completed. As it stands, there appears to be a cross connection issue that stems from this project. Tempered water and cold water are mixing. This cross connection should be investigated soon and corrected.

Throughout the building, the isolation/shut-off valves are failing. All of these valves should be replaced.

The existing counter tops in the toilet/ locker rooms were of particle board construction with plastic laminate surfaces. The particle board had severely swelled and was failing. Therefore, the lavs have been replaced with wall hung style fixtures.

There are 2 roof drains that were clogged during our site visit. These drains should be snaked out.

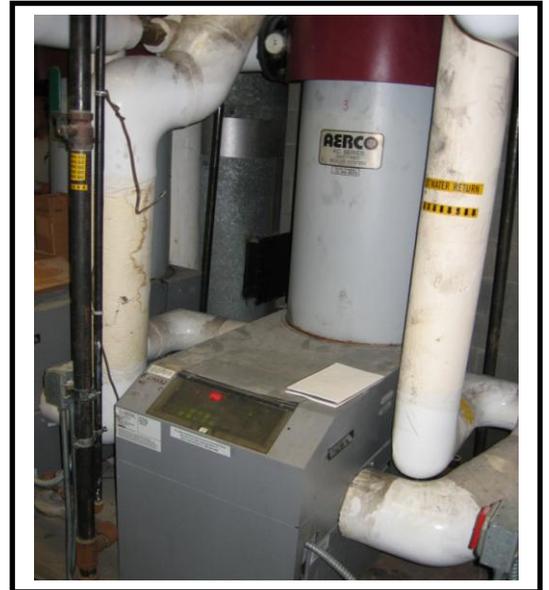
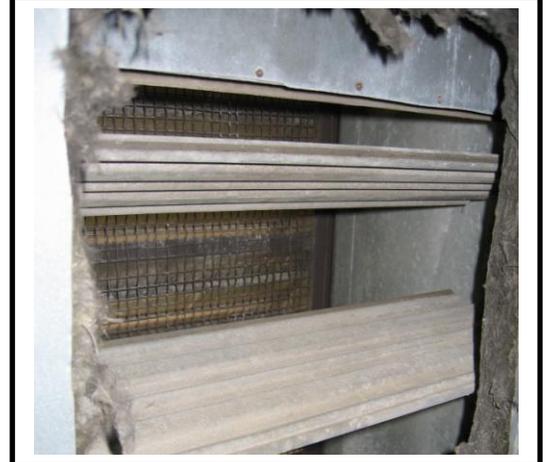
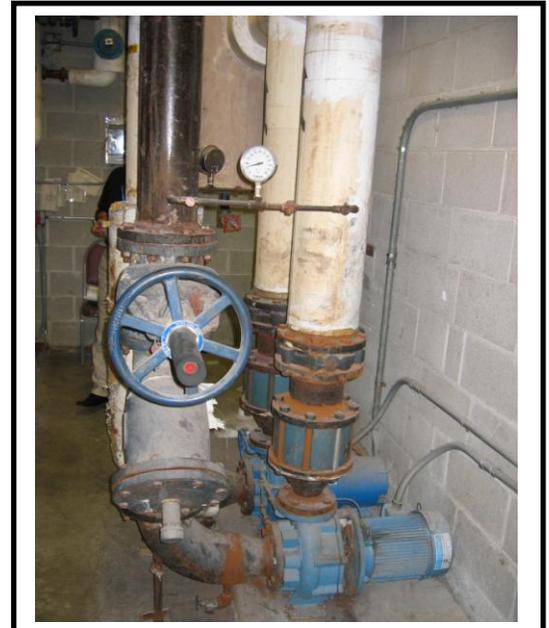
The boilers are approximately 15 years old. One boiler is not operational (control panel has been removed), boilers 2 & 3 need the control panels replaced (units are not modulating, and cycle on manual set of firing range – boiler 2 set at 66.6%, boiler 3 is set at 33%). All four boilers need an inspection and repairs or replacement of the heat exchangers. The boilers have the venting system extended through the side wall and the existing boiler vent is disabled.

The boiler room has a deficient combustion make up air system consisting of combustion louvers, non functional OA dampers, and a hole in the plenum (not in compliance with codes). The system needs to be re-engineered and replaced.

Most of the piping is black iron steel with the original isolation valves. Some of the isolation valves are not functional and result the result is an inability for ongoing maintenance. It requires all hot water maintenance to be done during summer shut-down cycle.

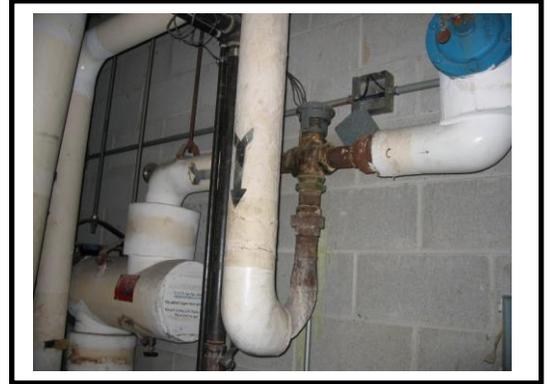
The pool heat exchanger was re-built 10 year ago.  
Unit was sized at 180 deg F but operates at 140 deg. F.

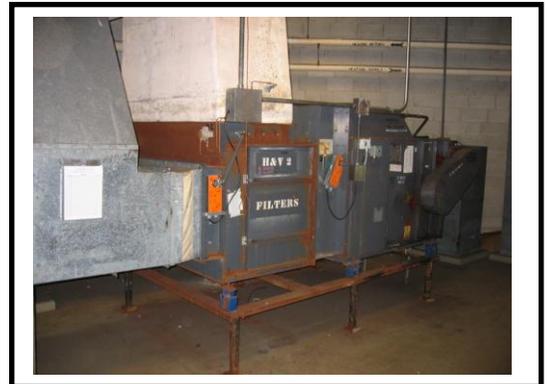
The outside air intake hood is fully corroded and needs to be replaced.

HV-2 is a 100% OA system consisting of a Trane modular air handler with a dual centrifugal fan assembly, a heating coil with three way control valve, 30% eff. 2" thick filter section, a return fan with relief dampers, outside air intake with a flat plate heat exchanger, and associate face-bypass dampers.

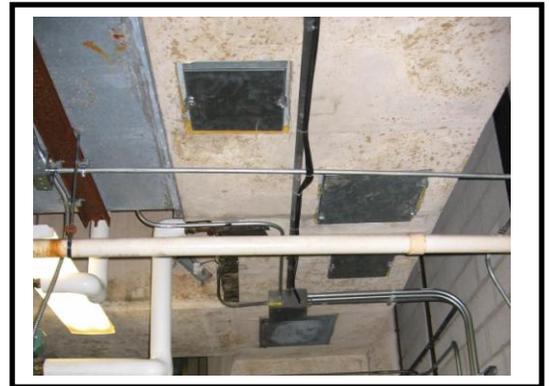
Baseboard radiators and cabinet heaters are original to the building. Several are corroded and covered in rust. They have two way control valves with old pneumatic control valves and the original isolation valves. As an ongoing maintenance item, the cabinets and fin tubes could be replaced. Control valves need to be replaced.

Ductwork distribution, especially outside air ductwork, and some of the exhaust air ductwork are corroded with moisture damaged insulation.

Diffusers, grilles, and registers throughout the building are covered in dust. These grilles and diffusers should be cleaned as an ongoing maintenance task.

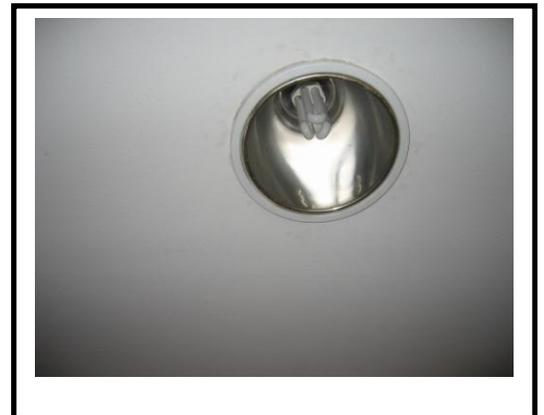
The quantity and location of emergency lights in the building appears to be inadequate in most areas to provide the code required means of egress lighting levels. Some emergency battery units located were tested and did not function.

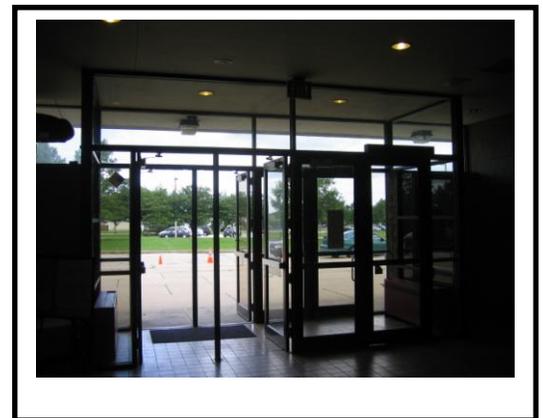
The security system appears to be the original system. I was told it is not used, but not directed if that was because it was broke or too old. It is recommended to replace the system if a functioning system is needed.

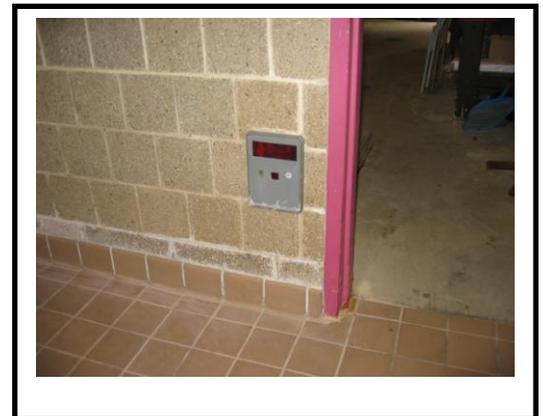
The electrical devices in the pool and pool equipment area are in need of repair. The cover plates are rusted and corroding. The electrical devices in the non-pool area appeared to be in good condition.

Electrical Devices in pool area	Electrical devices in pool and pool equipment area are rusted and corroding. Recommend replacing devices with weatherproof devices	\$5,000 – \$10,000	Medium

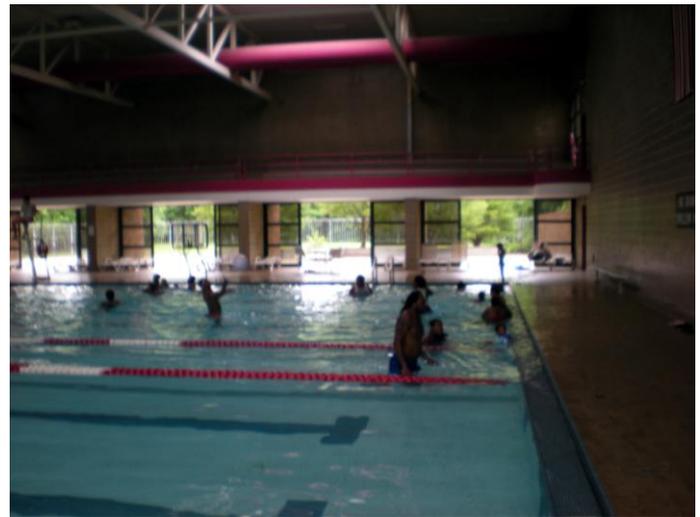
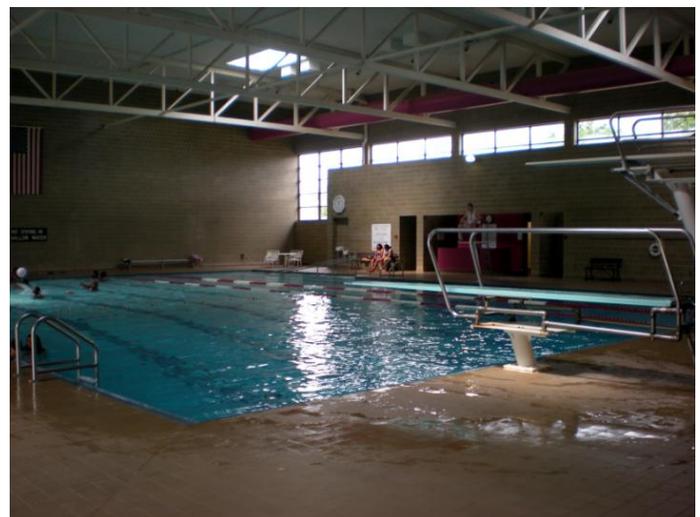
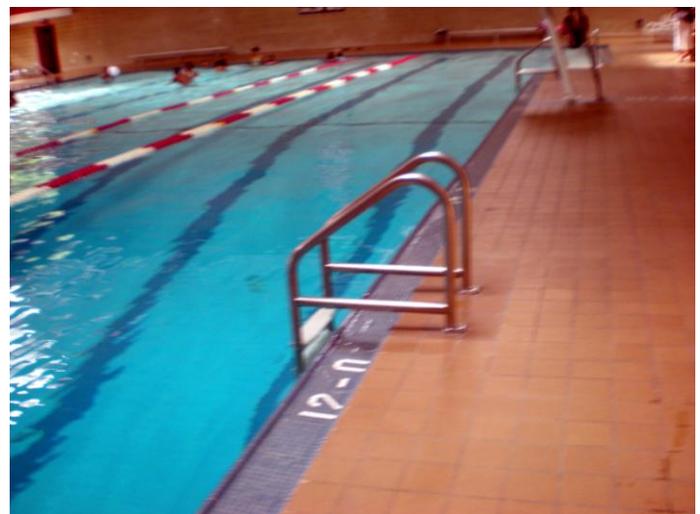
The pool deck and misc. deck equipment are in good condition. The pool deck consists of tiled concrete around the pool perimeter. Drainage of the main deck areas is achieved by sloping the deck to drain to the pool gutters. Standing water on the deck was not noted and indicates that the system is working adequately. Some corrosion is evident on the stainless steel ladders and other associated deck equipment.

As indicated previously in this report, there are some items with the pool structure that need to be addressed at this time: Clean corroded deck equipment; replace misc. pool equipment, relocate chemical systems, replace mechanical room steel hangers, and replace pool filtration and heating system.

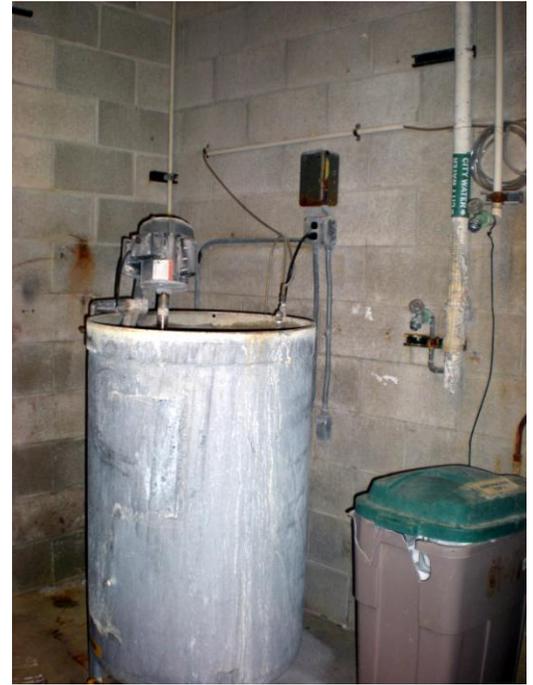
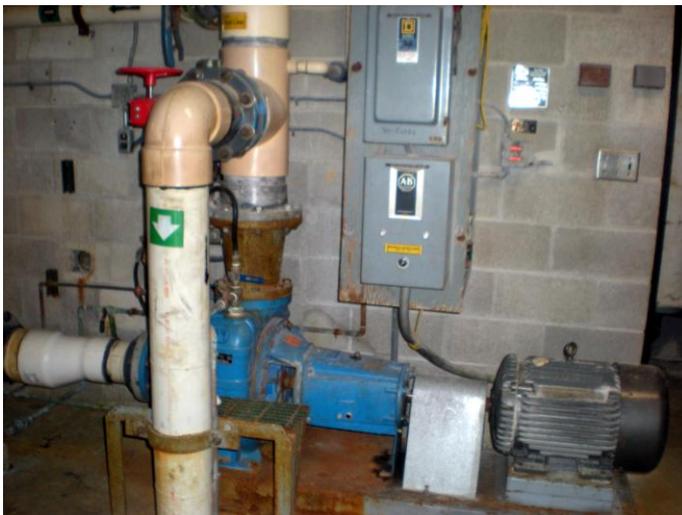
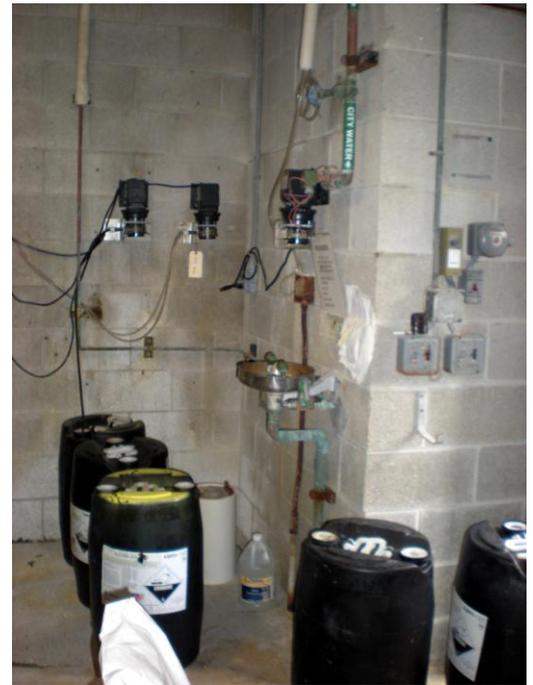
The pool's chemical balance is monitored and controlled by an automatic chemical controller. Disinfection is accomplished with sodium hypochlorite, which is fed by a Stenner metering pump. Ph reduction is accomplished by the addition of acid which is fed by a single Stenner metering pump. These pumps have been replaced in recent years and appear to be in good condition. There were no reports from the staff of difficulty with this equipment. However, all chemical tanks are open and located in the basement pool mechanical room. They are required to be manually filled and sometimes mixed. This causes corrosion and potential hazards.

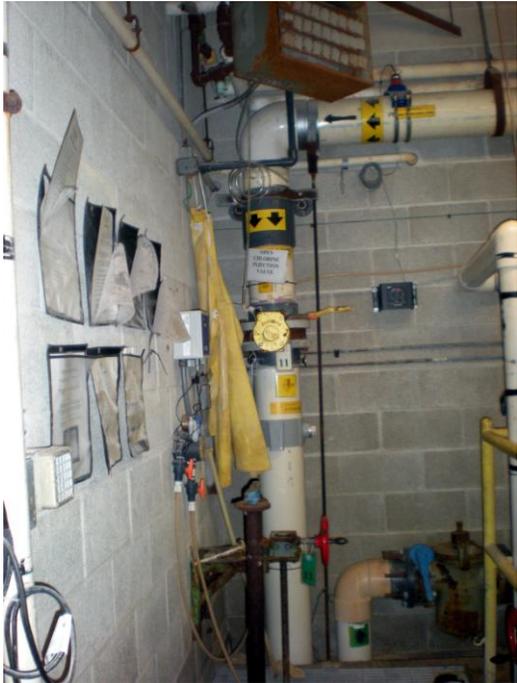
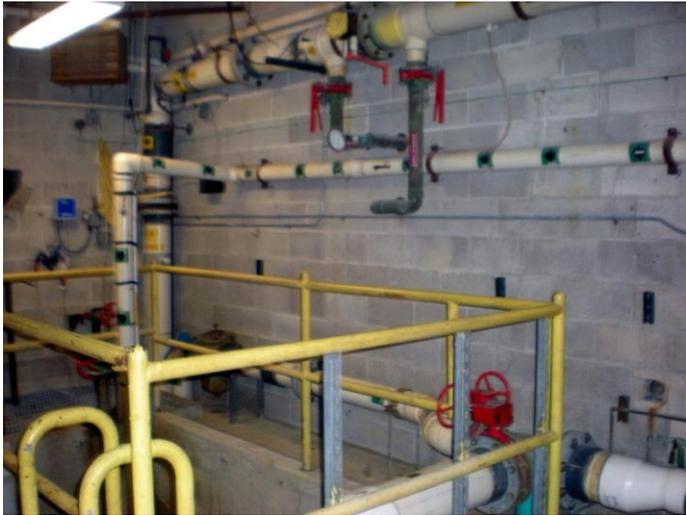
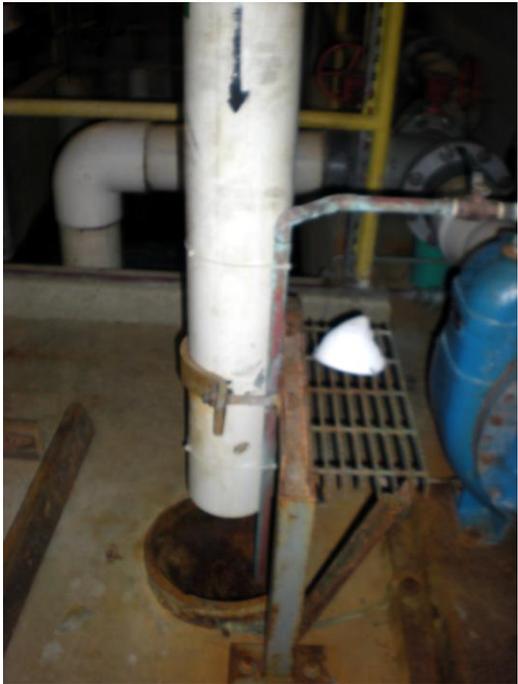
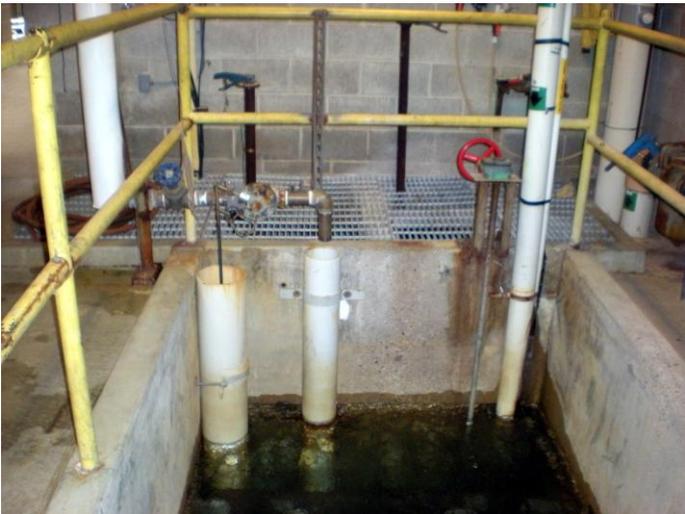
The pool is heated through the use of a single wall water to water heat exchanger. Current code requires the use of a dual wall heat exchanger or non-toxic fluids in the boiler. This system uses the building boilers to provide heat. It is recommended that this system be replaced with an independent pool heater. Pool blankets are budgeted to be installed.
