MILWAUKEE COUNTY
PARKS

FINAL REPORT

South Shore Park
Site Investigation and Schematic Design

Project No. P298-14616

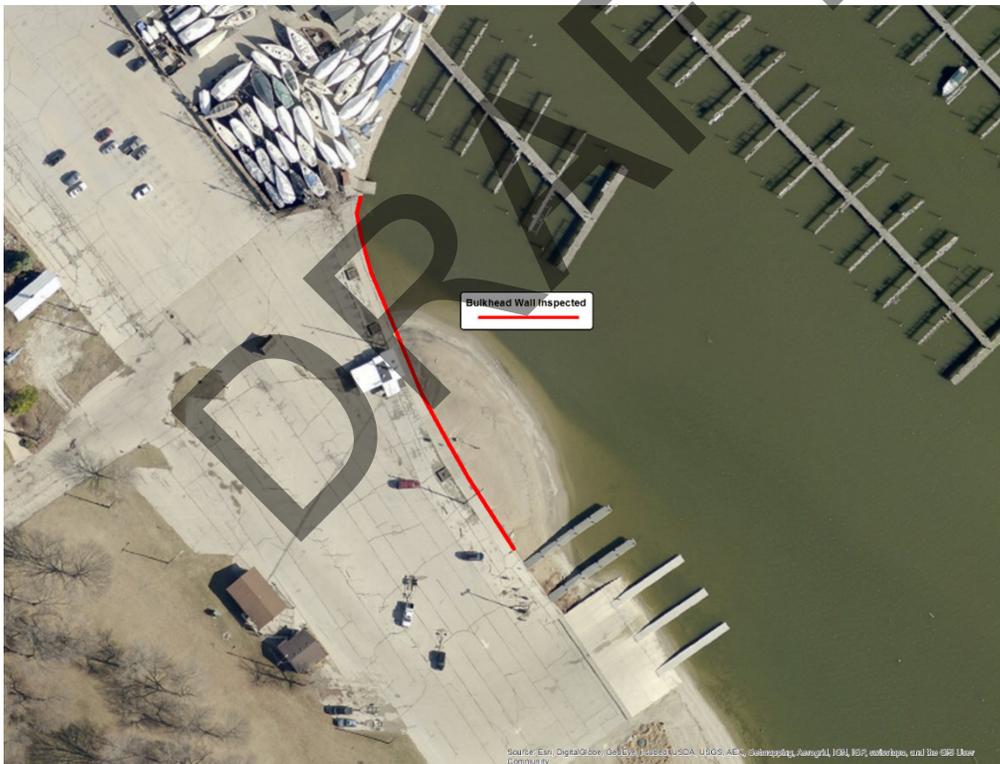
Areas of the upper portion of the Wakefield sheeting at the top of the crib were observed to be fully deteriorated along the entire length of the crib that was exposed to the lake during the inspection. The evidence suggests further structural degradation of the wall and tieback system due to missing wailers and fully corroded tie back rods.

There is significant degradation to the Wakefield sheeting and tie rod connections from the piles to the back side of the wall. This is due to the age of the structures, as well as continued ice and wave action along the entire length of the sheeting. These degradations and structural deficiencies have directly resulted in loss of fill materials from the cribs. Evidence of cracking of the concrete cap is indicative of the loss of materials from the crib into the lake resulting in a cantilever of the cap over the crib. Further degradation of the sheeting and loss of material may result in significant failures of the bulkhead wall and concrete cap.

For the sake of this report and future infrastructure planning and budgeting, this report has assumed the dockwall will need to be replaced. The replacement costs of the system will vary depending on the final design ranging from the most cost effective approach of stone revetment to the most costly approach of steel sheet piles.
