HISTORIC LAKE PARK ARCH BRIDGE OVER RAVINE ROAD IN-DEPTH INSPECTION REPORT

Structure P-40-576

Milwaukee County Project Number P484-15619

July, 2015

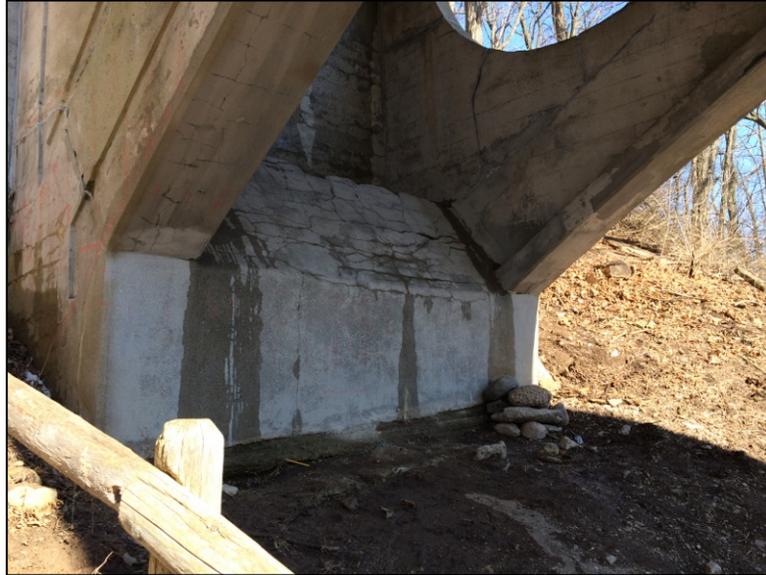
Both arch ribs contain many concrete patches. These earlier repairs are present along approximately 75% of the length of the rib soffits (bottom surfaces, Figure 3). Patches are also common on the rib soffit at all four spring lines (Figure 4). The soffit patches were apparently needed to fix spalls that had occurred at the lower corners. The rib backs (top surfaces) are exposed only along the circular and teardrop shaped spandrel openings, and patches exist along about 50% of the length of these surfaces. Fewer concrete patches were found on the rib vertical surfaces. Most were located near the arch crown between panel points 2 to 4 on the inside faces (Figure 5).

Figure 4: Concrete patches on arch rib soffits at the north spring line.

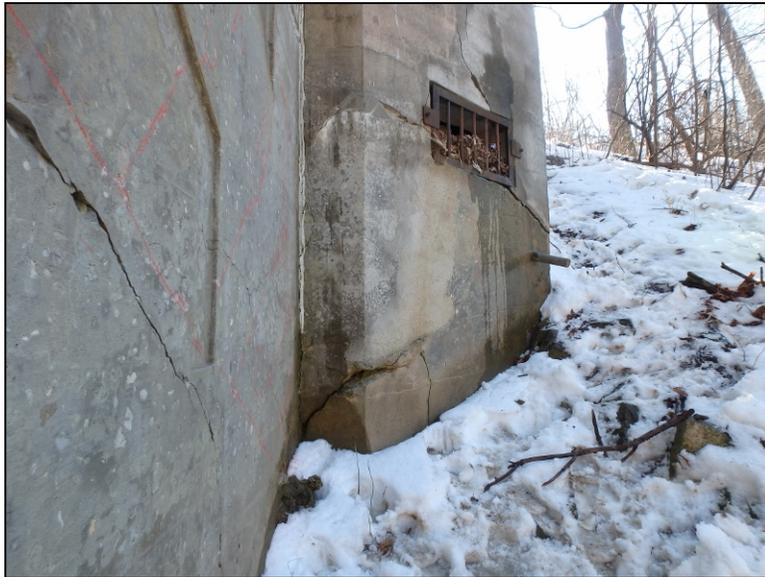
4. South abutment wall, northwest quadrant – there is a large concrete patch adjacent to the access opening that is part of an earlier repair effort (Figure 38). This area has wide unsealed vertical and horizontal cracks, and the patched region is bulged outwards. Soil aggradation inside of the vaulted abutment was evident at the grated opening. This aggradation is a result of scour along the wingwall inside faces farther upslope. Soils washed away from the wingwalls and were deposited inside of the octagonal shaped vaulted abutment. The deposited soil is imparting active pressure from the inside of the vault and causing the observed wall movement/bulging (Figure 39).

Figure 39: South abutment wall northwest quadrant with outward bulging (looking southwest)

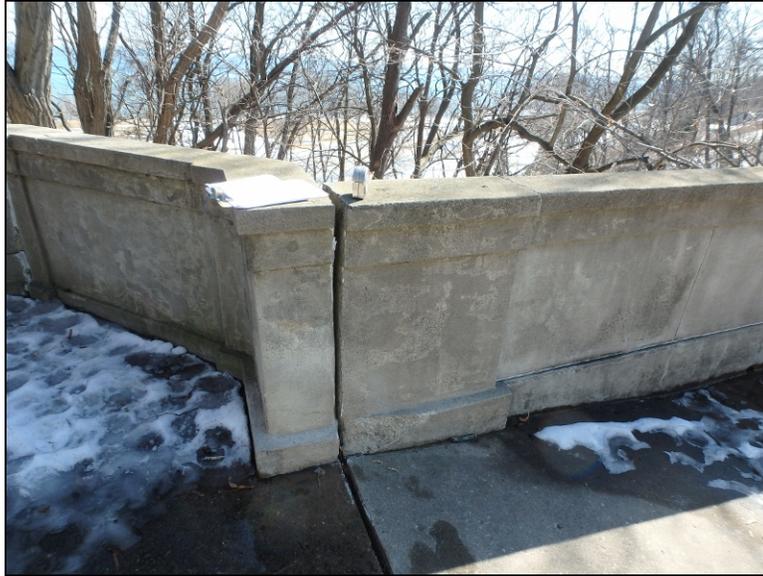
- Northeast
 - Horizontal gap parapet bottom = 1"
 - Horizontal gap parapet top = 1- $\frac{1}{4}$ "
 - Vertical difference parapet top = $\frac{3}{32}$ " (superstructure higher than abutment)
- Northwest
 - Horizontal gap parapet bottom = 1"
 - Horizontal gap parapet top = 1- $\frac{3}{4}$ "
 - Vertical difference parapet top = $\frac{5}{8}$ "
- Southeast
 - Horizontal gap parapet bottom = 1- $\frac{5}{8}$ "
 - Horizontal gap parapet top = 1- $\frac{11}{16}$ "
 - Vertical difference parapet top = $\frac{1}{2}$ "

- Southwest
 - Horizontal gap parapet bottom = 2-1/4"
 - Horizontal gap parapet top = 2-13/16"
 - Vertical difference parapet top = 3/4"

Figure 52: Open expansion joint at parapet and deck

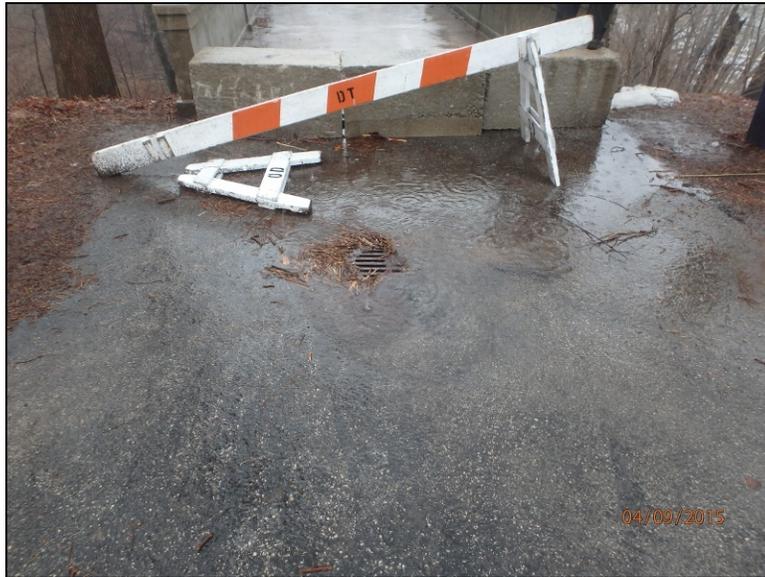
Both the north and south approaches slope down towards the structure. Although a storm drain exists at the south approach, severe erosion has occurred along the southeast wingwall (Figures 54). Southeast slope runoff directed towards the southeast wingwall has created a large washout hole (Figure 55). Water runs into this hole, under the wingwall strip footing, and into the vaulted abutment. This has caused erosion of the soil along the wingwall's inside face and undermining of the footing. Similar erosion has occurred along the southwest wingwall's inside face, though the source of the water could not be determined and the footing has not been undermined. Sandbags have recently been placed upslope of the southeast wingwall to help redirect rain runoff away from the washout hole.

Figure 54: Drainage inlet at south approach

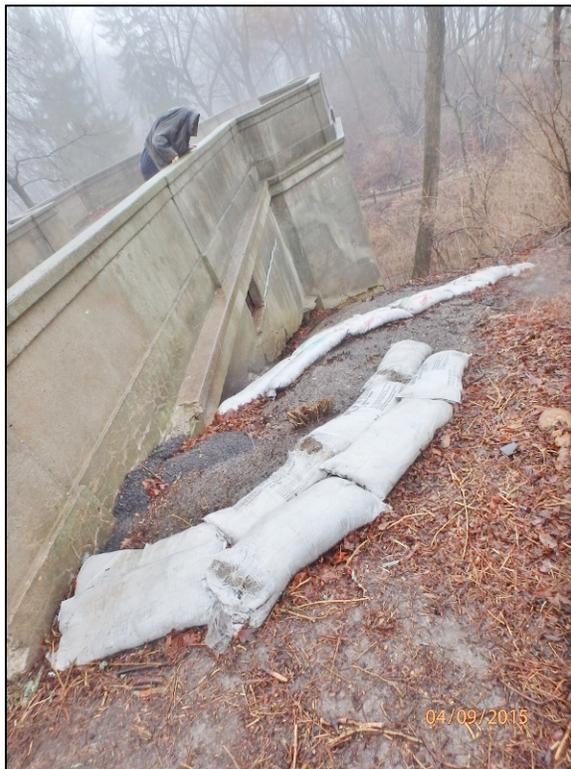
Figure 55: Sandbags to redirect runoff around the southeast wingwall

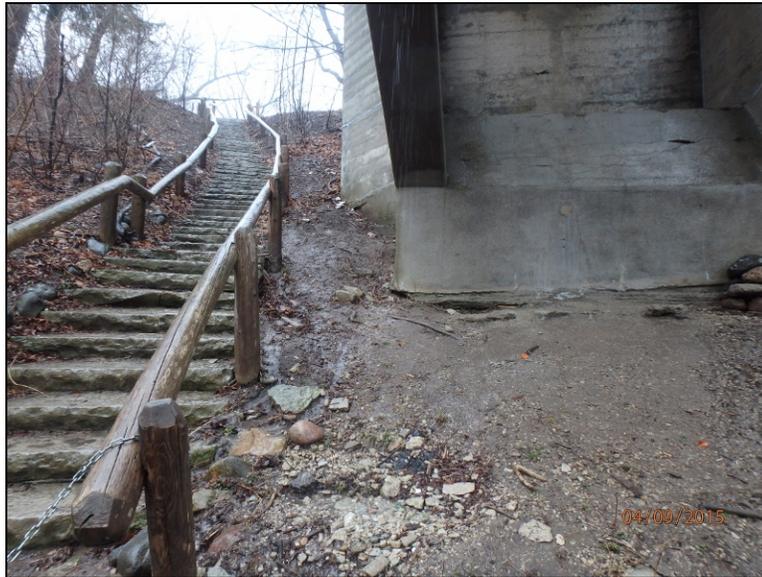
Less severe erosion was noted at the north abutment's south face. Approximately 8" of erosion has occurred since the concrete facing was placed on the thrust block (Figure 56).

Figure 56: Slope settlement in front of north abutment thrust block

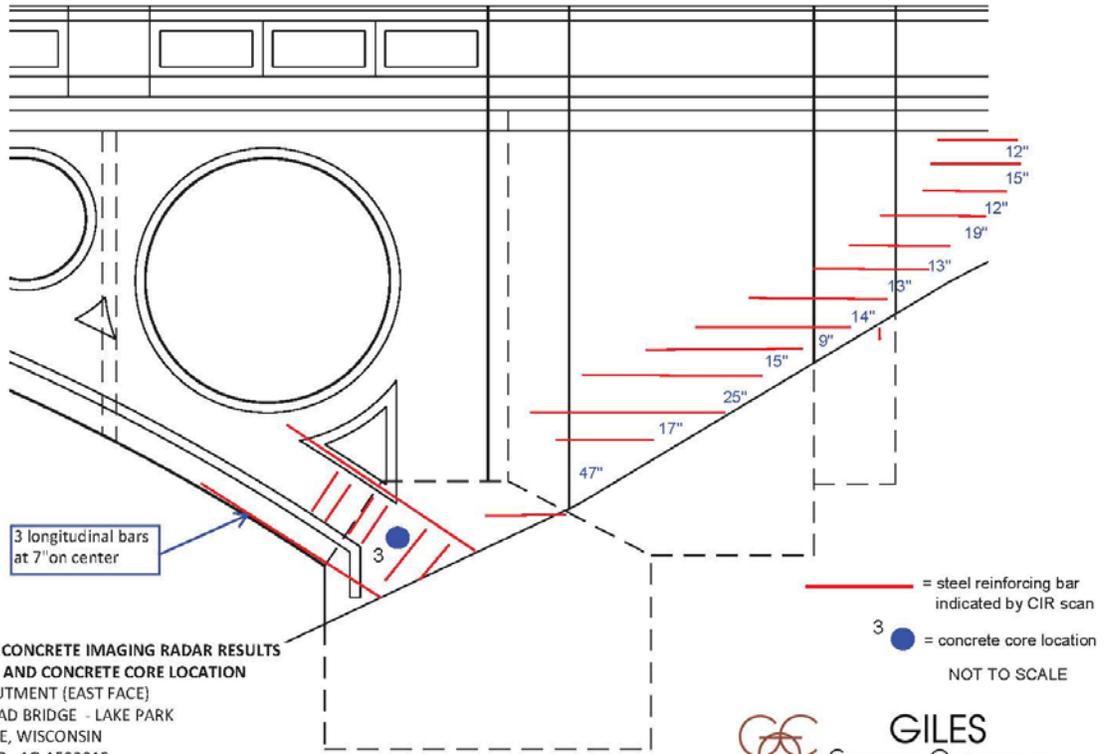
In summary, the CIR scanning indicated longitudinal steel reinforcement in the locations generally depicted on the original building plans. Additionally, the CIR scanning indicated the presence of three reinforcing bars, spaced at approximately 7 inches on center, within the 22± inch wide flange at the bottom of the arch. Additional steel reinforcement, likely indicating shear reinforcement, was also detected during the CIR scanning. The apparent shear reinforcement detected during CIR scanning was, in general, somewhat consistent with that shown on the original plan; however, the reinforcement indicated by the CIR scanning was generally more random than that shown on the plan. Additionally, shear reinforcing bars were generally not observed by CIR scanning in both directions, as indicated on the original plans. However, it should be noted that reinforcing may be present and not detected by the CIR scanning, due to its depth, shielding by other steel bars, or other factors. The results of the CIR scanning performed on the east and west sides of the thrust blocks are shown on the attached Figures 1 through 4.

FIGURE 2 - CONCRETE IMAGING RADAR RESULTS AND CONCRETE CORE LOCATION
 NORTH ABUTMENT (EAST FACE)
 RAVINE ROAD BRIDGE - LAKE PARK
 MILWAUKEE, WISCONSIN
 PROJECT NO: 1G-1503018

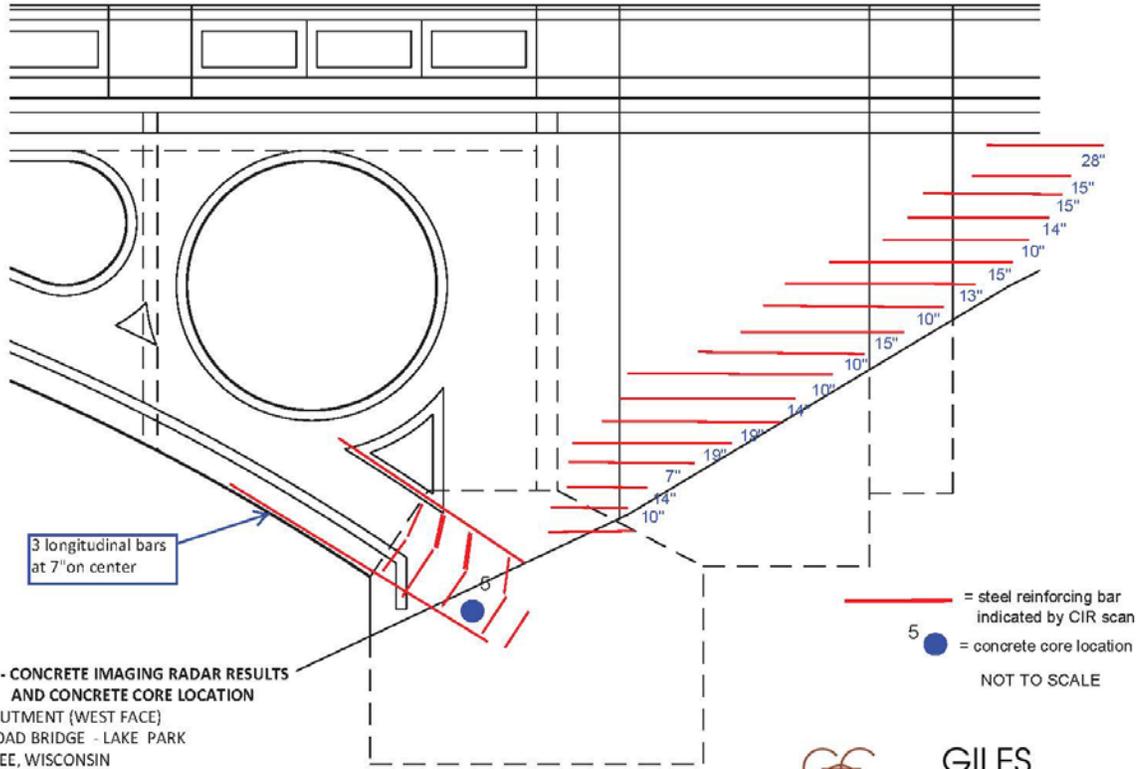
FIGURE 3 - CONCRETE IMAGING RADAR RESULTS AND CONCRETE CORE LOCATION
 SOUTH ABUTMENT (WEST FACE)
 RAVINE ROAD BRIDGE - LAKE PARK
 MILWAUKEE, WISCONSIN
 PROJECT NO: 1G-1503018

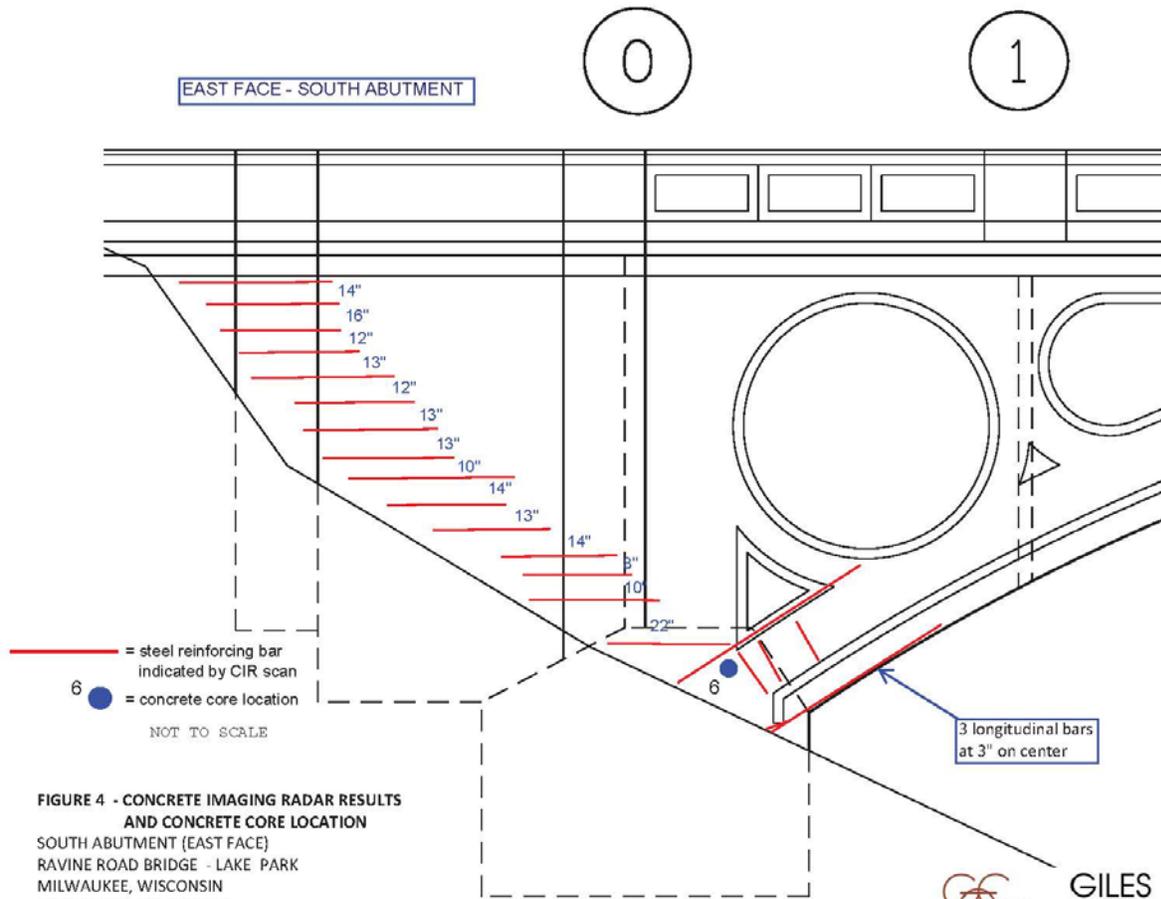
FIGURE 4 - CONCRETE IMAGING RADAR RESULTS AND CONCRETE CORE LOCATION
 SOUTH ABUTMENT (EAST FACE)
 RAVINE ROAD BRIDGE - LAKE PARK
 MILWAUKEE, WISCONSIN
 PROJECT NO: 1G-1503018

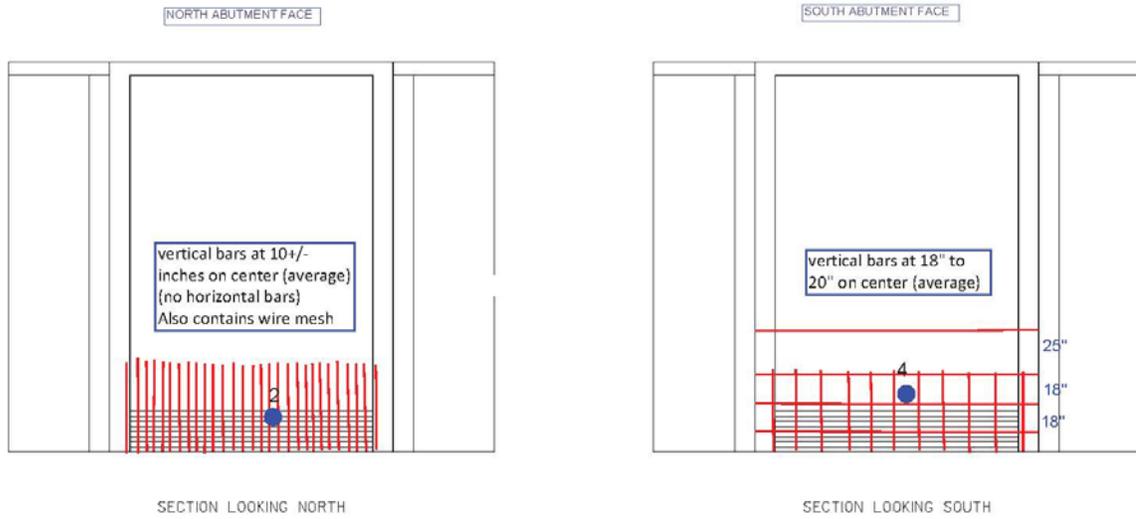
CIR scanning on the south face of the north abutment thrust block indicated vertical reinforcing steel at a spacing of approximately 10 inches on center. At the north face of the south abutment thrust block, vertical steel reinforcing at spacings between 18± and 20± inches was indicated by the scanning. Additionally, four horizontal steel bars were indicated by the CIR scanning at the north face of the south abutment thrust block. Wire fabric reinforcement was interpreted to be present at the north abutment thrust block face. The wire fabric appears to be related to surface patching previously performed on the south face of the north abutment thrust block. The results of the CIR scanning performed on the north and south faces of the thrust blocks are shown on the attached Figure 5.

FIGURE 5 - CONCRETE IMAGING RADAR RESULTS AND CONCRETE CORE LOCATIONS
 NORTH AND SOUTH ABUTMENT FACES
 RAVINE ROAD BRIDGE - LAKE PARK
 MILWAUKEE, WISCONSIN
 PROJECT NO: 1G-1503018

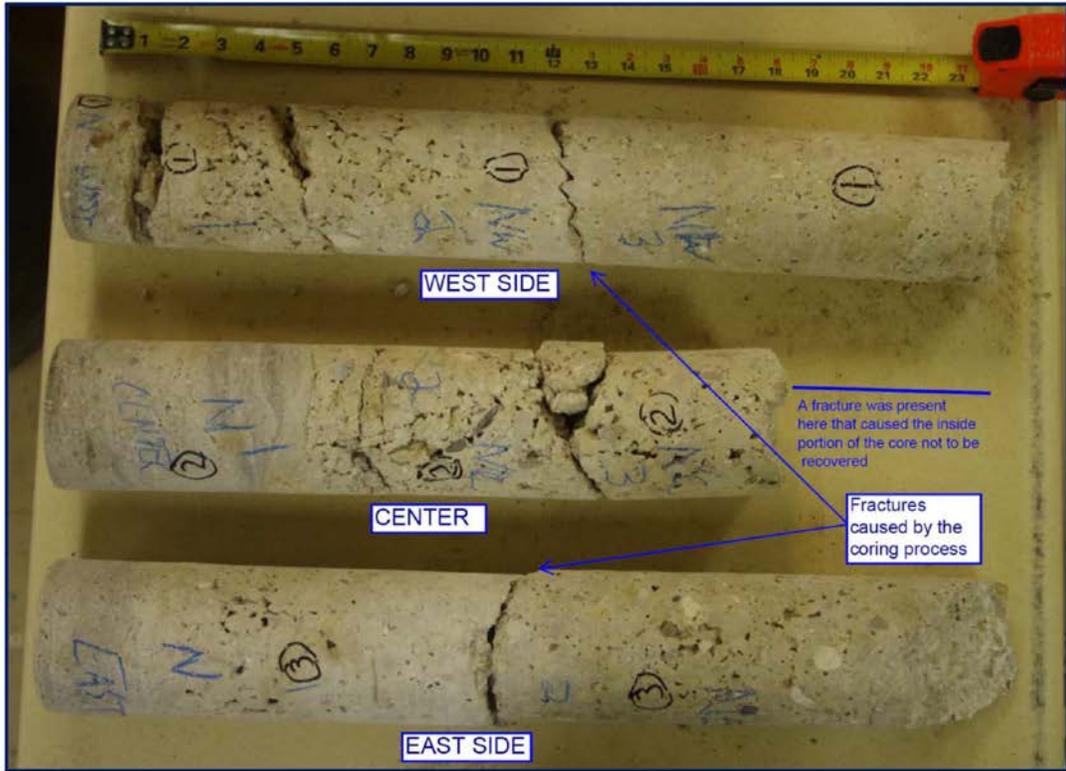
FIGURE 18 – CONCRETE CORE PHOTOGRAPHS

concrete cores recovered. The lower portions of Cores 2 and 5 were not recovered due to deeper fractures. A summary of the concrete core specimens recovered from the coring is provided in Table 2 below. Photographs of the core specimens recovered from the site are also provided in Figures 18 and 19.

Ravine Road Bridge - Lake Park
 North Abutment
 Milwaukee, Wisconsin
 Project No. 1G-1503018

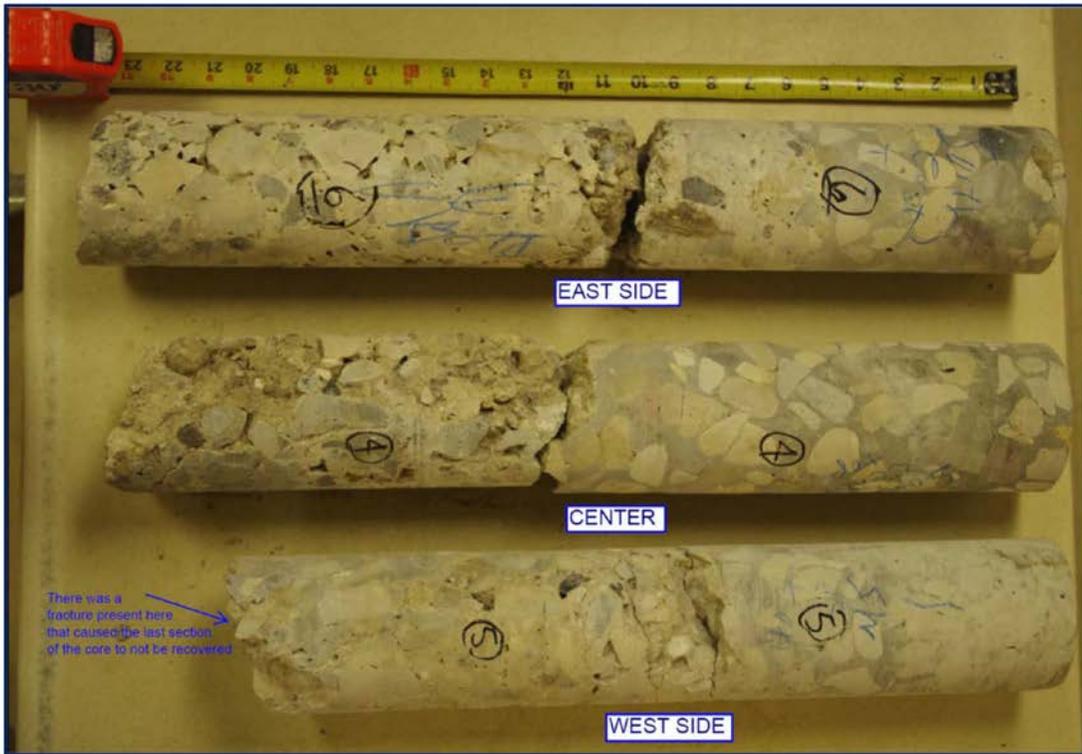
FIGURE 19 – CONCRETE CORE PHOTOGRAPHS

Ravine Road Bridge - Lake Park
South Abutment
Milwaukee, Wisconsin
Project No. 1G-1603018
