2013 WRONG-WAY DRIVER ANALYSIS

23 JANUARY 2014

Re: Wrong-Way Driver Analysis

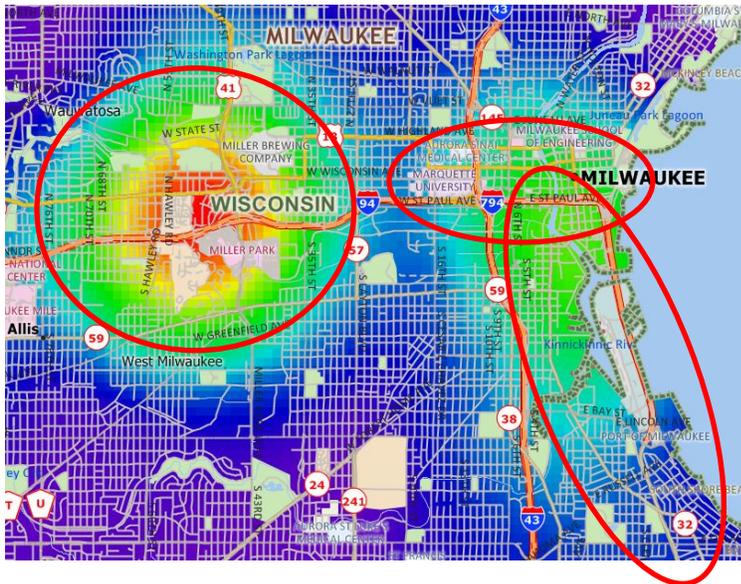
Based on reports of wrong-way drivers, the density grid shown to the left correlates to areas that have been identified as having poor design and minimal / ineffective signage. The highest frequency is occurring in and around the downtown Milwaukee area along I-94 and I-794.
