HOAN BRIDGE IN-DEPTH INSPECTION PRELIMINARY SUMMARY REPORT

**Structure B-40-400
Units 1A/1B through S24**

Wisconsin DOT Project ID 1300-00-05

January 14, 2011

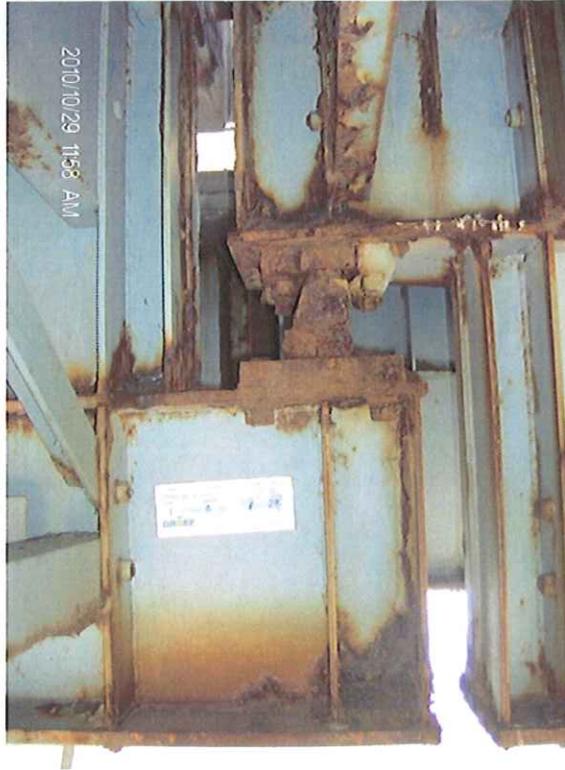
Scaling rust or laminated rust has built up on the sole plate of most lower laps. The corrosion product traps moisture which promotes further rusting, and it may restrict free movement of the rocker bearing. The curved bearing surfaces of some rockers were found to have rust pits, resulting in higher bearing or contact stresses and pockets for moisture and debris to accumulate (Photo 48). Rust pit depths are estimated to be 1/8". Some rockers seemed to be excessively tipped for the given ambient temperature (Photo 49).

Photo 49: Excessively tipped multigirder rocker bearing

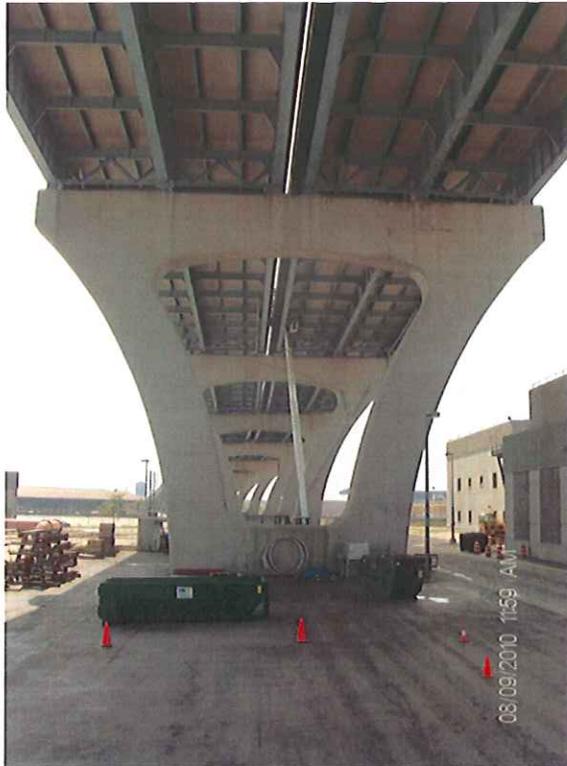
Piers - Flexural and shear cracks are common at delta piers 2S to 14S and 2N to 9N (Photo 64). Some of the delta piers located near the main span contain numerous delaminations, particularly piers 2N and 2S which are situated directly below finger plate expansion joints (Photo 65).

Photo 64: Typical delta pier

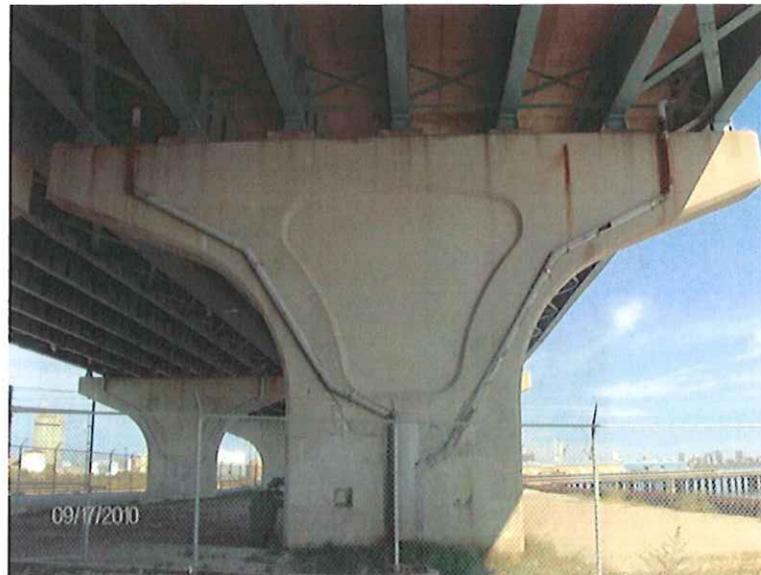
Solid piers 10N to 4-5A, 2-6B, and S15 to 56S/68S/71S, are generally in good condition, and contain only nominal cracks (Photo 66). Approximately 10% of these solid piers were found to have local delaminations or surface spalls with exposed rebar. Pier 4 of Unit 5A and Pier 3 of Unit 6B are in considerably worse condition than the other solid piers. These piers are directly below the expansion joint at the beginning of the concrete box girder units at the north end of the bridge, and contain numerous concrete delaminations.

Photo 66: Typical solid pier

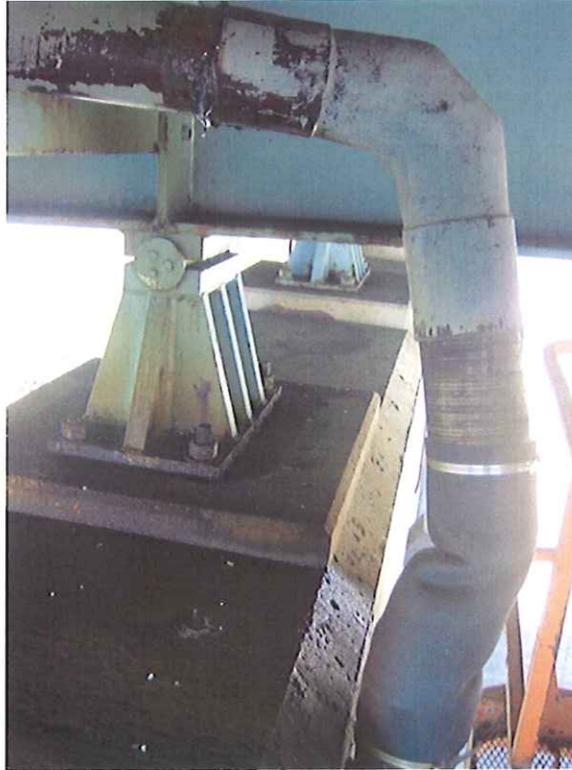
Downspouts - Most downspouts are clogged and inoperable (Photo 67). The rubber expansion boots on some downspouts are crushed, restricting the flow of water and trapping debris. A missing expansion boot and broken/disconnected downspouts were noted at a few piers. Many of the downspouts are disconnected at the joints, or have failed hanger connections.

Photo 67: Misaligned downspout and crushed expansion boot
