Pulaski Indoor Family Center Building Assessment

July 7, 2010

Pulaski and Noyes Indoor Family Aquatic Center Planning

**Milwaukee County – Pulaski Pool Building
July 7, 2010**

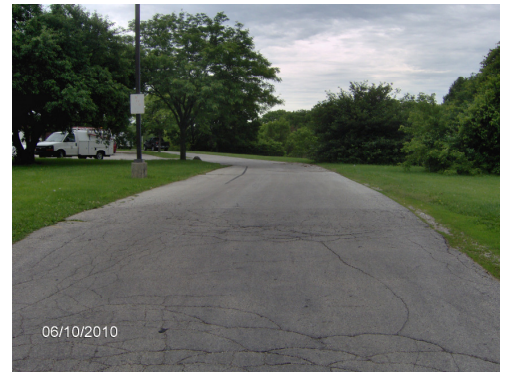
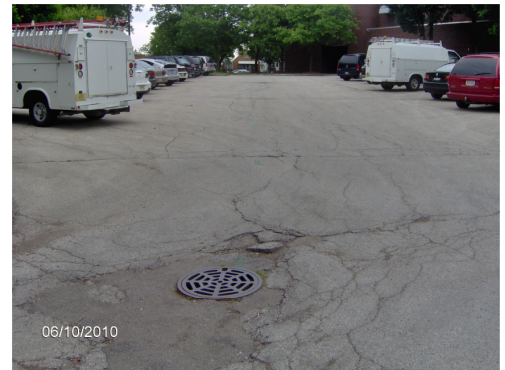
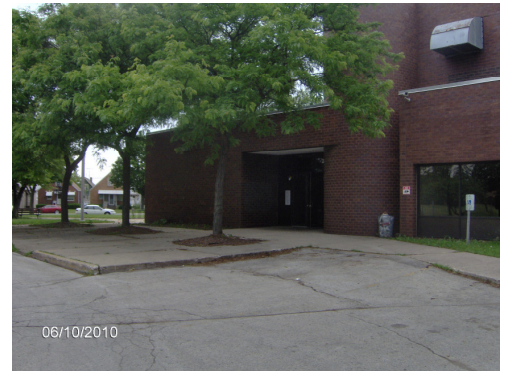
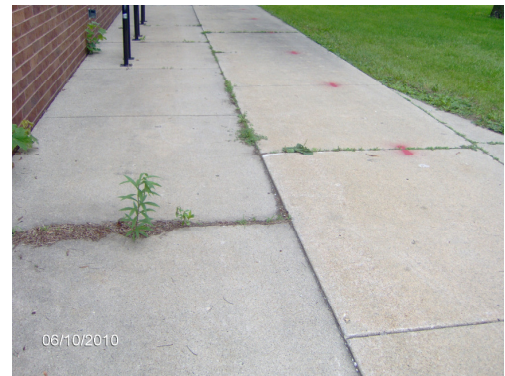
The existing concrete sidewalks at the building entrances are in relatively good condition. The exception to this is the sidewalk along the east side of the building where settlement has occurred in the first slab adjacent to the building, creating a tripping hazard. If this sidewalk will be used as part of the new site plan it is recommended to replace or mudjack this section.

The site contains many mature trees in the area of the building entrance, north of the parking lot, and south of the building. The trees at the building are recommended to be pruned to improve the visibility of the entry locations. There is one tree north of the parking lot that is dying and should be removed.

The existing parking lot is located on the north side of the building with a separate entrance and exit drive from and to West Cleveland Avenue. The parking lot pavement is in poor condition and in need of repair or replacement. The pavement has multiple areas of failure with potholes developing around the storm inlets. Additionally there is an area in the loading dock with a circular staining/ cracking pattern that was observed.

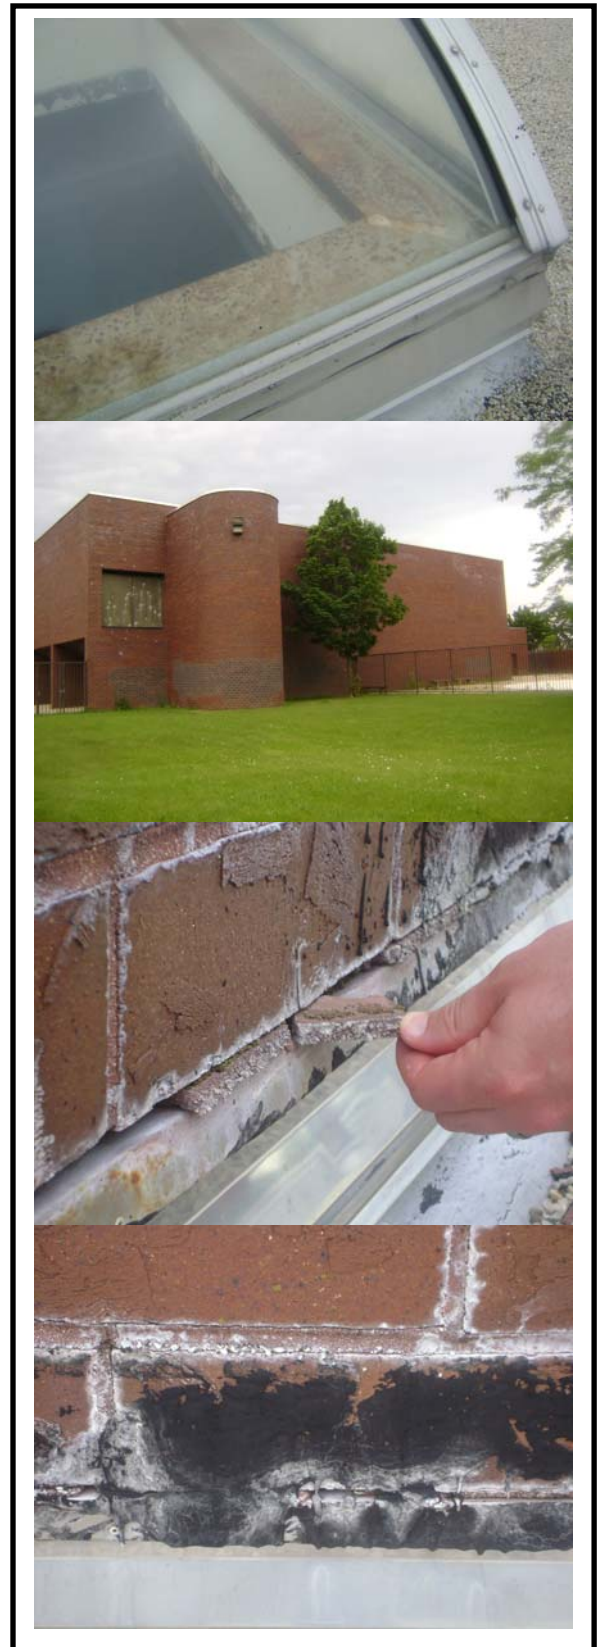
The exterior brick walls are in fair condition. Significant efflorescence is visible in numerous locations around the building. This is caused by moisture in the cavity migrating back through the masonry and mortar. As the moisture evaporates on the surface, it deposits minerals leached from the masonry and mortar on the surface. In locations where the wall is in relatively good condition, this moisture is most likely due to face absorption from the exterior and interior. Cotton wick weeps can be seen above most lintels, but these have long been ineffective, as over time the minerals deposited from weeping moisture have hardened them and made them mostly impervious. Furthermore, no weeps or flashing can be seen on the bases of exterior walls and parapets. With few directed exfiltration locations, moisture migrates back out throughout the face of the wall, leaving the efflorescence on the surface. This is particularly acute at the bases of walls and parapets, where mortar joints have been spalling out. As the moisture builds up and goes through freeze/thaw cycles, it is pushing the mortar out of its bed. Where it has not spalled yet, the mortar joints can be seen to have significant mineral deposits on the face where, again pointing to significant moisture build-up in the wall cavity. A more severe wall problem is the condition of the steel lintels over wall openings. In almost all cases, severe corrosion of the bottom plates of these lintels can be observed. The build-up of moisture in the wall is likely a significant contributor to this problem.

Replacement of the roof has likely curbed one of the significant contributors to wall moisture. But, in addition to infiltration of weather related water, another contributor to moisture in the wall cavity is likely the humid air in the pool room. As mentioned in an above paragraph, existing drawings do not indicate any sort of air or vapor retarder in

Steps should be taken to further mitigate water problems in the wall. Clear sealers can be applied to the interior face of the wall to decrease interior to exterior vapor migration. To assist moisture exfiltration from inside the wall cavity, weeps could still be introduced at the base and tops of the walls by removing the mortar at head joints between bricks at regular intervals, and leaving these head joints open. A second option may be to remove whole bricks at regular intervals and replace them with louvered vents to the cavity. Once this is done, spalled mortar joints should be repaired using tuck pointing, and sealants at all brick control joints should be removed and replaced.

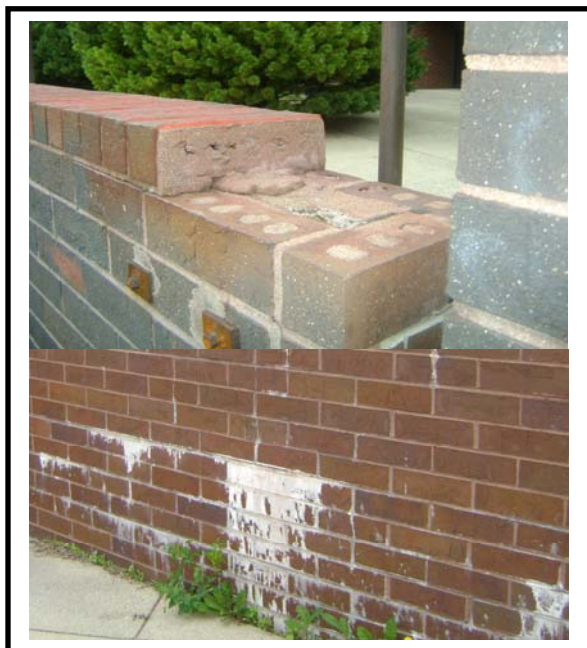
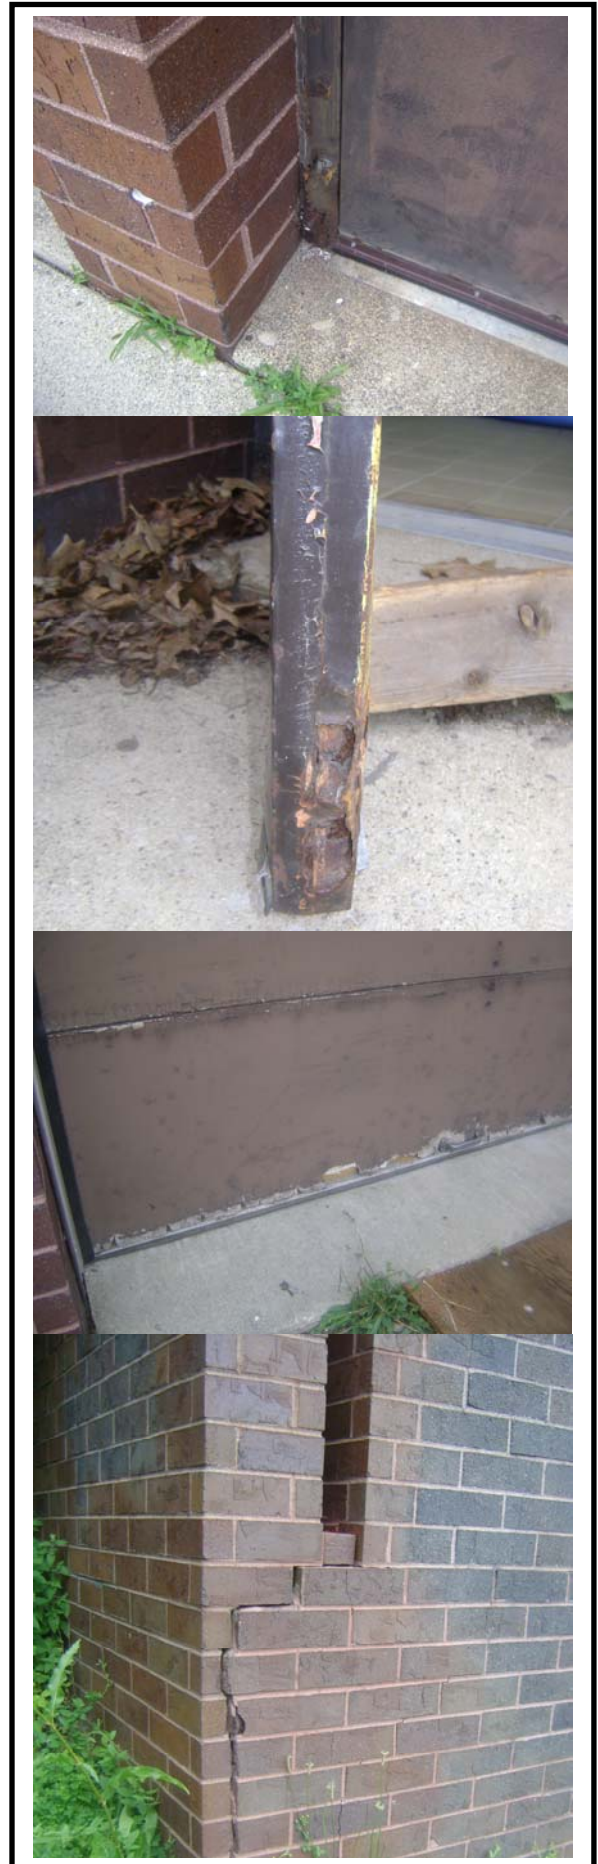
The overhead sectional service door appears to be of wood construction. The paint is peeling/faded away, and the bottom panel, in particular, is moderately to severely deteriorated. Temporary repairs can possibly be made, but for the long term, this door should be replaced.

The garden walls which surround the patio and wading pool areas are in particularly poor condition. According to the original drawings, these were constructed with a metal coping over the brick cap. This metal cap flashing is no longer present, and has likely been gone for a long time. Thus, these walls are absorbing a great deal of water through the brick cap. In the cold months, the freeze/thaw cycle of this water is putting enormous strain on the masonry and joints. As a result, these walls are experiencing significant cracking, spalling and efflorescence. (Additionally, they appear to be frequent targets of vandalism.) In order to maintain these walls long term, cracks should be repaired, missing/spalled bricks should be replaced, and new metal copings should be added at the top to prevent water infiltration at the top from rain and snowmelt. These garden walls are constructed of solid brick 3 wythes wide, and photos seem to indicate that the brick cores were grouted solid, leaving no true air cavities in the wall. Because of this, efforts to create weeps at the top and base of the wall would be mostly, if not completely, ineffective. Metal fences need repainting.

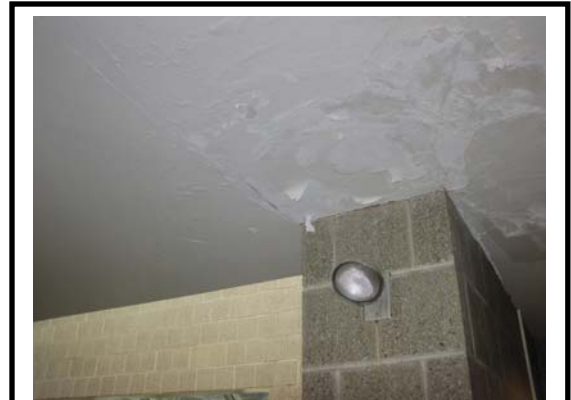
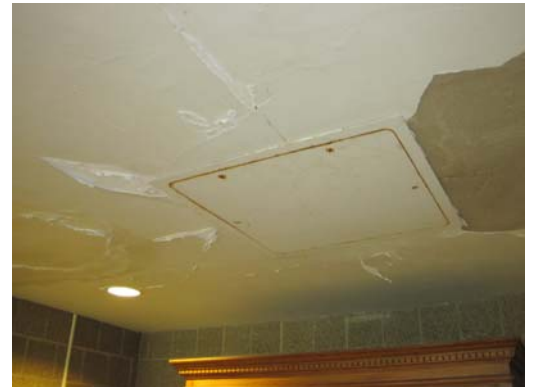
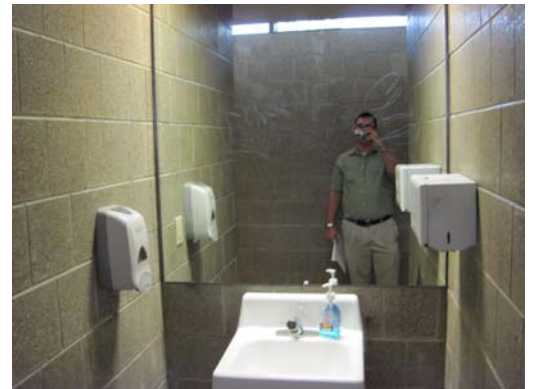
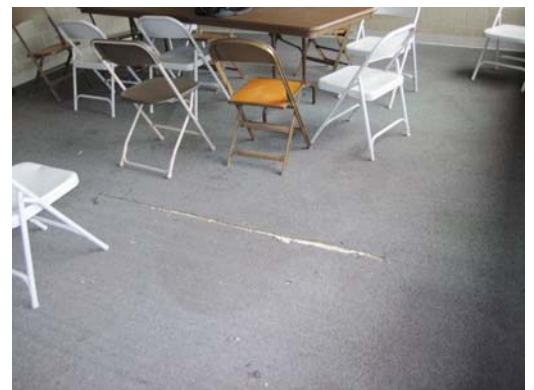
The entrance lobby is in great shape except for the ceiling. The plaster ceiling has signs of extensive water damage from either leaky walls or the roof above. It appears that some of the leaks are still occurring. Finding the leaks and repairing the ceiling is a necessity to providing a welcoming and warmer entry.

The men's restrooms off the lobby were in good shape but out dated. (The women's room is assumed to be in similar condition.) There was evidence of graffiti on the mirror that was attempted to be repaired, but still evident. Also, glass mirrors have lost a small amount of silvering around the edges. The toilet stalls do not have any significant damage or graffiti, and the door hardware appears to be in working condition. The exhaust grill was fully clogged due to dust and debris over it. We recommend the grill be cleaned to improve air quality and improve performance of the HVAC system.

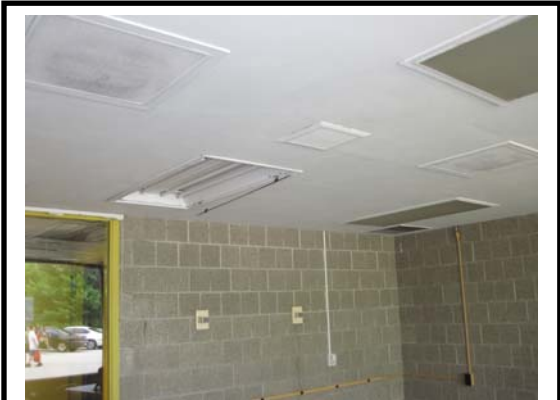
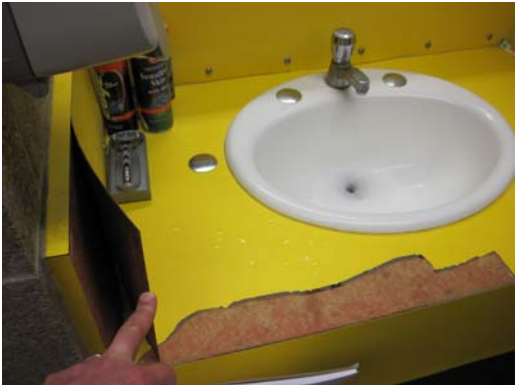
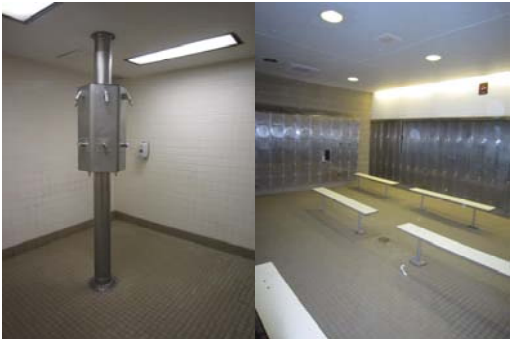
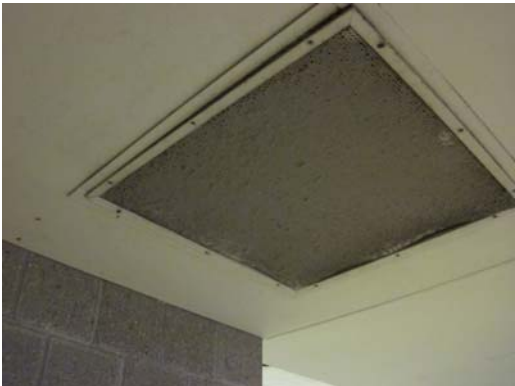
Within the locker room/storage room there is some minor water damage in the ceiling, which looks to be from many years prior. The sliding door to the locker room is falling from the ceiling and needs to be repaired or replaced with a swinging door and frame.

The locker rooms are adjacent to the lobby with both the women’s and men’s having direct access to the pool. The men’s locker room is in moderate condition but dated. The layout of the locker room is a large open space with a few areas for privacy. The lockers are made of stainless steel, which are in pretty good shape with only one locker door missing out of the group. The solid surface countertops and sinks are in fair condition. The countertop is sagging/not level and is causing water to damage the joint at side splash and wall.

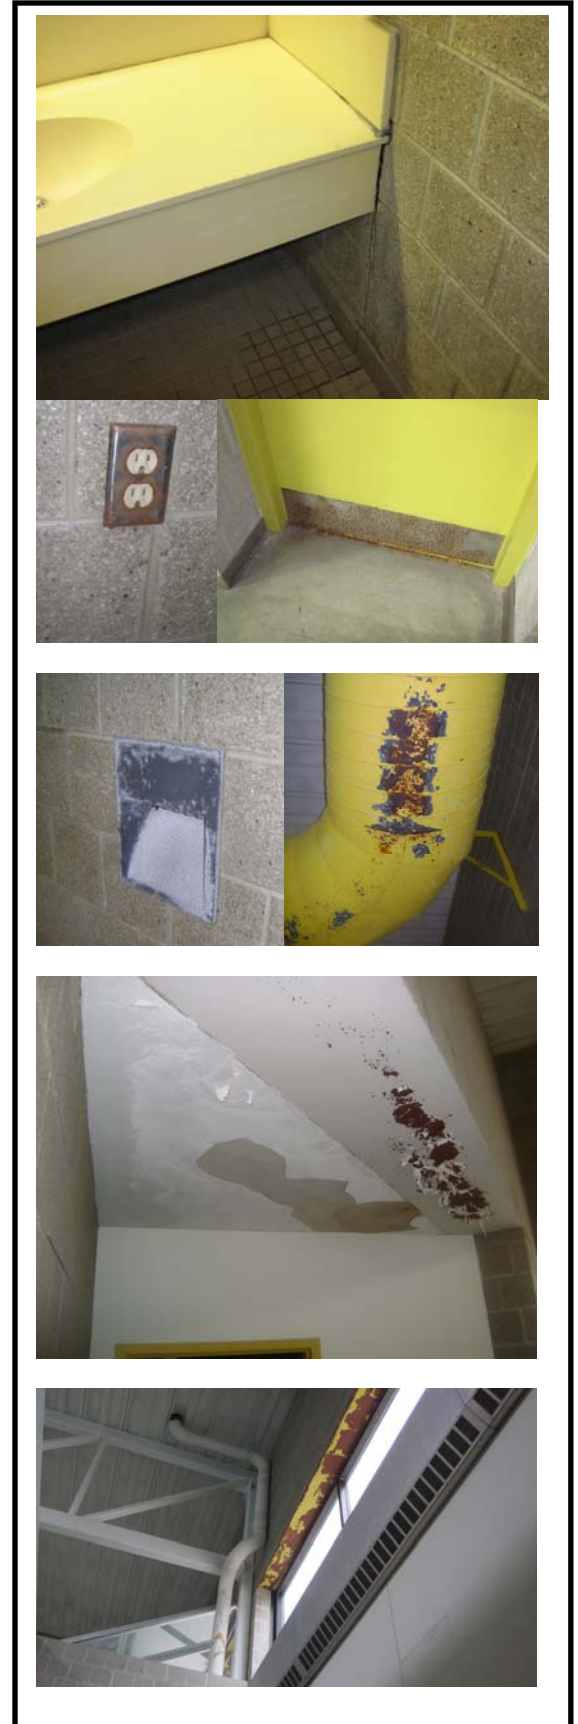
Most of the metal objects including; trusses, beams, decking, HVAC ducts, roof conductors, lintels, metal door frames and guard railings, appear to have original paint from the 1970's. The paint has/is cracking and peeling from all above. In many locations where the paint has peeled off rusting has occurred. The rusting appears to have only cause minor damage and if repaired soon and repainted it will limit the extent of the problem.

The lintels on the clearstory on the East wall have significant water damage. The damage is been caused

by moisture within the pool air condensing on the cold lintels in the winter and/or water penetrating from the exterior wall. From our visual review and comments for the maintenance staff we believe that the exterior wall is the main culprit and will need to be repaired prior to the lintels being repaired and repainted. Most likely this wall is also causing the damage/leaks in the ceiling in the lobby.

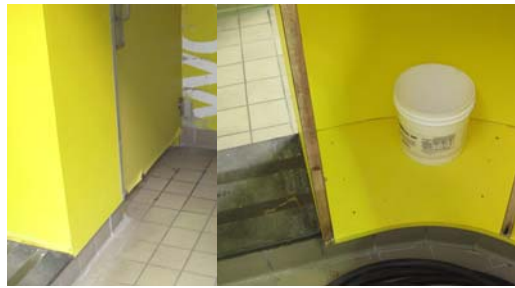
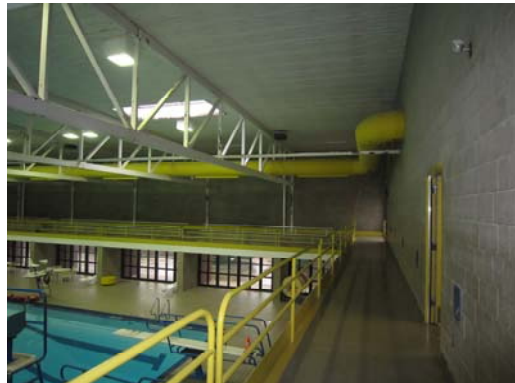
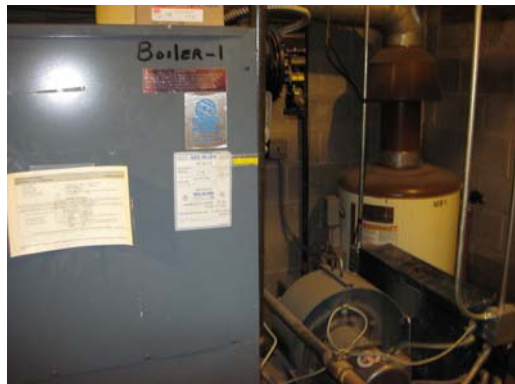
The bones of the rooms; walls, doors, floors and ceilings appear to be in good condition for the age of the building. The equipment is dated with some pieces rusting, special the electrical boxes in the pool equipment room. The rooms are all very limited for space and have no additional room for any future equipment. If any of the existing pieces of large equipment were to fail, their removal and replace would be a challenge due to the standard size doors (special the boiler room).

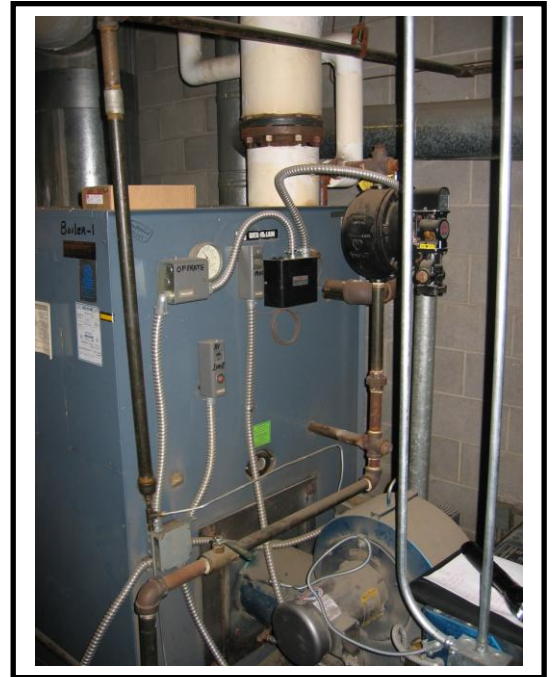
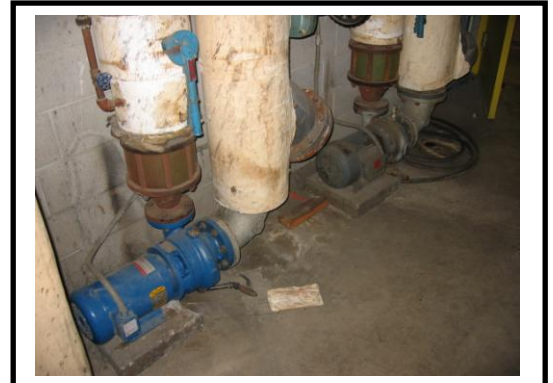
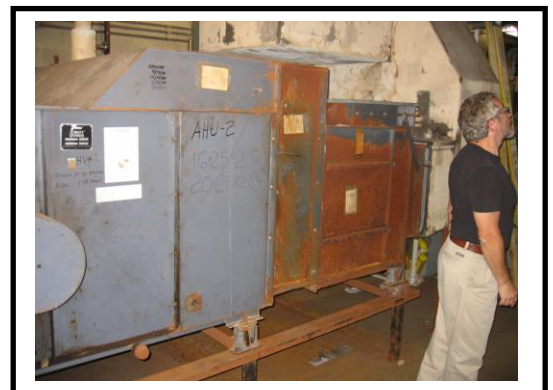
Most of the piping is black iron steel with the original isolation valves. Some of the isolation valves are not functional and resulting inability of ongoing maintenance (requires all hot water maintenance to be done during summer shut-down cycle). The hot water is distributed to the two air-handling units, de-frost control coils at the outside air heat exchangers, pool heater heat exchanger, cabinet heaters, unit heaters and baseboard radiators.

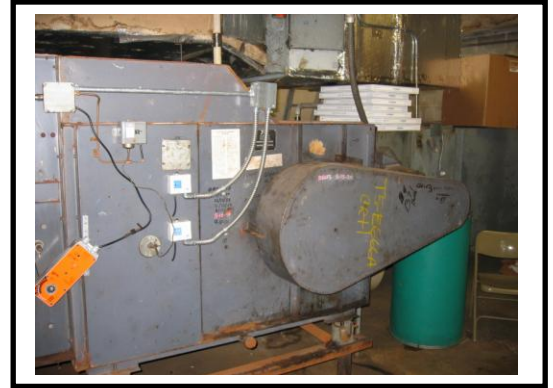
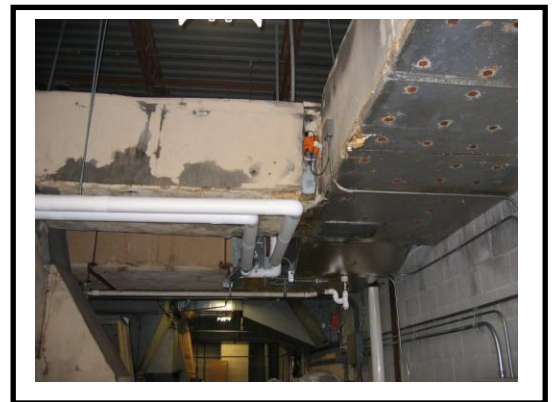
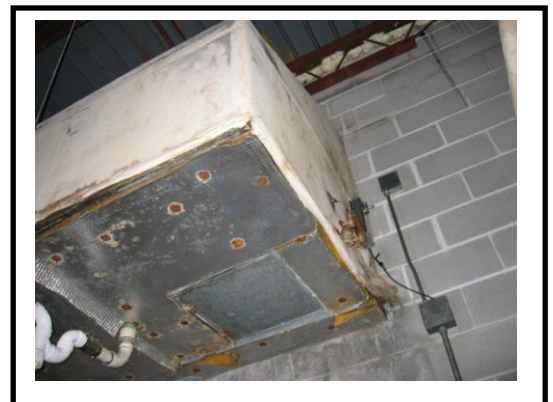
Ductwork distribution, especially outside air ductwork, and some of the exhaust air ductwork are corroded with moisture damaged insulation.

Diffusers, grilles, and registers throughout the building are covered in dust. These grilles and diffusers should be cleaned as an ongoing maintenance task.

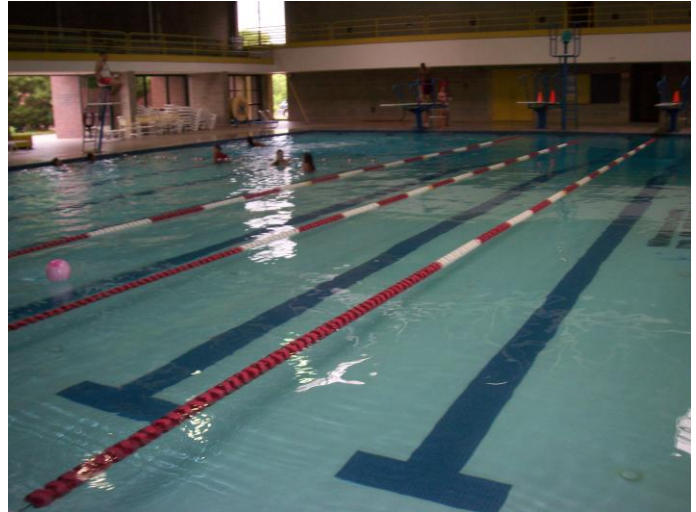
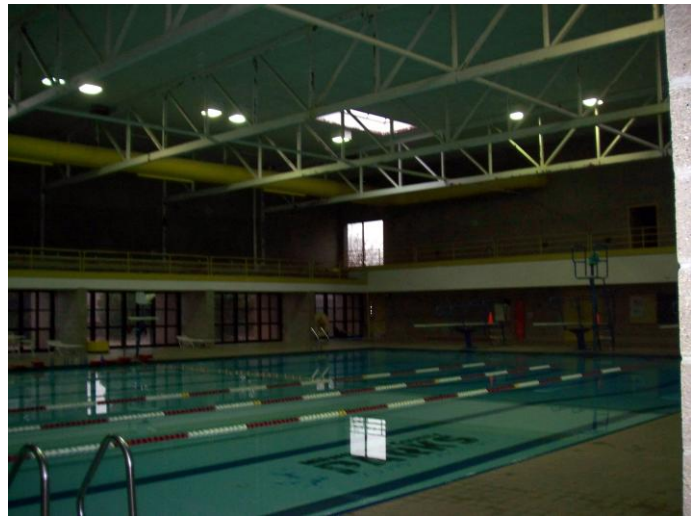
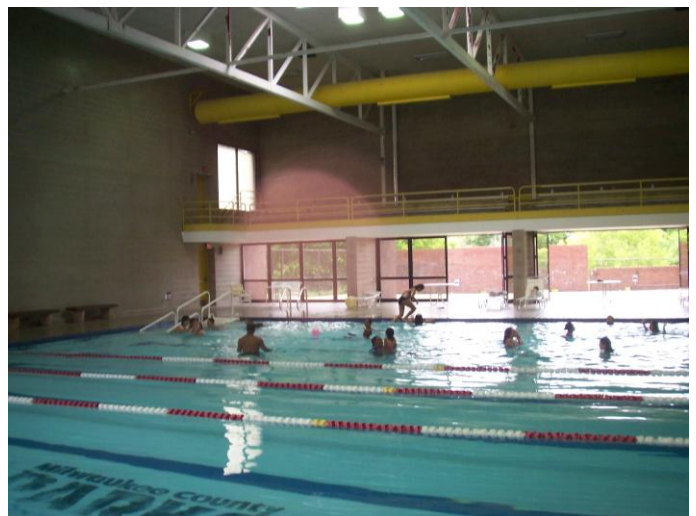
The pool deck and misc. deck equipment are in good condition. The pool deck consists of tiled concrete around the pool perimeter. Drainage of the main deck areas is achieved by sloping the deck to drain to the pool gutters. Standing water on the deck was not noted and indicates that the system is working adequately. Some corrosion is evident on the stainless steel ladders and other associated deck equipment.

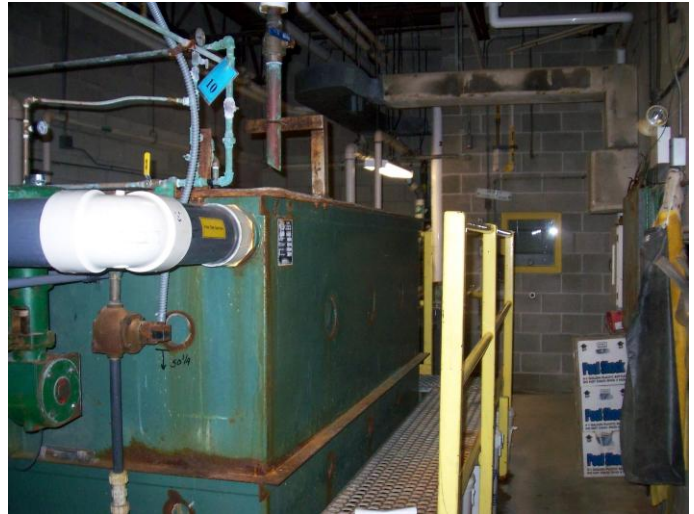
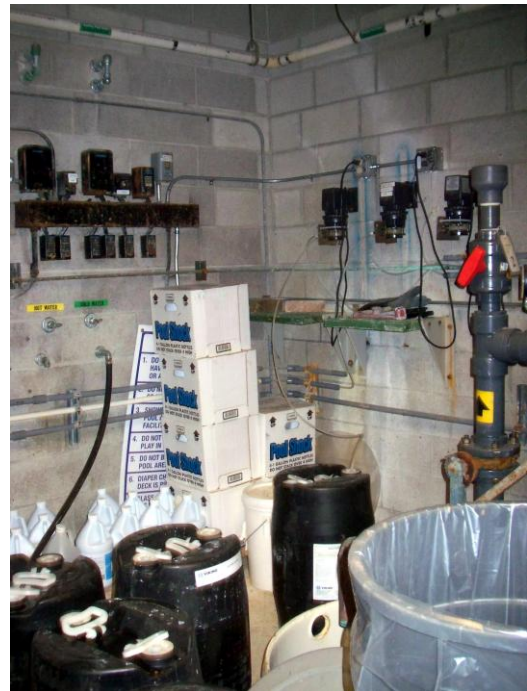
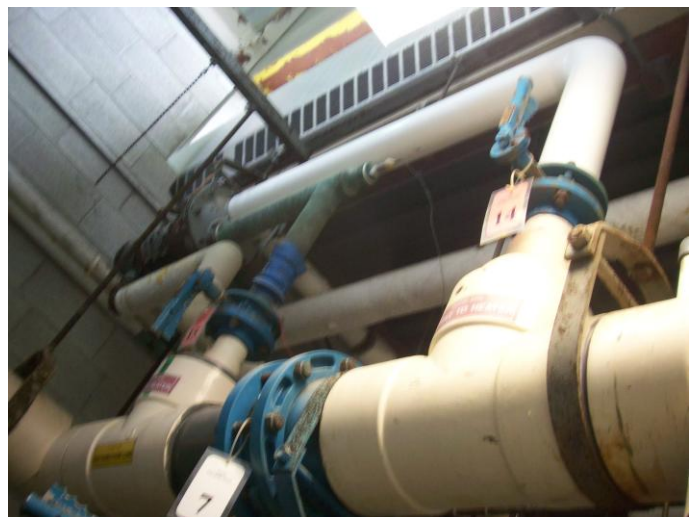
The indoor pool is heated through the use of a single wall water to water heat exchanger. Current code requires the use of a dual wall heat exchanger or non-toxic fluids in the boiler. This system uses the building boilers to provide heat. It is recommended that this system be replaced with an independent pool heater. Pool blankets are budgeted to be installed.
