ADDENDUM NUMBER 1

**PROJECT TITLE: GMIA HVAC System Retro commissioning**  
**Project Address: 5300 South Howell Avenue, Milwaukee, WI.**

Project Number: 5041-11457

Date of Addendum: January 11, 2013

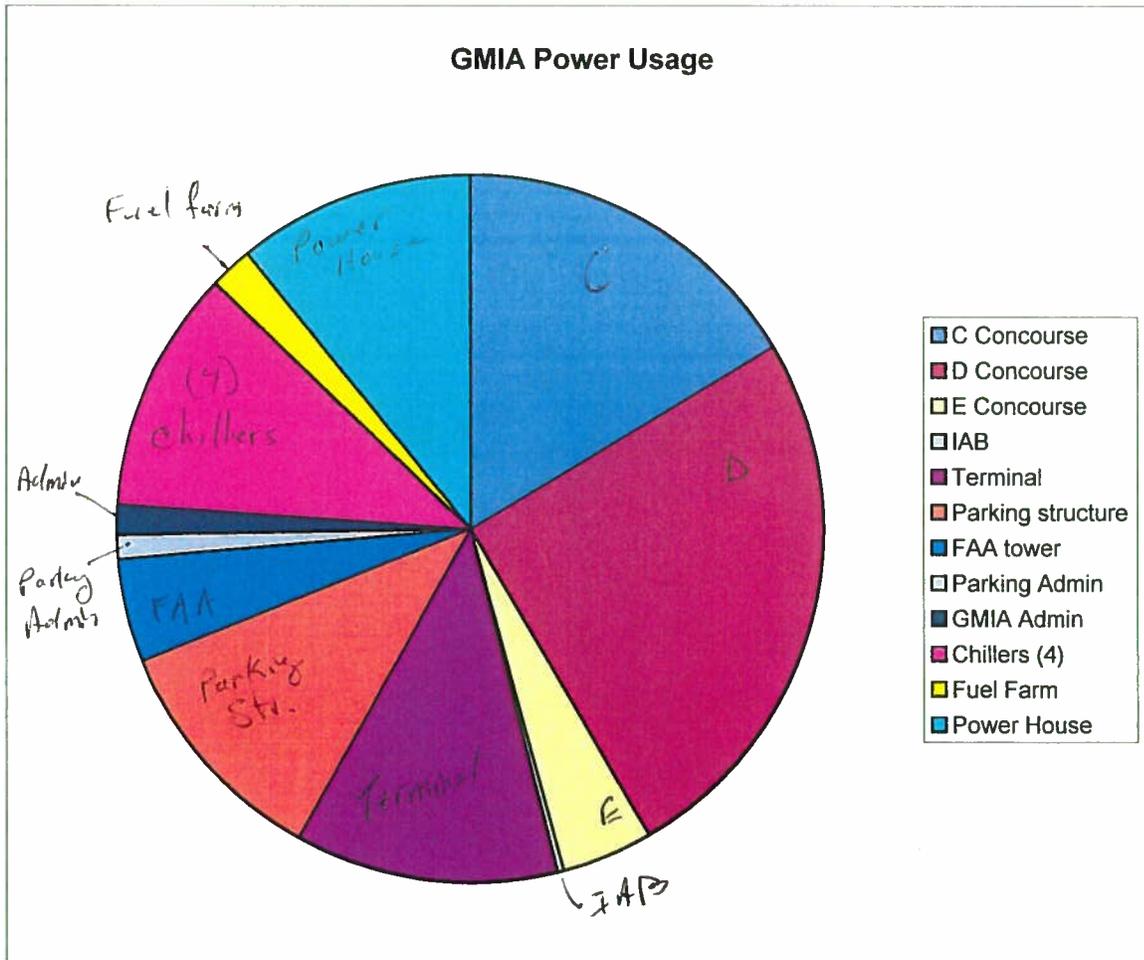
Power usage at GMIA

location	KVA max	percentage	Concourses C,D,E, IAB
C Concourse	1369	16%	46%
D Concourse	2124	25%	
E Concourse	337	4%	
IAB	43	1%	
Terminal	994	12%	
Parking structure	898	11%	
FAA tower	396	5%	
Parking Admin	107	1%	
GMIA Admin	99	1%	
Chillers (4)	948	11%	
Fuel Farm	166	2%	
Power House	899	11%	
<b>total</b>	<b>8380</b>	<b>100%</b>

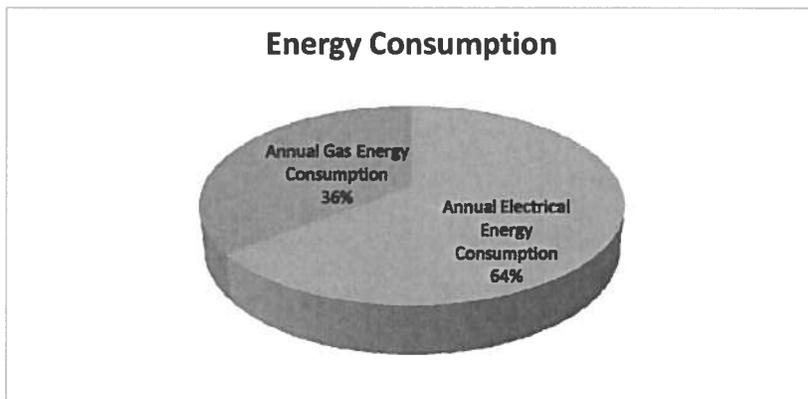
Annual Electrical Energy kBtu	130,045,500
Annual Gas Energy kBtu	72,226,400
Annual Total kBtu	202,271,900
Annual Electrical Energy Consumption	64.29%
Annual Gas Energy Consumption	35.71%

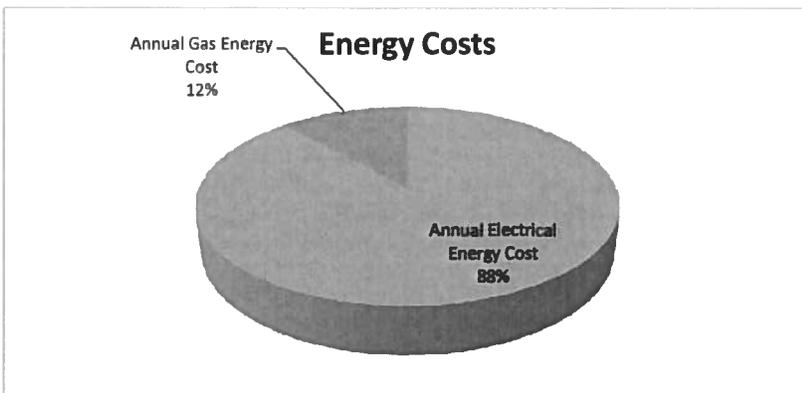
Energy Costs

Annual Electrical Energy Cost	\$2,915,101.73
Annual Gas Energy Cost	\$383,683.30
Total Annual Energy Cost	\$3,298,785.03
Annual Electrical Energy Cost	88.37%
Annual Gas Energy Cost	11.63%
