Estabrook Dam – A Discussion of Alternatives

Public Scoping Meeting
June 5, 2014

Estabrook Dam Environmental Assessment Public Scoping Meeting

Hydraulic Analyses of Alternatives

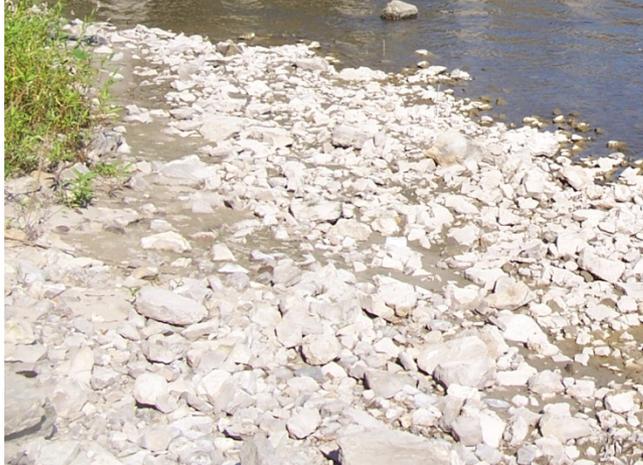
Gated Spillway
Section, 10
moveable gates
Photo 8/12/10

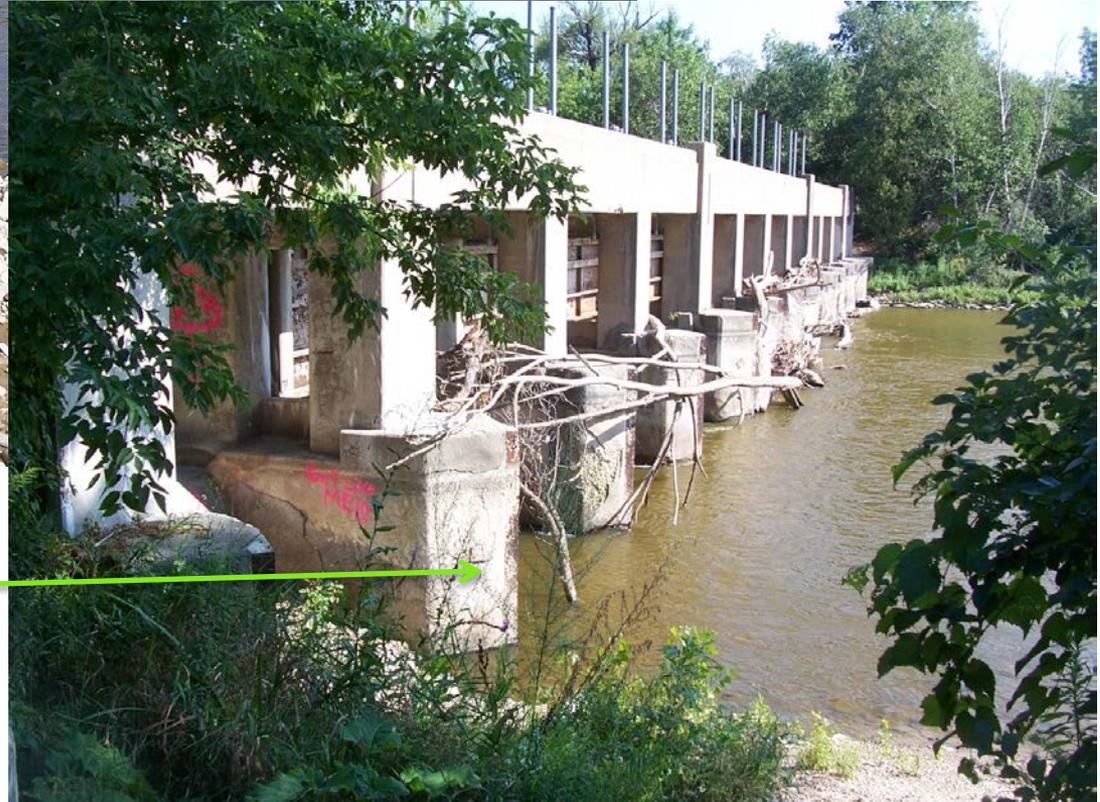
Photo 8/12/10
Concrete
Deterioration
concentrated in
lower piers

- Concrete and masonry weathering after 75+ years
- All deterioration is repairable
- Gated spillway requires upstream tie-down anchoring to resist full pool loading with ice loading and factor of safety
- Remove vegetation along shore near dam
- Maintenance and upgrade gates

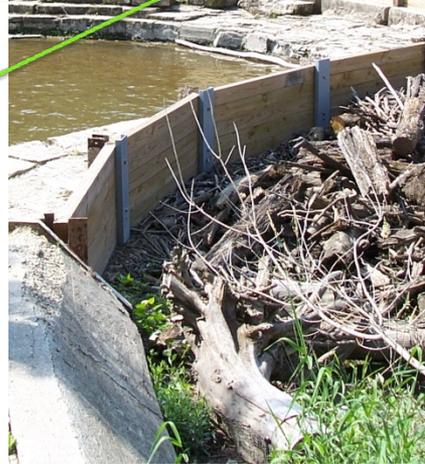
Overflow Spillway Before July 22, 2010

Photo 6/25/10

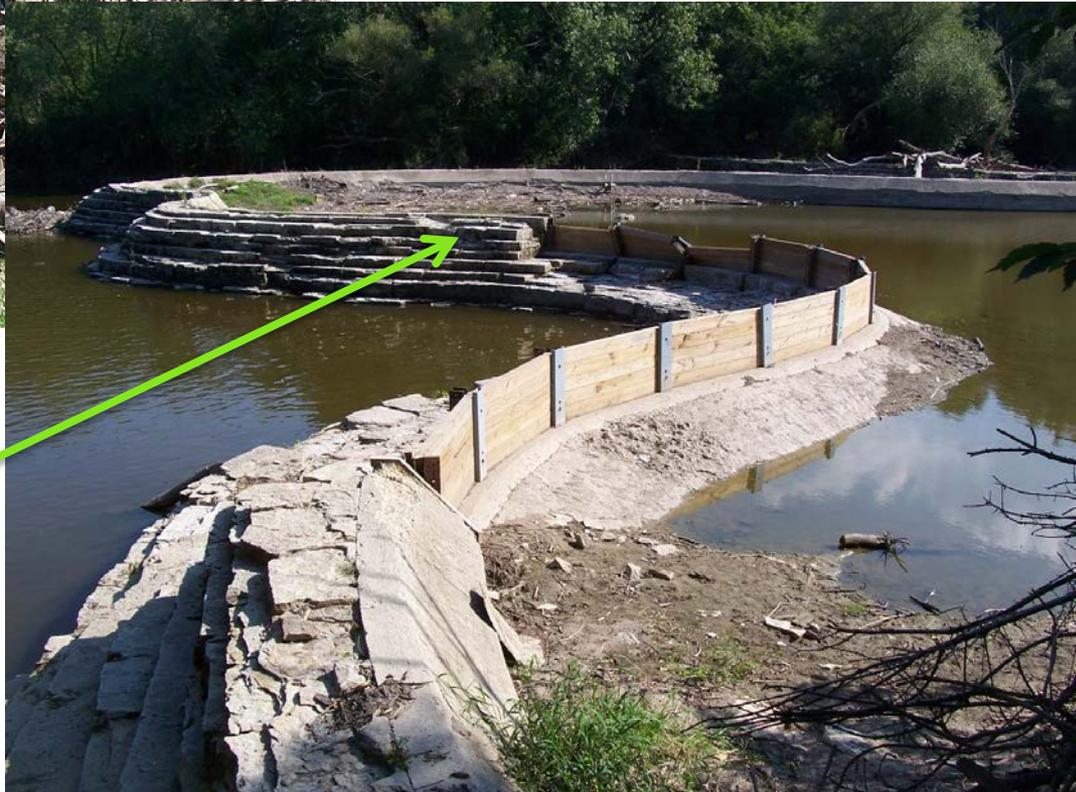
Overflow Spillway After July 22, 2010 (Taken 8/12/10)

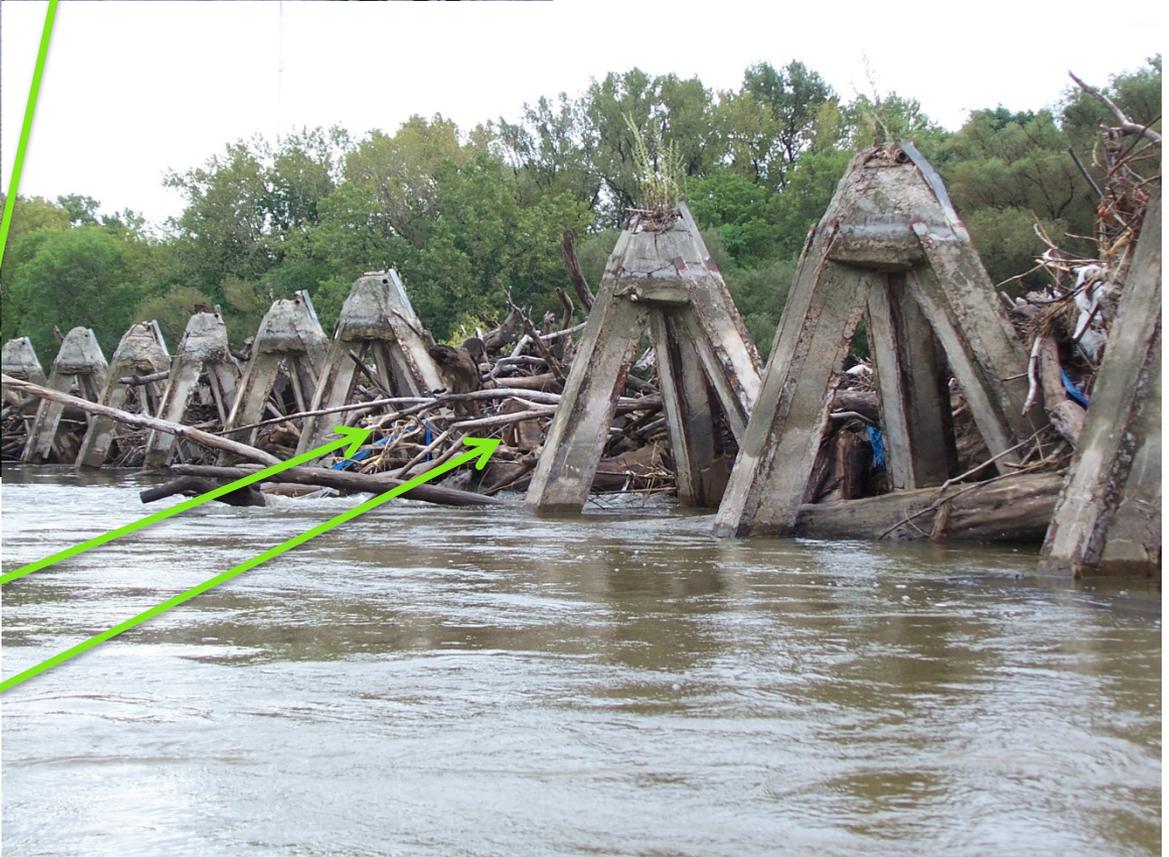
Ice Breakers, collected
new logs after July 22,
2010

Missing Icebreaker
Photo 8/12/10

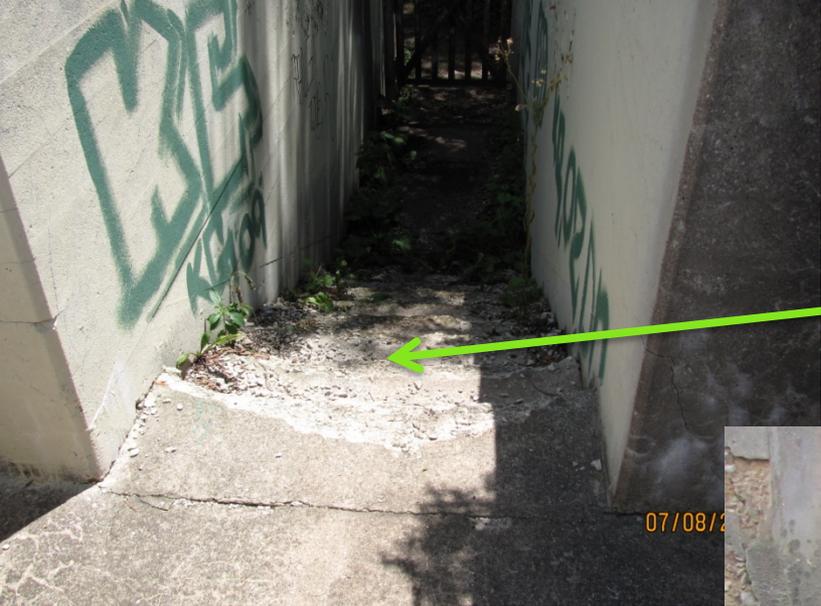
Repair stairs at both ends of gated spillway

Photo 7/8/10

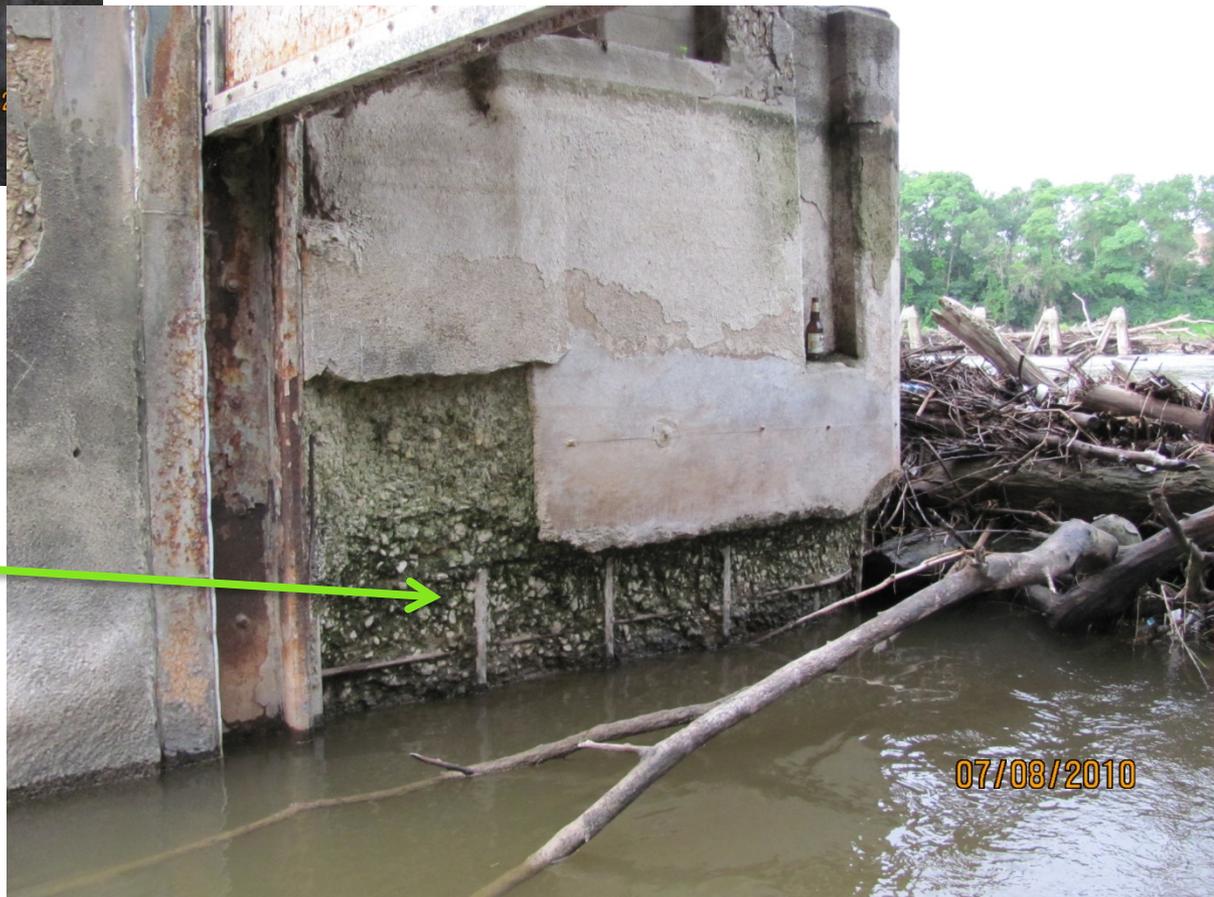
Repair deterioration below water line at gate piers

Photo 8/8/10

Overflow Spillway Debris Pre- and Post-July Flood

- Debris management is key element in annual O&M

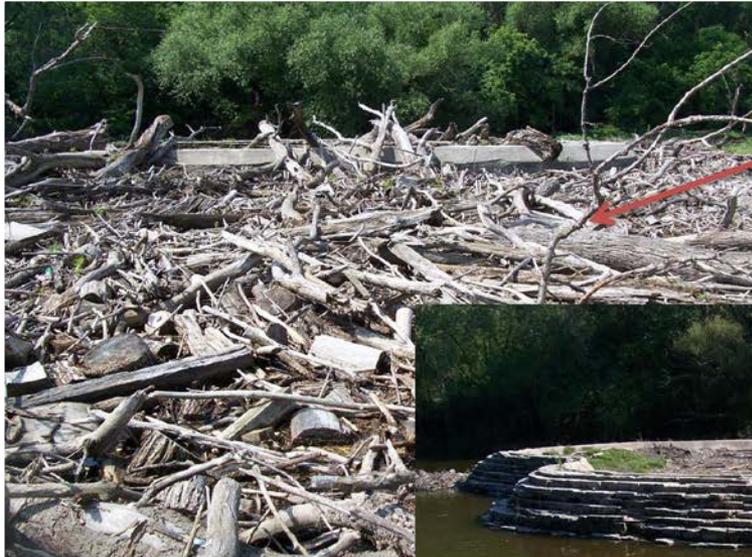
Overflow Spillway Before
July 22, 2010

Photo 6/25/10

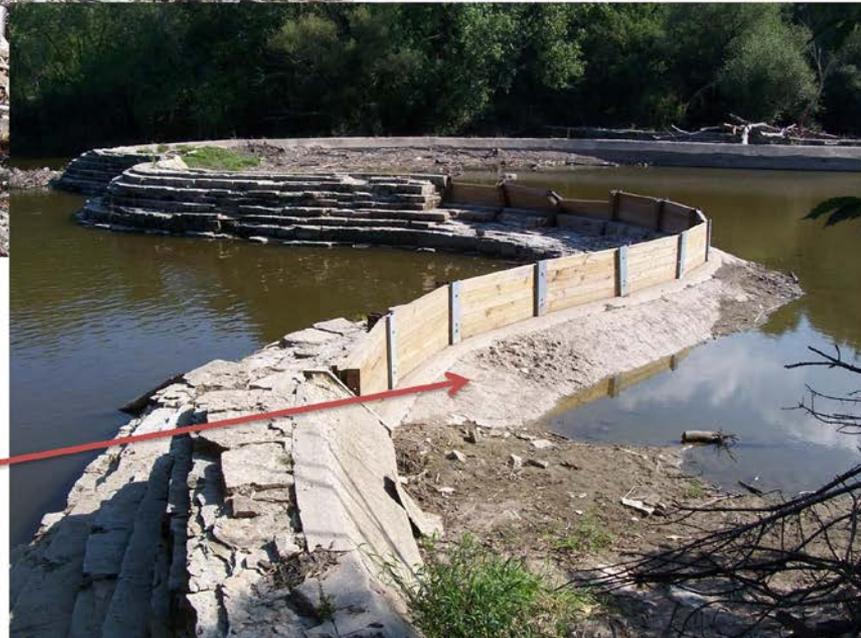
Spillway After July 22,
2010
(Taken 8/12/10)

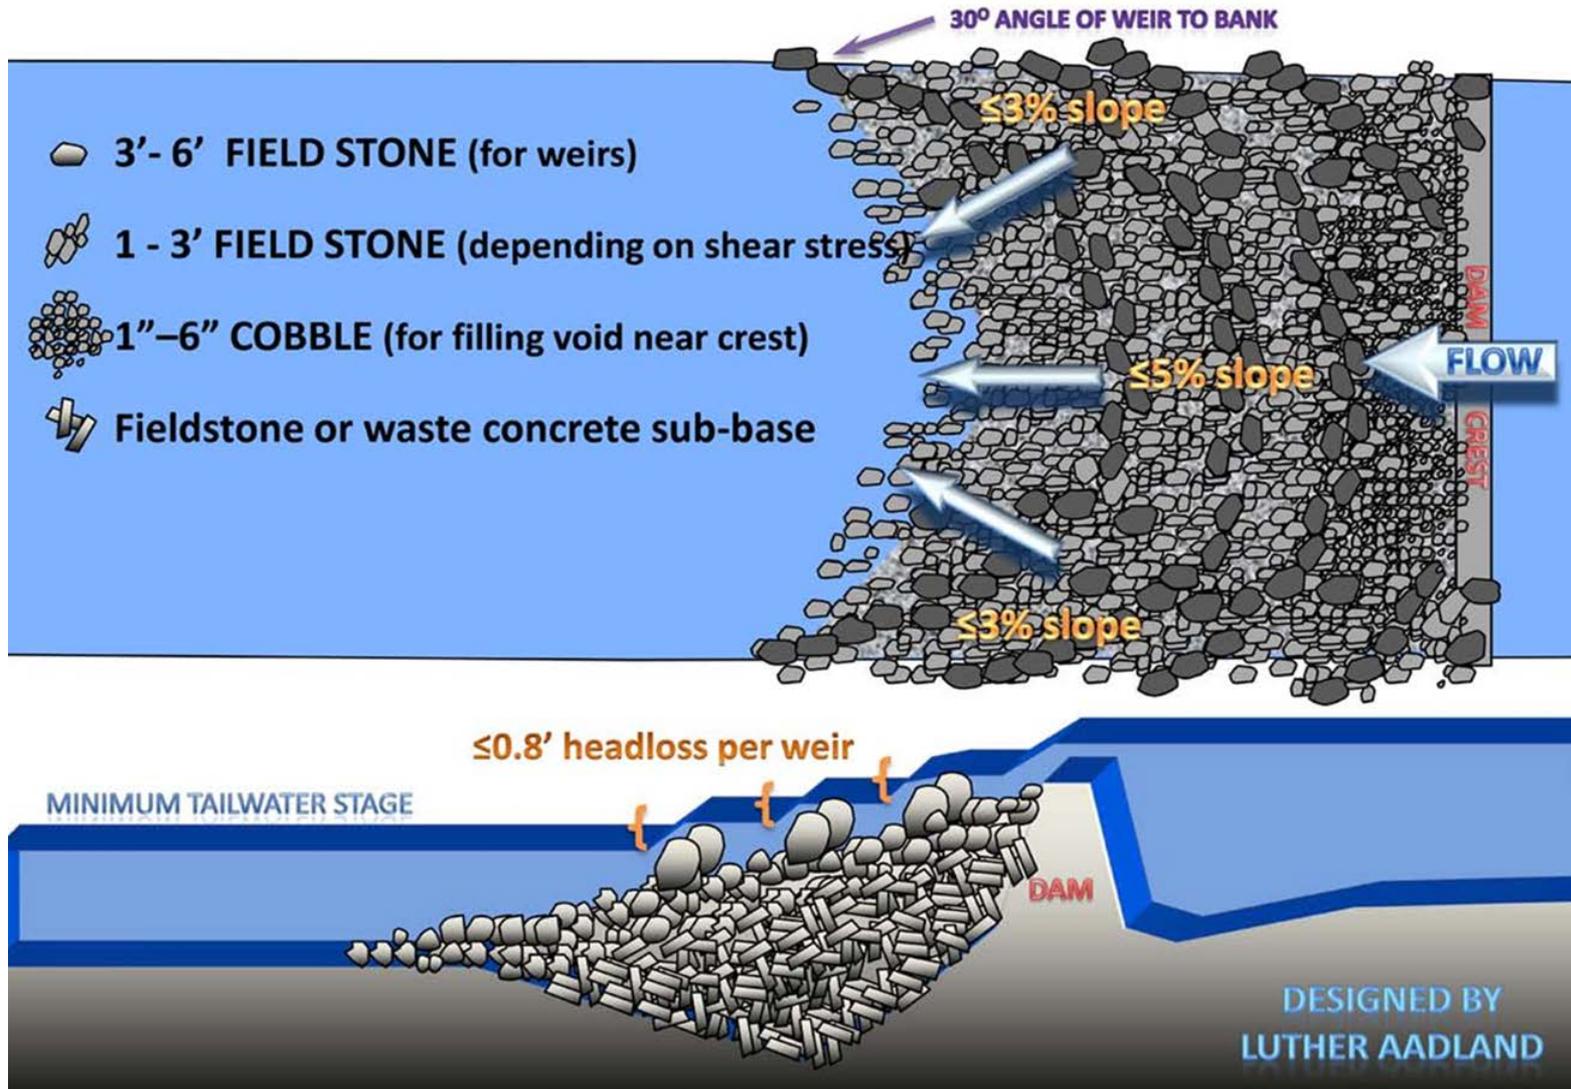
Figure 54. Generalized conceptual design of the Rock Arch Rapids. *Reconnecting Rivers: Natural Channel Design in Dam Removals and Fish Passage*, p. 48. Minnesota Department of Natural Resources Ecological Resources Division, 2010.

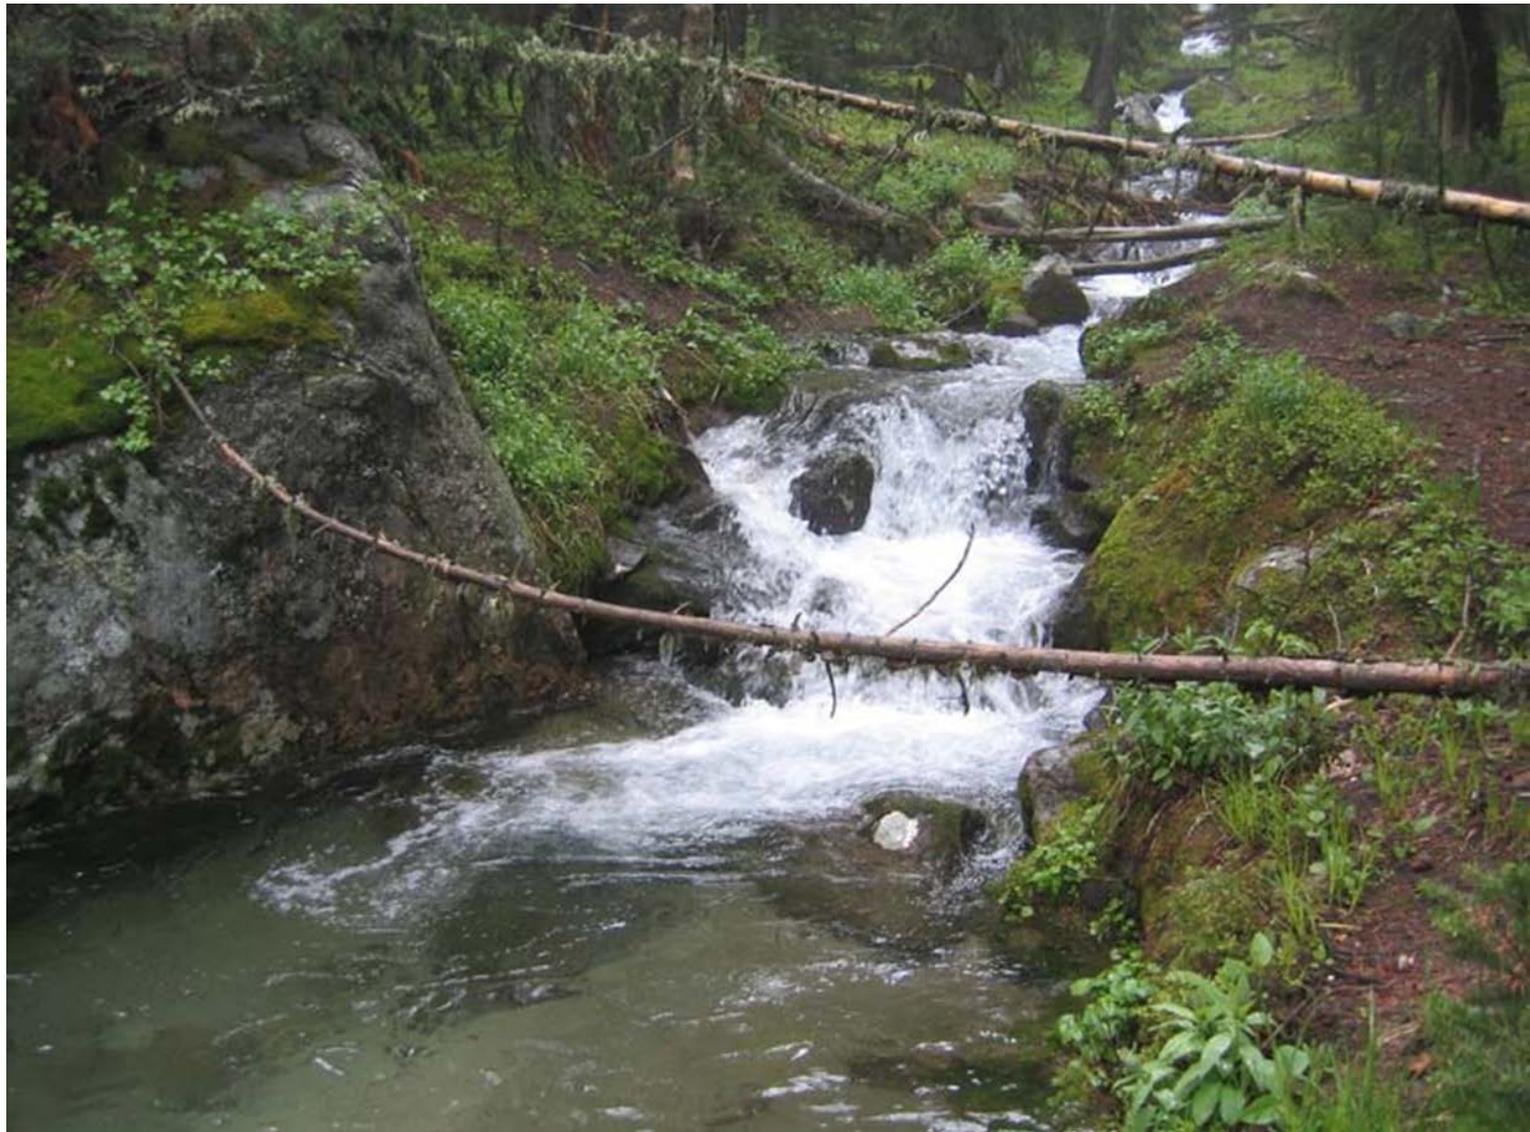
Figure 58. Hellroaring Creek, Montana, a steep , natural, stream with a step-pool channel. *Reconnecting Rivers: Natural Channel Design in Dam Removals and Fish Passage*, p. 54. Minnesota Department of Natural Resources Ecological Resources Division, 2010.

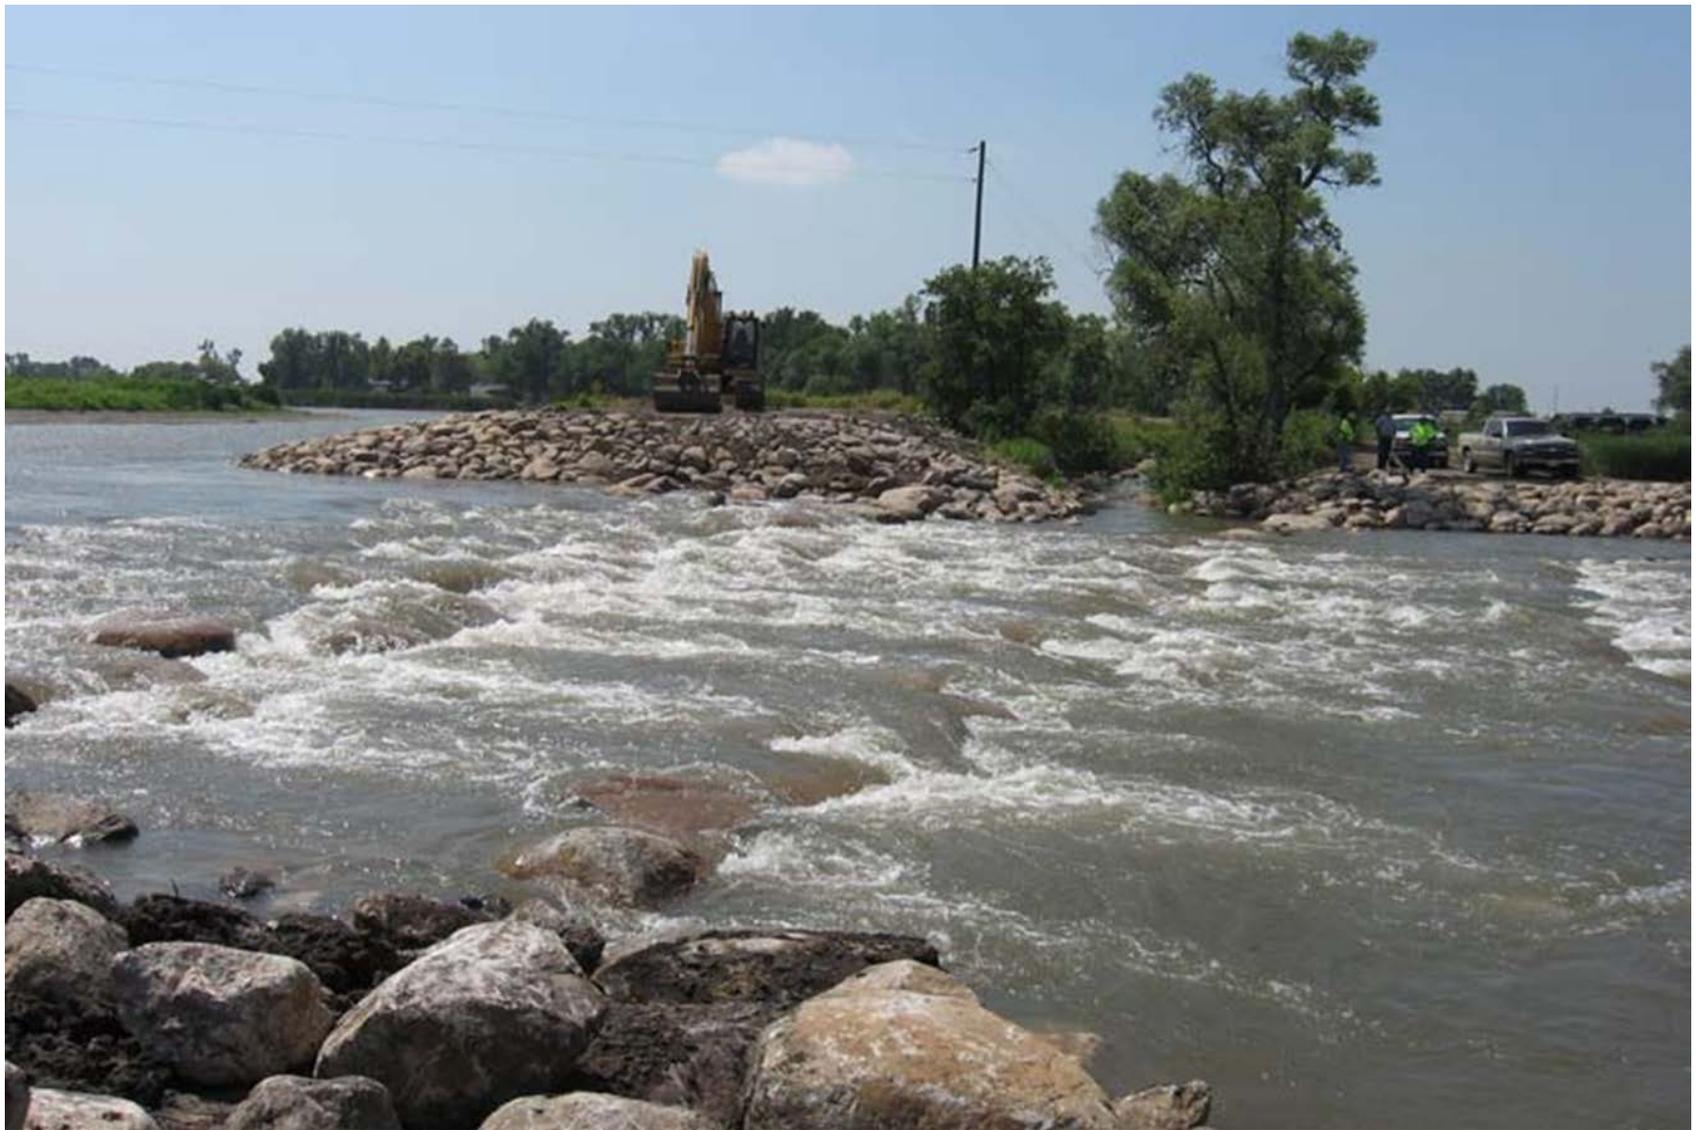
Figure 91. Rapids replacing dam to provide grade control and facilitate fish and canoe passage. *Reconnecting Rivers: Natural Channel Design in Dam Removals and Fish Passage*, p. 80. Minnesota Department of Natural Resources Ecological Resources Division, 2010.

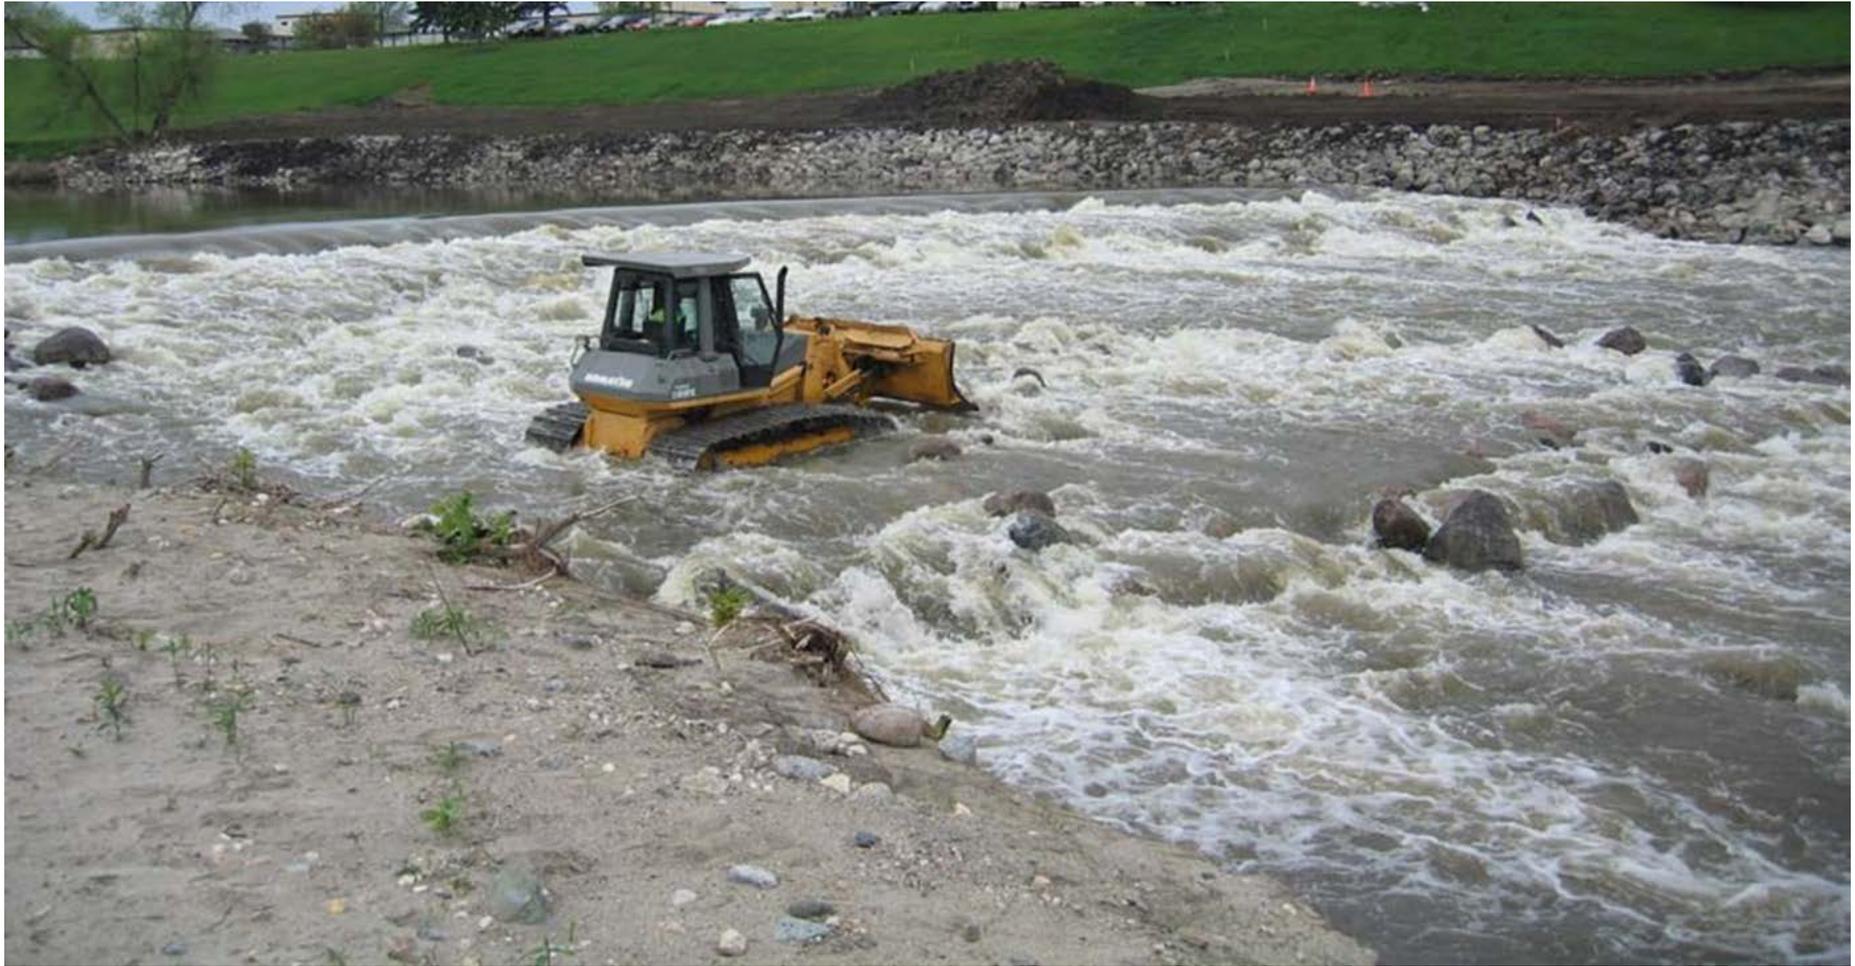
Figure 100. Grading the fieldstone base with a bulldozer. *Reconnecting Rivers: Natural Channel Design in Dam Removals and Fish Passage*, p. 86. Minnesota Department of Natural Resources Ecological Resources Division, 2010.

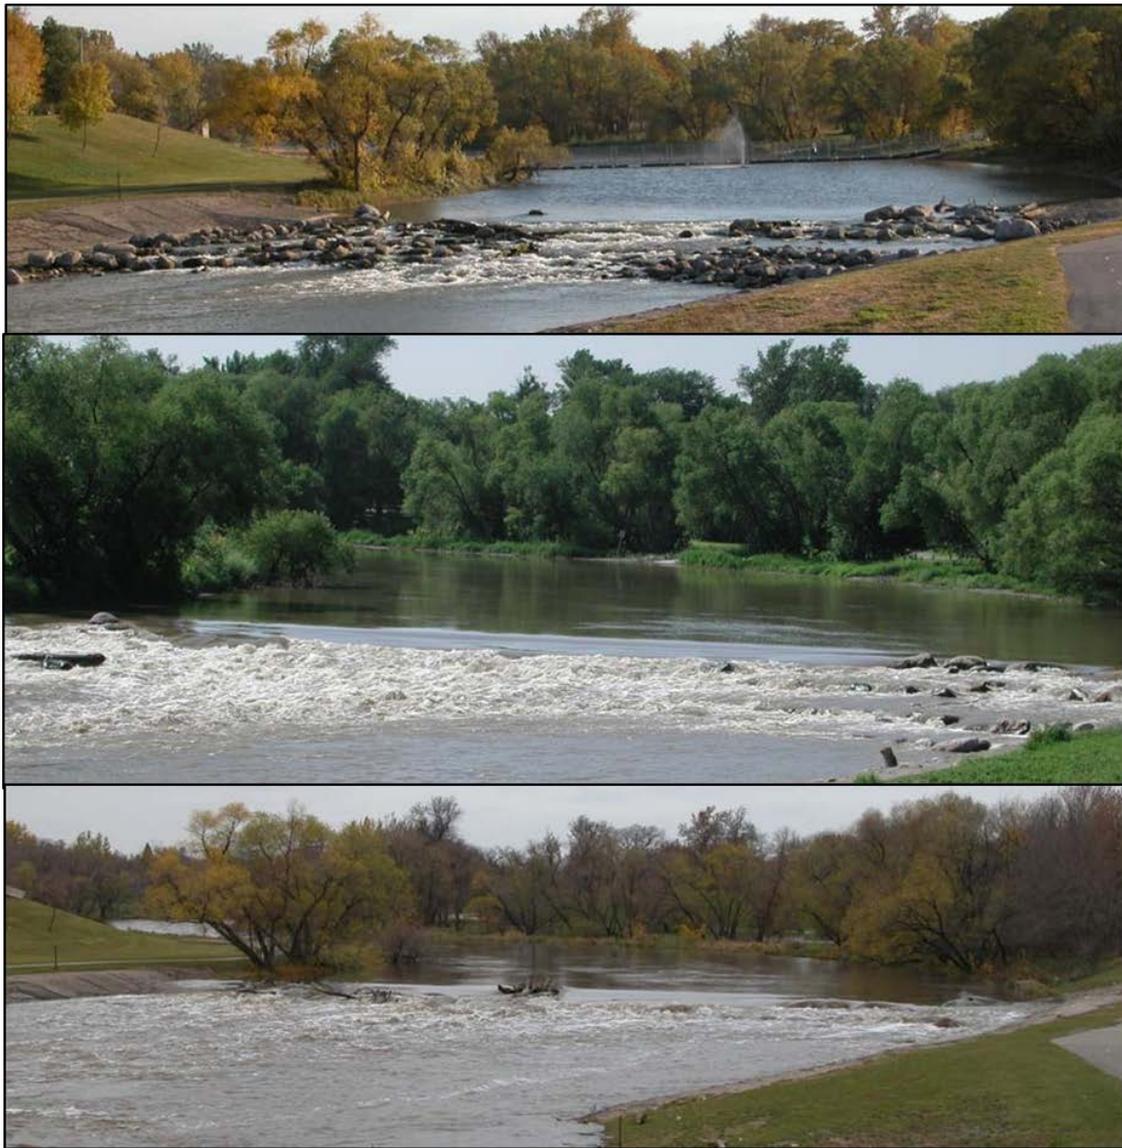
Figure 75. Rapids at flows of 405 cfs (upper photo), 1,640 cfs (middle photo), and 2,560 cfs (bottom photo). *Reconnecting Rivers: Natural Channel Design in Dam Removals and Fish Passage*, p. 68. Minnesota Department of Natural Resources Ecological Resources Division, 2010.

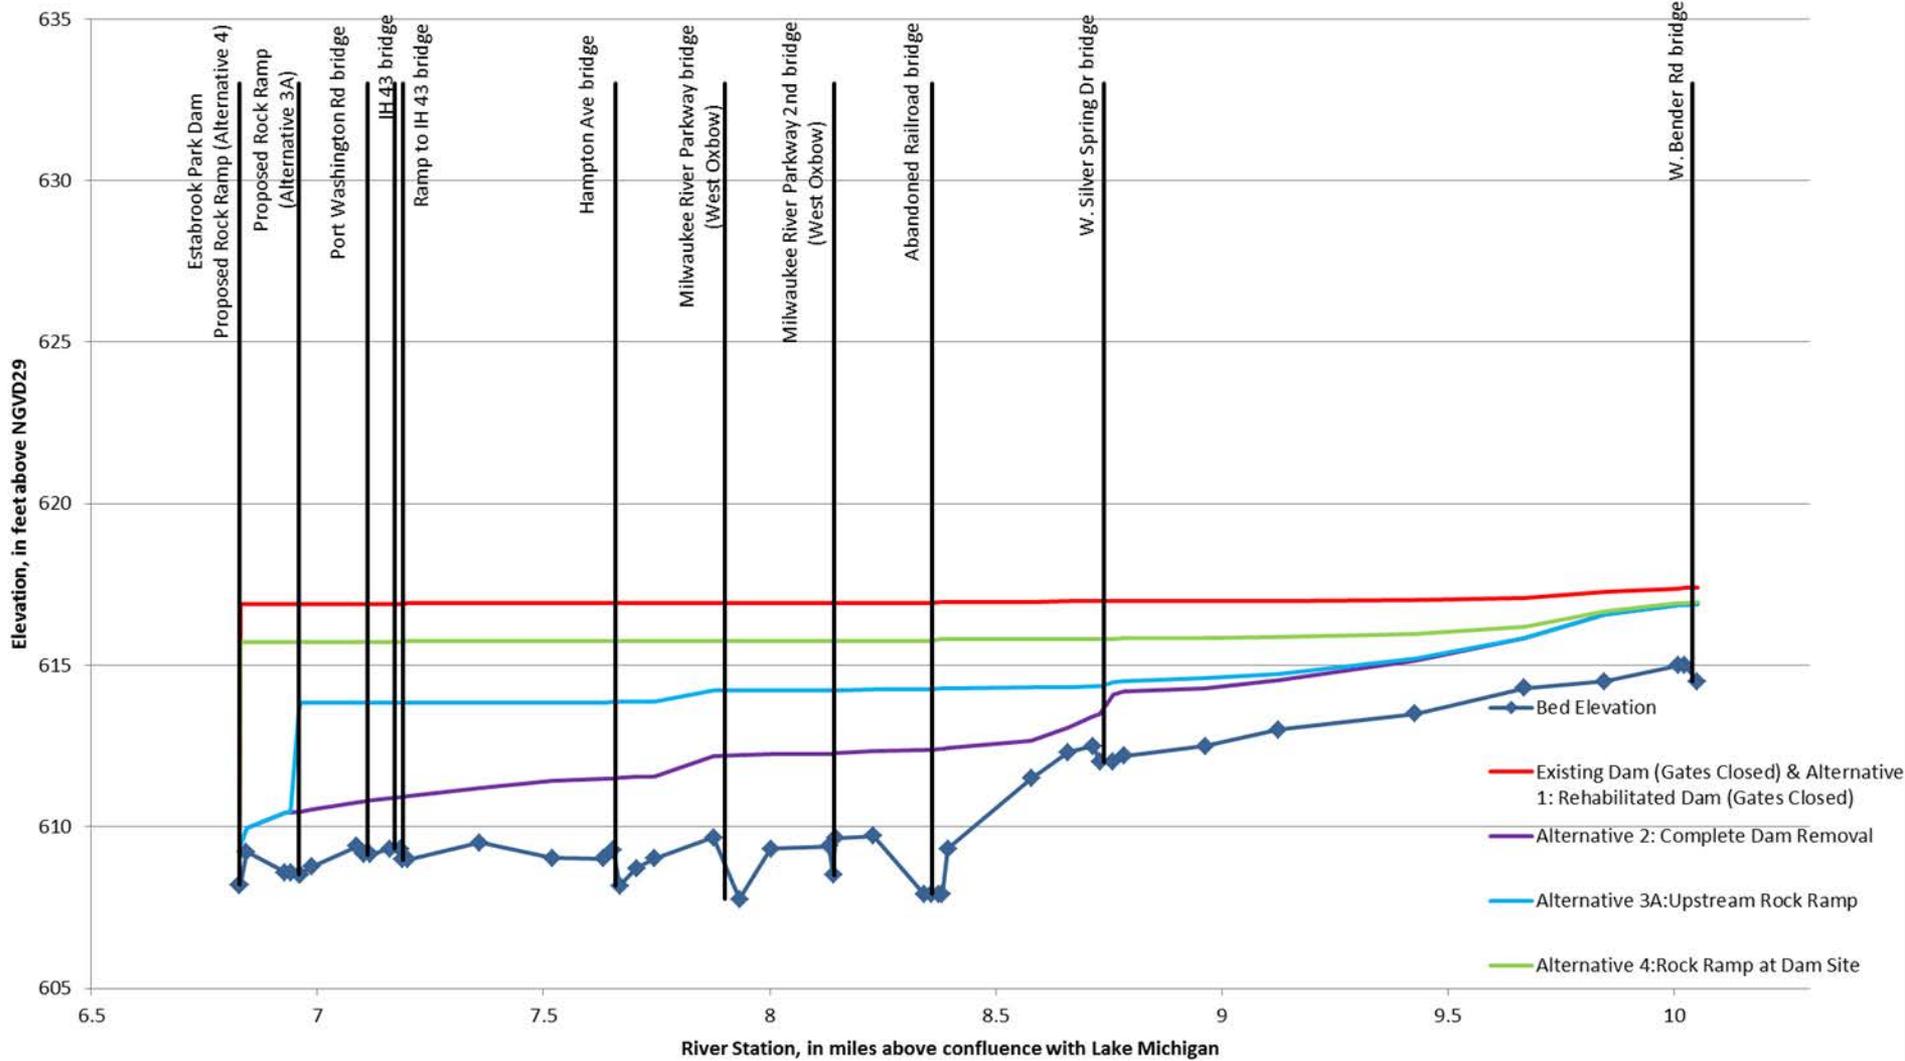
Estabrook Dam Environmental Assessment Alternatives, Milwaukee River Water Surface Profiles for Normal (Median) Flow

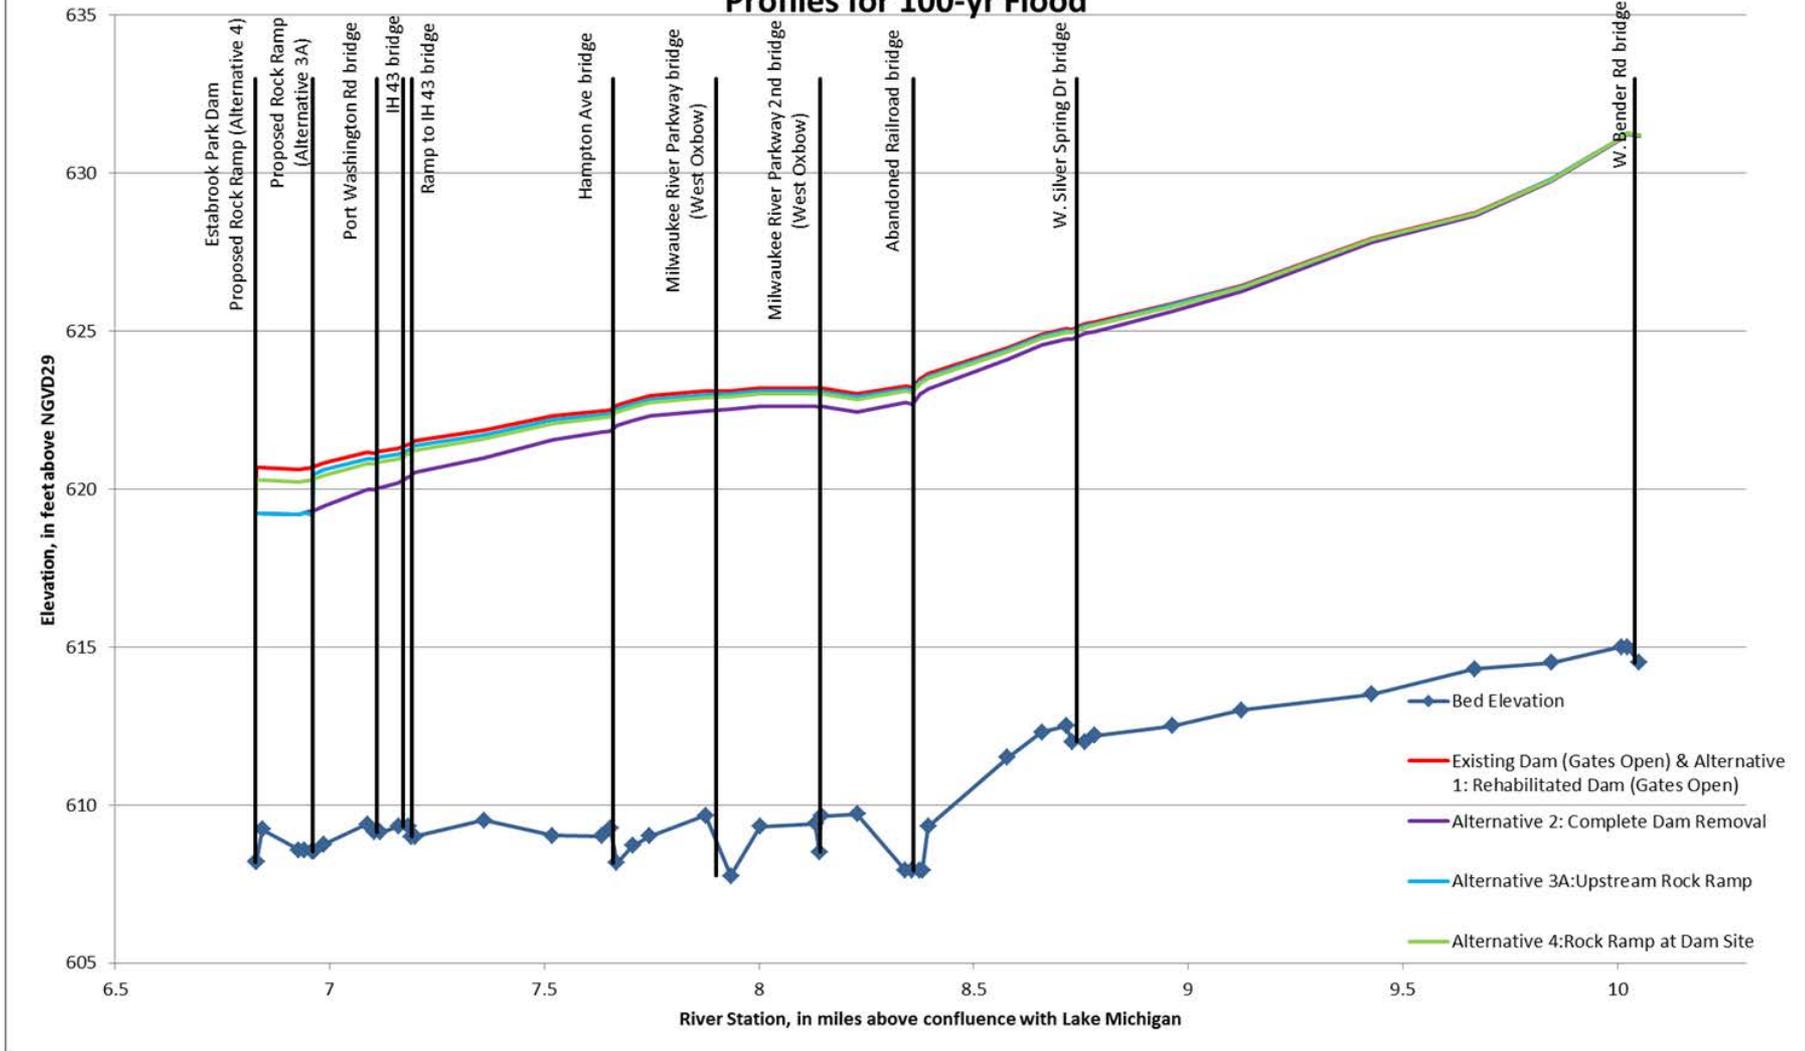
Estabrook Dam Environmental Assessment Alternatives, Milwaukee River Water Surface Profiles for 100-yr Flood

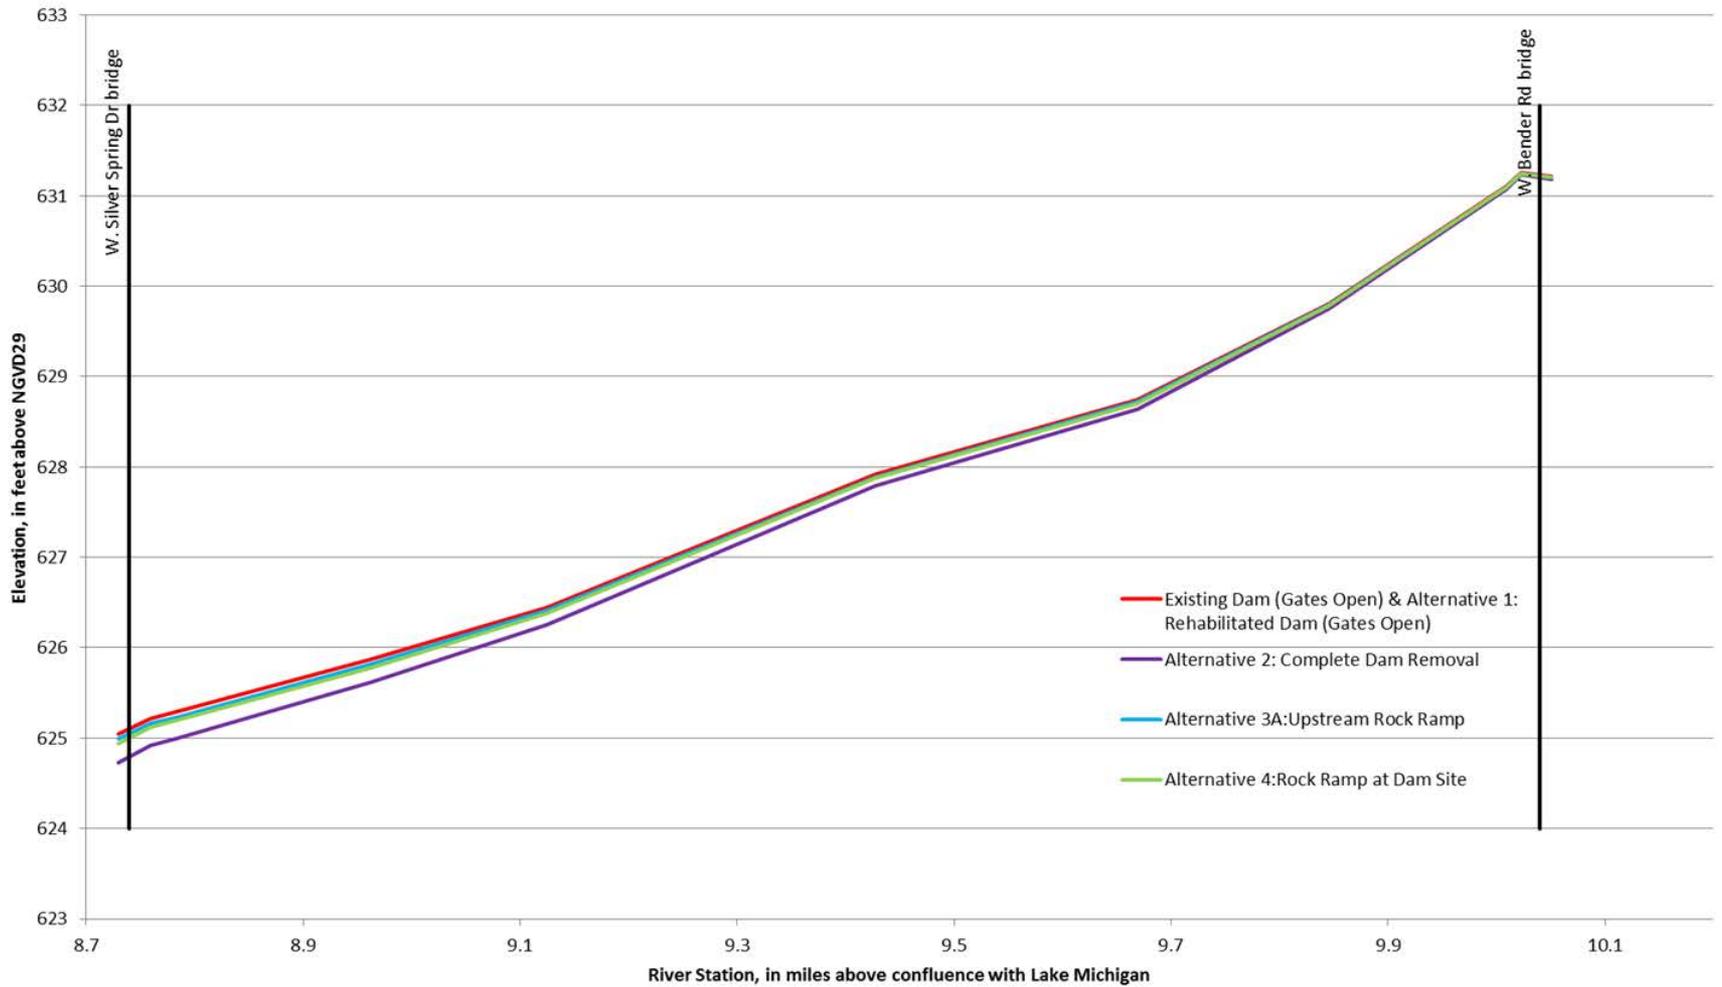
W. Silver Spring Drive to W. Bender Road, Milwaukee River Water Surface Profiles for 100-yr Flood
