### **REQUEST FOR PROPOSAL FOR**

**Sheridan Bluff Stability**

**PROJECT NO. WP083801**

# COASTAL ANALYSIS AND BASIS OF DESIGN REPORT

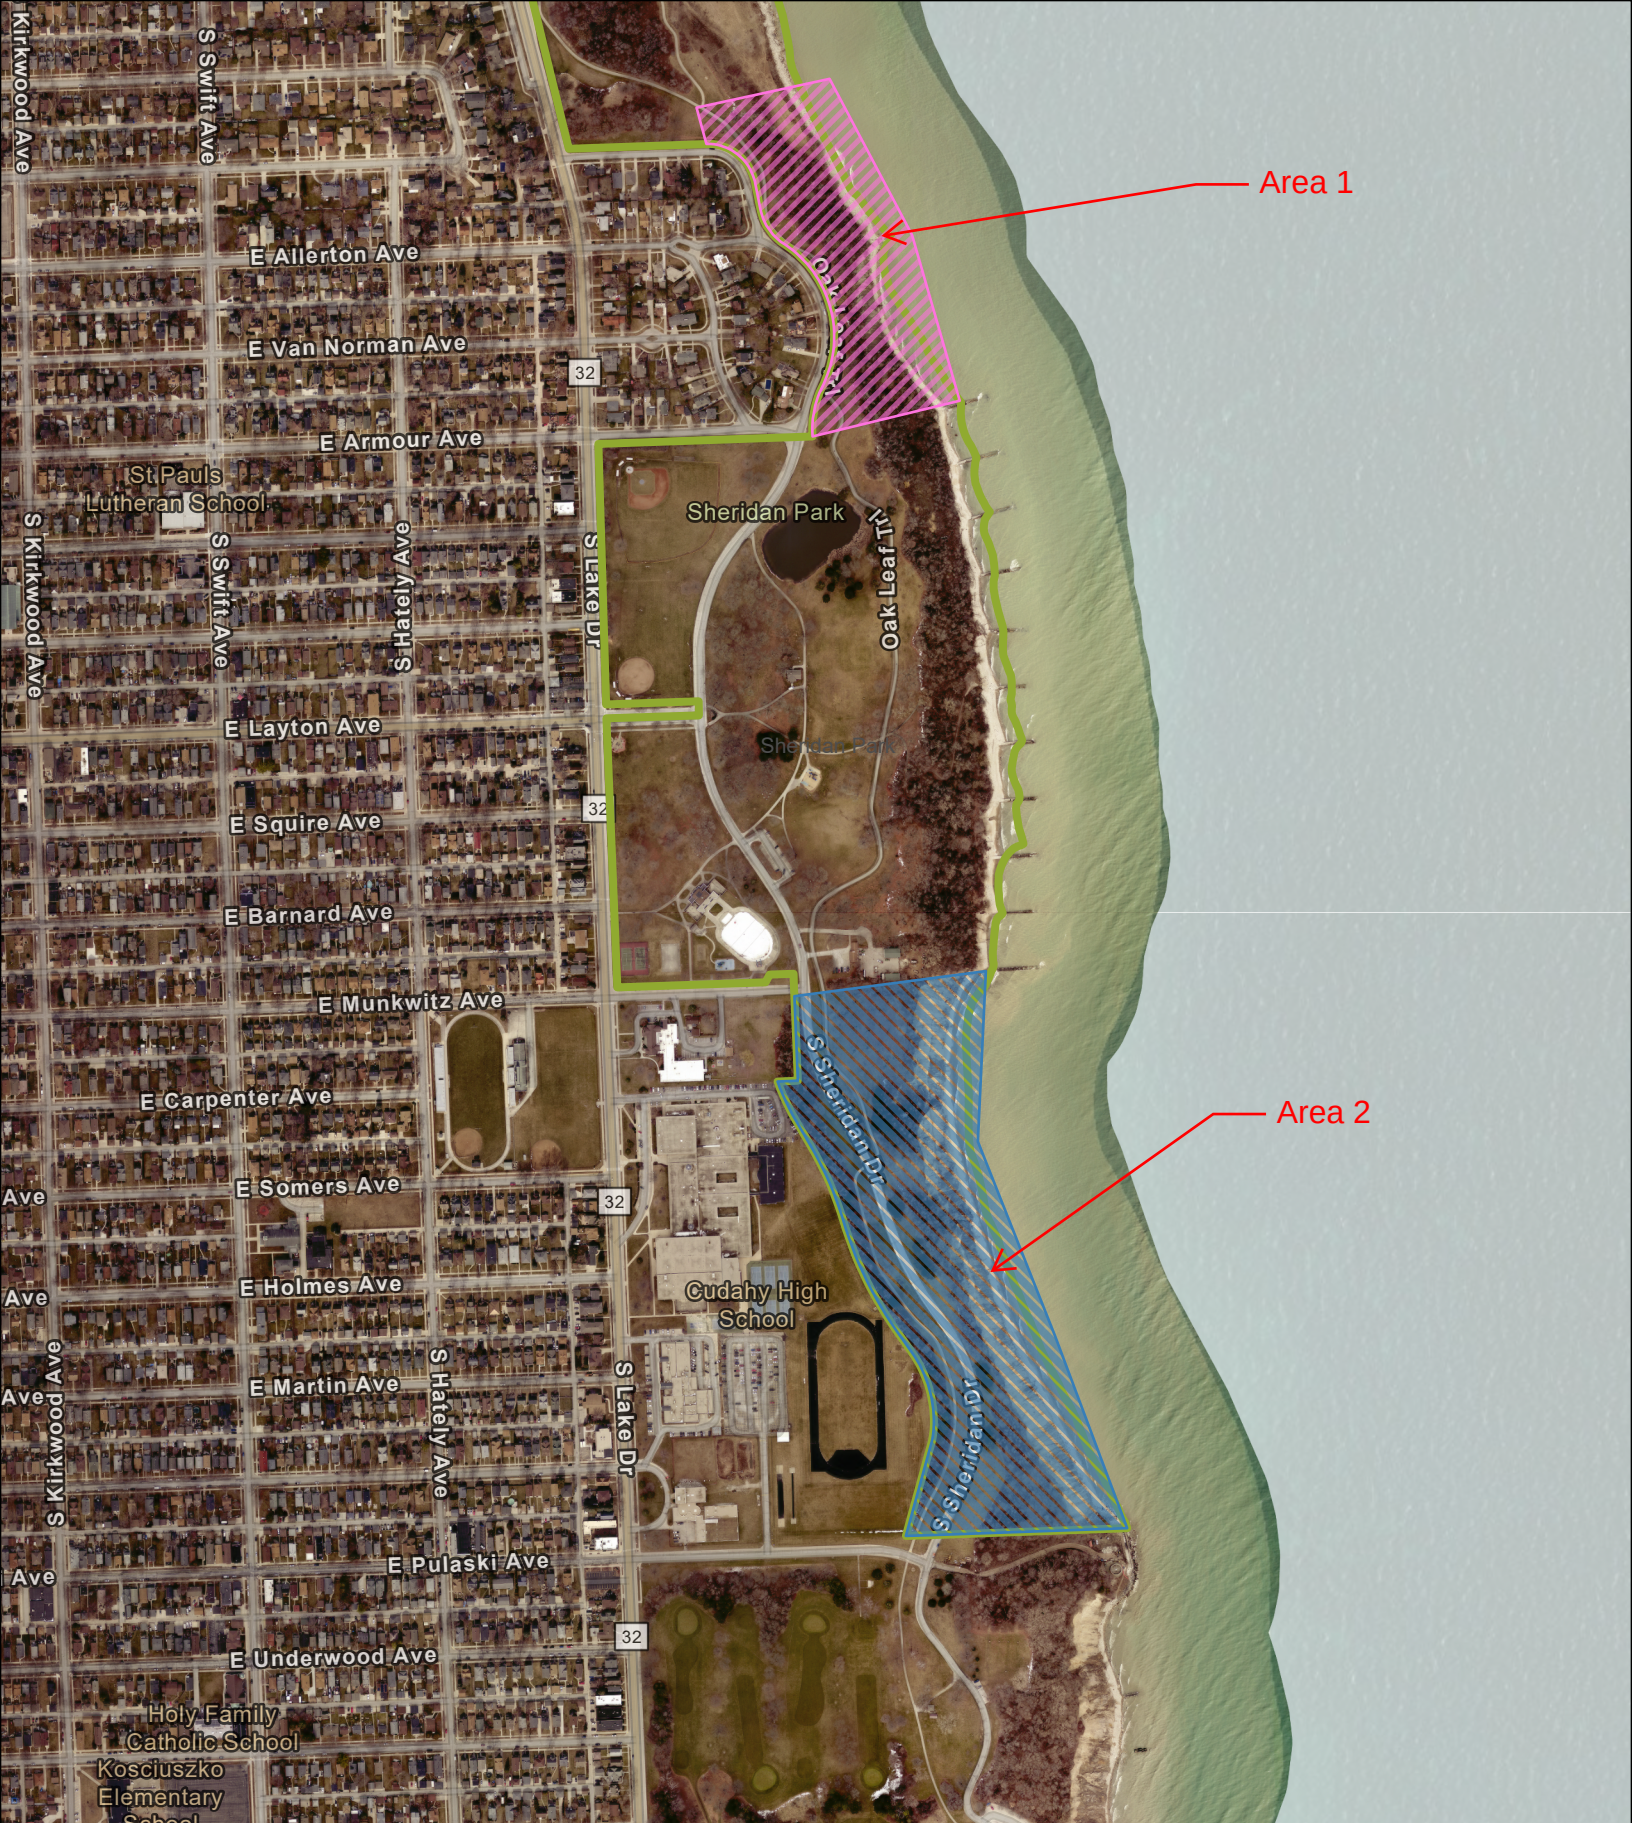
FIGURE 2

# Milwaukee County Parks - Sheridan Park Sheridan Park Bluff Stability Project Areas

- Sheridan Park
- Sheridan Park Bluff Stability Project Area 1
- Sheridan Park Bluff Stability Project Area 2

A study completed in 2025 by Milwaukee County identified the Sheridan Park bluffs as one of the least resilient bluffs in the county and one of the highest priorities for remediation. The study identified two potential project locations within the park. Area 1 is in the north end of the park just east of South Sheridan Drive between East Allerton Avenue and East Armour Avenue. Area 2 is at the south end of the park between East Munkewitz Avenue and East Pulaski Avenue. See Figure 2.

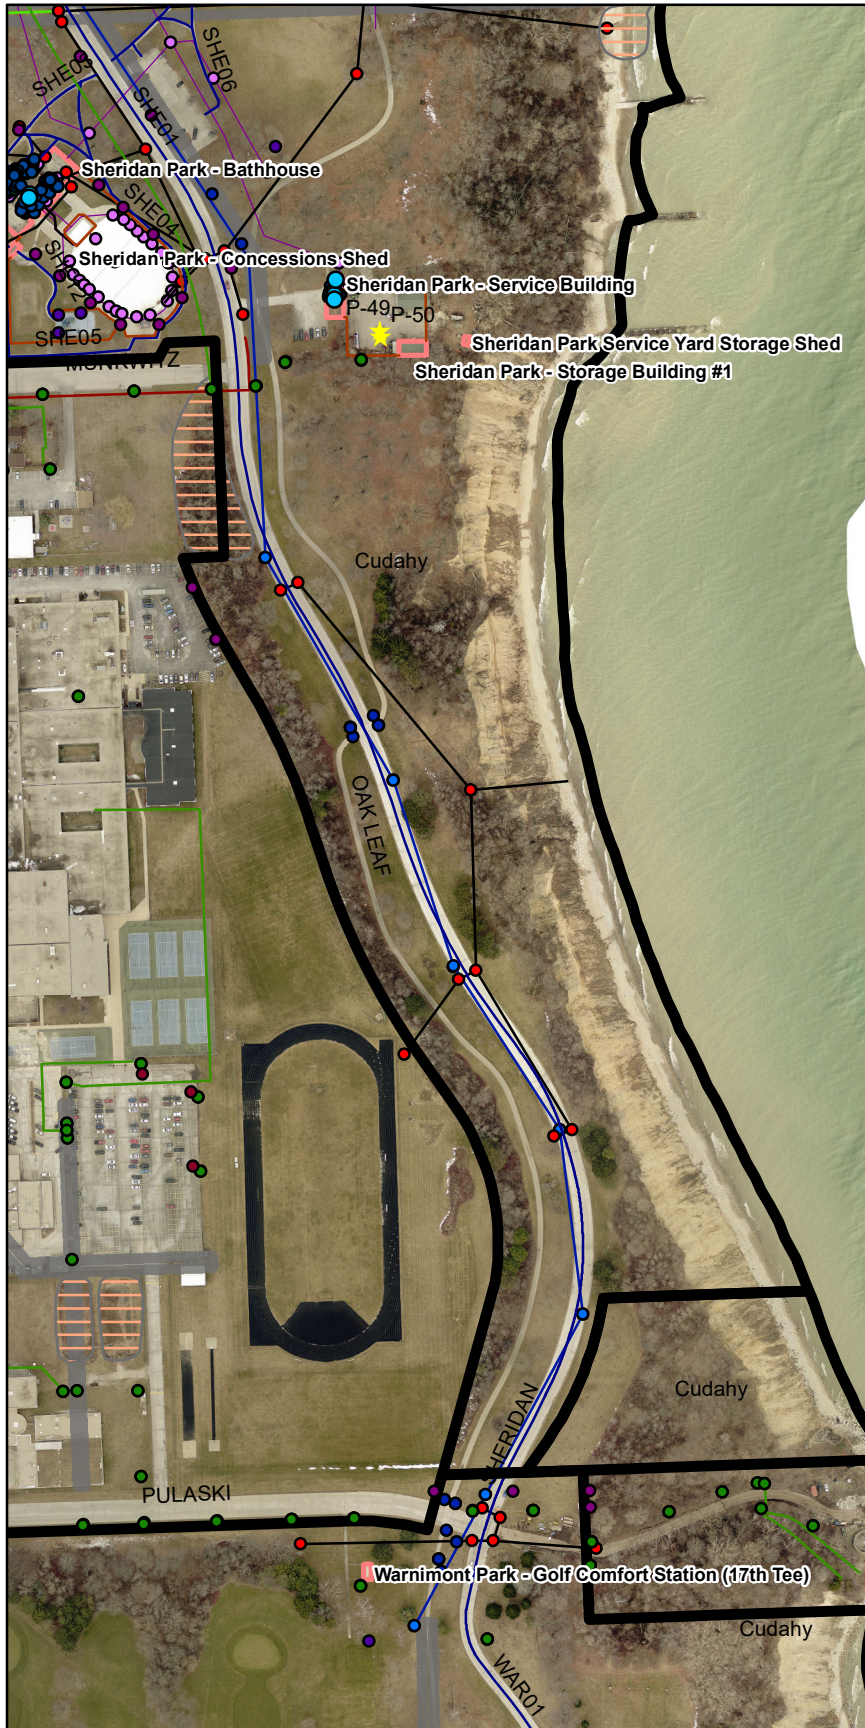
### MAP OF SHERIDAN BLUFF UTILITIES IN PROJECT AREA

# Sheridan Bluff

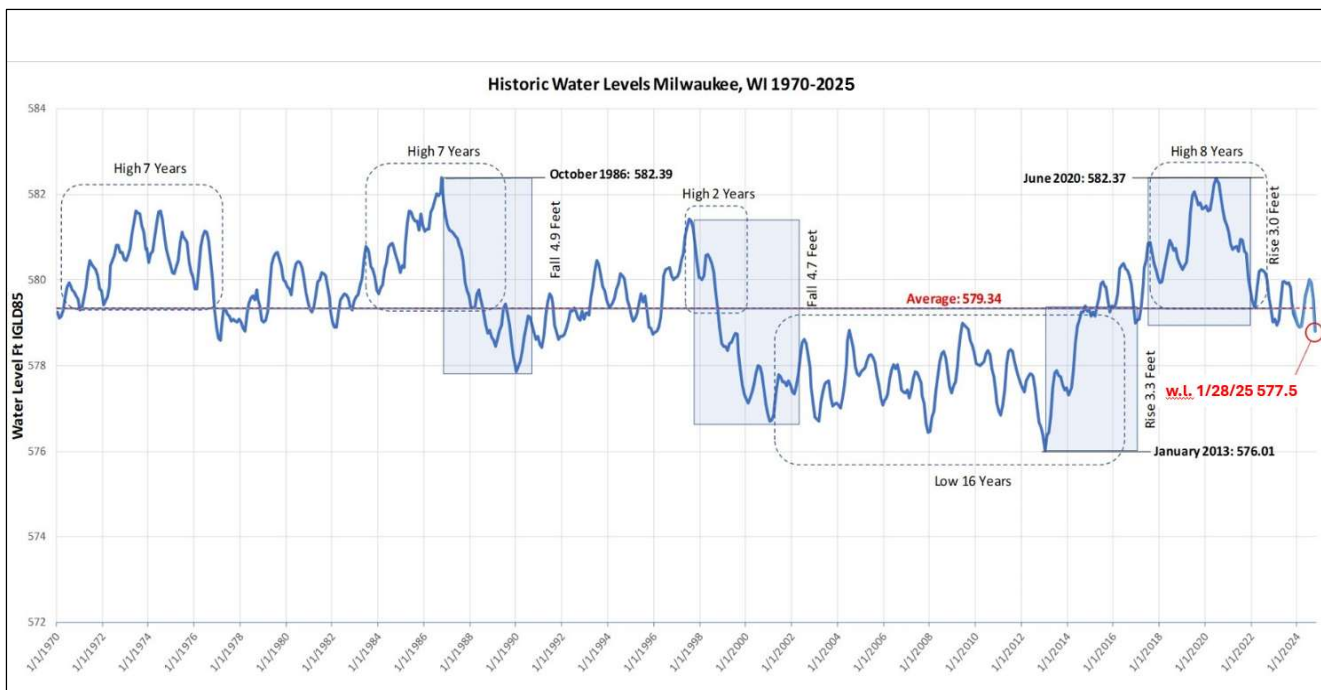
Figure 1. Milwaukee Water Levels (1970-2025)

The maximum daily recorded lake level in Milwaukee was 583.0 feet on January 11, 2020, during a significant storm from the northeast. **Figure 1** shows the Milwaukee water levels between 1970 and 2024.

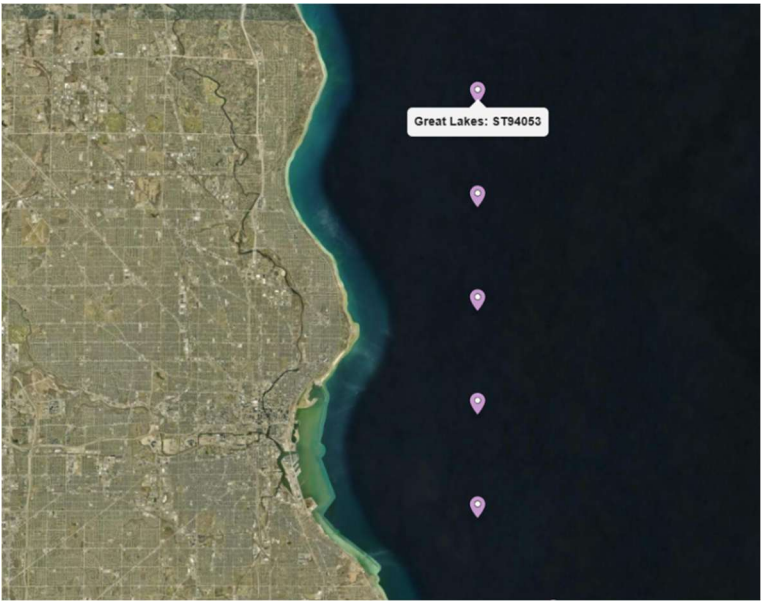
Figure 2. ST94053 Location Map

Station ST94053, shown on **Figure 2**, is located at the north end of the project area in deep water (200 feet). The extreme wave height analysis for Station ST94053 is shown in **Figure 3**.

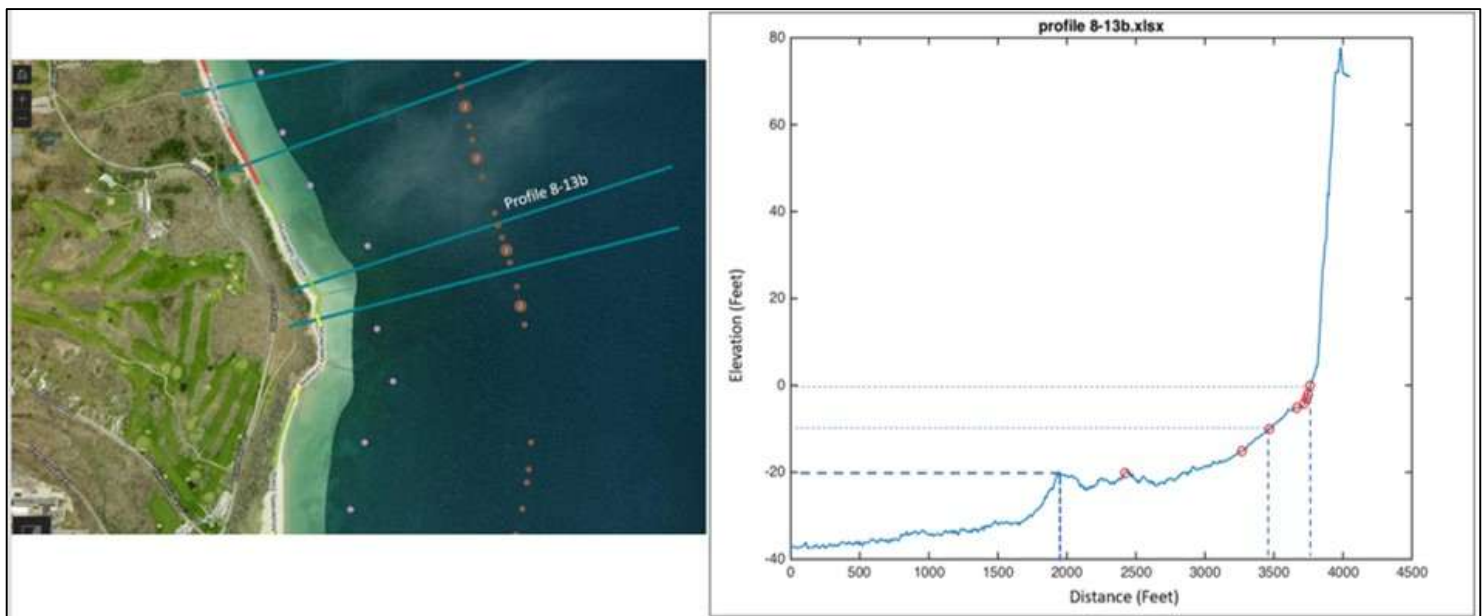
**Figure 4. Grant Park Offshore Lakebed Transect Location and Profile Elevation**

For this study, the beach slopes were calculated from the water's edge to the toe of the nearest bluff. Offshore lakebed slopes were calculated from the water's edge (surveyed level) to a reference depth of 10 feet below water surface elevation, as well as 10 to 20 feet below water surface elevation for comparison. The Wisconsin Department of Natural Resources (WDNR) collected bathymetric data along select transects in the project area, extending to deep water (minimum 4,000 feet offshore in up to 50 feet of water depth) in 2012. **Figure 4** shows an example of a plotted bathymetric transect at Grant Park (location and elevation data) and **Figure 5** shows a direct comparison of the transect using the USACE 2020 LiDAR data, with data that is well in agreement for the slope up to 10 feet of water depth. It is noted that the LiDAR data extends only to the 570.0 feet IGLD 85 elevation, therefore, the deeper slopes could not be verified. However, we believe that the deeper water lakebed elevation does not significantly change with time.

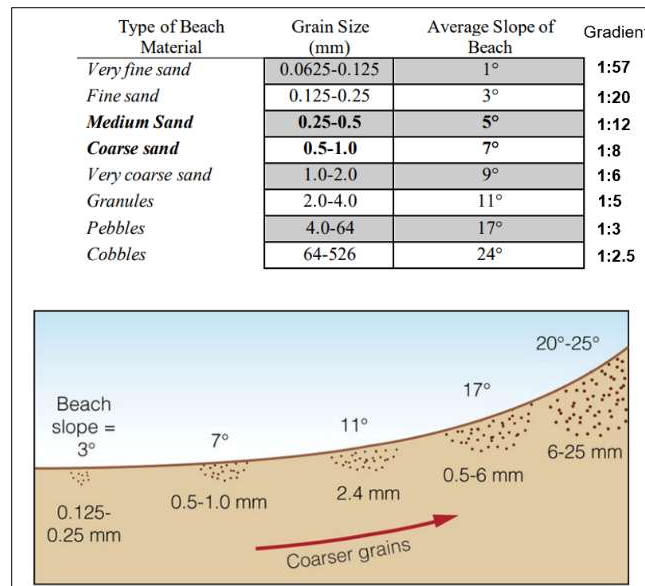
**Figure 6. Beach Grain Sizes and Slopes (Hyndman, 2017)**

The project area shorelines quickly respond to the water level variations and significant storms. Shallow water, shallow offshore slope, and coarse-grained sediments generally promote more stable beach slopes. The grain size directly influences the stability of the beach slope (i.e., the coarser the material, the more stable the slope). **Figure 6** shows a typical plot of the grain size influence on the beach slope.

The plot shows that medium sand will have a 1:12 stable slope after placement, while a steeper stable slope will be achieved for coarse sand (1:8), gravel (1:5), and pebbles (1:3). The plot is in general agreement with the existing slopes and material properties reported in **Table 4** above.

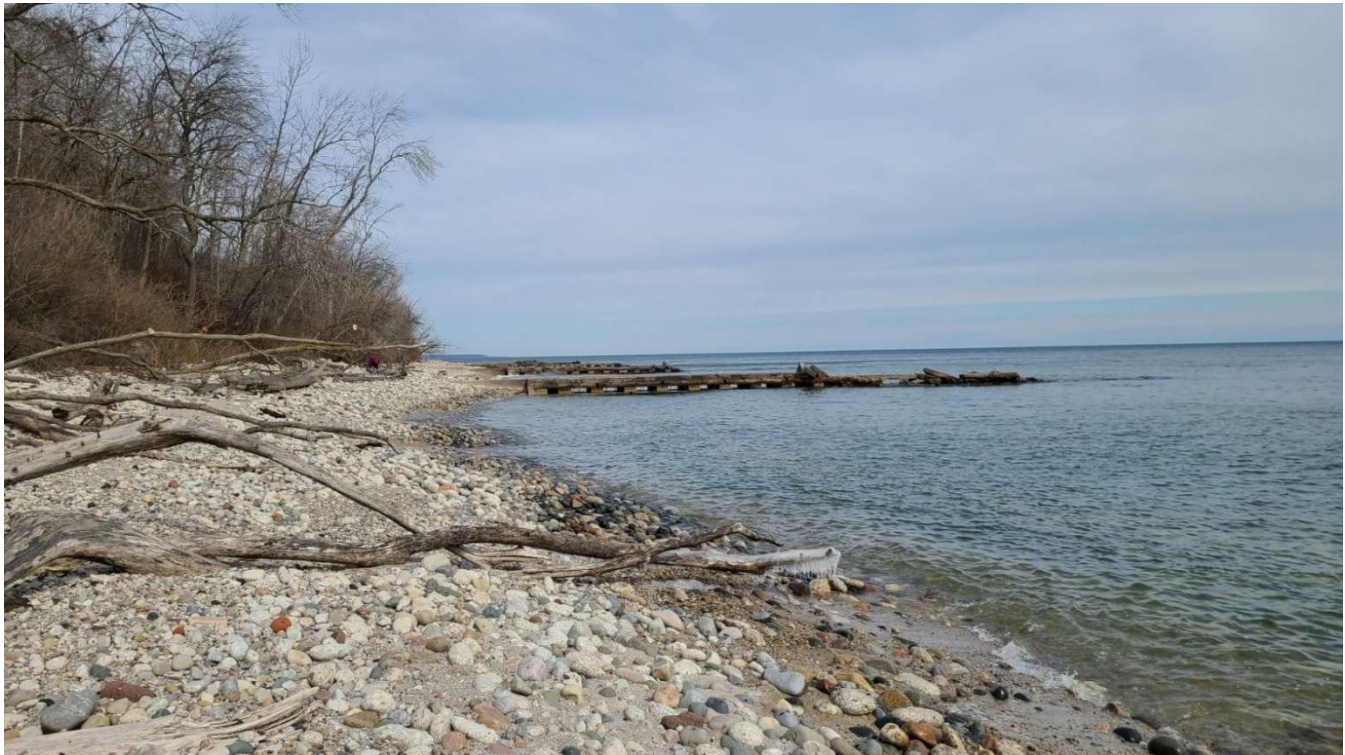
**Figure 7. Sheridan Park Groin Field**

Various coastal structures (groins, jetties, detached breakwaters) can impact this process by trapping a portion of the LST. Some of the parks have groin fields, provided as a series of shore-perpendicular structures. These are intended to stabilize the beaches and counteract the shoreline erosion. By design, a groin maintains the updrift (north) beach, and a series of groins are required to protect both sides. Most of the existing groins in the parks were built as an open concrete frame and piers, as shown in **Figure 7**. The groin structures allow some sediment transport through the open spaces and are beneficial by providing partial sediment retention and reducing the incoming wave energy during storms from most directions (except straight east with waves perpendicular to the shoreline). Most existing park groin structures show significant deterioration and are in need of immediate rehabilitation. Some groin sections failed (especially at the offshore end) and require immediate improvements.

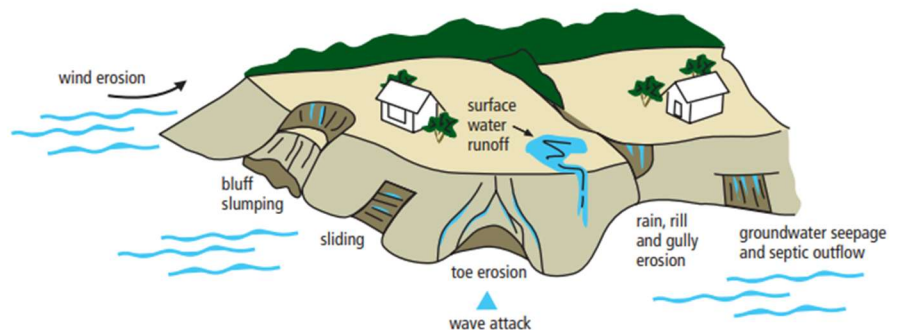
Increases in Lake Michigan water levels, the frequency of large storm events, and the intensity of storm events have led to destabilization of the bluffs in the County. Generally, the observed destabilization is caused by larger waves and increased energy in the nearshore environment causing more erosion and material loss at the bluff toe (bottom). Removal of material at the bottom of the slope is one of four ways slopes can change to become destabilized. Three additional ways are: 1) addition of material or weight (force) at the top of the slope; 2) seismic forces; or 3) reduction of soil shear strength. The third of these changes can be caused by groundwater presence, surface water infiltration, freeze thaw cycles, or soil grain reorientation due to occurrence of a slope failure. The image (right) shows a few of the factors that can contribute to slope instability.<sup>2</sup>

<sup>2</sup> Image: USACE, 2023. *Living on the Coast*. Page 10; USACE and University of Wisconsin; Detroit, MI; 2023.

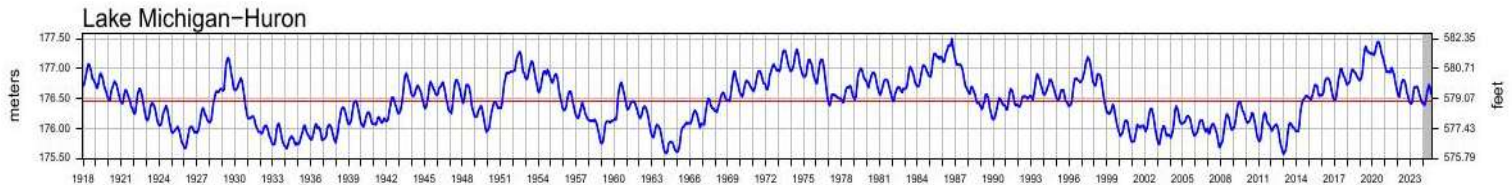
**Notes:**

1. Red Line = Measured Period Average Water Level.
2. Blue Line = Monthly Average Water Level.
3. Elevations shown are presented in International Great Lakes Datum (IGLD 85)

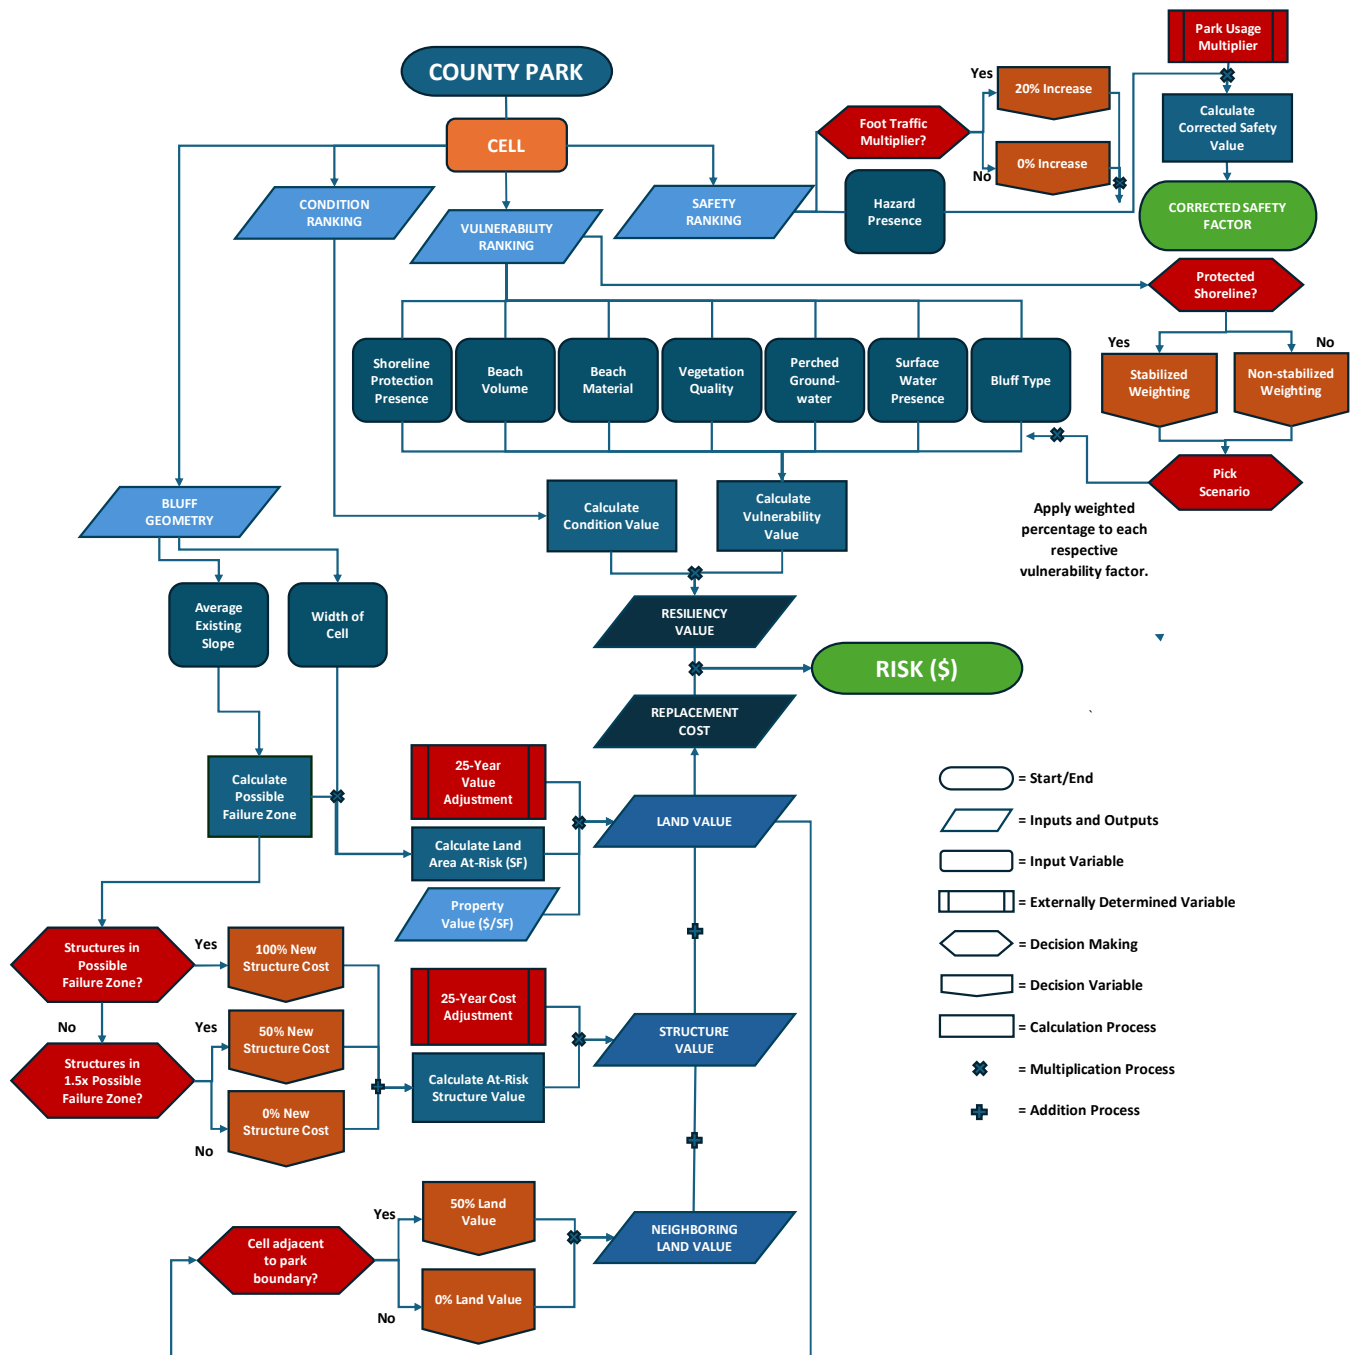
To better assess the County bluffs and prioritize potential project areas, the Project Team developed a project-specific methodology for ranking bluff condition, vulnerability, and safety. Due to the highly variable nature of the bluffs and shoreline, the Project Team assessed the parks in 100- to 200-foot Cells. GZA assigned condition and vulnerability rankings based on the observations and experiences detailed in **Section 3.0**. Using the product of numerical values of the condition and vulnerability rankings, a resiliency value was obtained. The resiliency value was then multiplied by the replacement cost for land, structures, and neighboring property to obtain the risk value for that Cell. This methodology is simplified in the flow chart below and further detailed in the following subsections.

To determine prioritization of bluff repair projects, the Project Team utilized the calculated resiliency and risk values. Due to the assessment process, these values are subjective. When possible, the Project Team attempted to use quantitative data to determine condition and vulnerability scores. There is some degree of subjectivity in the ranking given the natural variability in the soils, vegetation, and various other materials that make up and influence the bluffs' stability. The rankings assigned were based on our experience performing work on the County bluffs and the need to account for the County's priorities.

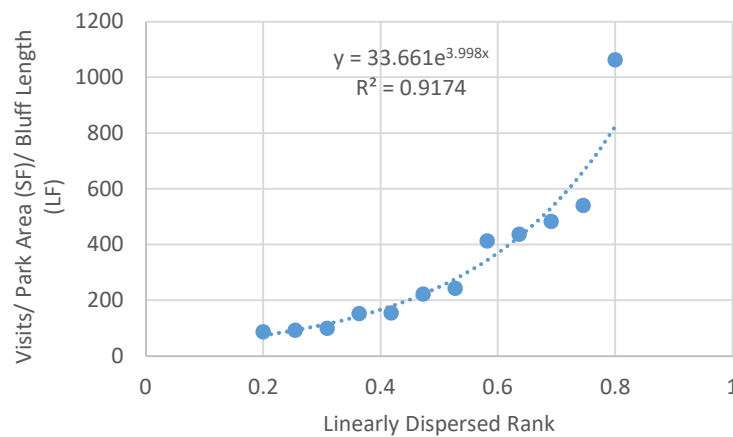
1. Based on the trend line equation  $M = 33.661e^{3.998x}$  where “M” is the park usage multiplier and “X” is linearly dispersed, ranking values correlated to the rankings of visits per shoreline length/area set to range from 0.2 to 0.8. See graph below.

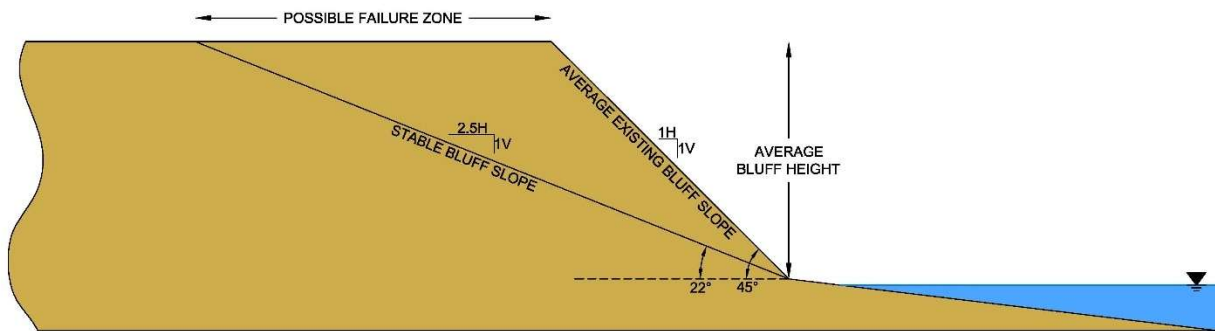
To determine the value of land that could be lost due to slope failure or movement, the Project Team compared the average existing slope of the bluff Cell to the steepest, typically stable slope of 2.5H [Horizontal]:1V [Vertical] in Milwaukee County. It should be noted that slopes shallower than 2.5H:1V may still experience failure; however, such failures would likely require a series of unlikely events to occur simultaneously. Additionally, slopes steeper than 2.5H:1V may remain stable in particular circumstances, such as soils with greater than average cohesion or internal friction angles. Average slopes of the Cells were determined using “zonal statistics” in GIS taken from the digital elevation models that were developed by the Project Team. The GIS tool reported the average gradient (slope) of the grid points within the bluff Cell as a percent slope. Using this methodology, a “Possible Failure Zone” was established. Taller bluffs with steeper slopes had larger Possible Failure Zones, therefore, more land value was at risk than smaller bluffs with more gradual slopes that had smaller Possible Failure Zones. Slopes already less steep than 2.5H:1V were given a Possible Failure Depth of 1-foot to account for possible surface erosion.

$$\text{POSSIBLE FAILURE ZONE} \times \text{SECTION LENGTH} = \text{AT-RISK LAND AREA}$$
$$\text{AT-RISK AREA} \times \text{25-YEAR ADJUSTED LAND VALUE} = \text{AT-RISK LAND VALUE}$$

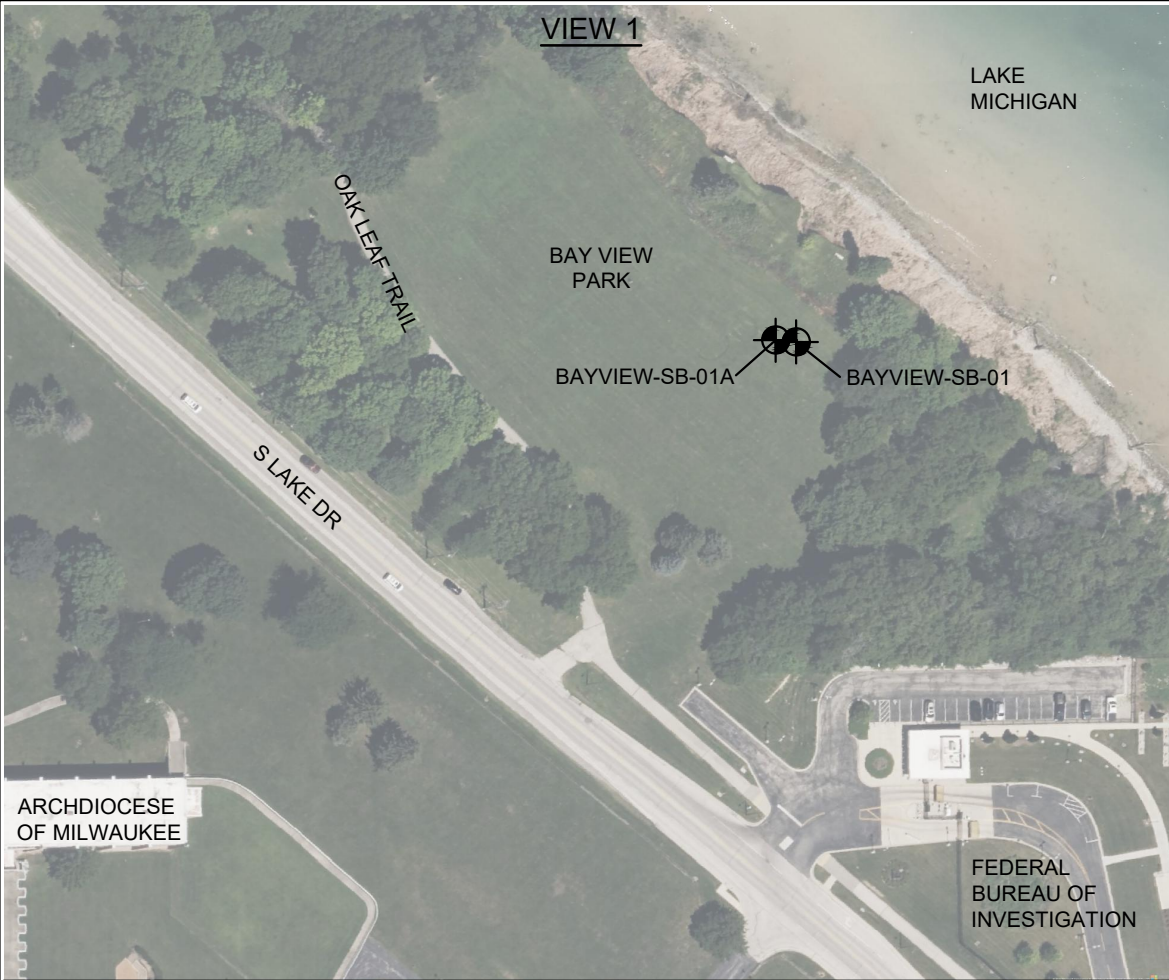
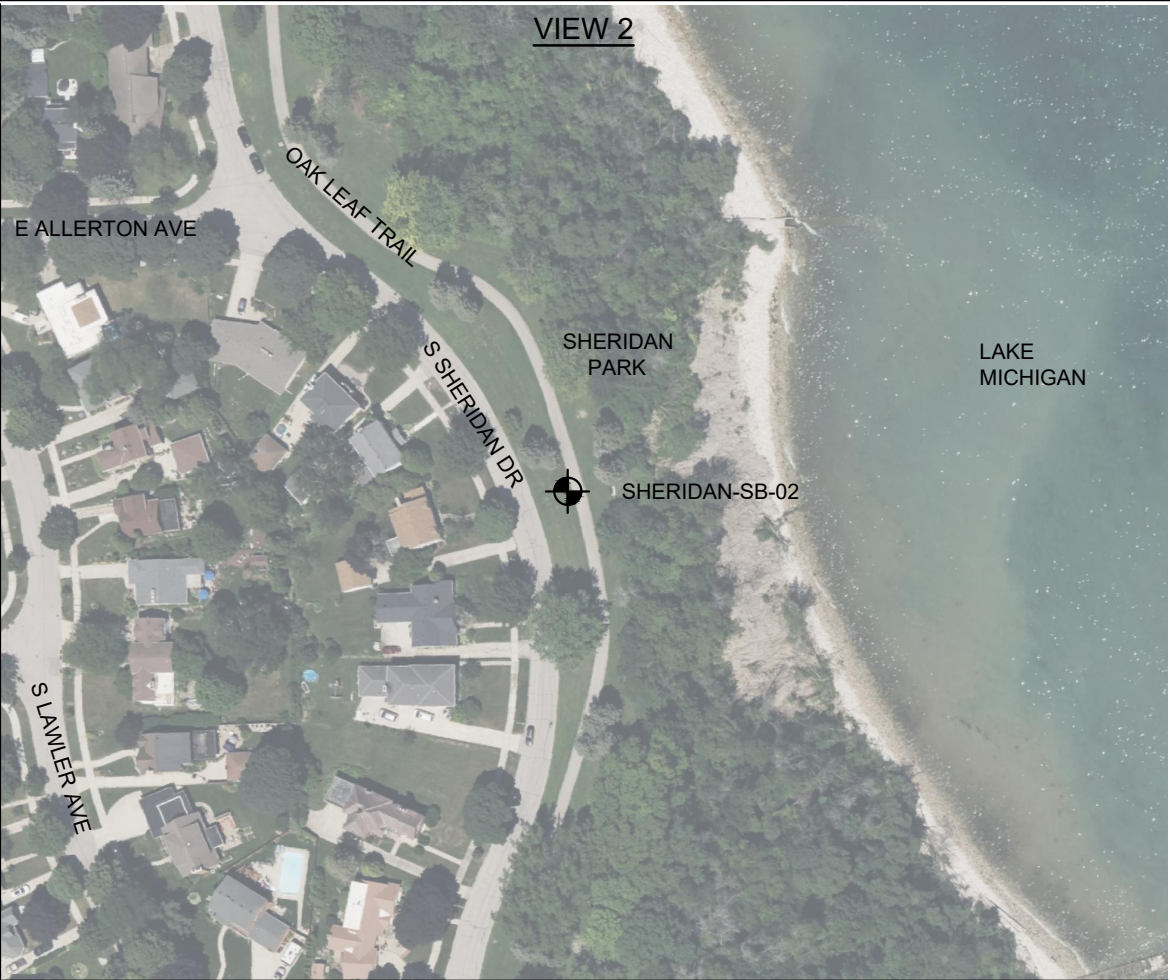
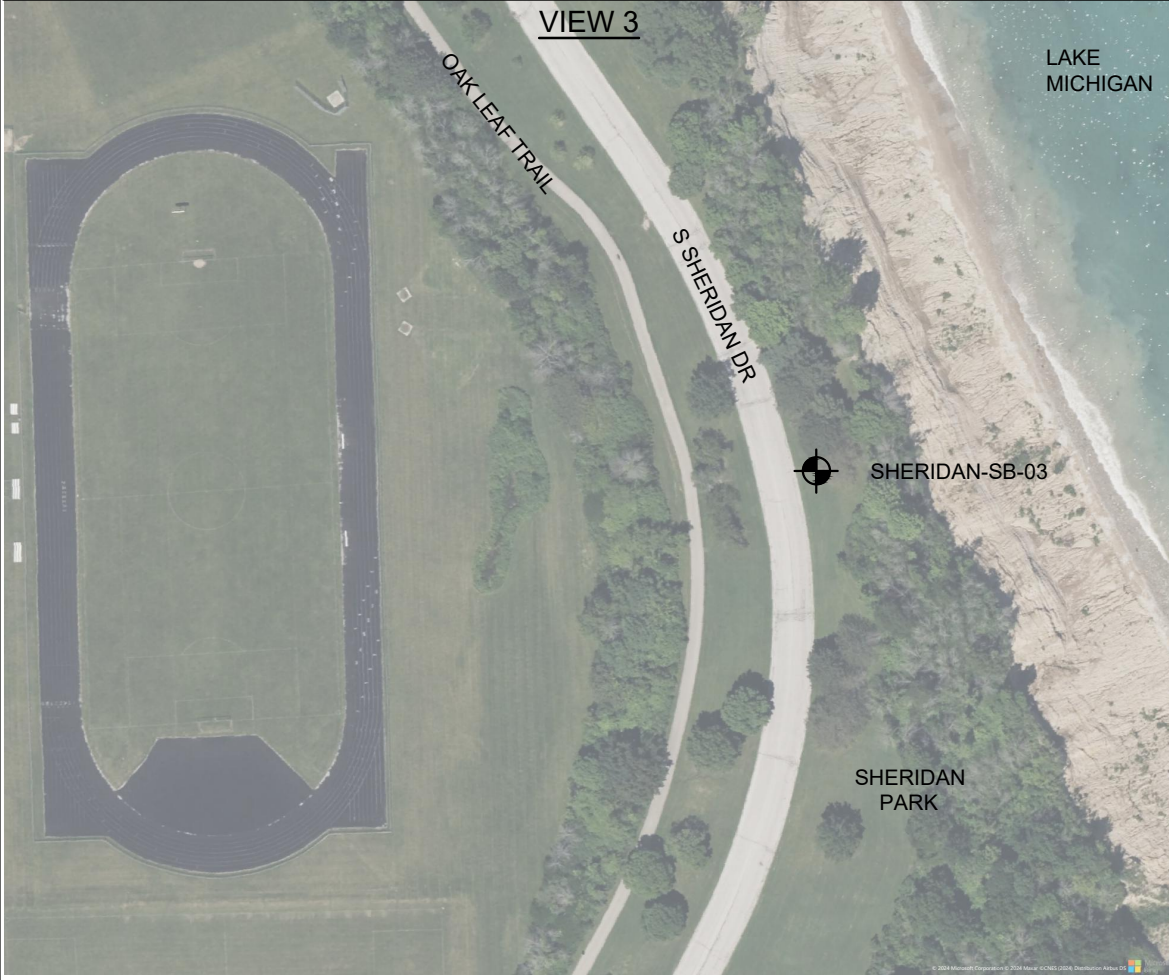
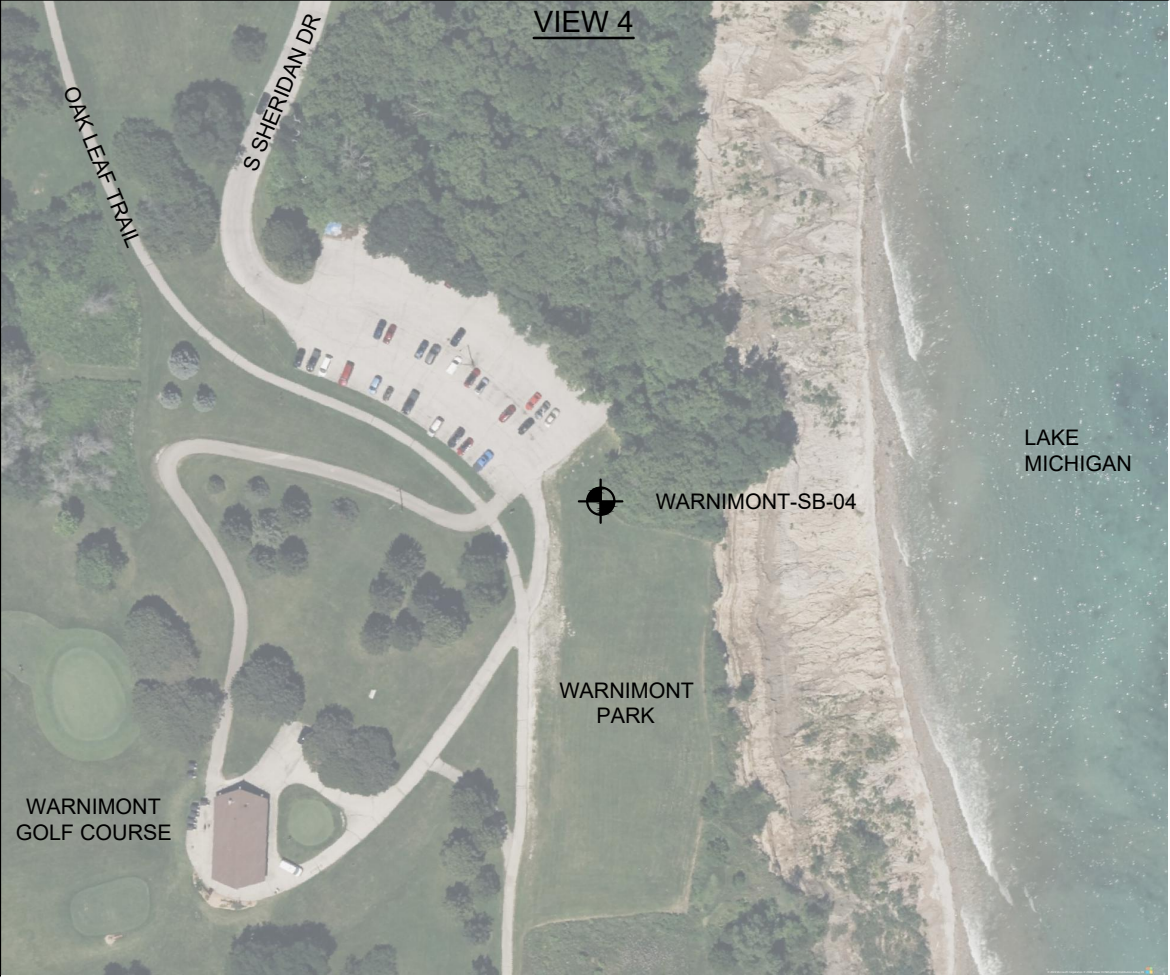
| BORING LOCATION TABLE | | | |
|---|---|---|---|
| SHERIDAN-SB-03 | 354,640' | 2,545,279' | 683' |
| WARNIMONT-SB-04 | 352,966' | 2,545,511' | 686' |

As part of the allowance work for the project, the Project Team conducted a series of five geotechnical soil borings (BAYVIEW-SB-01, BAYVIEW-SB-01A, SHERIDAN-SB-02, SHERIDAN-SB-03, and WARNIMONT-SB-04) at identified potential high-risk areas in Bay View, Sheridan, and Warnimont Parks. The locations of the borings were determined based on the resiliency and risk analysis performed as part of this project and are discussed in detail later in this Report. Borings were advanced to depths of 60 to 90 feet below ground surface (bgs) to terminate below the Lake Michigan water level. Select soil samples collected during the subsurface exploration were submitted for additional lab testing to better refine the conceptual repair designs for the respective boring areas. Details regarding the soil borings and associated laboratory testing are provided in **Section 6.0**. Locations of the borings are provided in **Figures 2 and 3**.

GZA’s subcontractor, Drill Point, Inc. (Drill Point) of Waterford, Wisconsin drilled five soil borings at locations determined by the Project Team and presented on **Figure 3**. The borings, SB-01 through SB-04, were drilled from October 16 to 18, 2024, to depths of 60, 90, 90, and 90 feet bgs, respectively (approximate boring termination depths at El. 572 to 595.7 [+/- 1 foot]). Boring BAYVIEW-SB-01 encountered refusal during drilling and was moved west to the BAYVIEW-SB-01A location shown on **Figure 3**. For simplicity, the results of these soil boring were combined and are generally referred to as boring SB-01 herein. The actual termination depths of the borings are noted on the boring logs in **Appendix E**.

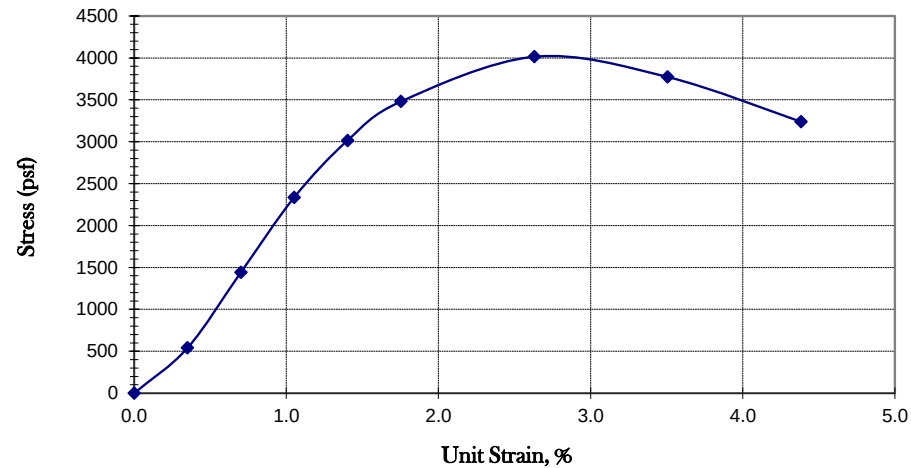
Boring no.: BAYVIEW SB-01  
Sample no.: ST-6  
Depth of Soil: 13.5-14.5  
Description of Soil: Strain Rate Lean clay, brown with dark brown and orange, moist, very stiff, trace sand.  
(in/min): 0.060

UC Strength,  $Q_u$  (tsf) 2.01  
Wet Density (pcf) 129.6  
Dry Density (pcf) 107.3  
Moisture Content (%) 20.8

Remarks Preformed in place of consolidated undrained due to low recovery.  
Sample fractured along weathered surfaces (orange and dark brown in color).

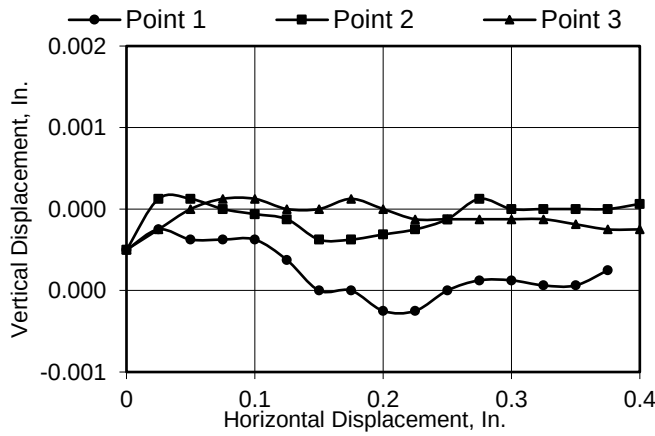
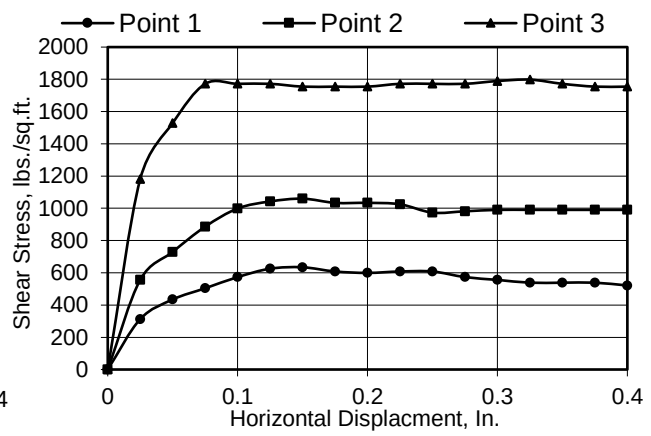
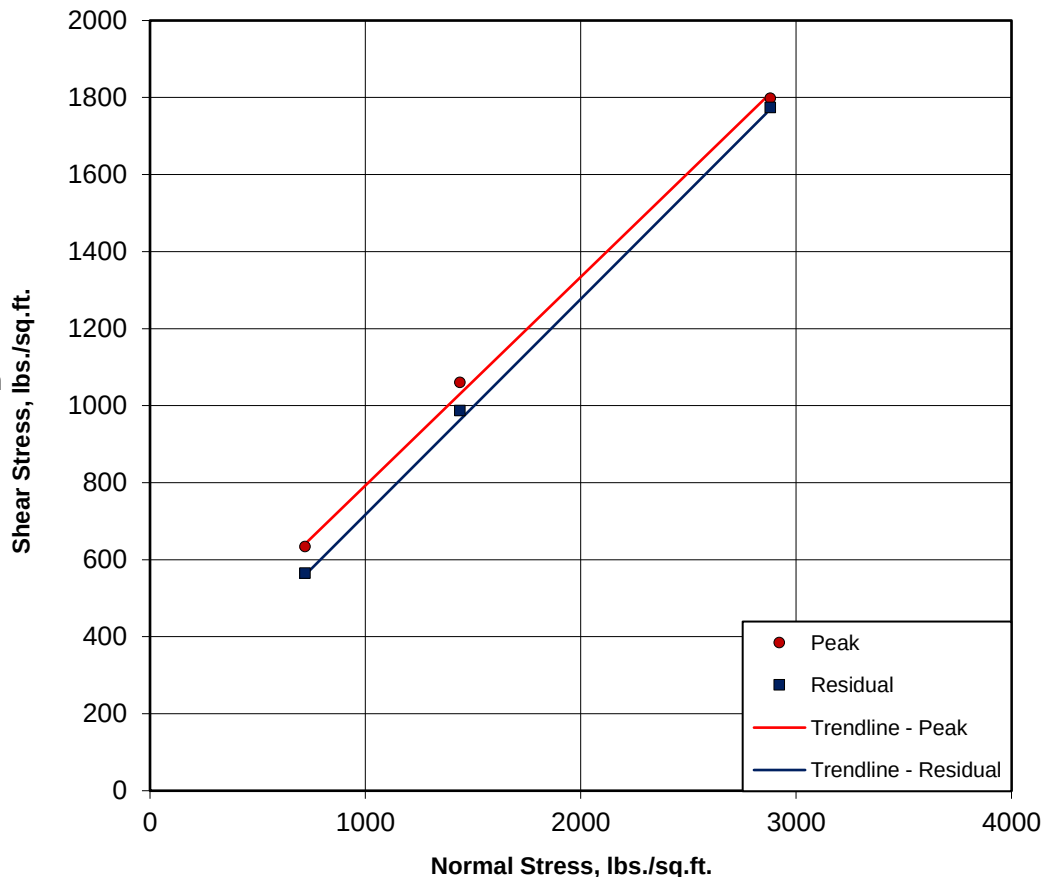
| Sample Number: ST-9 | Strain Rate: 1.1 percent/min. | | |
| Description: Silt, gray, moist, stiff. | | | |

Portion of sample retained on No. 10 sieve was removed.

Sample was tested in saturated condition.

Angle of Internal Friction:

$\phi = 28.4^\circ$  (residual)  
 $29.2^\circ$  (peak)

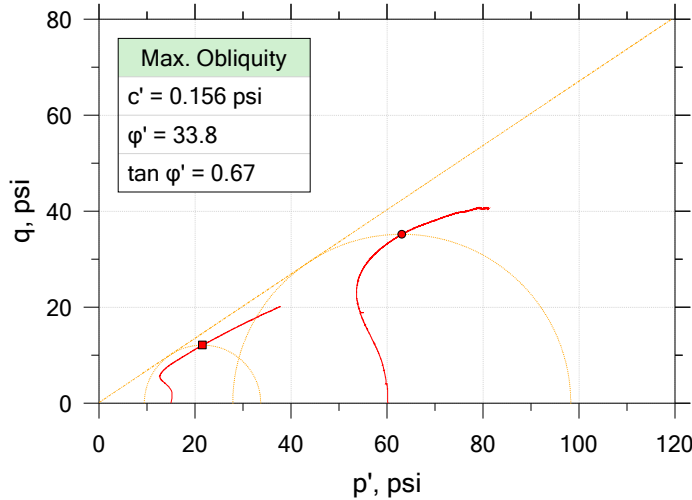
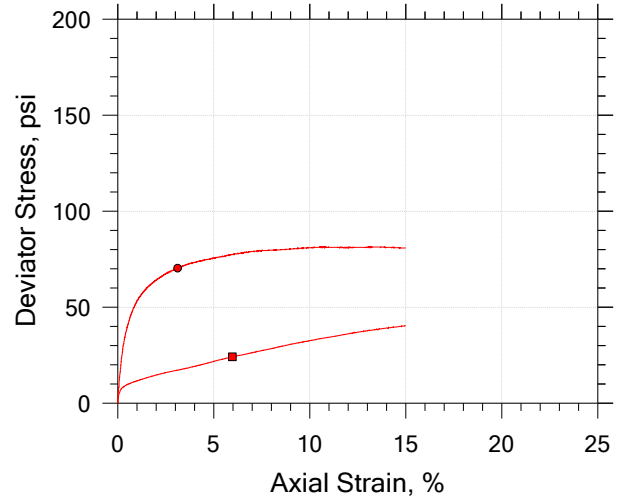
# Consolidated Undrained by ASTM D4767

| Sample ID | ST-18 | ST-18 | | |
| Deviator Stress at Failure, psi | 24.24 | 70.43 | | |

- Before Shear Saturation set to 100% for phase calculation.
  - Moisture Content determined by ASTM D2216.
  - Deviator Stress includes membrane correction.
  - Values for  $c$  and  $\phi$  determined from best-fit straight line for the specific test conditions.
- Actual strength parameters may vary and should be determined by an engineer for site conditions.
