### **REQUEST FOR PROPOSAL FOR**

**Sheridan Bluff Stability**

**PROJECT NO. WP083801**

# COASTAL ANALYSIS AND BASIS OF DESIGN REPORT

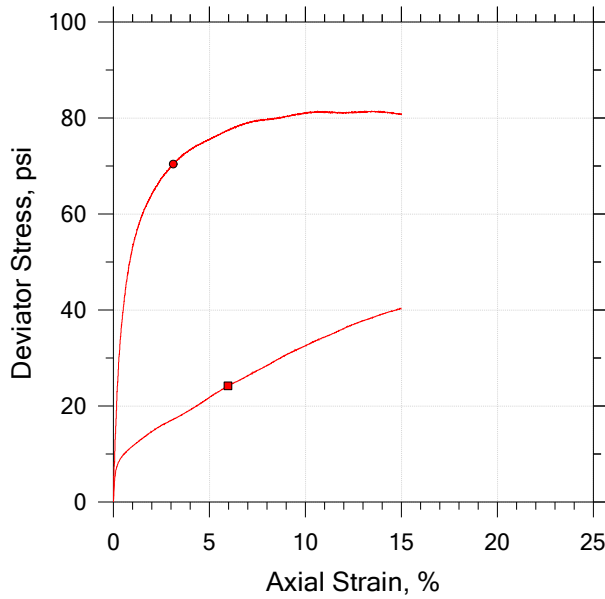
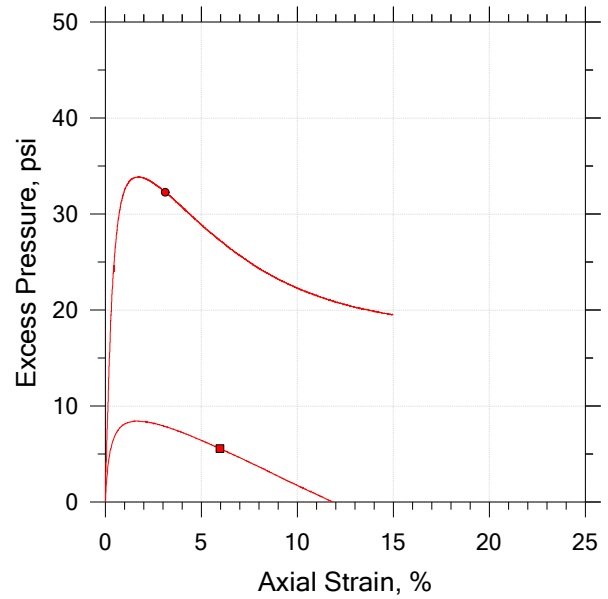
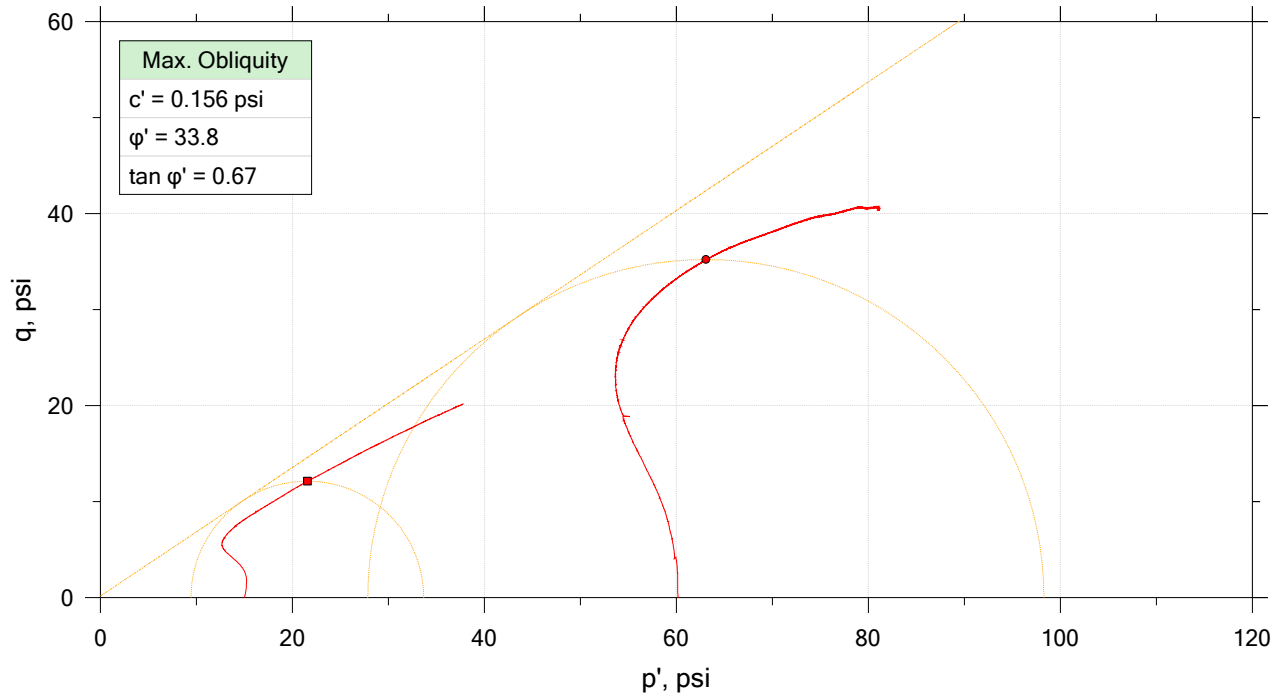
# Consolidated Undrained by ASTM D4767

| | Sample No. | Test No. | Depth | Tested By | Test Date | Checked By | Check Date | Test File |
|---|---|---|---|---|---|---|---|---|
| ■ | ST-18 | 1 | 56'-58' | S. McLafferty | 10-31-2024 | N. Merkes | 11-8-2024 | BAYVIEW SB-01, ST-18, 15psi.dat |

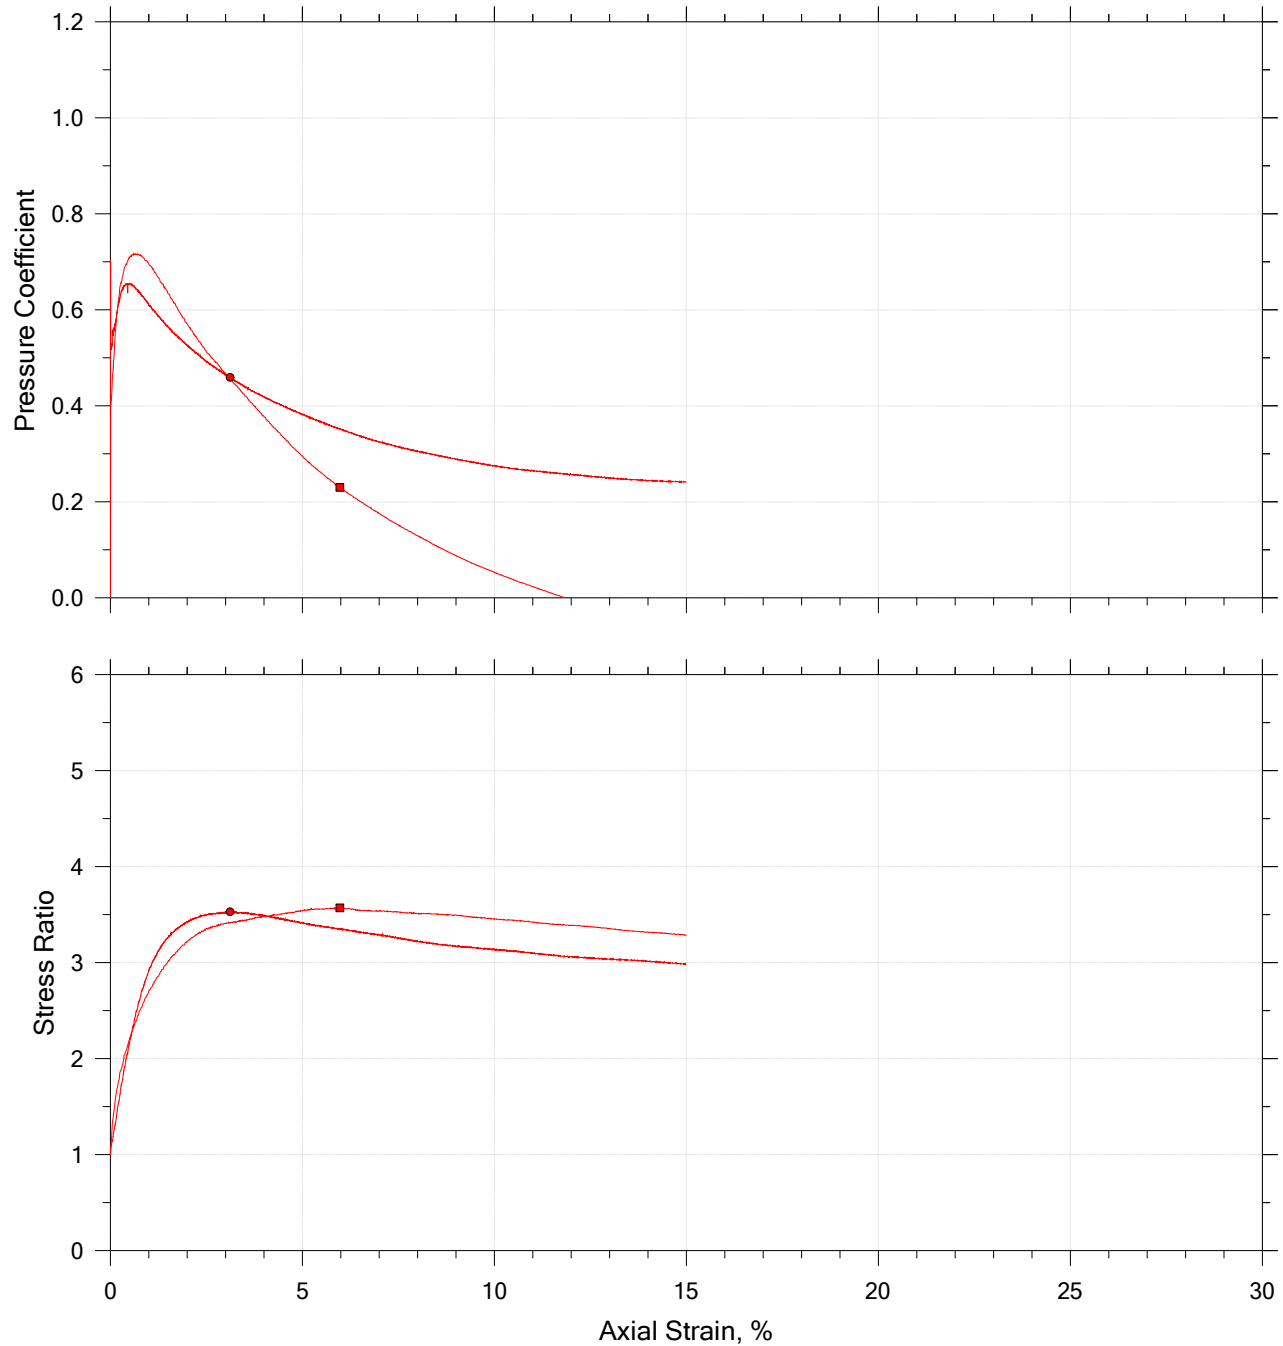
## Consolidated Undrained by ASTM D4767

| | Sample No. | Test No. | Depth | Tested By | Test Date | Checked By | Check Date | Test File |
|---|---|---|---|---|---|---|---|---|
| ■ | ST-18 | 1 | 56'-58' | S. McLafferty | 10-31-2024 | N. Merkes | 11-8-2024 | BAYVIEW SB-01, ST-18, 15psi.dat |

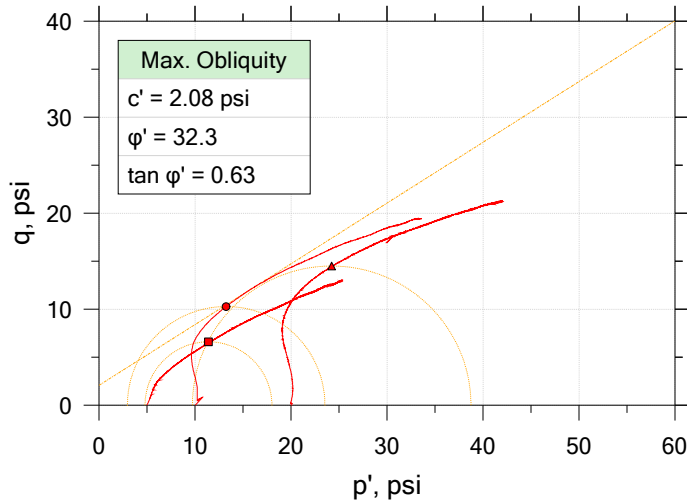
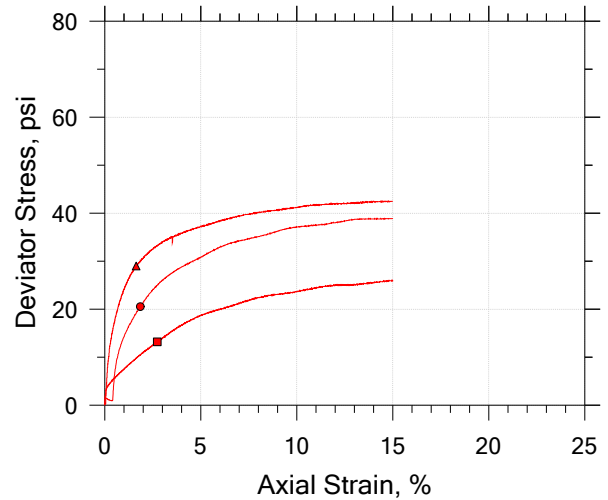
# Consolidated Undrained by ASTM D4767

| Sample ID | ST-6 | ST-6 | ST-6 | |
| Deviator Stress at Failure, psi | 13.22 | 20.58 | 29.01 | |

Notes:  
 - Before Shear Saturation set to 100% for phase calculation.  
 - Moisture Content determined by ASTM D2216.  
 - Atterberg Limits determined by ASTM D4318.  
 - Deviator Stress includes membrane correction.  
 - Values for  $c$  and  $\phi$  determined from best-fit straight line for the specific test conditions.  
 Actual strength parameters may vary and should be determined by an engineer for site conditions.

| | Description: Lean clay, gray, moist, very stiff, trace sand and gravel. | | |

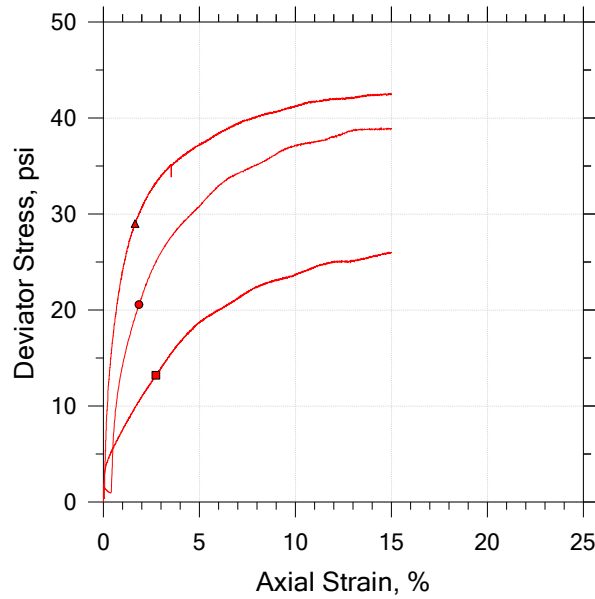
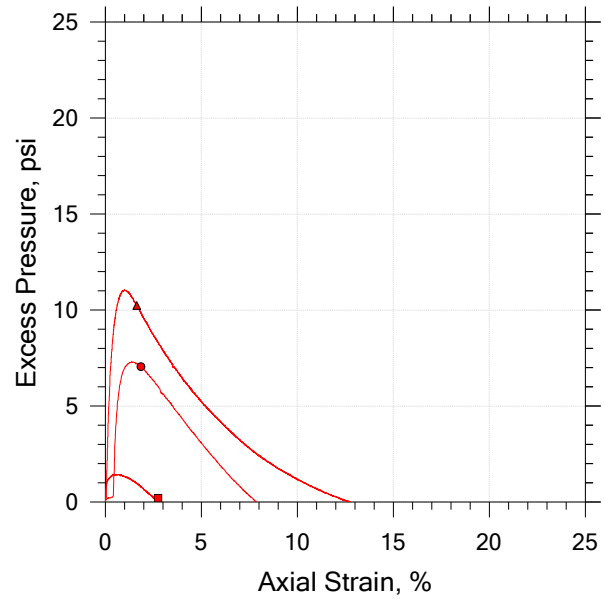
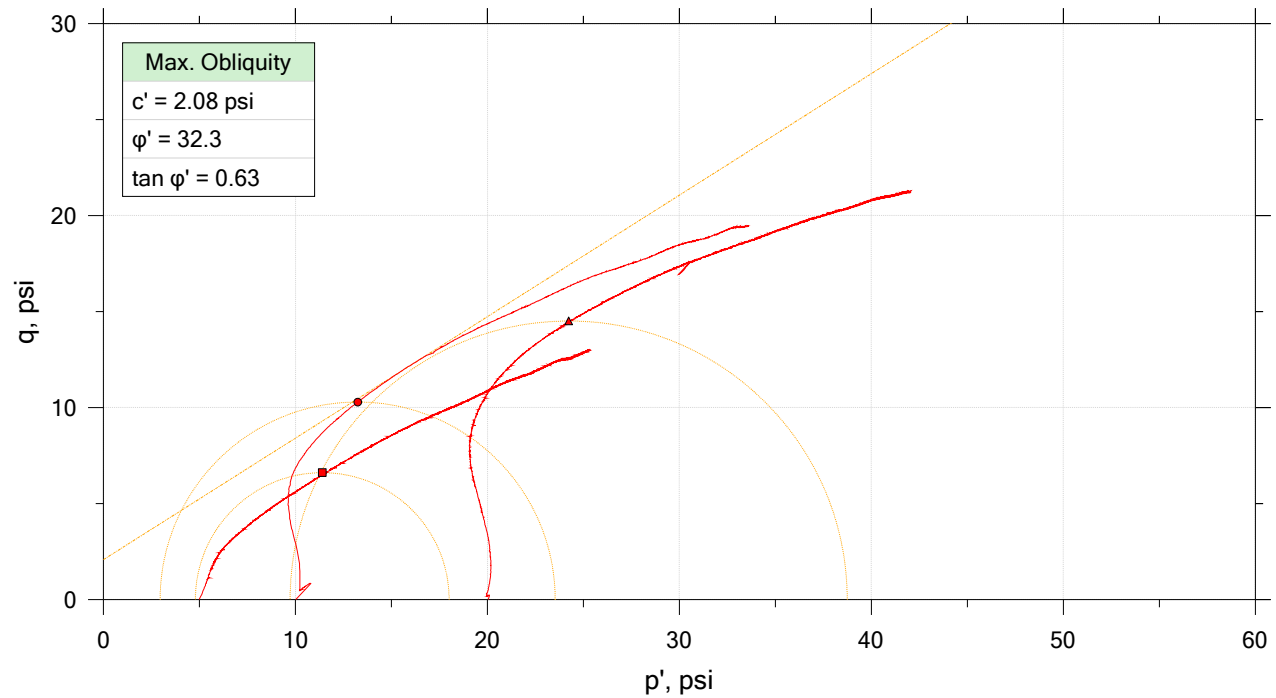
# Consolidated Undrained by ASTM D4767

| | Sample No. | Test No. | Depth | Tested By | Test Date | Checked By | Check Date | Test File |
|---|---|---|---|---|---|---|---|---|
| ■ | ST-6 | 1 | 14'-16' | S. McLafferty | 11/25/24 | N. Merkes | 12/5/24 | SHERIDAN-SB-03, ST-6, 5 PSI.dat |

| | Description: Lean clay, gray, moist, very stiff, trace sand and gravel. | | |

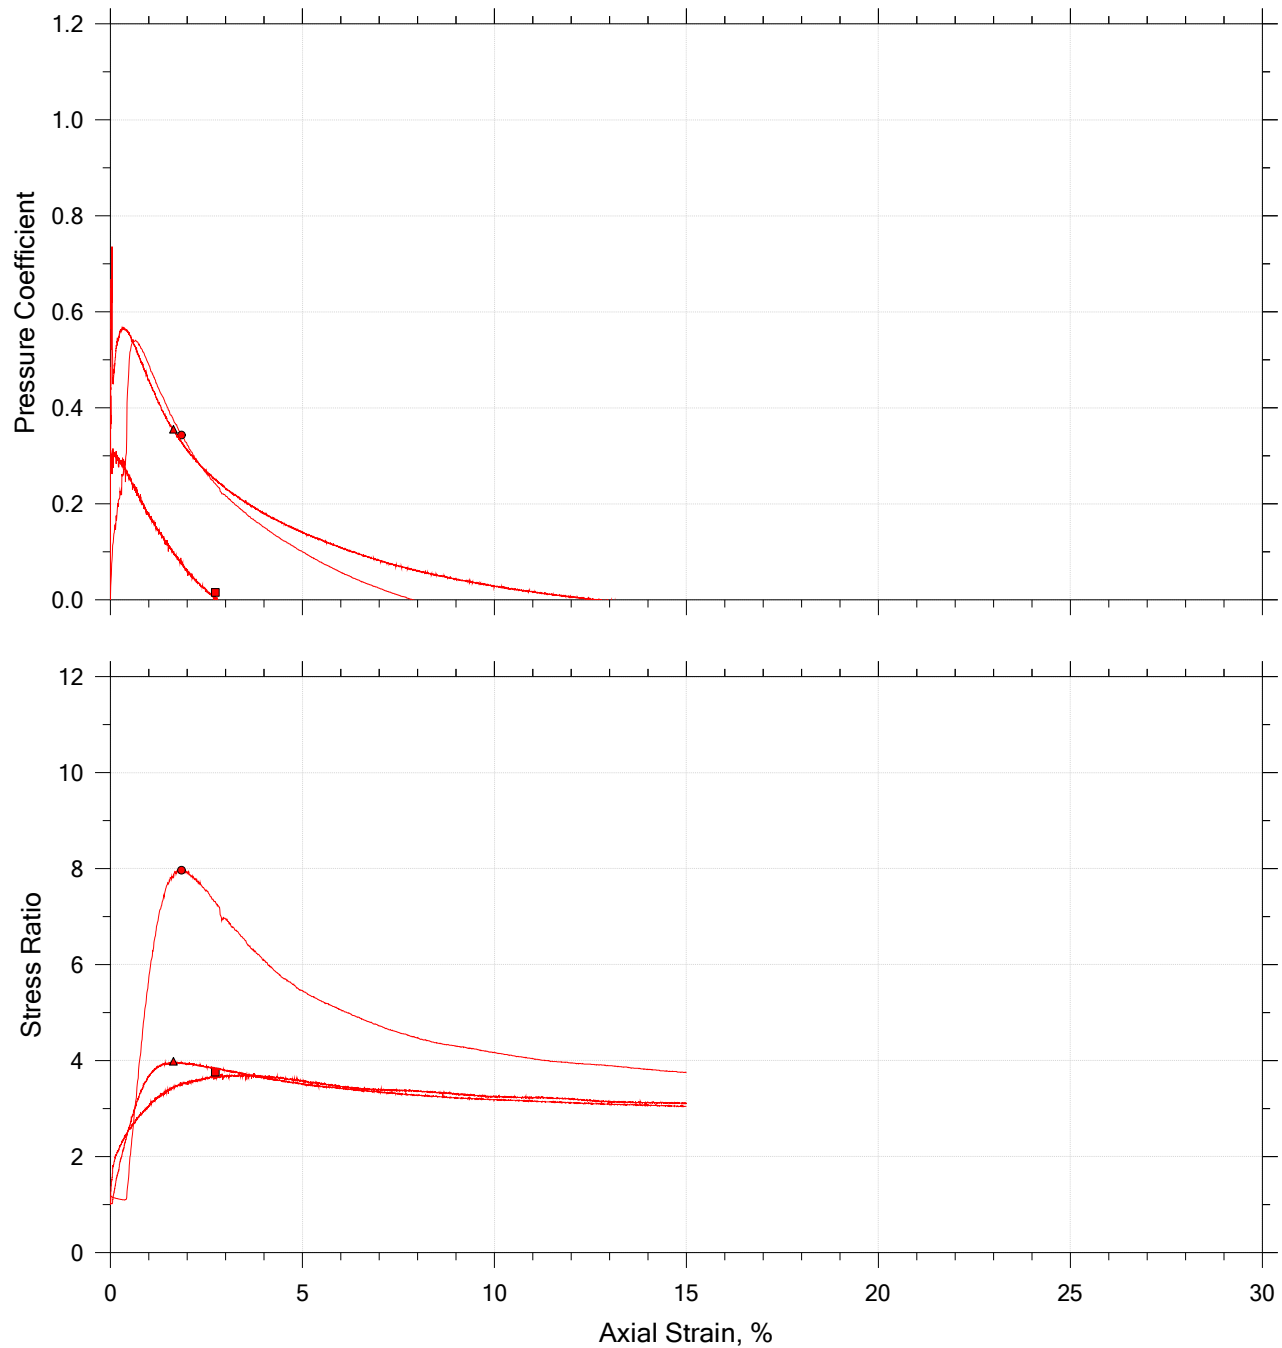
## Consolidated Undrained by ASTM D4767

| | Sample No. | Test No. | Depth | Tested By | Test Date | Checked By | Check Date | Test File |
|---|---|---|---|---|---|---|---|---|
| ■ | ST-6 | 1 | 14'-16' | S. McLafferty | 11/25/24 | N. Merkes | 12/5/24 | SHERIDAN-SB-03, ST-6, 5 PSI.dat |
| | Description: Lean clay, gray, moist, very stiff, trace sand and gravel. | | | | | | | |

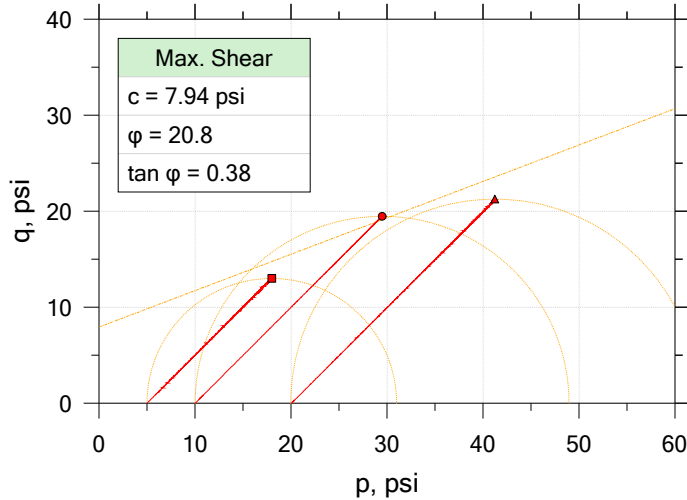
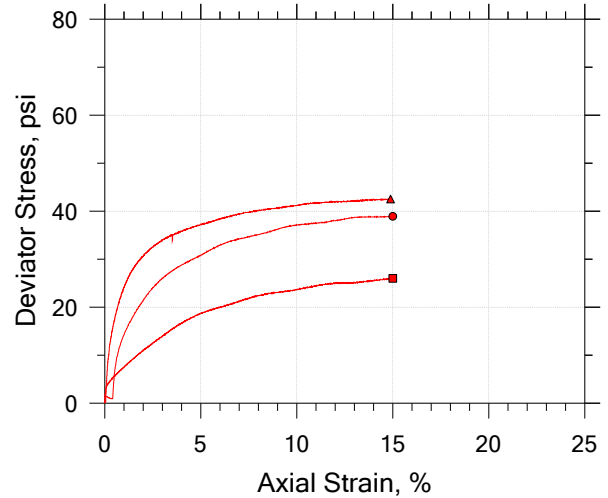
# Consolidated Undrained by ASTM D4767

| Sample ID | ST-6 | ST-6 | ST-6 | |
| Deviator Stress at Failure, psi | 26.00 | 38.95 | 42.52 | |

- Before Shear Saturation set to 100% for phase calculation.
  - Moisture Content determined by ASTM D2216.
  - Atterberg Limits determined by ASTM D4318.
  - Deviator Stress includes membrane correction.
  - Values for  $c$  and  $\phi$  determined from best-fit straight line for the specific test conditions.
- Actual strength parameters may vary and should be determined by an engineer for site conditions.

| | Description: Lean clay, gray, moist, very stiff, trace sand and gravel. | | |

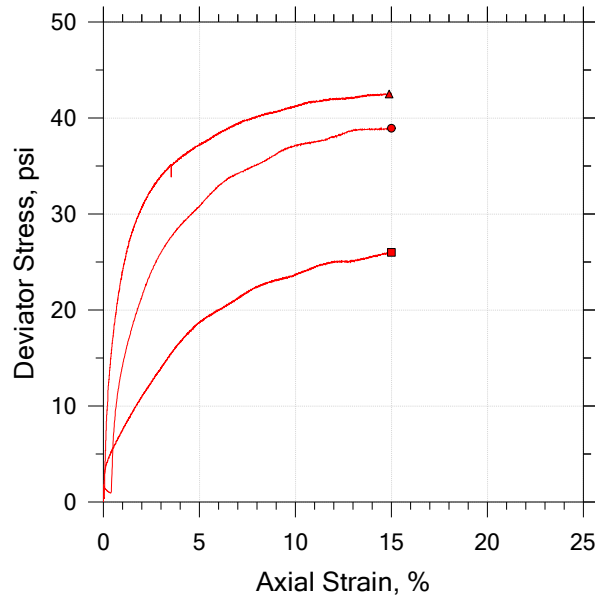
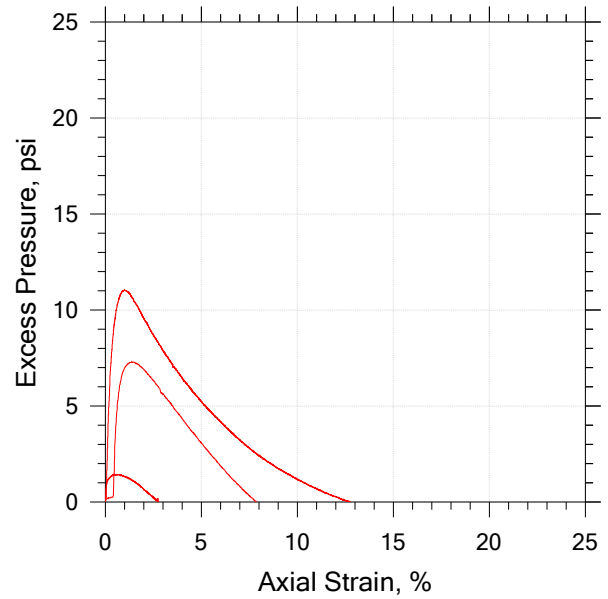
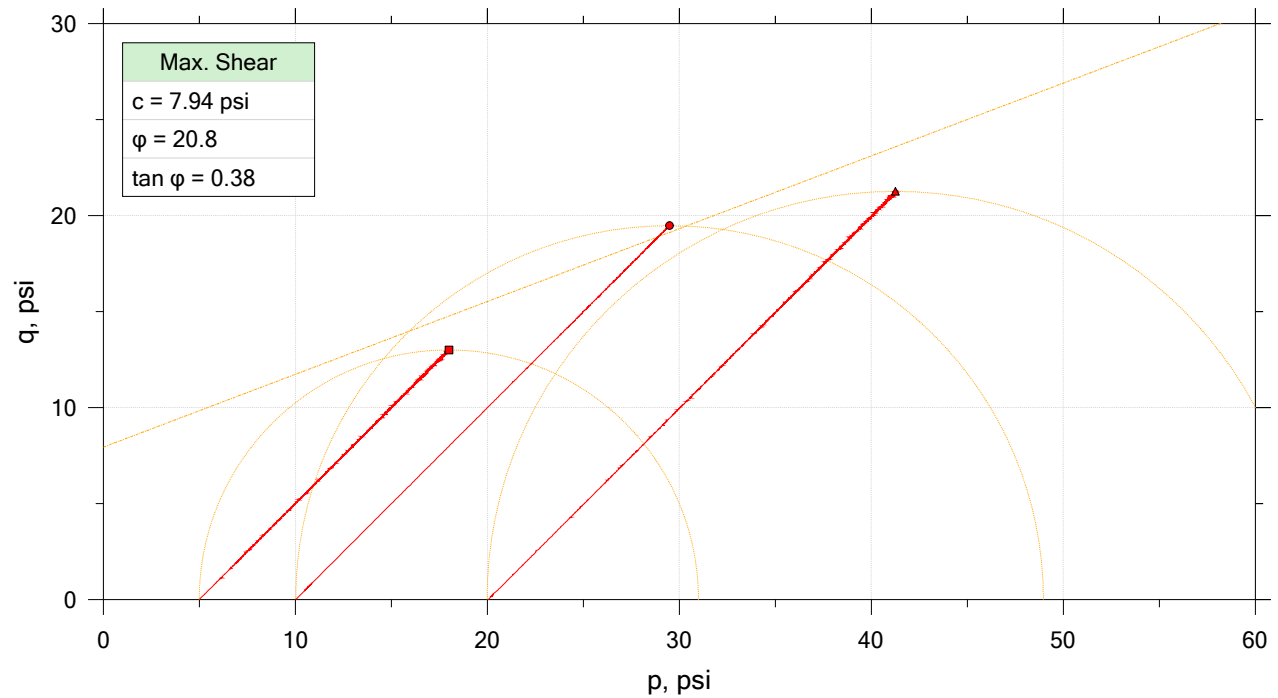
# Consolidated Undrained by ASTM D4767

| | Sample No. | Test No. | Depth | Tested By | Test Date | Checked By | Check Date | Test File |
|---|---|---|---|---|---|---|---|---|
| ■ | ST-6 | 1 | 14'-16' | S. McLafferty | 11/25/24 | N. Merkes | 12/5/24 | SHERIDAN-SB-03, ST-6, 5 PSI.dat |

| | Description: Lean clay, gray, moist, very stiff, trace sand and gravel. | | |

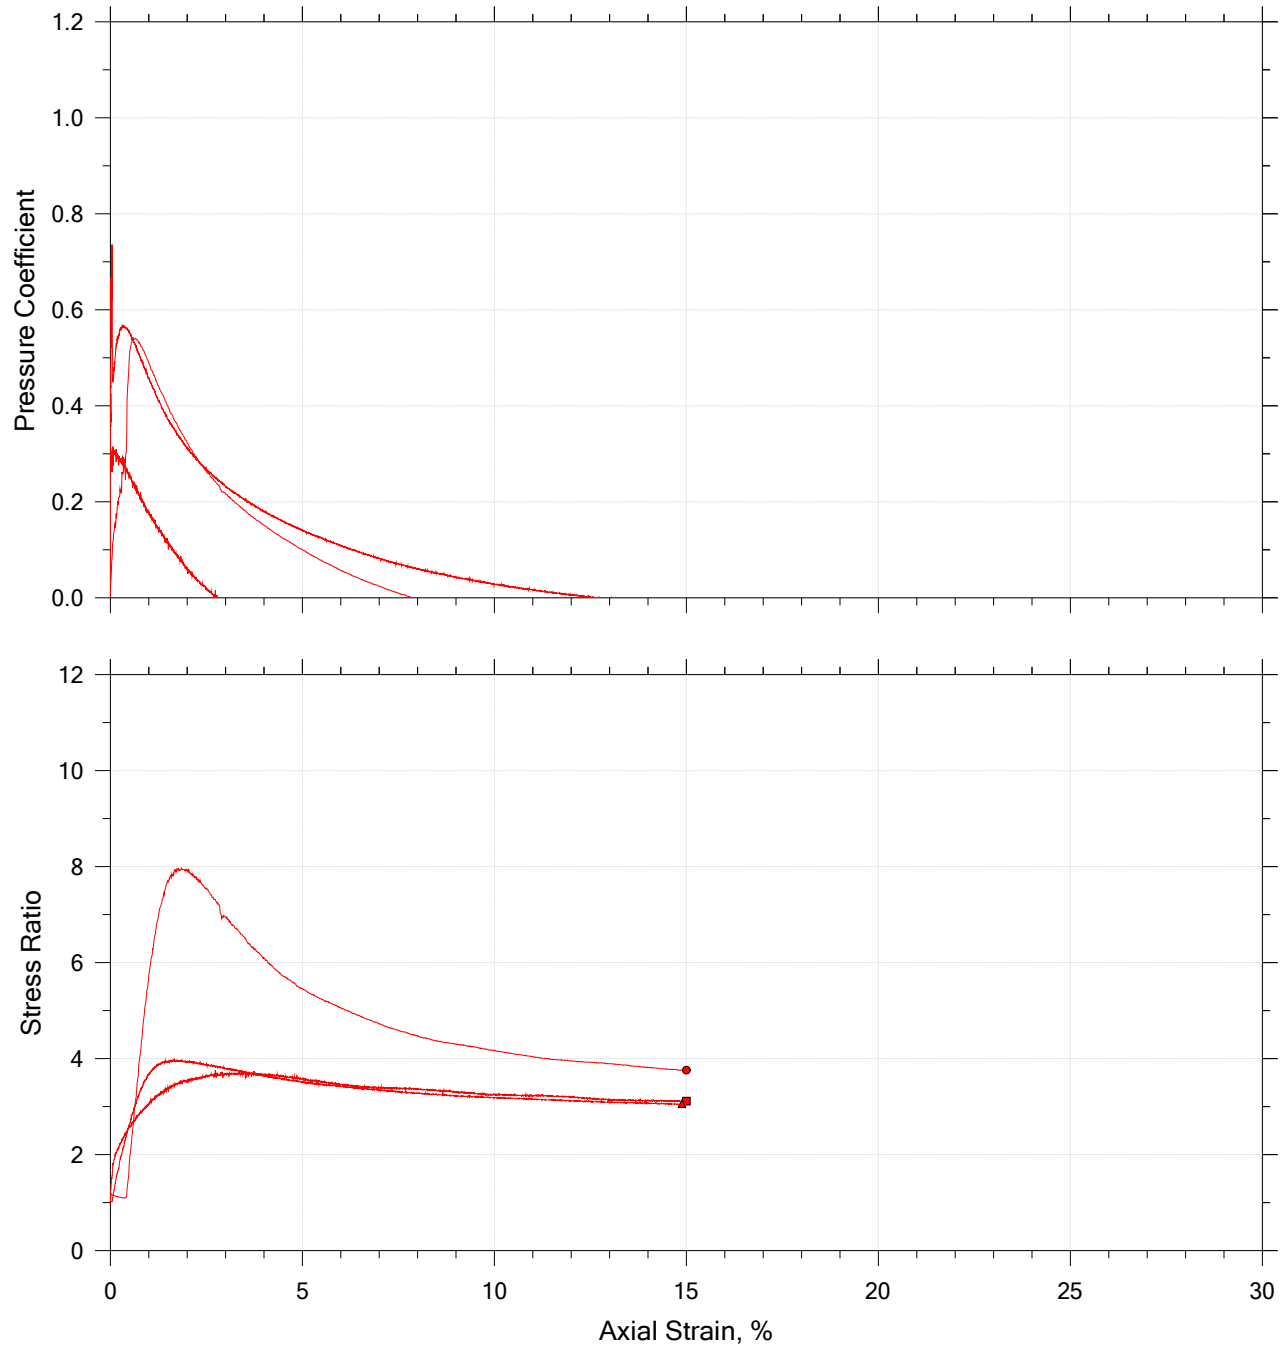
# Consolidated Undrained by ASTM D4767

| | Sample No. | Test No. | Depth | Tested By | Test Date | Checked By | Check Date | Test File |
|---|---|---|---|---|---|---|---|---|
| ■ | ST-6 | 1 | 14'-16' | S. McLafferty | 11/25/24 | N. Merkes | 12/5/24 | SHERIDAN-SB-03, ST-6, 5 PSI.dat |
| | Description: Lean clay, gray, moist, very stiff, trace sand and gravel. | | | | | | | |

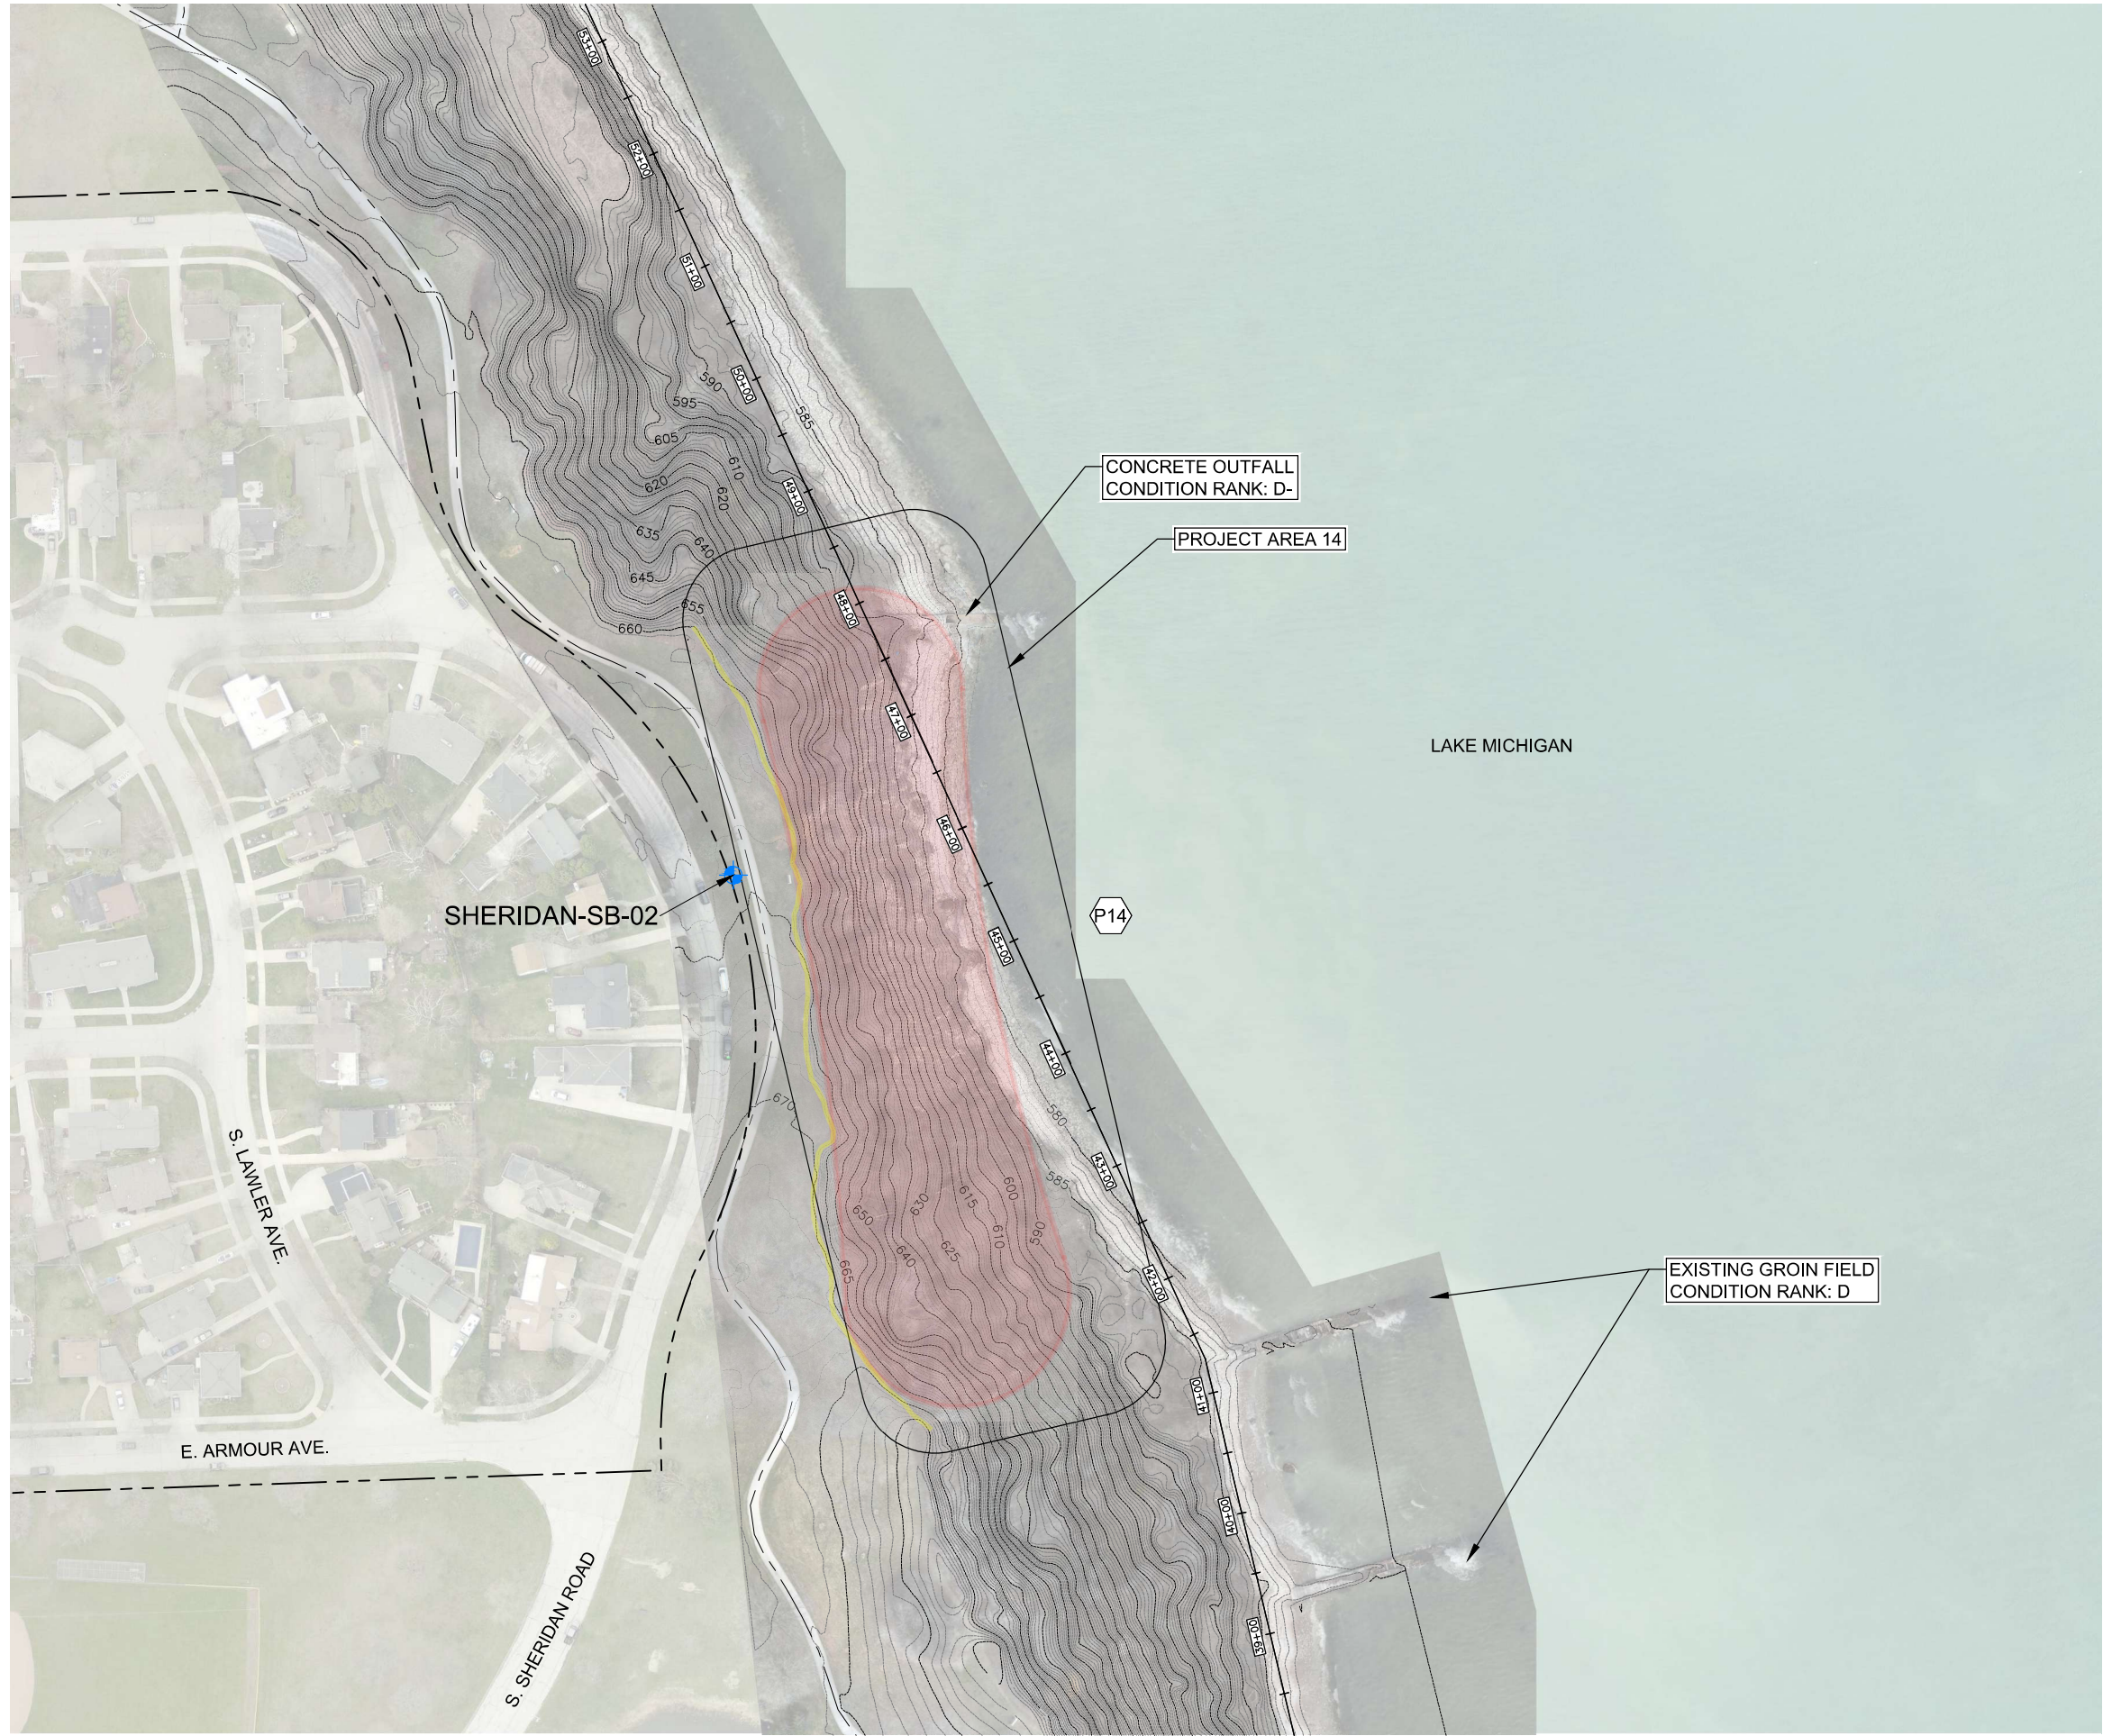
© 2025 - GZA GeoEnvironmental, Inc. GZA-158819-MKE CNTY LAKE MI BLUFFS\FIGURES\CAD\10. SHERIDAN\PRODUCTION DRAWINGS\GZA\_20.0158819.00\_SHERIDAN PARK\_VA.DWG PROJECT AREA 14 EXISTING CONDITIONS MAY 29, 2025 9:18AM COLIN BYRON

- LEGEND**
- -610--- EXISTING MAJOR TOPOGRAPHIC CONTOUR LINE
  - EXISTING MINOR TOPOGRAPHIC CONTOUR LINE
  - - - - - APPROXIMATE SHERIDAN PARK BOUNDARY
  - PROJECT AREA
  - - - - - MILWAUKEE COUNTY TRAIL
  - P14 PHOTO LOCATION
  - BORING LOCATION DRILLED BY DRILL POINT INC. AND OBSERVED BY GZA ON 10-16-2024
  - BLUFF INSTABILITY
  - SLOPE SAFETY CONCERN

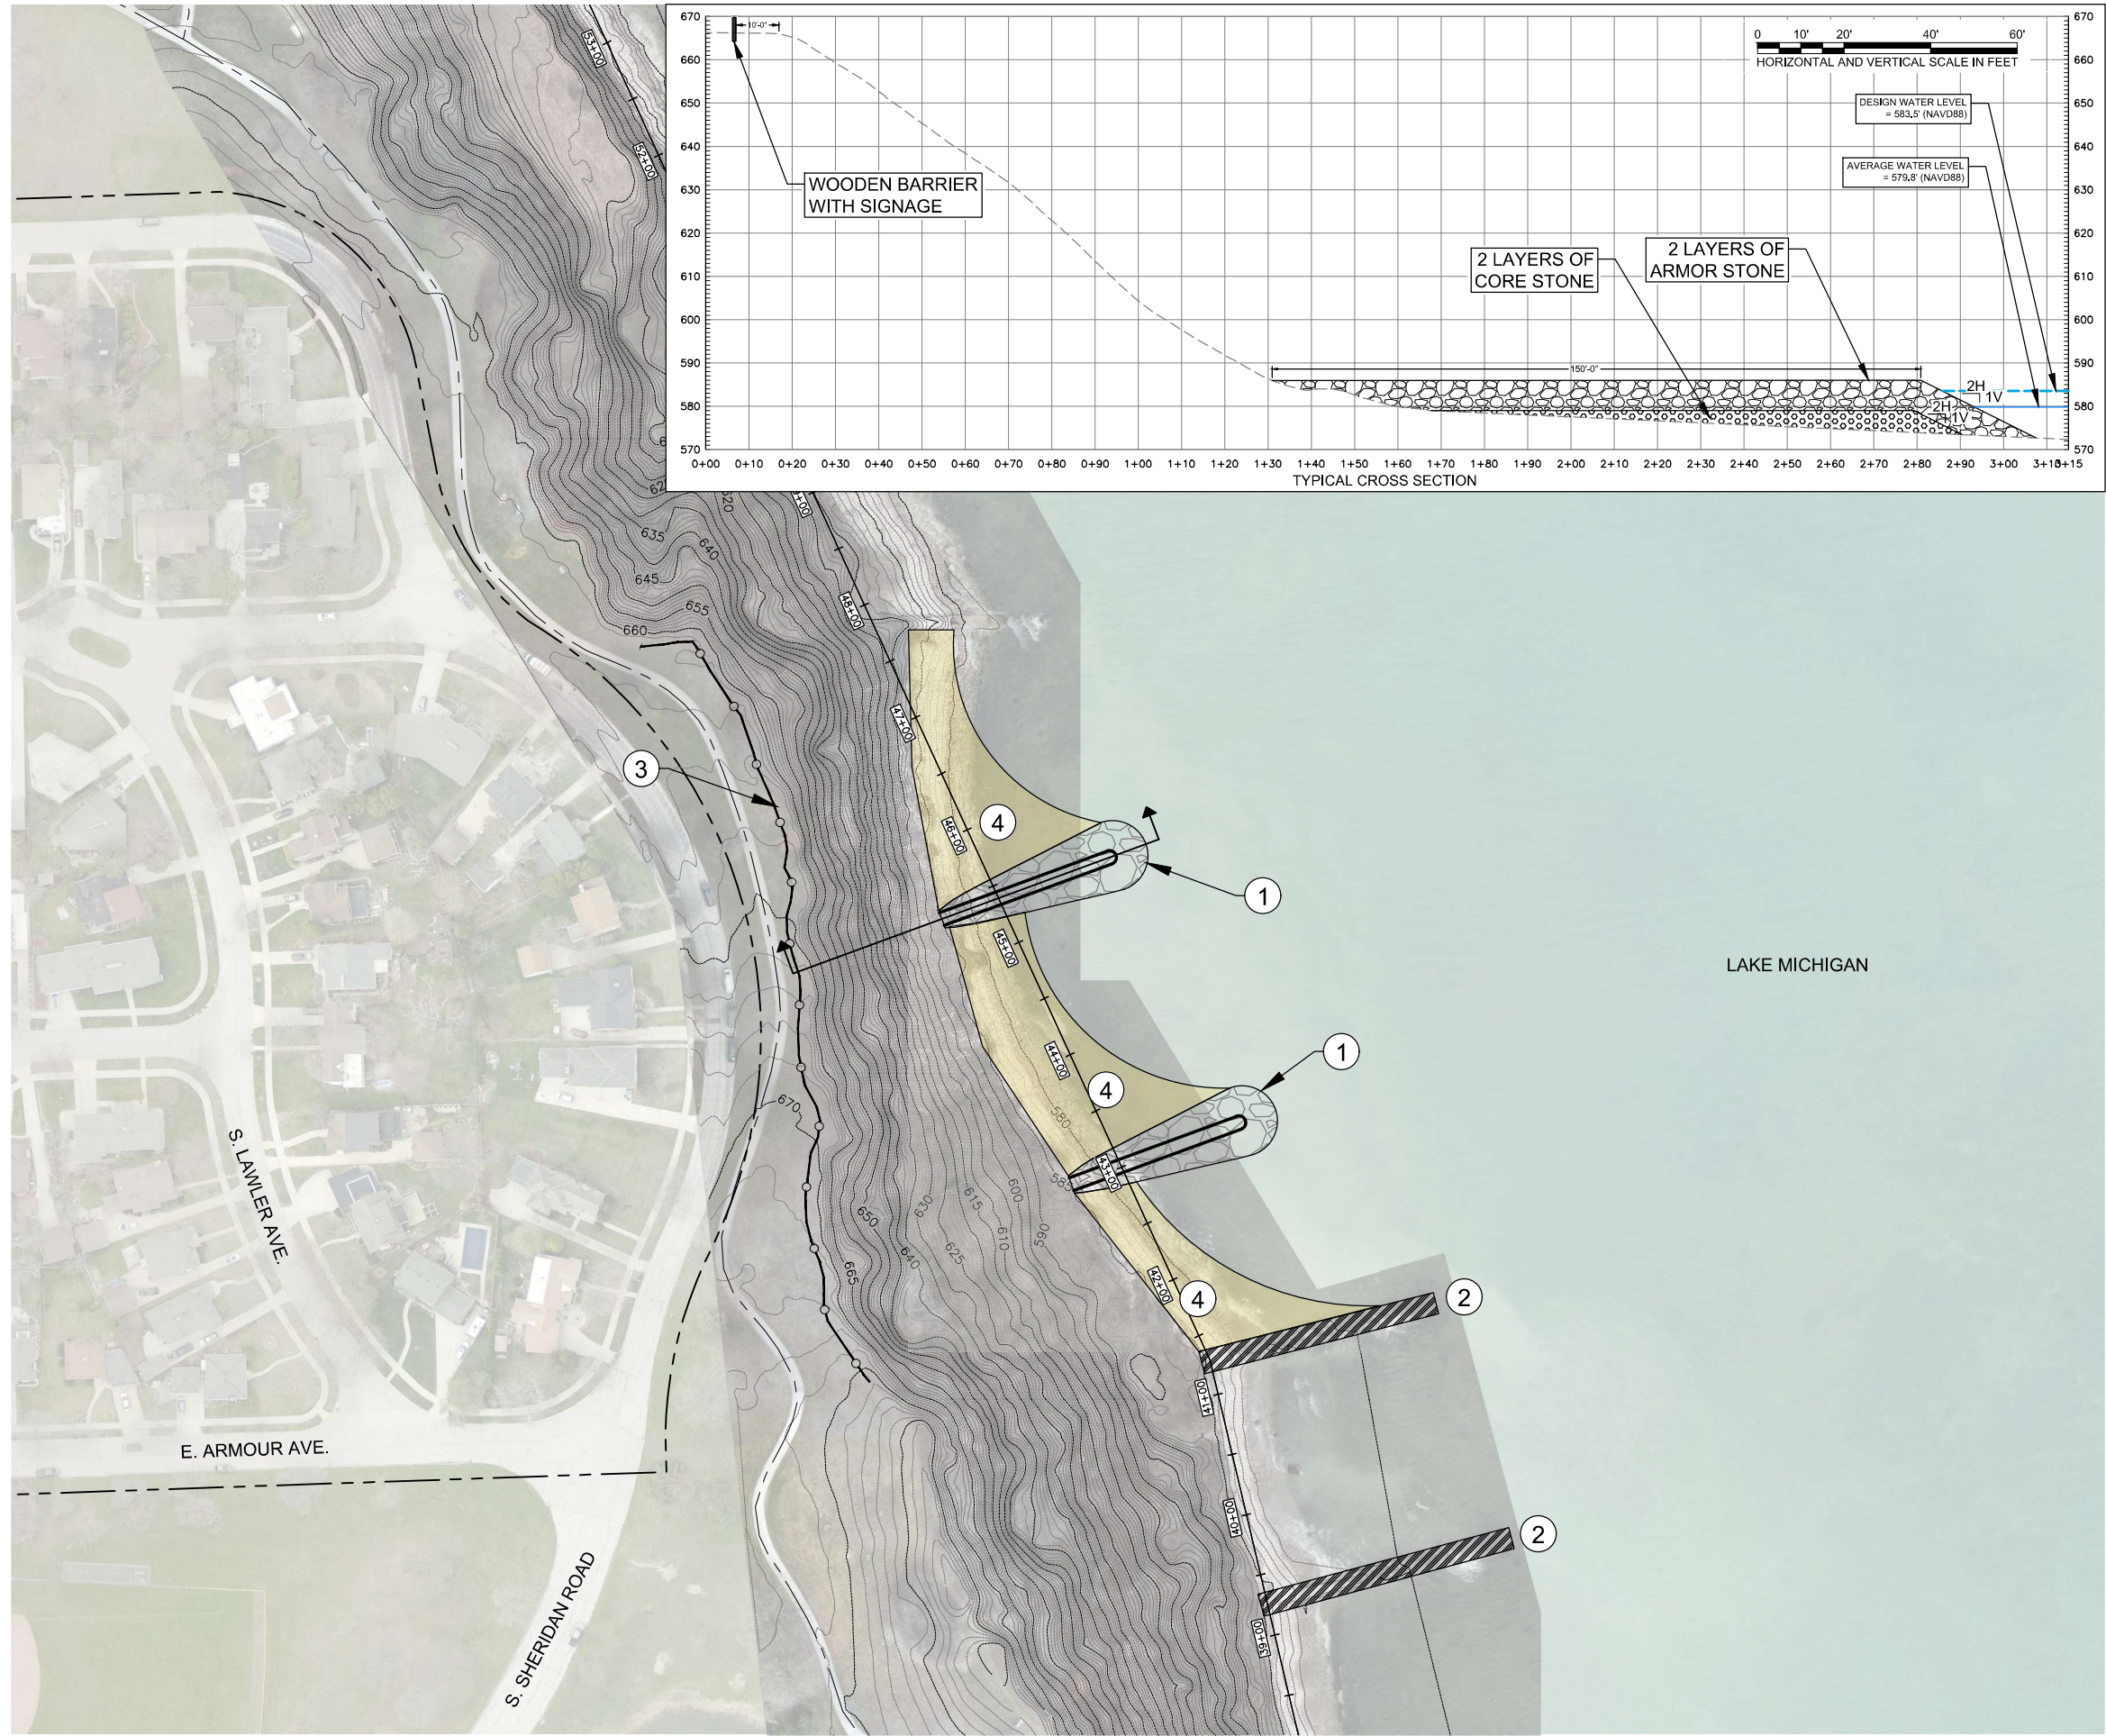
© 2025 - GZA GeoEnvironmental, Inc. GZA--L-1588070158809\158819 MKE CNTY LAKE MI BLUFFS\FIGURES\CAD\10. SHERIDAN\PRODUCTION DRAWINGS\GZA\_20.0158819.00\_SHERIDAN PARK\_VA.DWG PROJECT AREA 14. CONCEPT 1 MAY 29, 2025 9:16AM COLIN BYRON

| SHERIDAN PARK CONCEPT 1 - ESTIMATED QUANTITIES AND DETAILS | | | | |
