### **REQUEST FOR PROPOSAL FOR**

**Sheridan Bluff Stability**

**PROJECT NO. WP083801**

# COASTAL ANALYSIS AND BASIS OF DESIGN REPORT

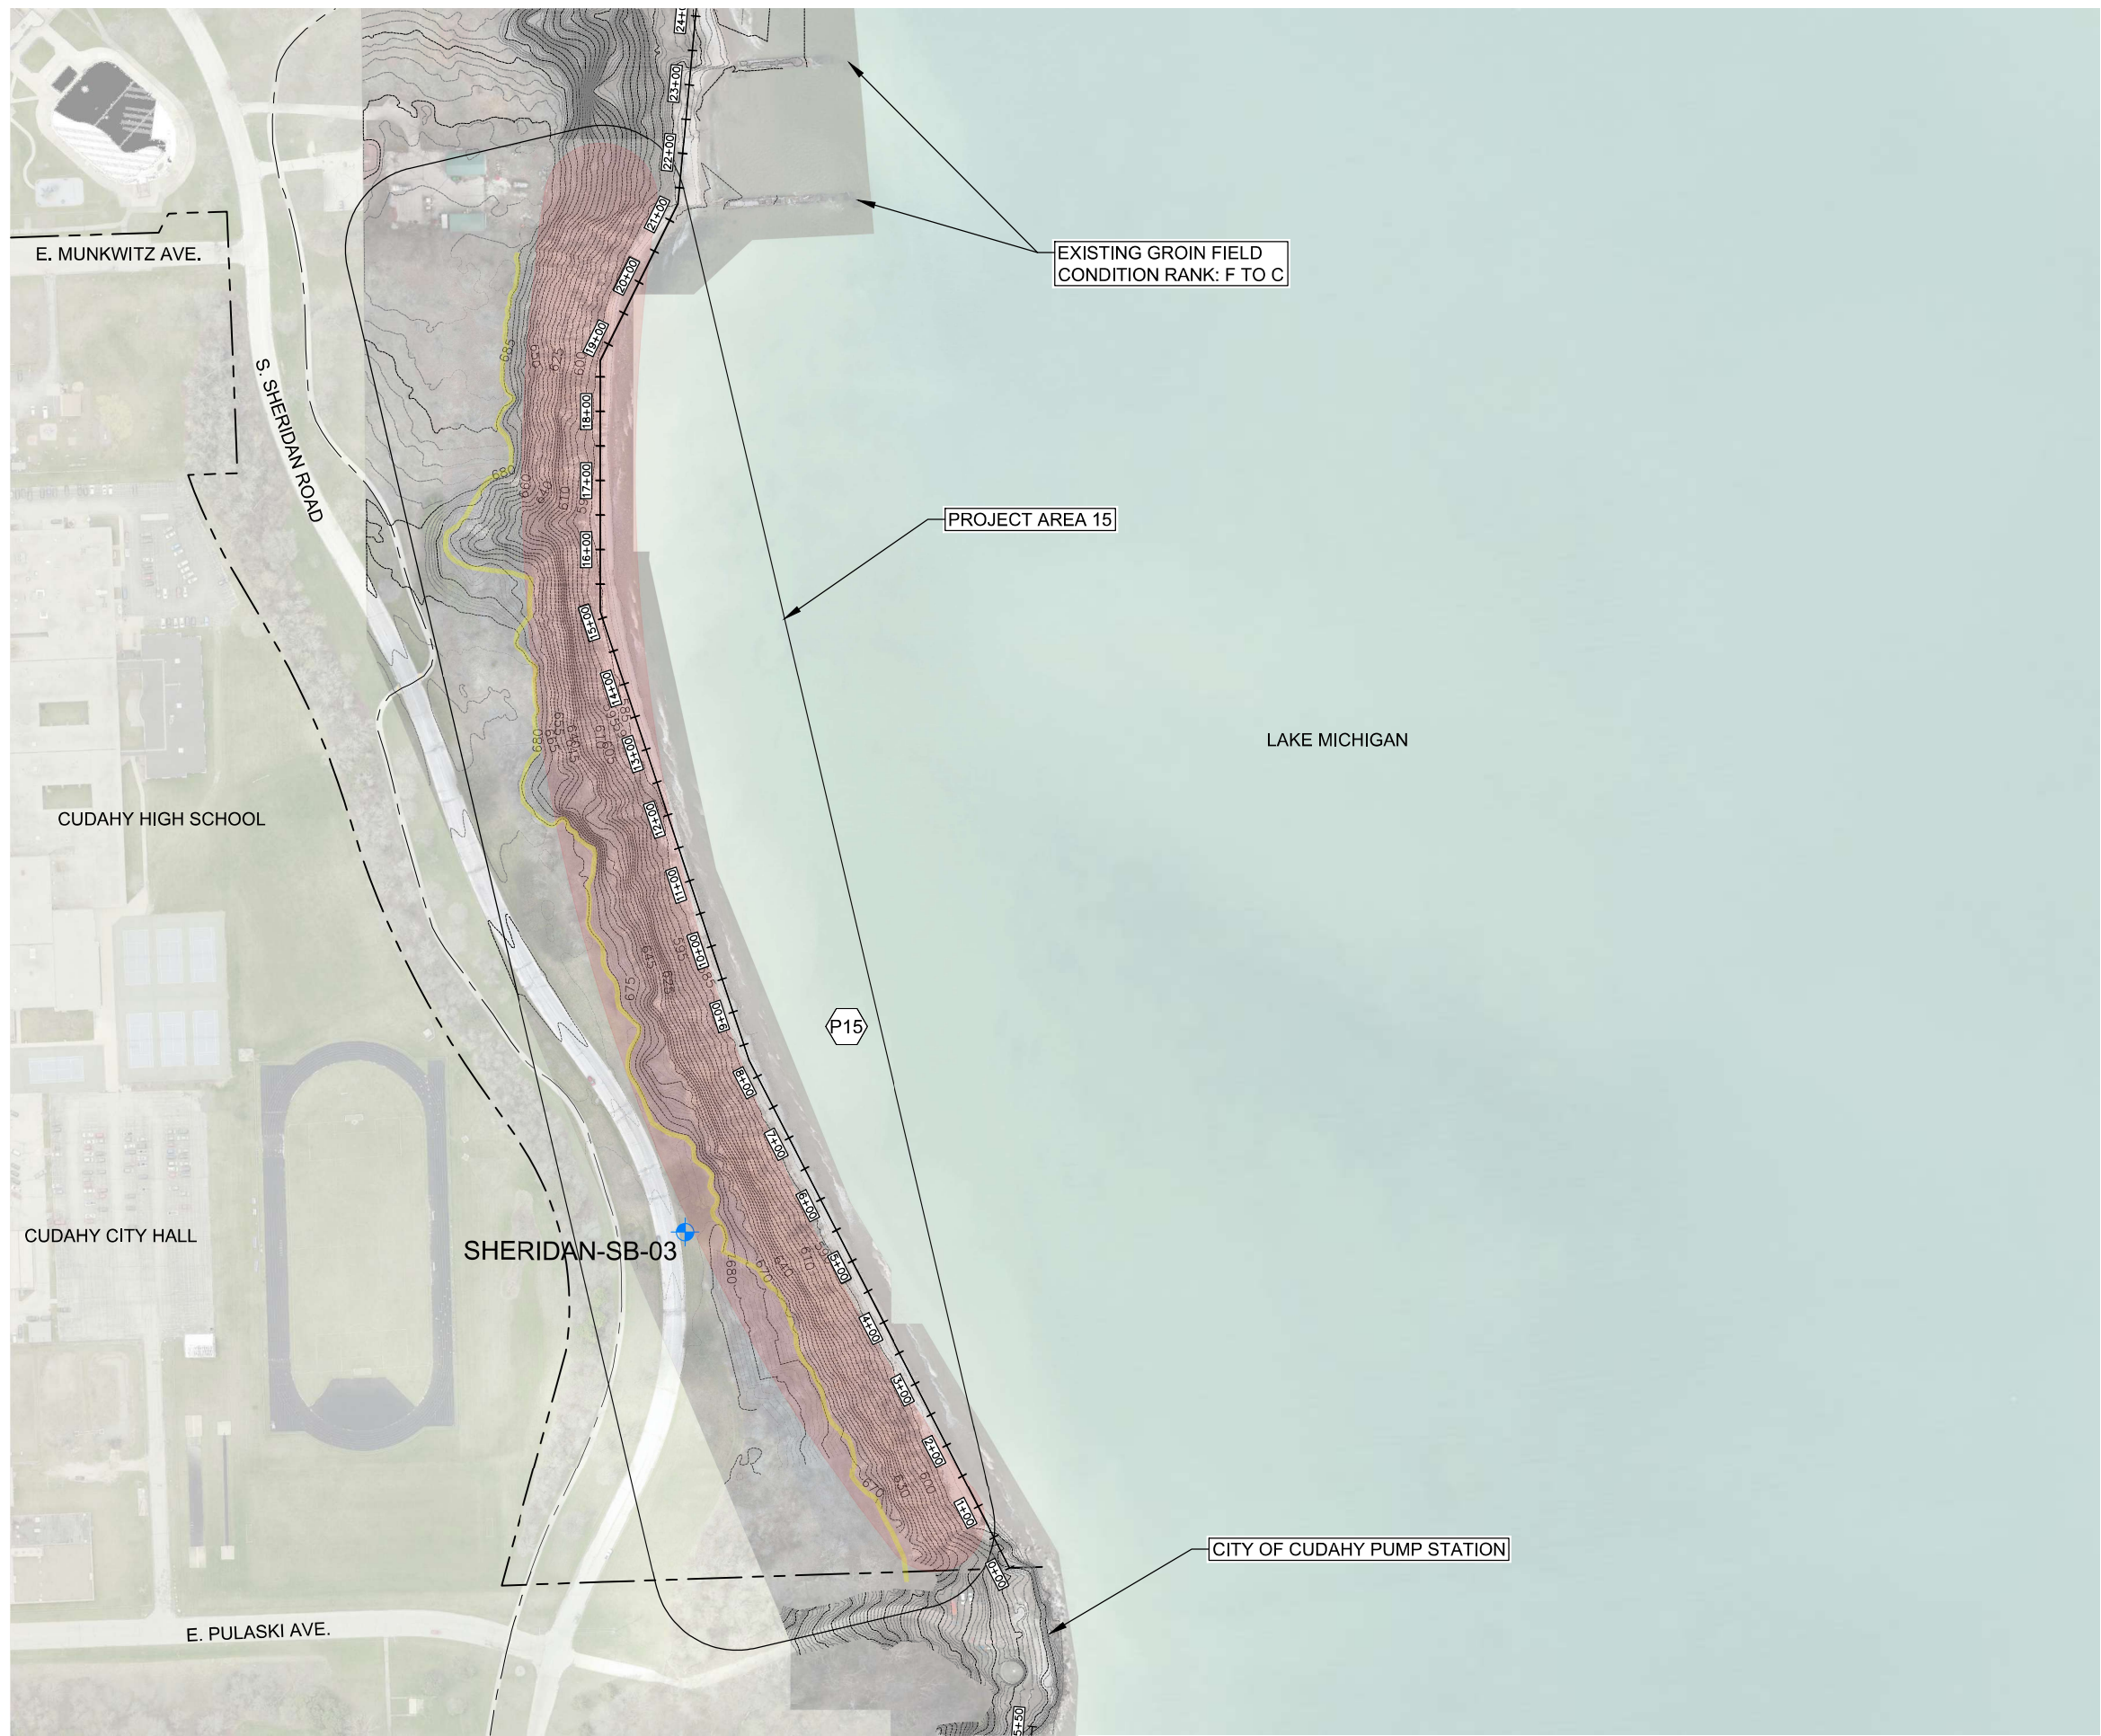
© 2025 - GZA GeoEnvironmental, Inc. GZA-IL-1588070158809\158819 MKE CNTY LAKE MI BLUFFS\FIGURES\CAD\10. SHERIDAN\PRODUCTION DRAWINGS\GZA\_20.0158819.00\_SHERIDAN PARK\_VA.DWG PROJECT AREA 15 EXISTING CONDITIONS MAY 29, 2025 9:18AM COLIN BYRON

- LEGEND**
- -610 --- EXISTING MAJOR TOPOGRAPHIC CONTOUR LINE
  - EXISTING MINOR TOPOGRAPHIC CONTOUR LINE
  - - - - - APPROXIMATE SHERIDAN PARK BOUNDARY
  - PROJECT AREA
  - - - - - MILWAUKEE COUNTY TRAIL
  - P15 PHOTO LOCATION
  - ★ BORING LOCATION DRILLED BY DRILL POINT INC. AND OBSERVED BY GZA ON 10/16/24 AND 10/17/24
  - BLUFF INSTABILITY
  - SLOPE SAFETY CONCERN

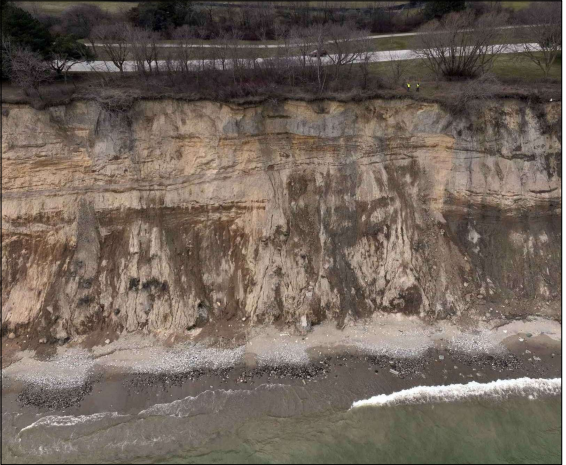
TYPICAL PROJECT AREA 15 CONDITIONS

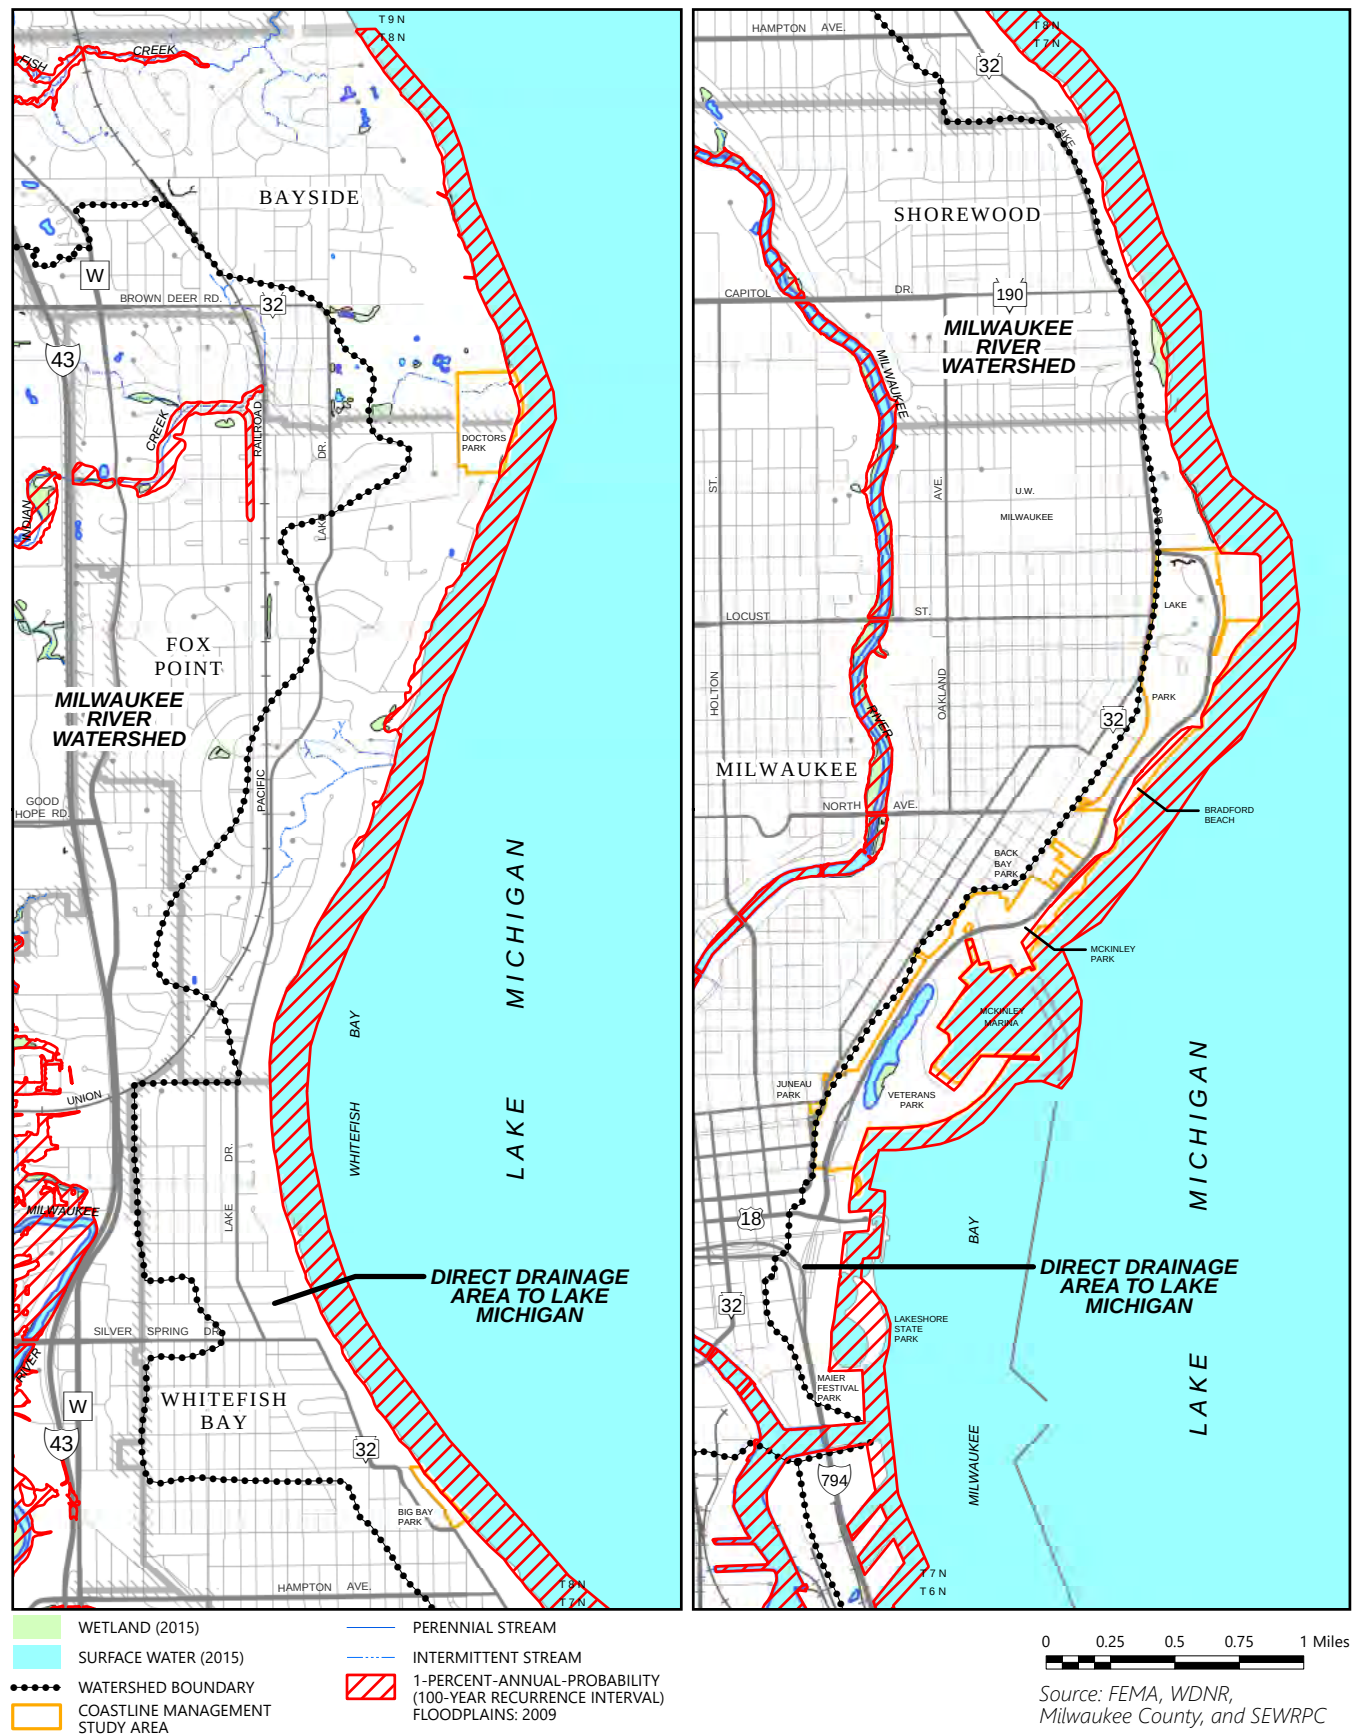
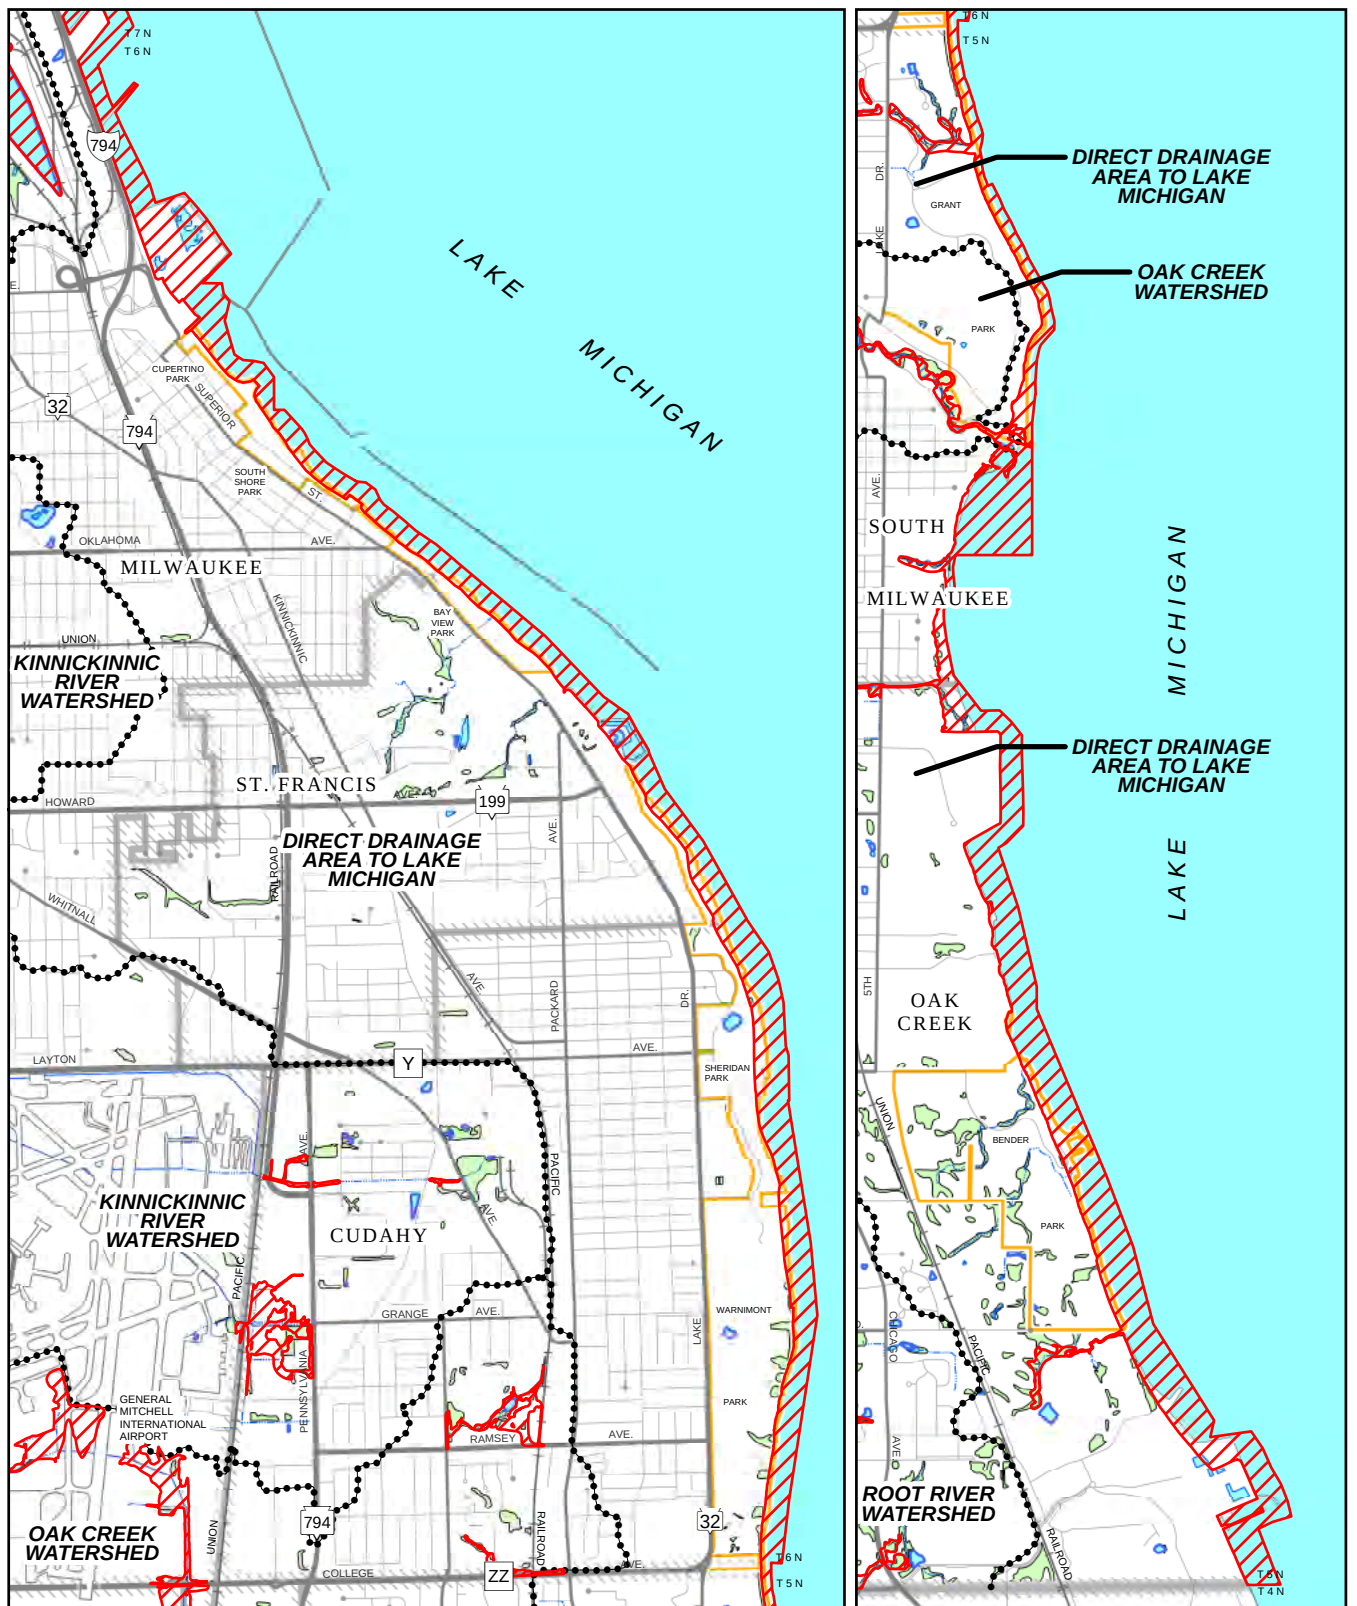
## Map 2.1

### Surface Waters, Wetlands, and Floodplains Along the Milwaukee County Lake Michigan Coastline

As shown on Map 2.1, surface water resources also include minor natural and man-made lakes and ponds ranging from five to 49 acres in size,<sup>16</sup> most of which are park lagoons within County-owned lands. The County's coastline area also features four major streams, or streams that maintain, at a minimum, a small continuous flow throughout the year—except under unusual drought conditions. These major streams include Oak Creek and the Kinnickinnic, Menomonee, and Milwaukee Rivers, which comprise a majority of Milwaukee County's parkway system.

Map 2.1 shows the location and extent of wetlands in the County,<sup>20</sup> including coastal wetlands, in 2015. Numerous permanent wetland types<sup>21</sup> are found within County-owned parks, one of which—the Warnimont Bluff Fens in Warnimont Park—has been designated a “Wetland Gem” by the Wisconsin Wetland Association.<sup>22</sup>

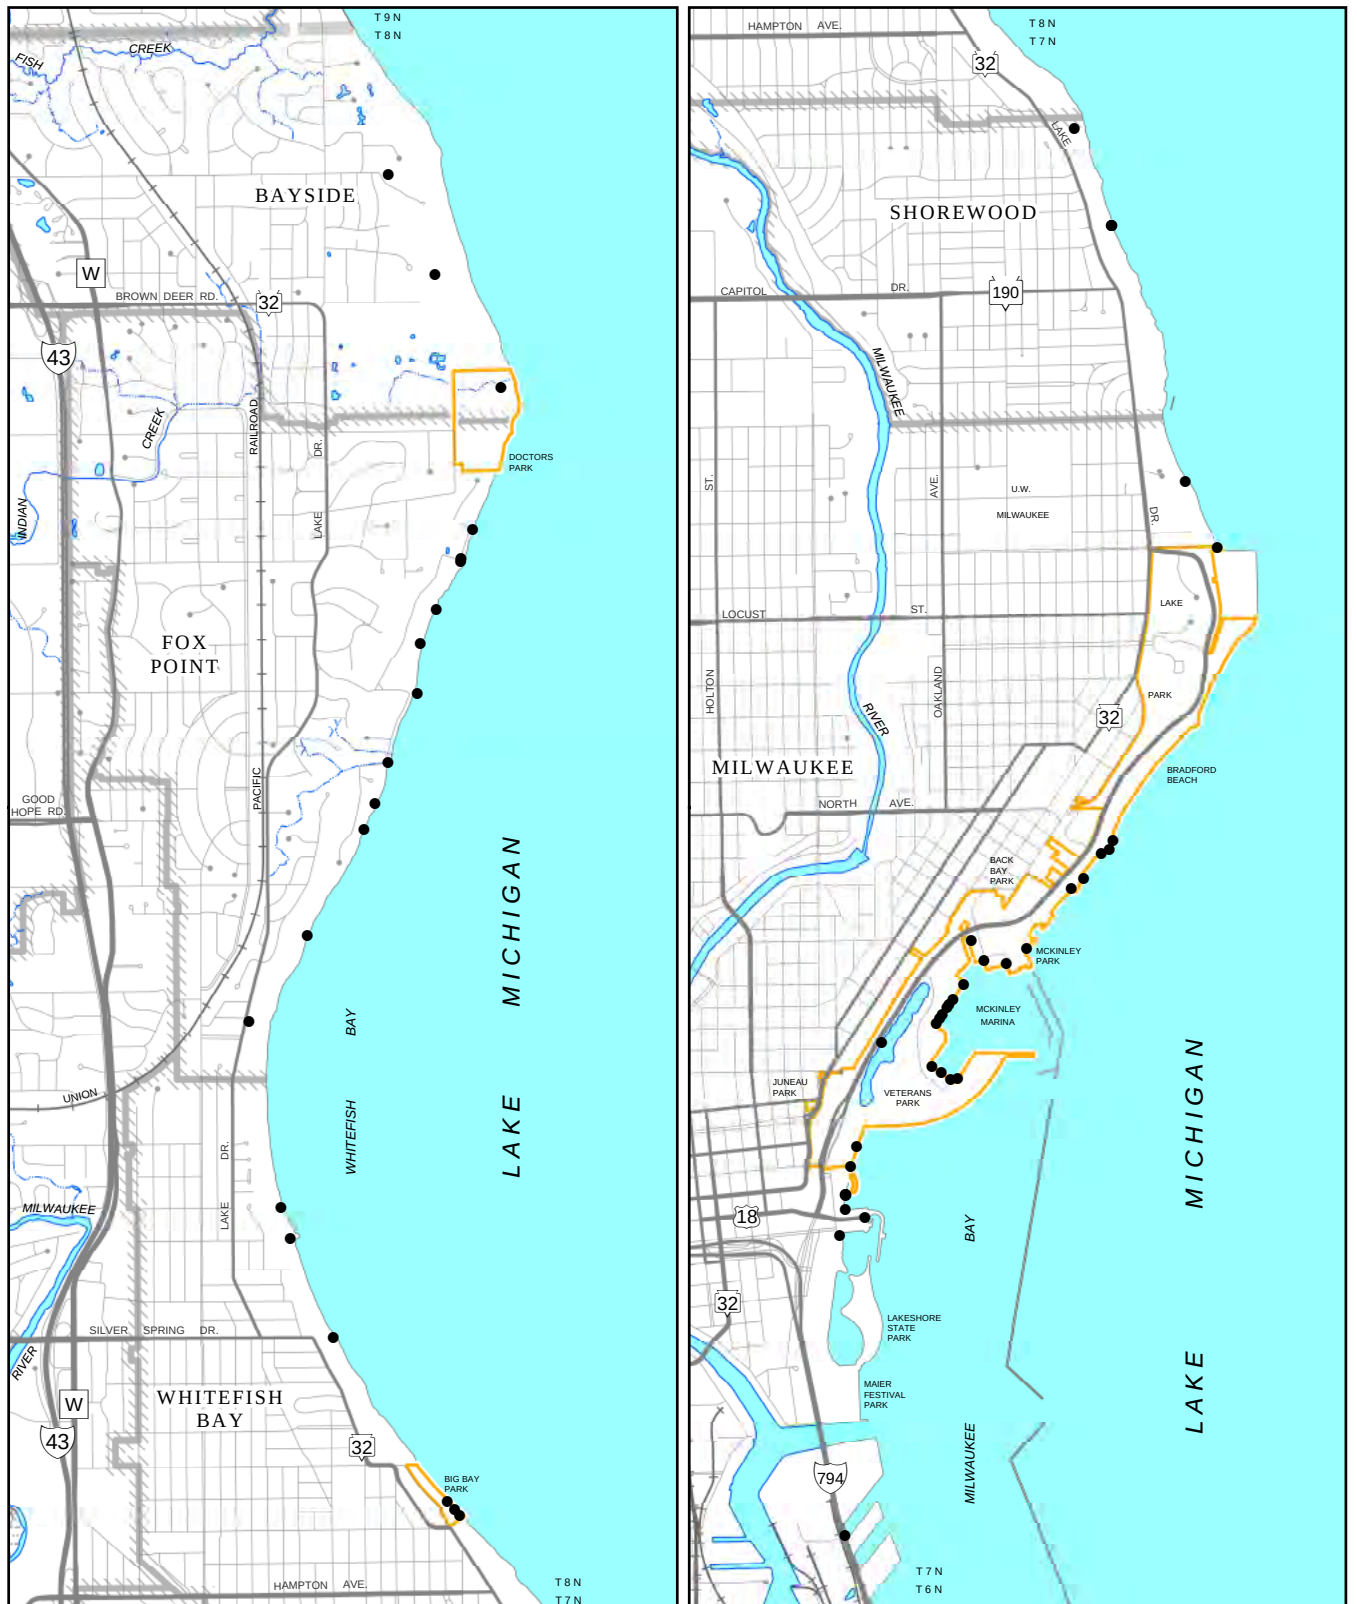
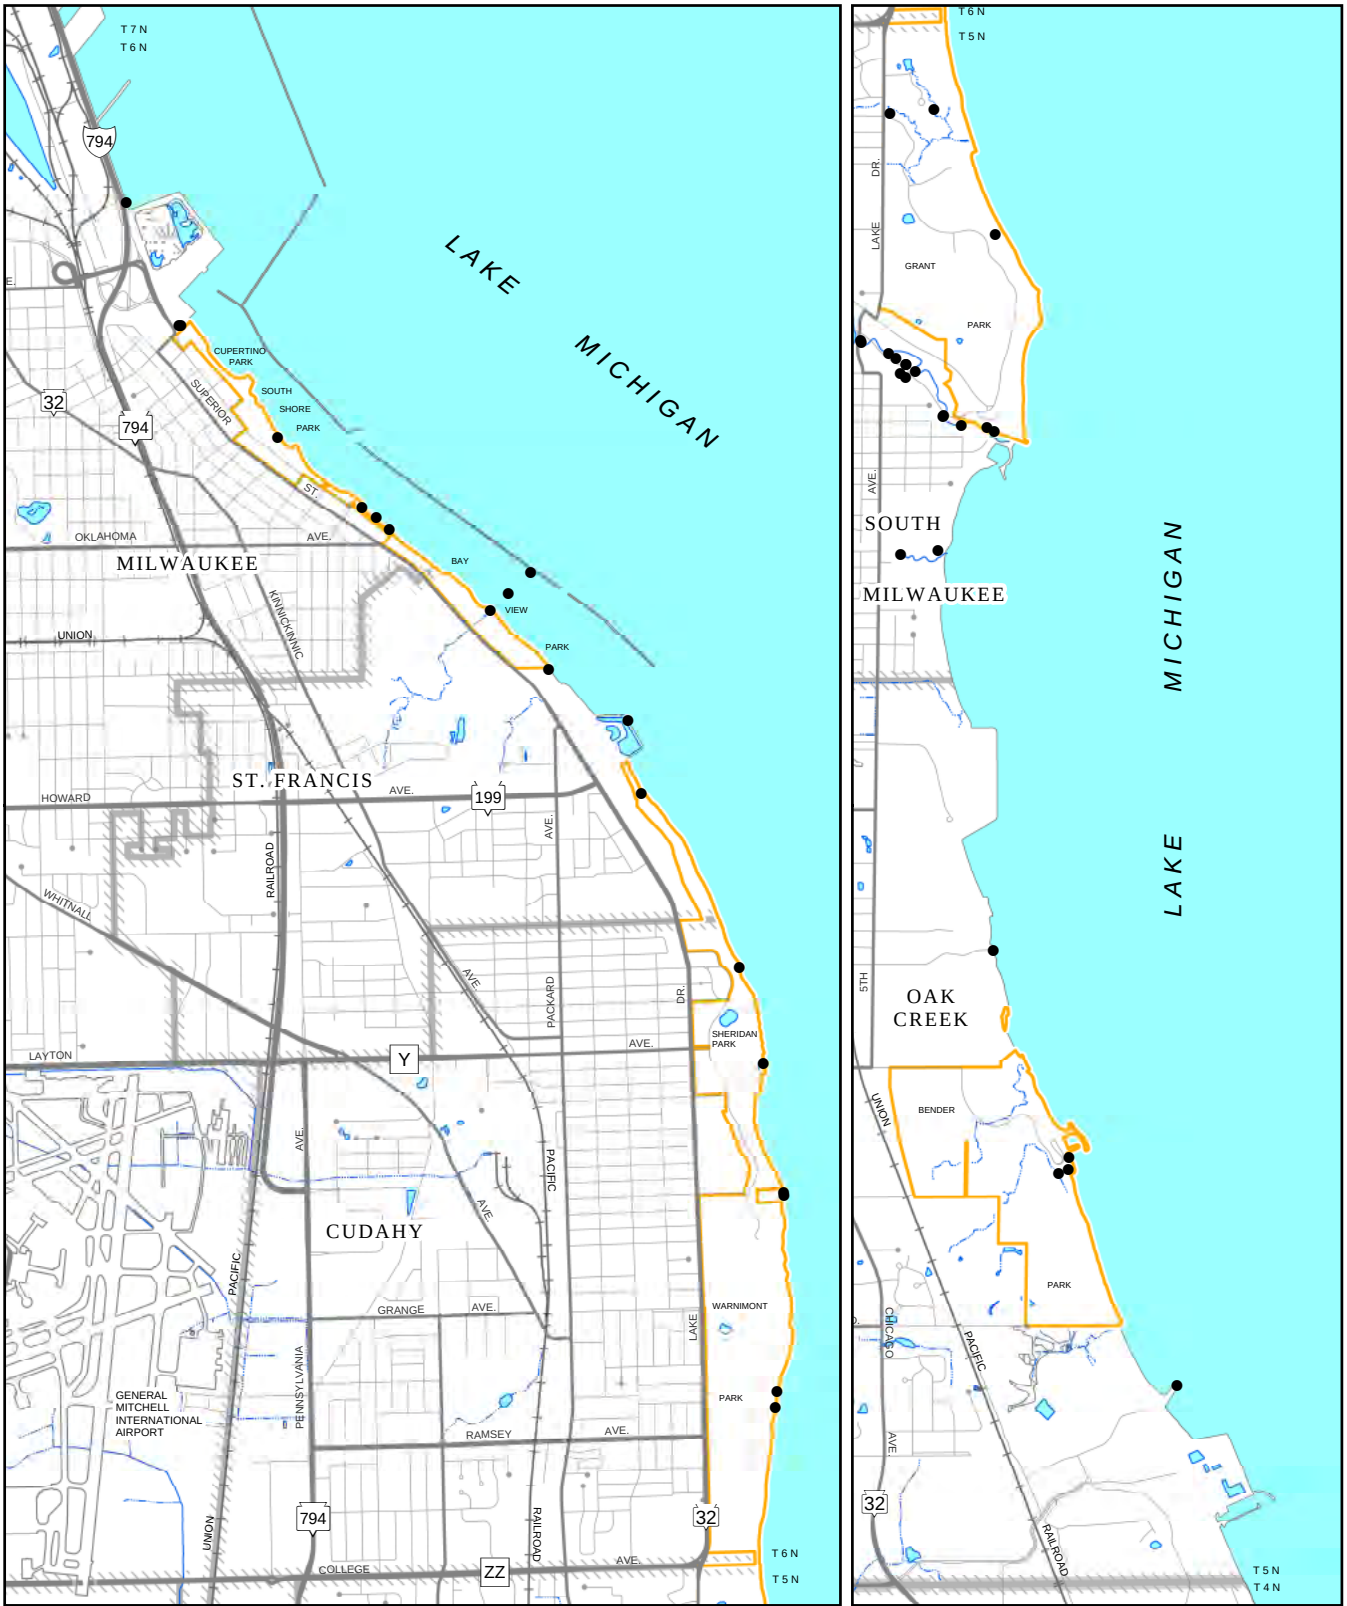
## Map 2.5

### Stormwater Outfalls Along the Milwaukee County Lake Michigan Coastline

- STORMWATER OUTFALL
- ▭ COASTLINE MANAGEMENT STUDY AREA

Stormwater infrastructure that discharges into the Lake can be potentially damaging to the coastline and is susceptible to damage from coastline impacts. Negative impacts from such outfalls include declines in water quality and erosion. These impacts can be exacerbated during periods of heavy rainfall as high amounts of stormwater, the volume of which fluctuates with the amount of precipitation collected in a stormwater system, may be conveyed and discharged over relatively short time spans. Increases in water volume and speed can significantly increase the erosive impact of stormwater discharge. In addition, stormwater infrastructure can be susceptible to potential damage from coastline impacts particularly as result of high water levels in the Lake. High lake levels can flood an outfall and cause debris to enter stormwater infrastructure, or subject stormwater infrastructure to damage from erosion around outfalls. The general locations of outfalls in Milwaukee County that discharge into Lake Michigan are shown on Map 2.5.

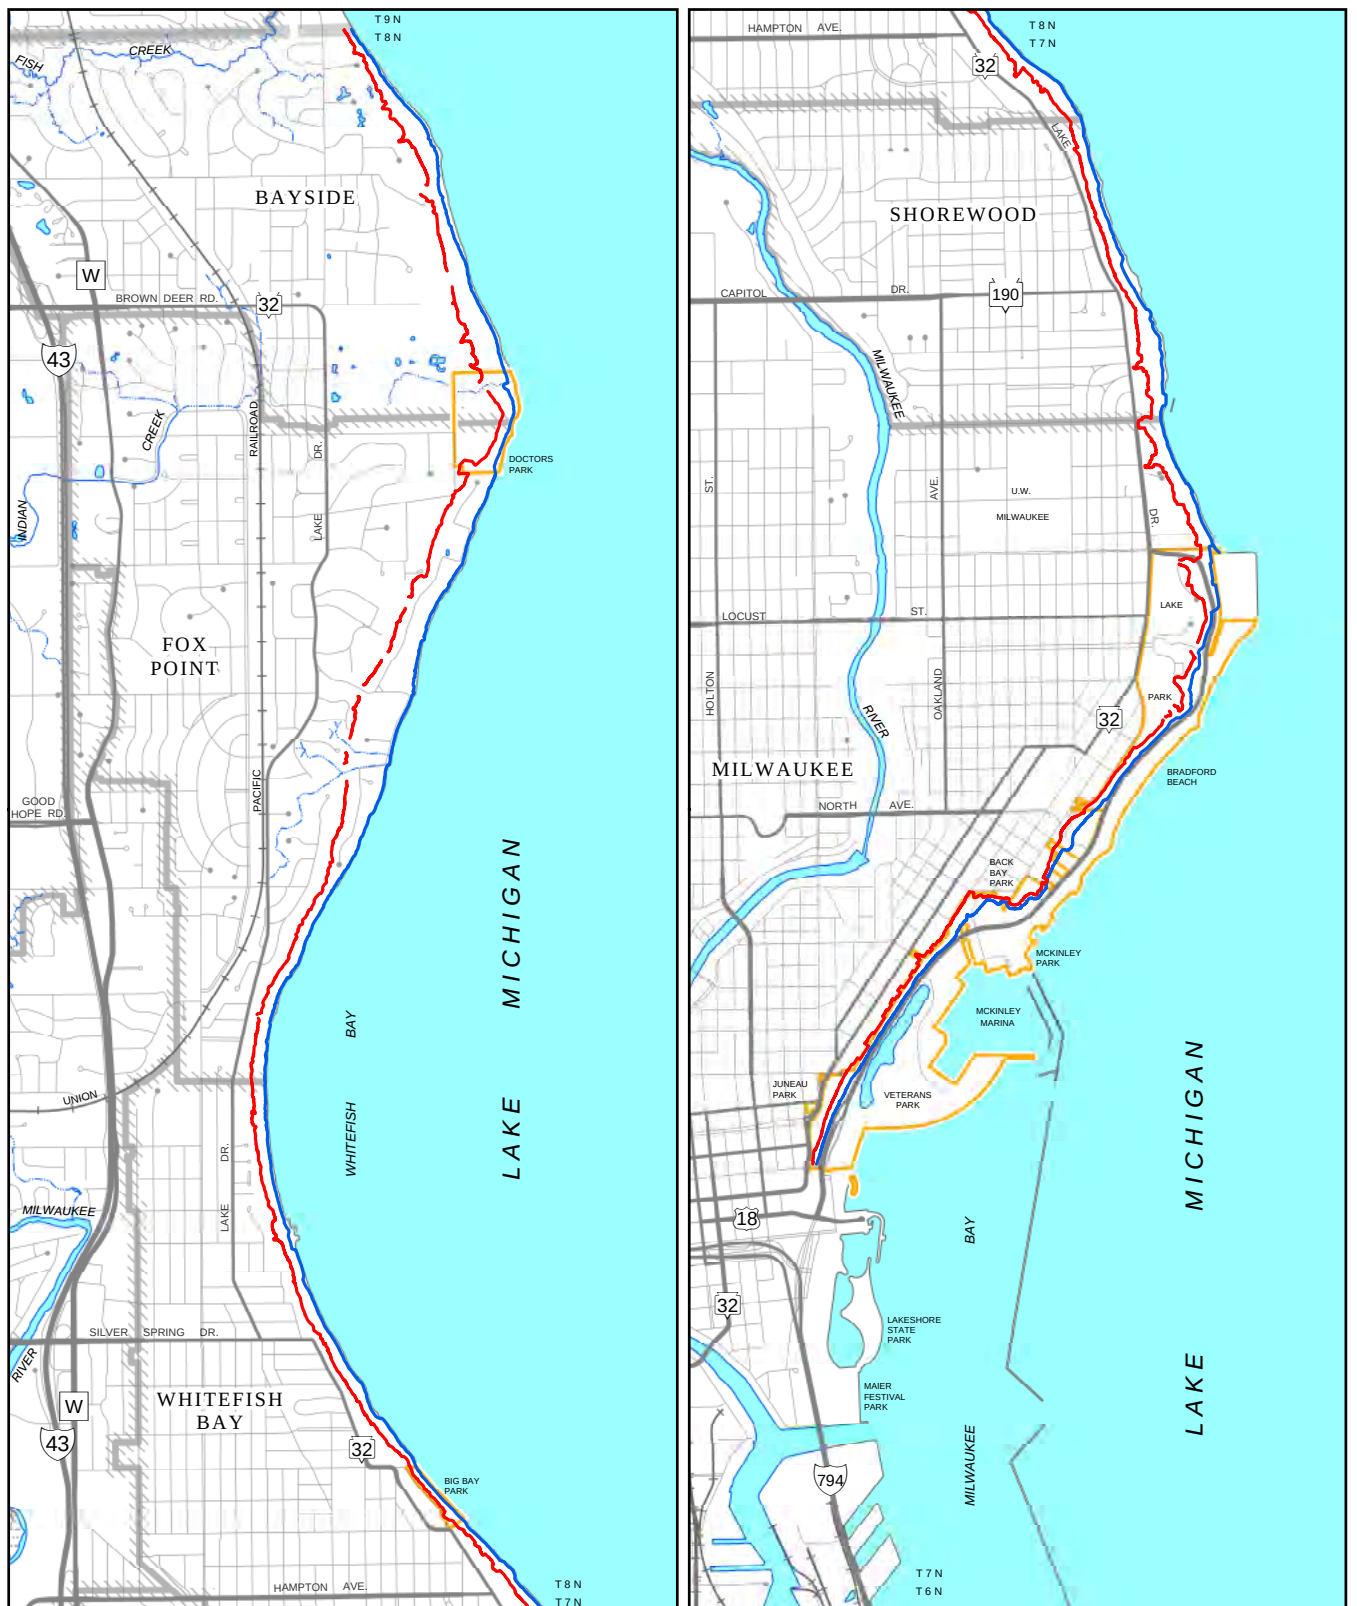
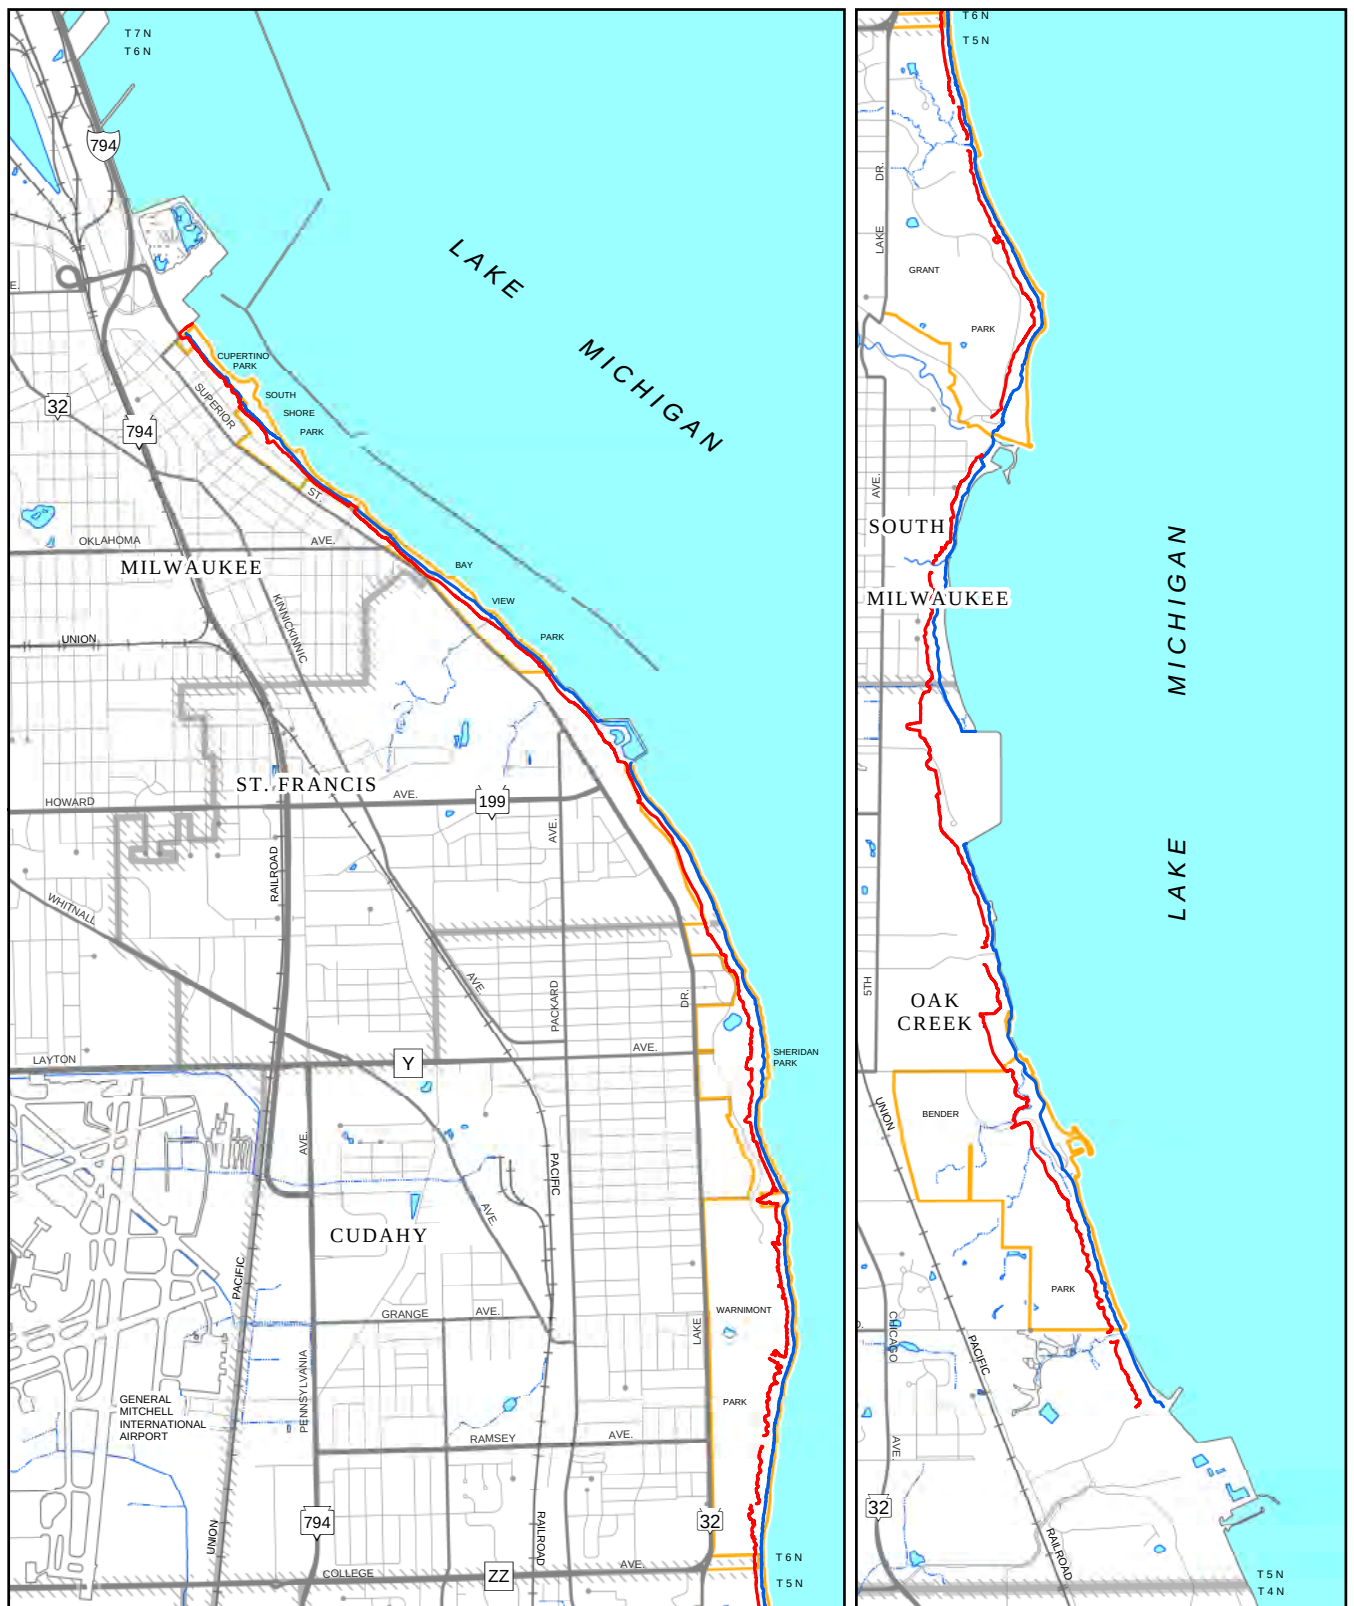
## Map 2.8

### Approximate Bluff Crest and Bluff Toe Locations Along the Milwaukee County Lake Michigan Coastline

Note: Based on 2015 Lidar Topo but aligned in various locations to data provided to SEWRPC by Wisconsin Coastal Management Program
