ADDENDUM NUMBER 2

SMITH PARK PAVILION
RETAINING WALL REPAIRS
Site #708, Bldg. #1470
5462 North 33rd Street
Milwaukee, WI 53209

Project Number: P603-15661

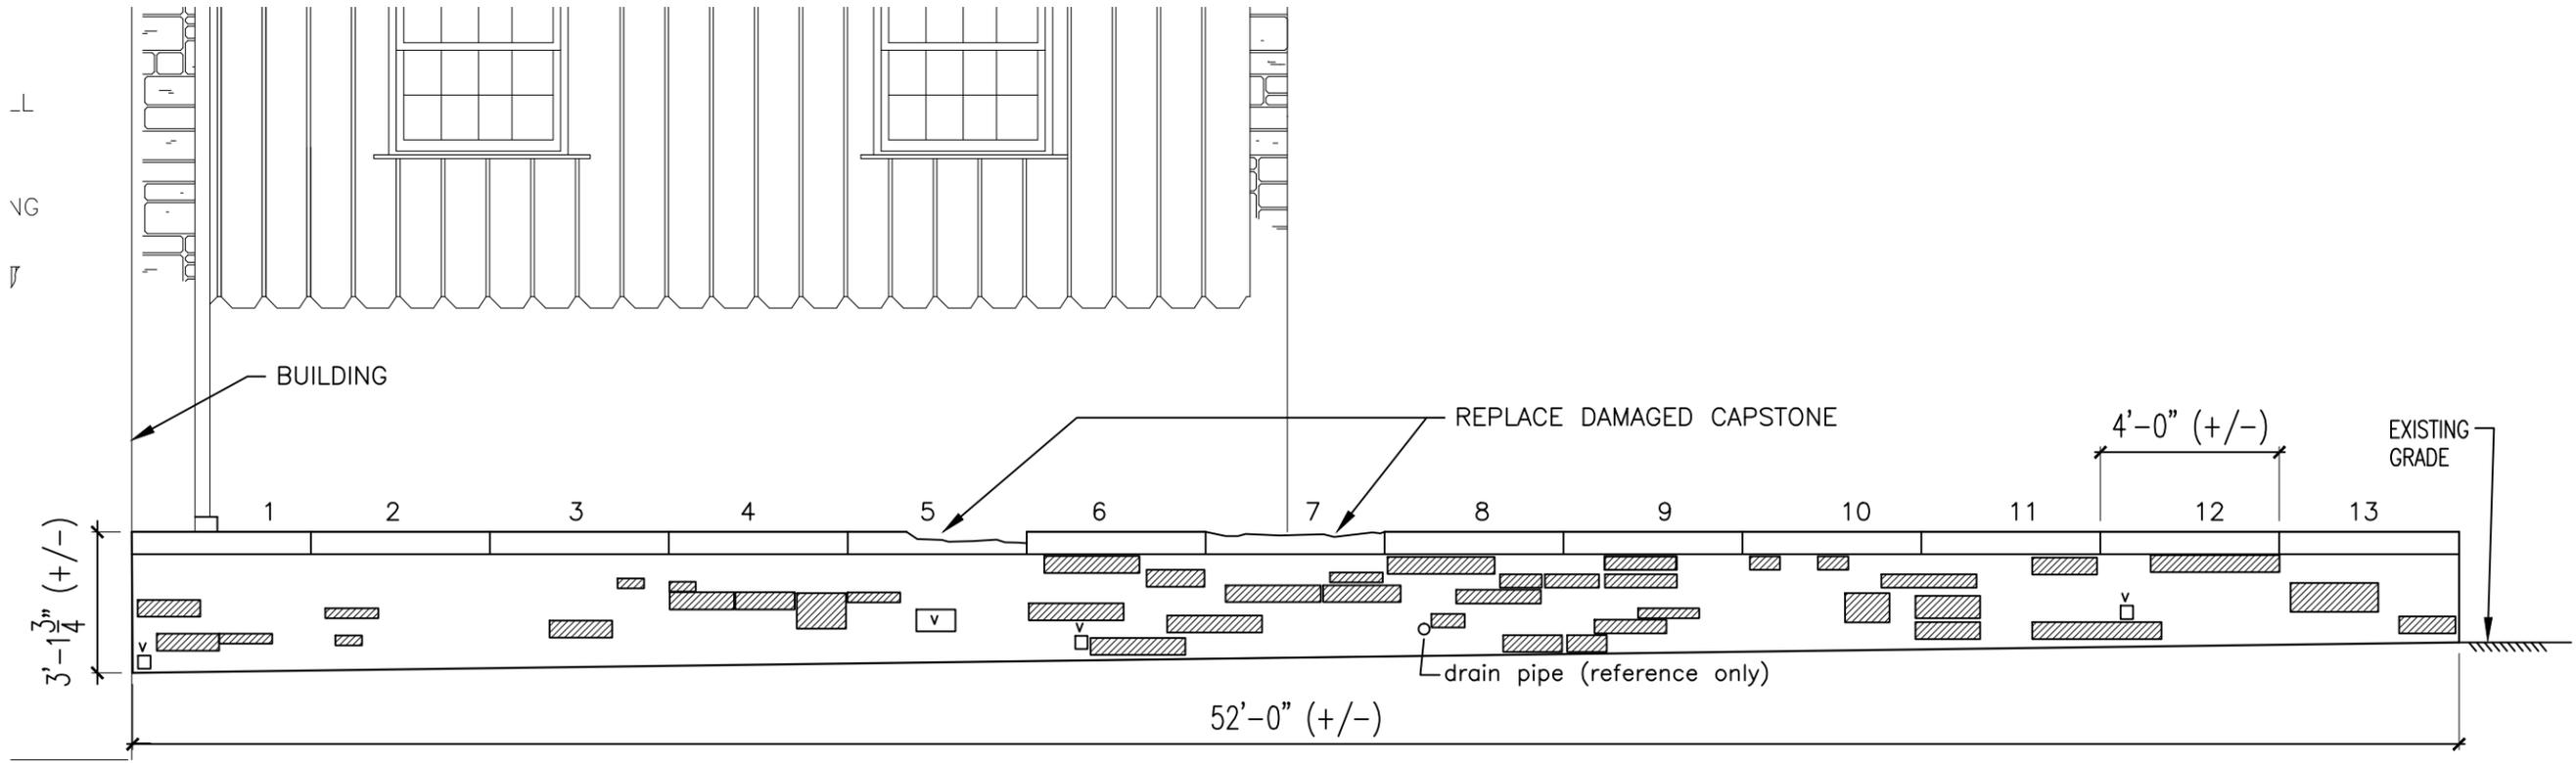
NORTH WALL RESTORATION (REPAIR QUANTITIES)

(LOOKING WEST) SCALE 1/4" = 1'-0"

- 35.00 SF PARTIAL DEPTH REPAIR
- 20 LF EPOXY RESIN INJECTING

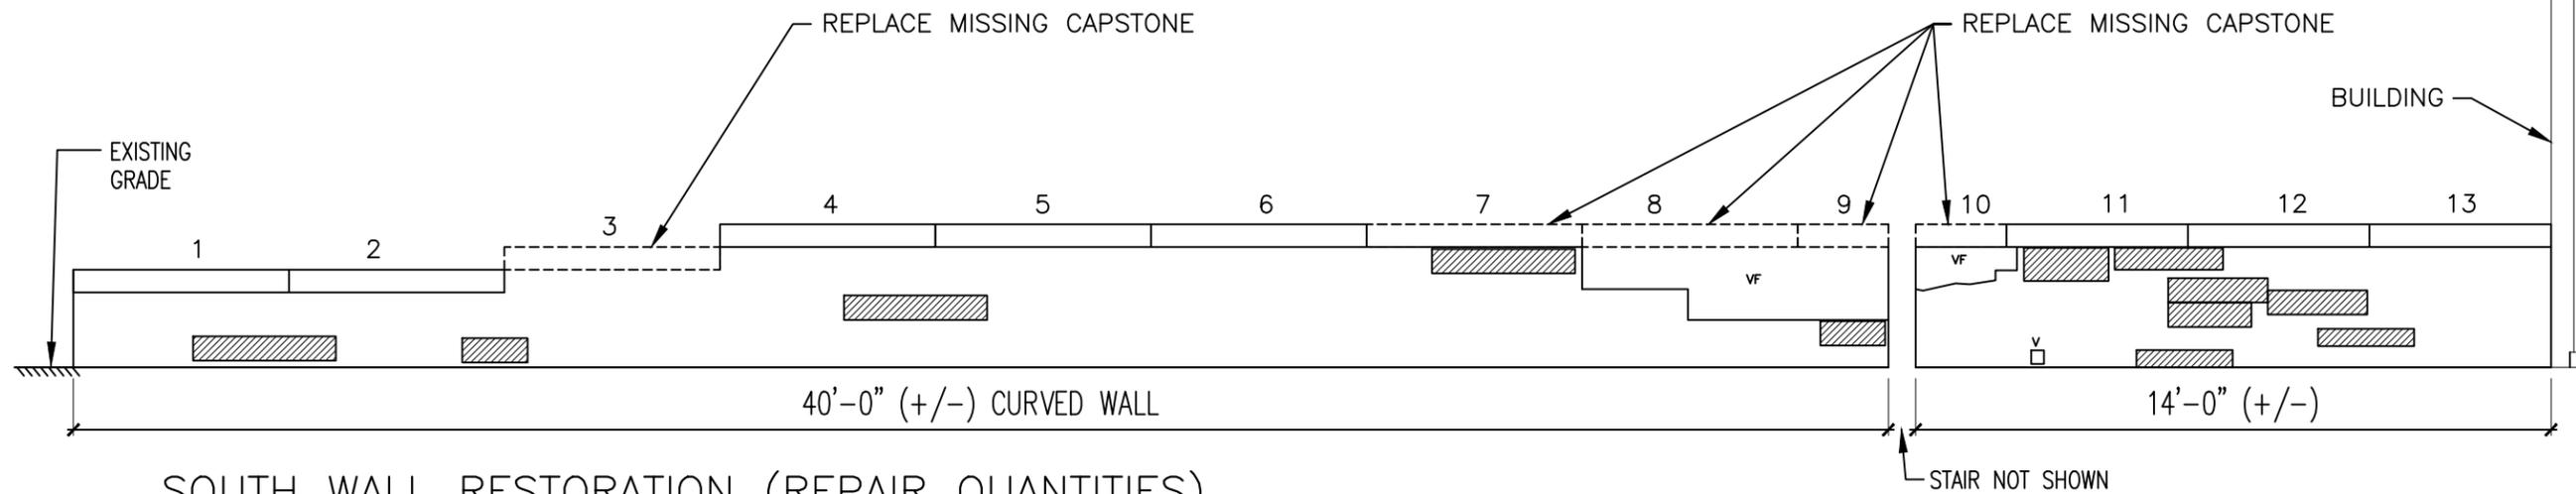
SOUTH WALL RESTORATION (REPAIR QUANTITIES)

(LOOKING WEST) SCALE 1/4" = 1'-0"

40.00 SF PARTIAL DEPTH REPAIR

16.00 SF FULL DEPTH REPAIR

30 LF EPOXY RESIN INJECTING

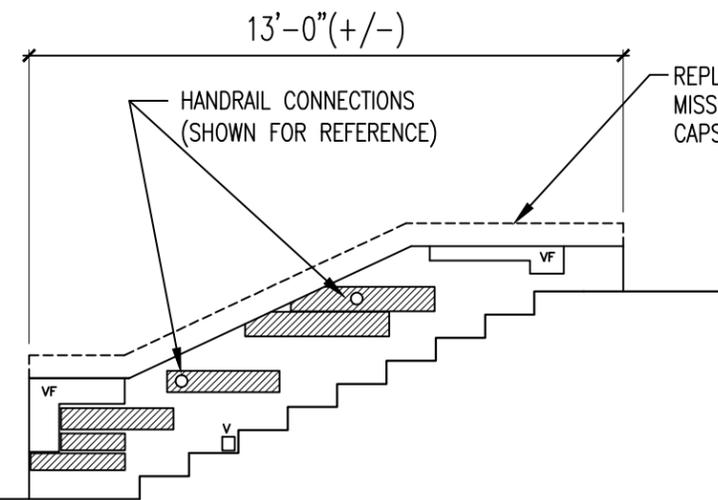
SOUTH PORTION OF SOUTH STAIR WALL RESTORATION

(LOOKING SOUTH)

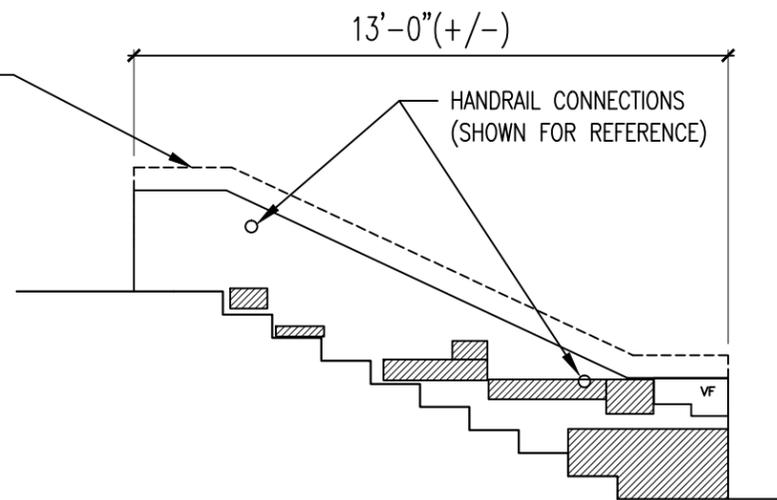
NORTH PORTION OF SOUTH STAIR WALL RESTORATION

(LOOKING NORTH)

REPLACE MISSING STAIR RAILING WITH NEW GALVANIZED METAL PIPE RAILING, APPROX. 10'-0" (+/-) LONG, MATCH EXISTING
