Submitted by:
AECOM
Vernon Hills, IL
Project No. 60159452
September 28, 2010

Structural Engineering Evaluation of the Estabrook Park Dam

Milwaukee River, Milwaukee, WI

RE: Structural Engineering Evaluation of the Estabrook Park Dam Located on the Milwaukee River, Milwaukee, Wisconsin – AECOM Project No. 60159452

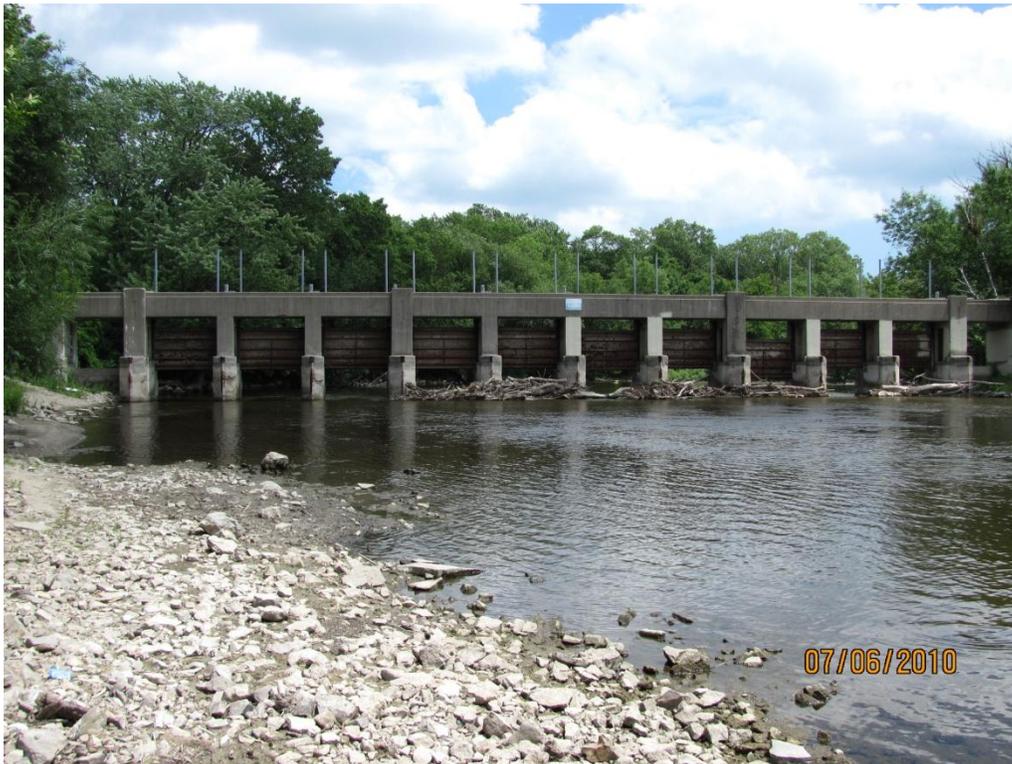
Photo 1: Upstream view of gated spillway structure of Estabrook Dam, gates open.

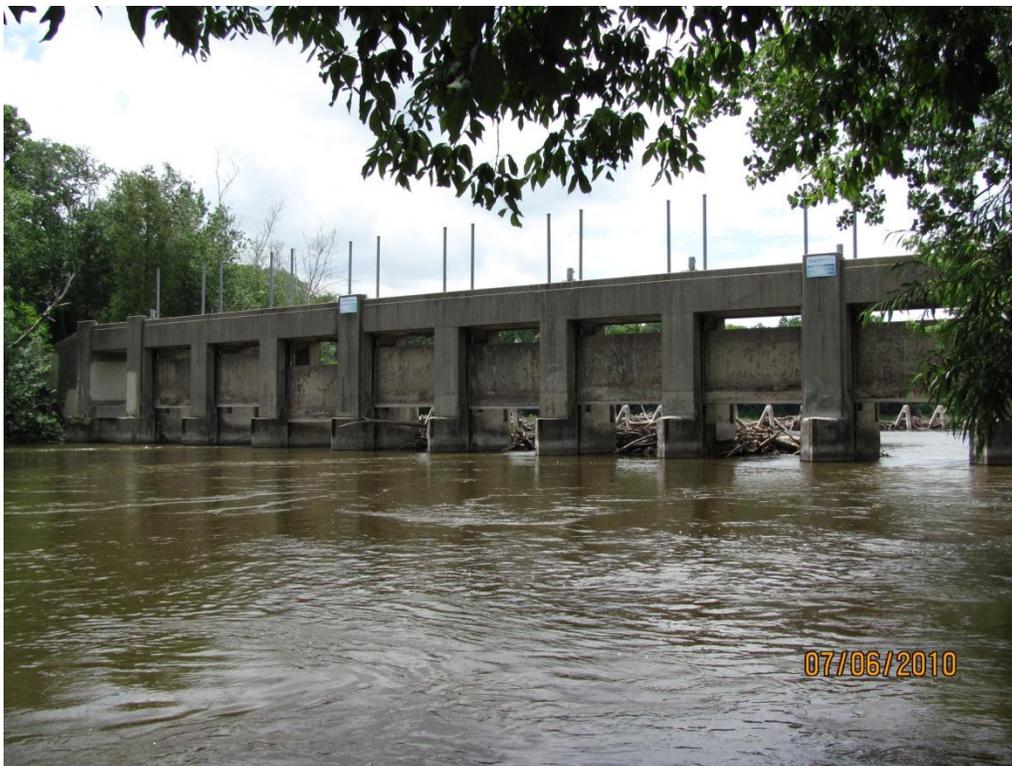
Photo 2: Downstream side of the gated spillway structure of Estabrook Dam, gates open.

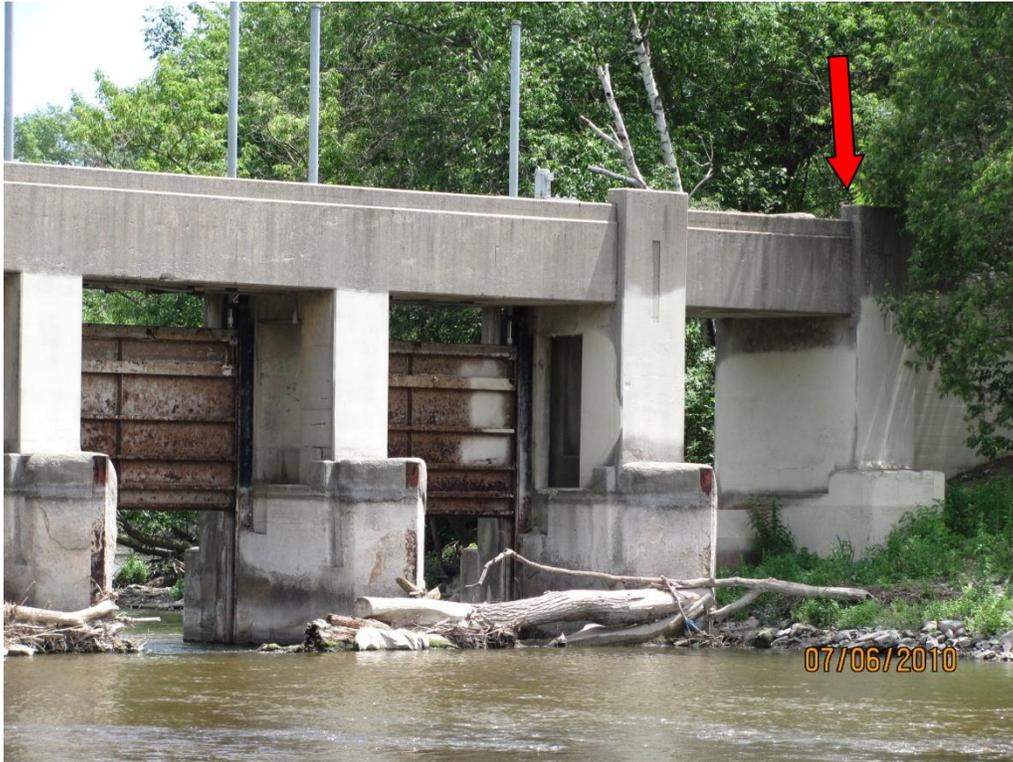
Photo 3: View of the right side of the gated spillway structure. Note arrow pointing to the right abutment.

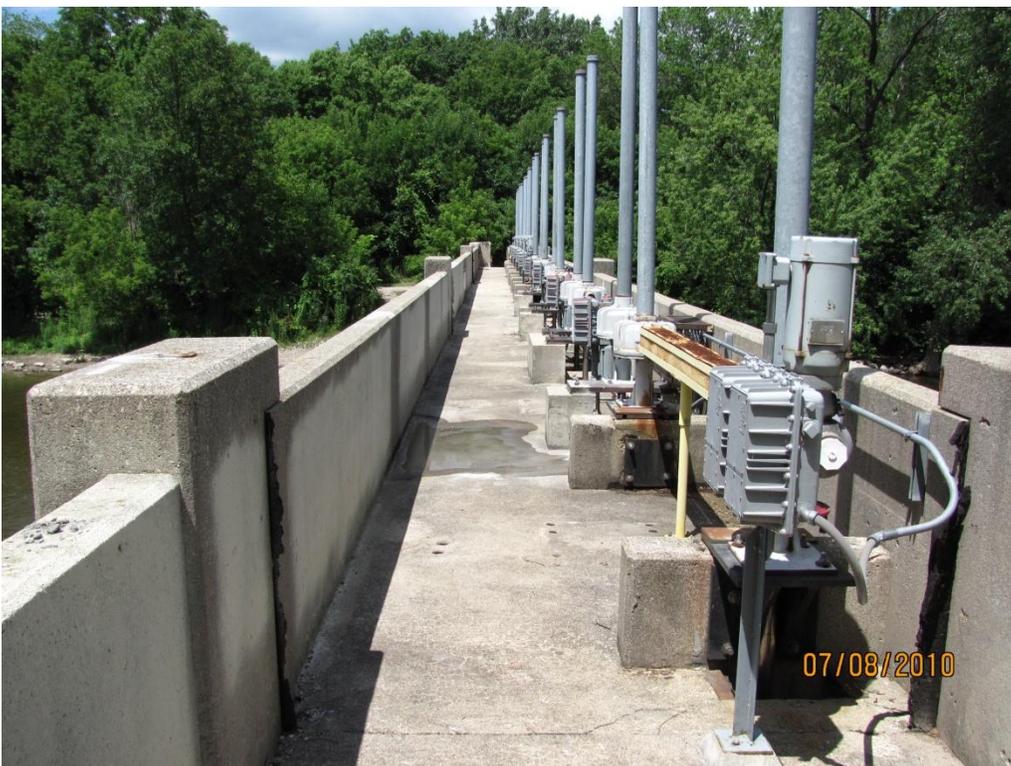
Photo 6: View of the operating deck from the right abutment, looking north.

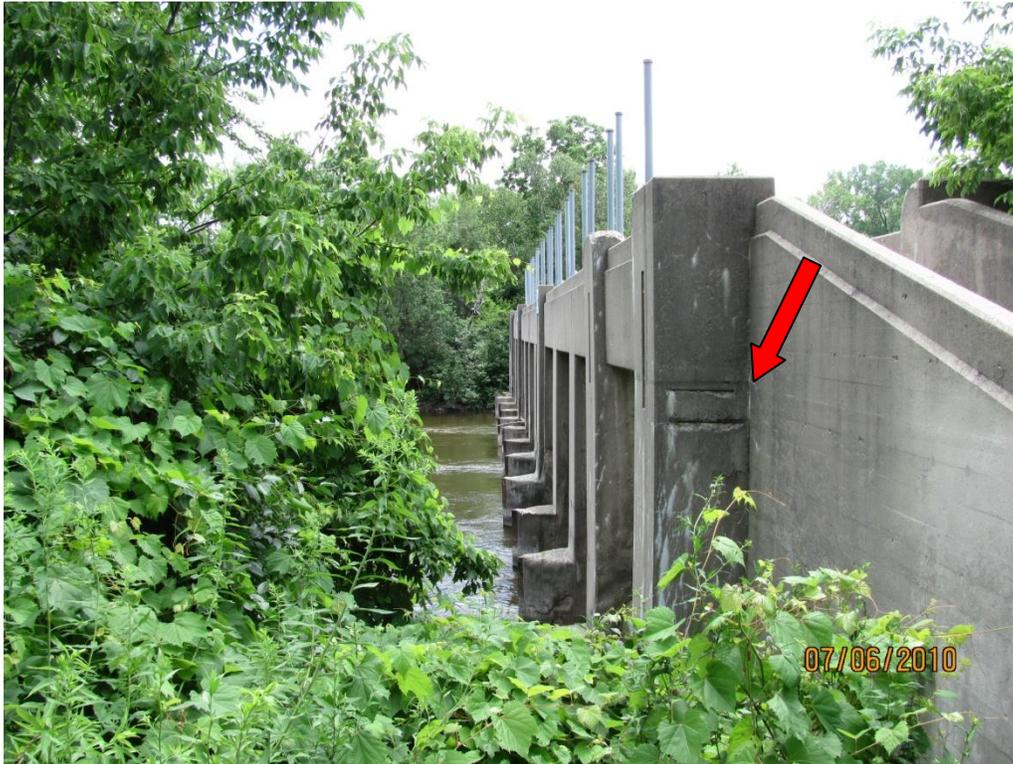
The left abutment walls were in overall fair condition. The walls at the left end near the pedestrian gate exhibited cracking, efflorescence and spalling. Efflorescence is a whitish deposit left on the surface from water flowing through cracks in the concrete and evaporating on the surface. Spalling is the cracking and falling off of the concrete surface from the concrete substrate behind. The spalling was more frequent near the ground line and at the top of the walls. Both abutment walls running left to right have cracks and spalls at the top of the walls and above stair treads on the inside face of the walls. Concrete disintegration, due to freeze thaw damage, was present at all of the stairs. The right side of the abutment pier exhibited widespread cracking and efflorescence, in addition to delaminations on the upstream side of the pier above Elevation 37.75 feet and spalling on the downstream side of the pier below Elevation 34.0 feet. Delaminations are defined as spalls that have not detached from the substrate yet.

Photo 13: View of efflorescence and exposed reinforcing steel (arrow) of the left abutment.

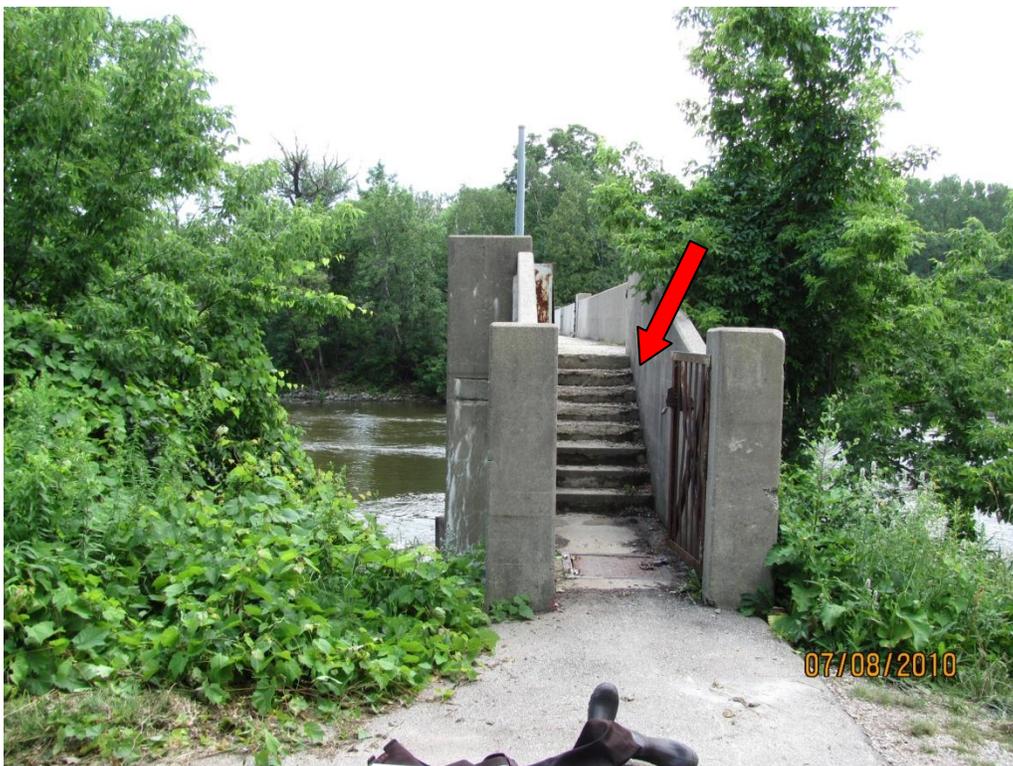
Photo 14: View of the left abutment. Note disintegration of the top five stair nosings (arrow).

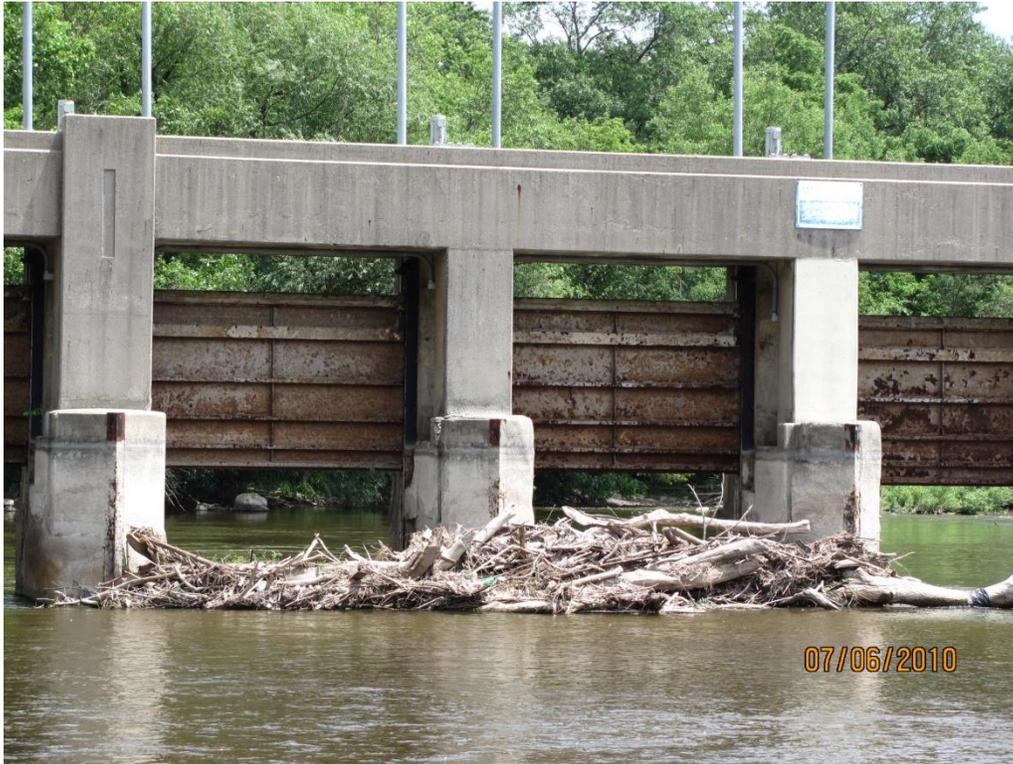
Photo 15: Typical view of the upstream side of piers (Piers P4, P5 and P6).

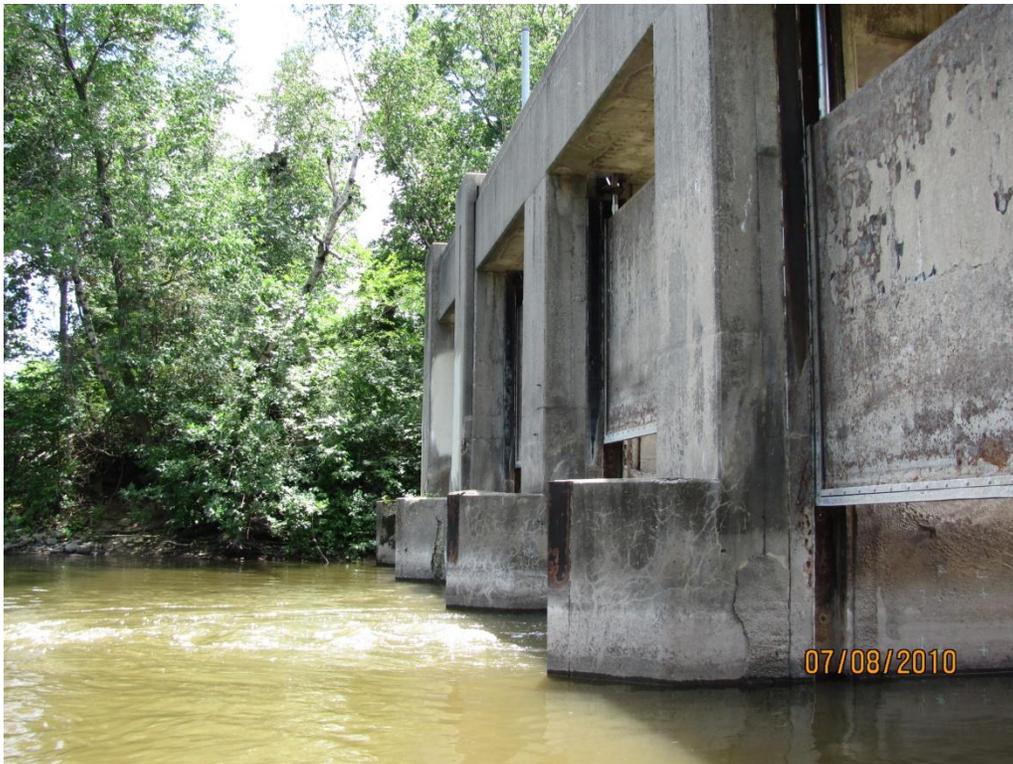
Photo 16: Typical view of the downstream side of piers (Pier 9, 10 and 11, from right to left).

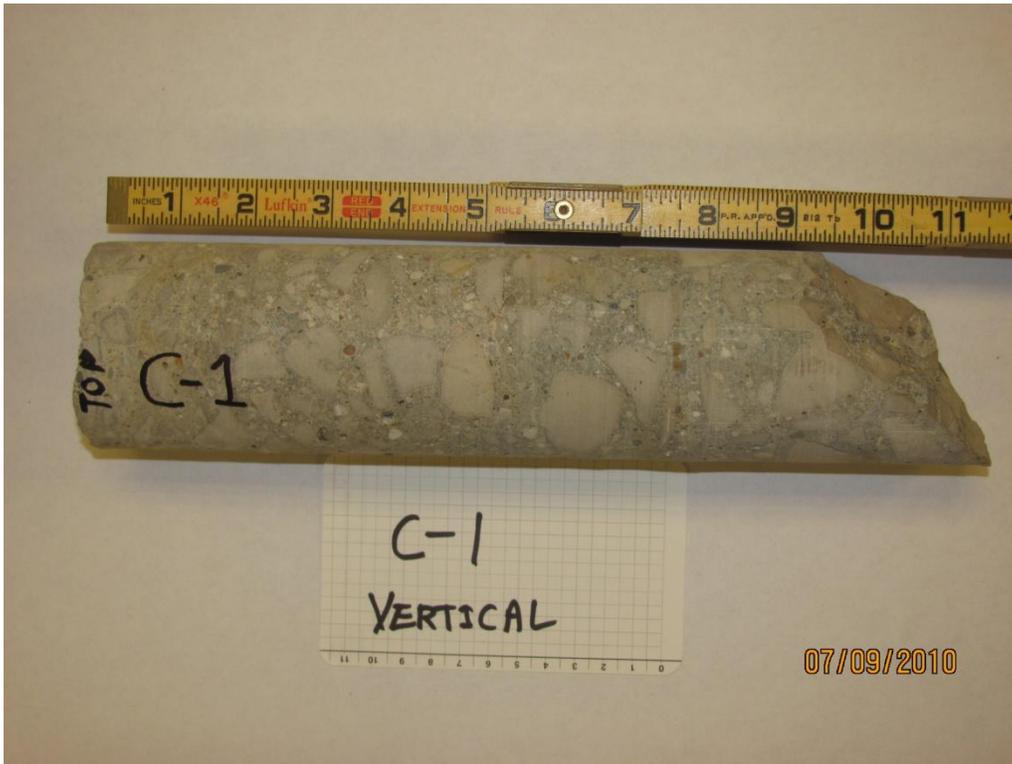
Photo 29: Core C-1 extracted from top of pier at Elevation 37.75', Pier 1.

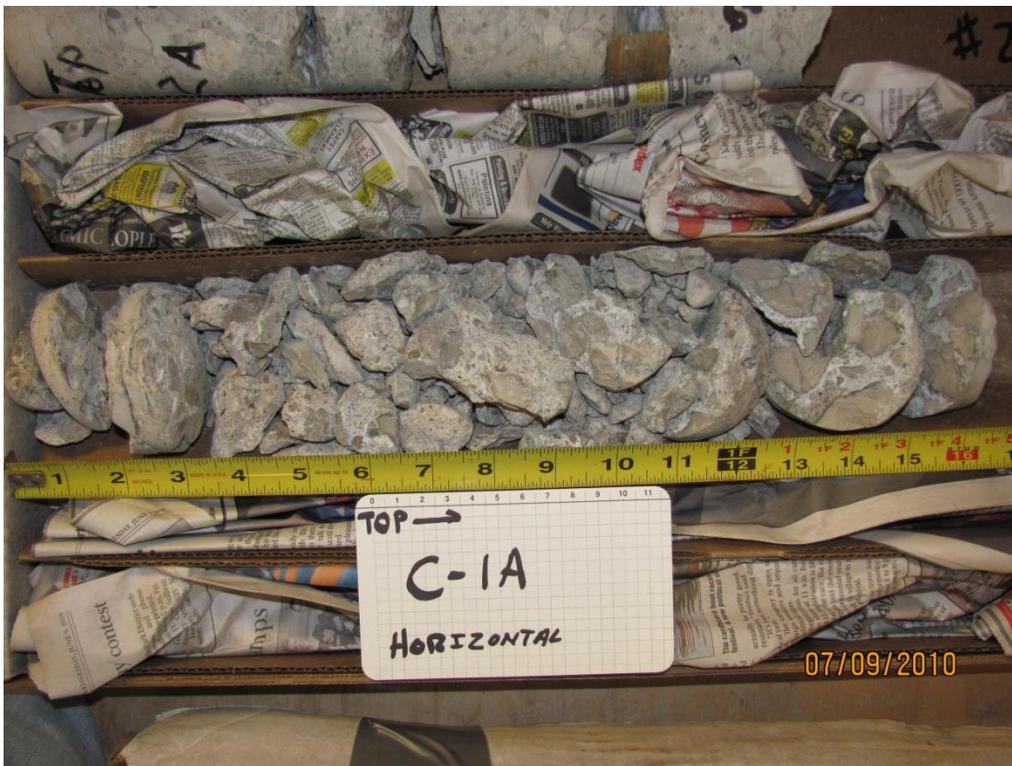
Photo 30: View of Core C-1A, Pier 1. The core broke apart during coring operations.

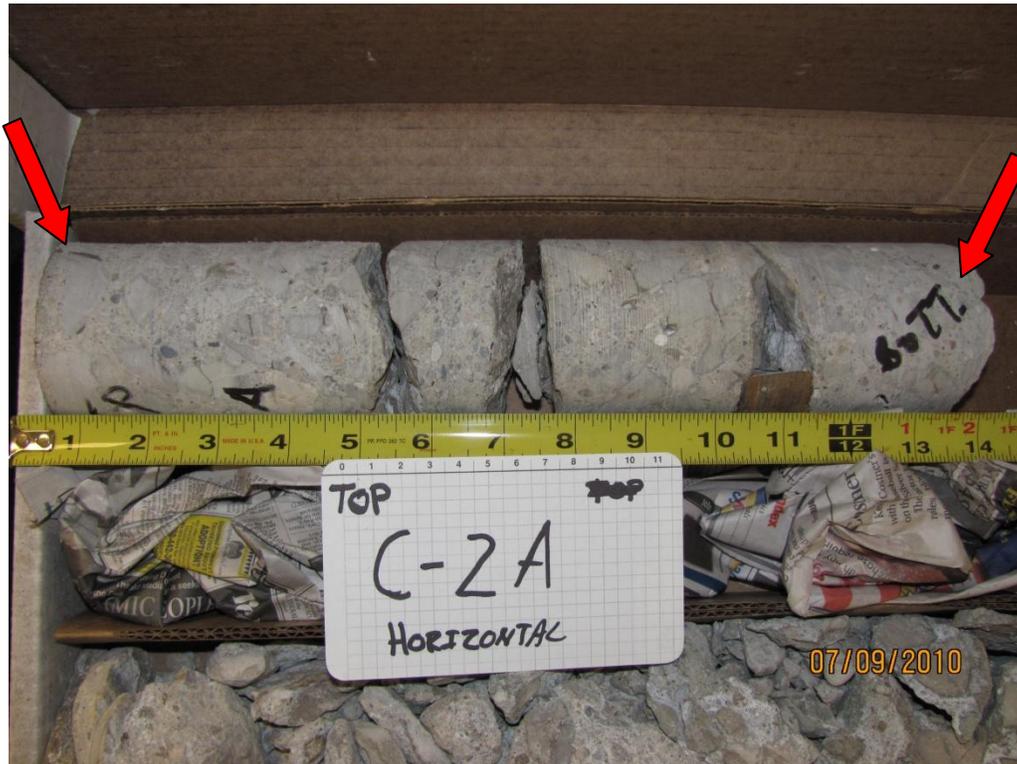
Photo 31: View of Core C-2A (arrows), Pier 3. The core broke apart during coring operations.

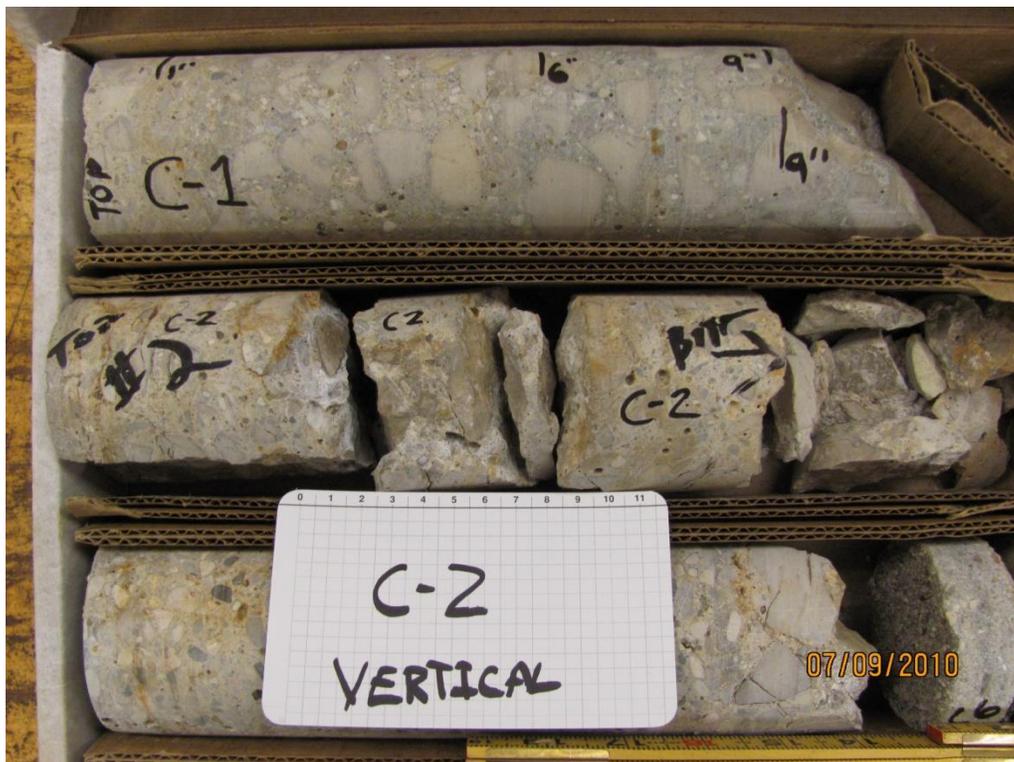
Photo 32: View of Core C-2 extracted from top of Pier 3 at Elevation 37.75'. Core broke apart during coring operations.

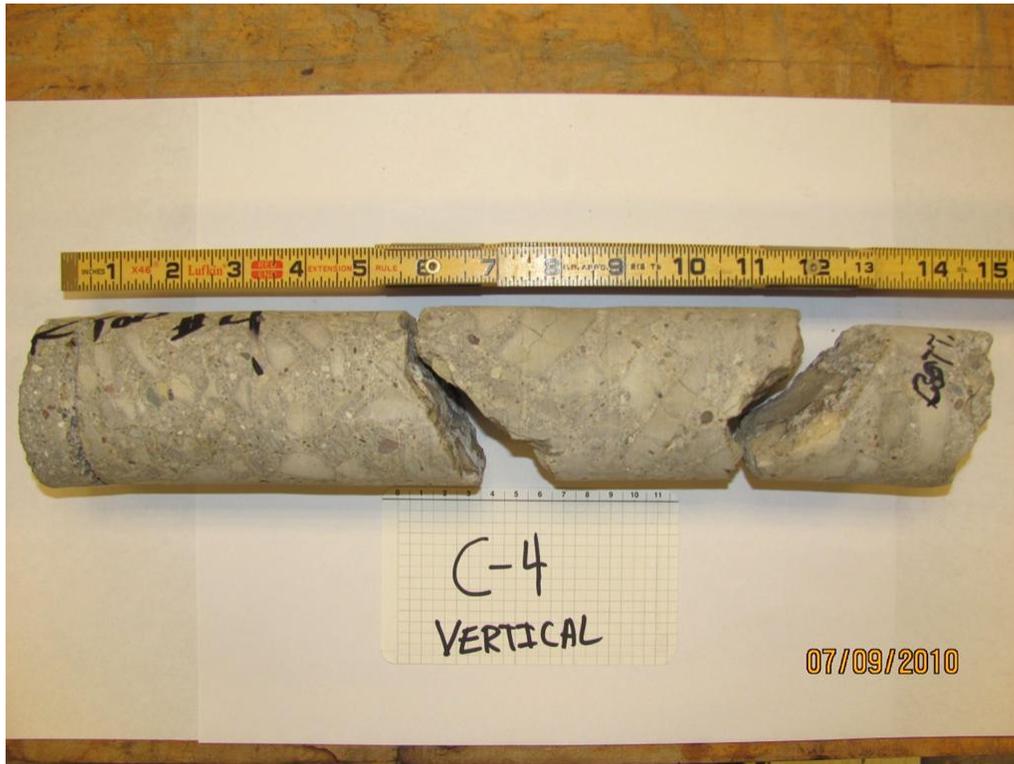
Photo 35: Core C-4 extracted from top down of Pier 7 at Elevation 37.75'.

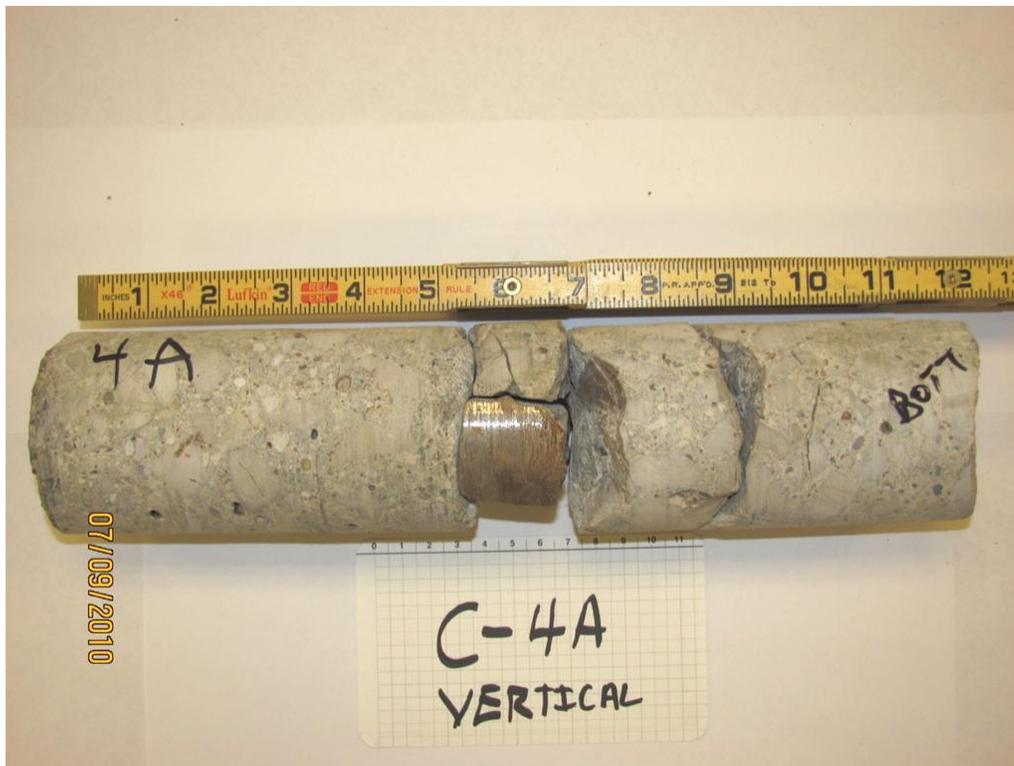
Photo 36: View of Core C-4A; note on photo should read C-4A, Horizontal.

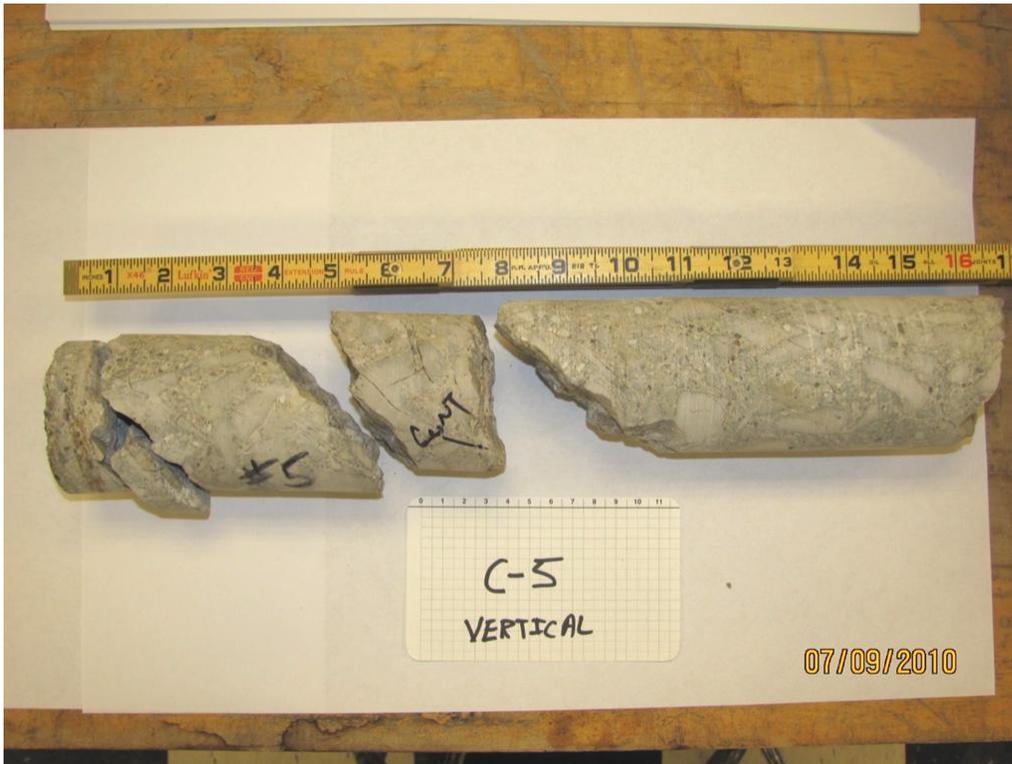
Photo 37: Core C-5 extracted from top down of Pier 9 at Elevation 37.75'.

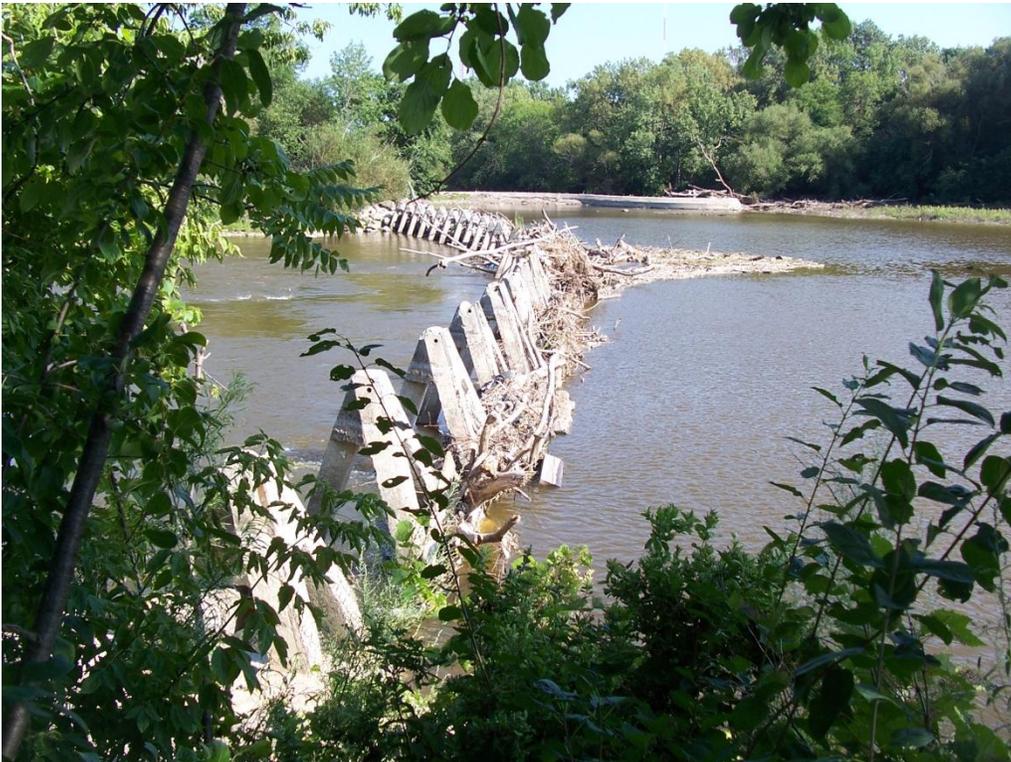
Photo 44: View of ice breakers with spillway beyond.

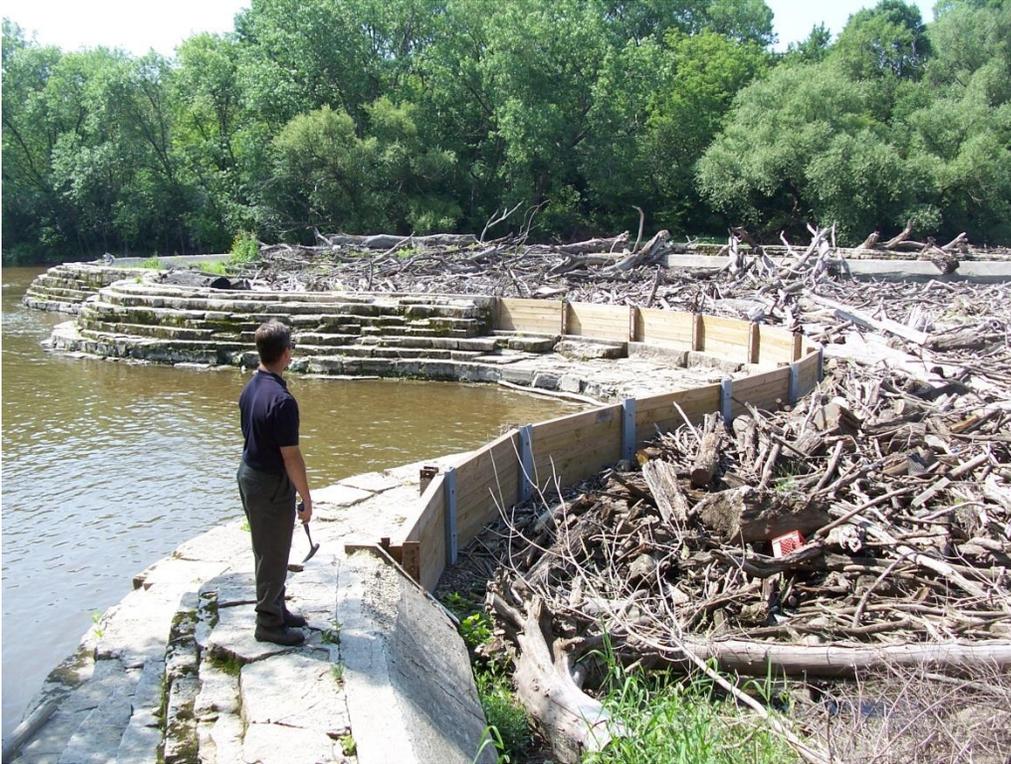
Photo 45: View of spillway at stoplog section, June 2010.

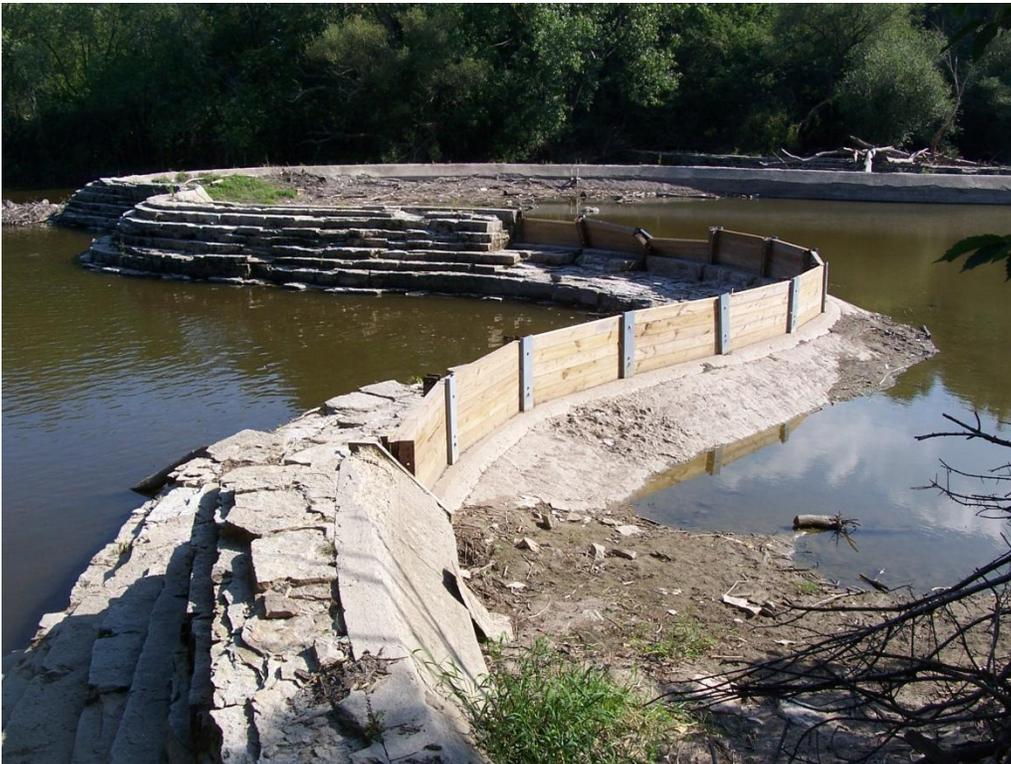
Photo 46: View of spillway at stoplog section, after July 2010 flood. Note bent wood stoplog post.

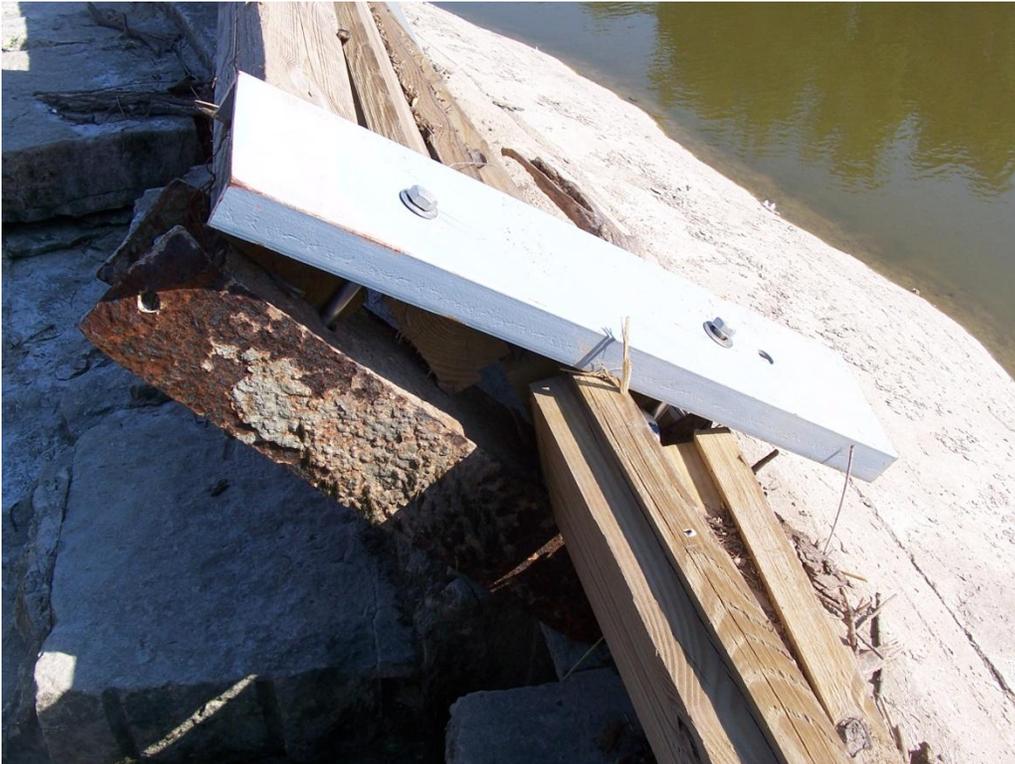
Photo 47: Close-up of bent stoplog post, see photo 44.

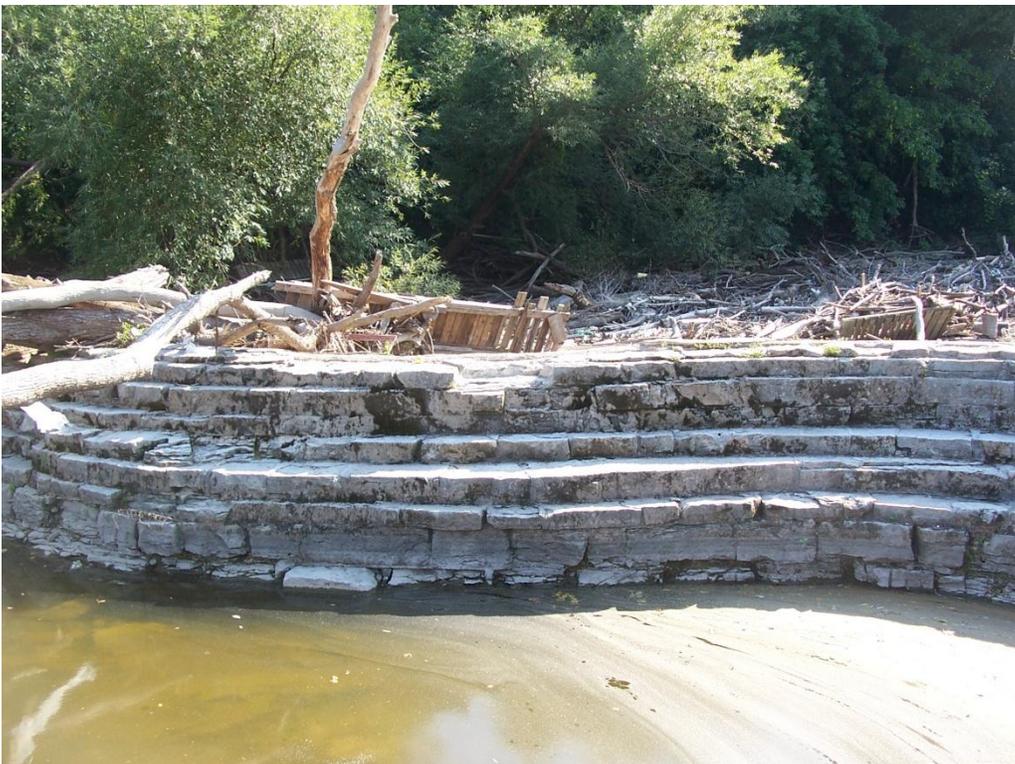
Photo 48: Masonry facing on spillway near south shoreline.
